STAFF REPORT ACTION REQUIRED

Alteration to a Designated Heritage Property (revised application) – 129 St. Clair Avenue West (Deer Park United Church)

Date:	February 16, 2012
To:	Toronto Preservation Board Toronto and East York Community Council
From:	Acting Director, Policy & Research, City Planning Division
Wards:	Ward 22 St. Paul's
Reference Number:	P:\2012\Cluster B\PLN\HPS\CC\March 5/6 2012\ccHPS15

**129 ST. CLAIR AVENUE WEST
HERITAGE IMPACT ASSESSMENT
16 November 2011**

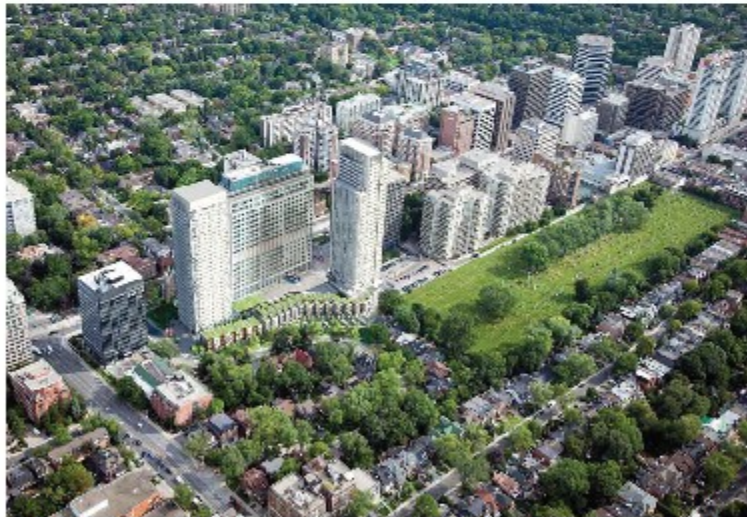
Fig 1. Rendering of proposed development in relation to adjacent redevelopment site and site context (DSAI).

The application proposes the adaptive reuse of a portion of the church structure to accommodate retail and or amenity uses, a high-rise residential tower to the south, and six 3-storey townhouses facing Foxbar Road. The current conservation strategy involves the in situ retention of the north portion of the original church structure and the 1961 addition, and the removal of the transept and the 1931 Sunday school wing addition. A portion of the remaining roof will be removed to create an outdoor courtyard.

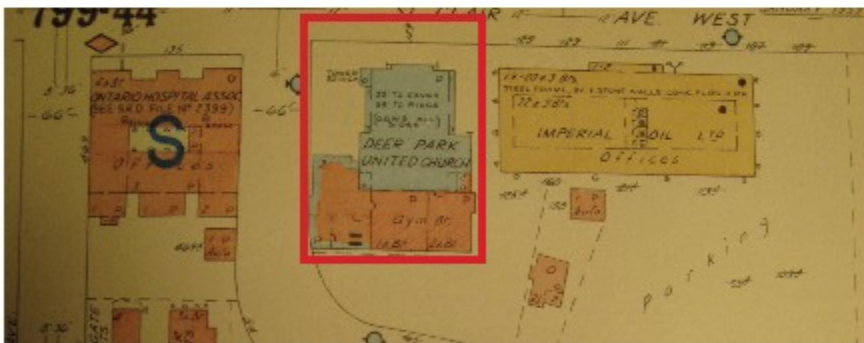
Fig 8. 1959 Fire Insurance Plan, Underwriters Insurance. (Annotated by ERA)

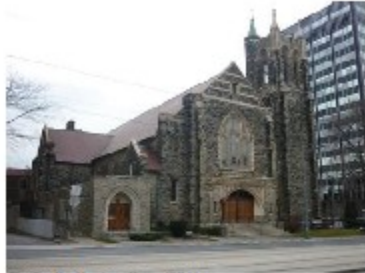
Fig 9. North elevation. (ERA)

The 1912 church, designed by Sharp & Brown architects, is a credit valley stone Neo-Gothic building with terra cotta detailing, and a cross-gabled red slate roof. The structure faces onto St. Clair Avenue and is marked with a tall square tower at the north-west corner. The building is cruciform in plan with a large sanctuary including balcony at the north end, shallow side aisles on the east and west side, east and west transept, and an altered chancel at the south end. The church has two corner stones, one from the second Deer Park Presbyterian Church (1888) found to the east of the main entry, and the corner stone from this current structure (1911) to the west of the main entry.

The principal entrance is located on the north facade, a wide straight stair leads to the projected round-arched entry porch decorated with terra cotta relief panels. The entryway is comprised of a pair of double wooden doors with multiple leaded lights above. Over the entry porch is a large stained glass window in a terra cotta surround. A secondary entrance on the north facade is located just east of the principal entryway in the east narthex addition, in the form of a double entry door within a pointed stone arch. The gable end is decorated with four horizontal bands of terra cotta and a central louvered terra cotta roof vent opening.

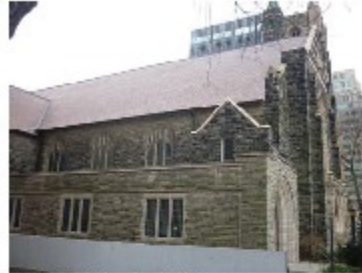
Fig 10. East elevation. (ERA)

The east side of the building features the narthex addition and a below grade well towards the rear of the property. The narthex has three sets of casement windows following the rhythm of the bays in the sanctuary above. The openings of the west transept have been enclosed. The rear addition is comprised of brick on this and the south elevation. Four pairs of casement windows can be found on each level, a small decorative red slate mansard transitions into a flat roof above. The basement well provides access to an egress stair on the north face of the rear addition. Three large hopper style windows are found in the basement level of the transept.

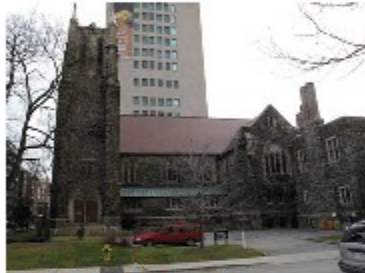
Fig 11. West elevation, front. (ERA)

The west transept is partially obscured by the 1931 addition in this area. The transept follows a similar fenestration pattern as the sanctuary with a three small rectangular casement windows on the main level, and a large stained glass window with a pointed-arch terra cotta surround and tracery. The gable end features a vent opening with terra cotta surround. Three large steel hopper style windows are found in the basement level of the transept. The west transept is partially obscured by the addition in this area. A set of three vertical paneled, double vision lighted solid wood doors are found in the middle of the elevation with a large nine unit rectangular window above.

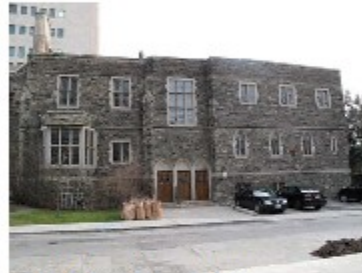
Fig 12. West elevation, rear. (ERA)

- In 1931 the original octagonal Sunday School wing was replaced with a larger structure which extends west past the building envelope of the main church, this addition partially obscures the west transept.

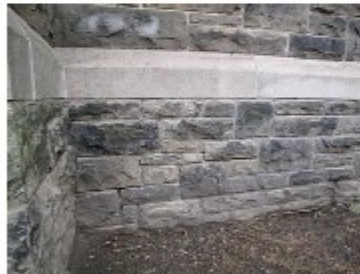
Fig 16. Recessed joints in foundation.(ERA)

The foundations of the 1911-12 structure are rubble stone below grade, and ashlar above, and are generally in good condition. There are selective areas where the condition is considered fair due to recessed/eroded joints and obvious re-pointing. This condition is the result of normal wear and erosion. Selective re-pointing with a lime based mortar is recommended in these areas.

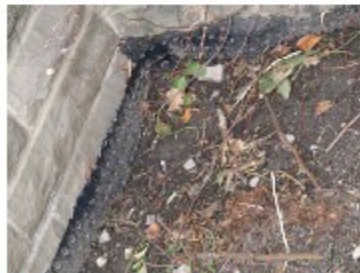
Fig 17. Damp proof layer on west foundation. (ERA)

A damp proof layer was noted on the west foundation of the sanctuary as well as a bond break between the asphalt and the building.

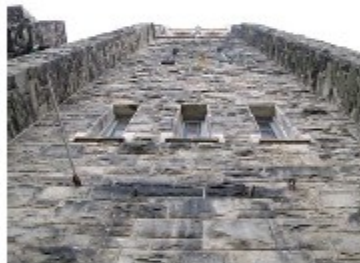
Fig 19. Bulging stone, north face of tower. (ERA)

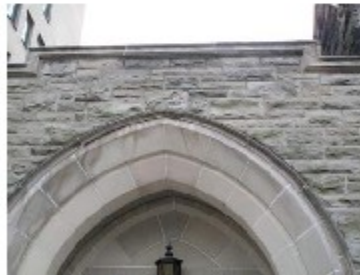
Fig 20. Cracked and recessed joints found in upper portion of east door. (ERA)

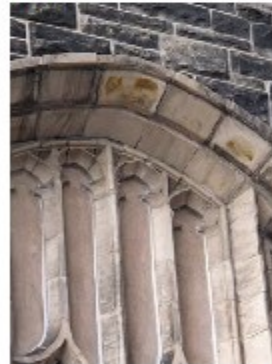
Fig 23. Black staining and ironoxide staining on east transept surround. (ERA)

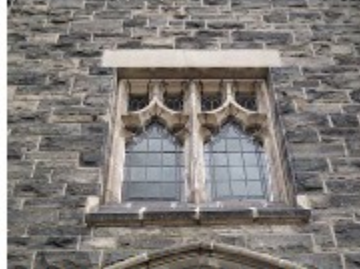
Fig 24. Dark mortar and widened joints in window surrounds. (ERA)

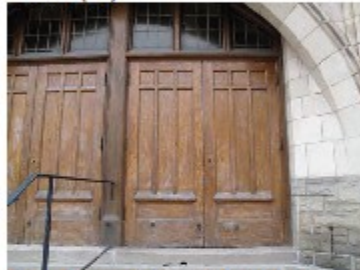
Fig 25. Discolouration found on front entry doors. (ERA)

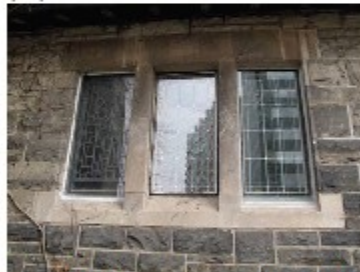
Fig 26. Exterior storms on casement windows. (ERA)

The metal casement windows found in the side aisles are in fair condition. Exterior storms are caulked to the window surround, and are un-vented creating issues of heat and moisture within the unit. There is some distortion of these window units. The operable casement windows have a similar storm arrangement, with the storm affixed to the inner window with caulking. There is a broken storm on the south chapel window.

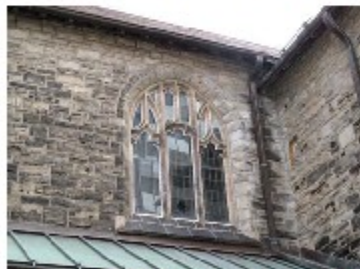
Fig 27. Broken storm on south clerestory window. (ERA)

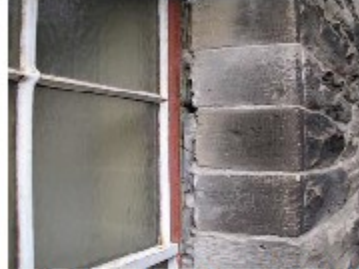
Fig 28. Gaps around basement hopper window. (ERA)

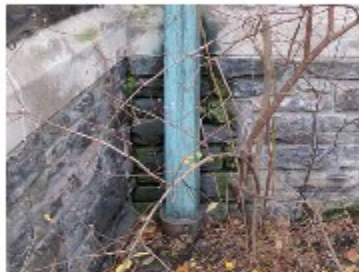
Fig 29. Efflorescence, organic blooms on masonry.(ERA)

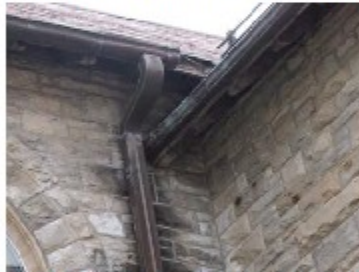
Fig 30. Efflorescence, discoloured stone at gutter.(ERA)

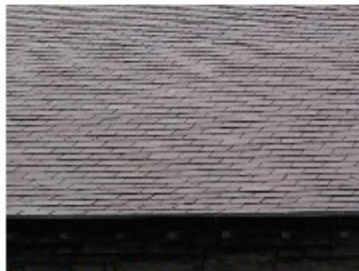
Fig 31. Poorly matched replacement slates on roof. (ERA)

The steeply-pitched cross-gabled roof over the main church is primarily slate, and the south facing roof over the transept has been replaced with red asphalt shingles, as has the gabled roof over the eastern stair bay.

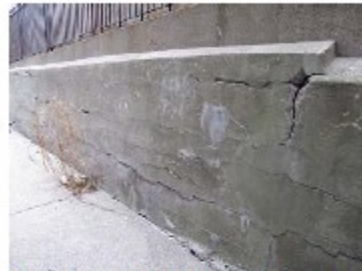
Fig 32. Severe cracking in east retaining wall. (ERA)

The concrete retaining wall found in the egress well on the east side is in poor condition with severe cracking.

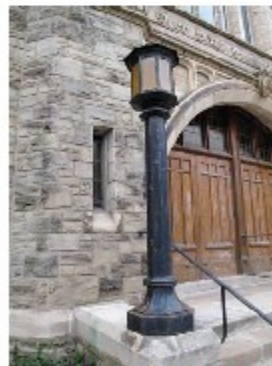
Fig 34. Light standard at main entrance. (ERA)

The front entry stair is in poor condition the stone units have shifted and settled. The hand rails are badly corroded at the contact points with the stone and have shifted, staining the stone at its present location. The adjacent light standards are in fair condition, there is some surface corrosion on both. The west light has a broken glazed panel.

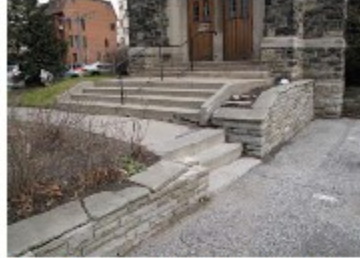
Fig 35. West tower entrance, and cracked retaining wall. (ERA)

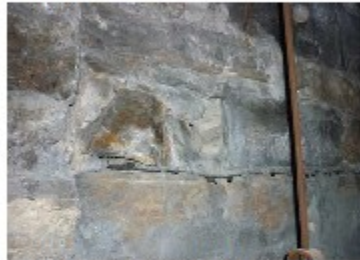
Fig 36. Damp proof layer in foundations. (ERA)

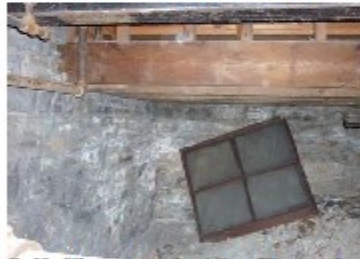
Fig 37. Efflorescence on foundations, SW corner of tower. (ERA)

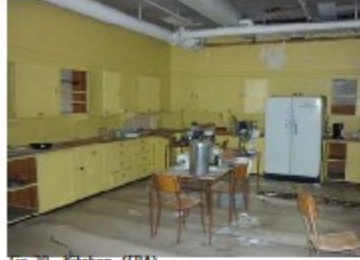
Fig 39. Kitchen. (ERA)

The kitchen floor is in poor condition, and is heavily

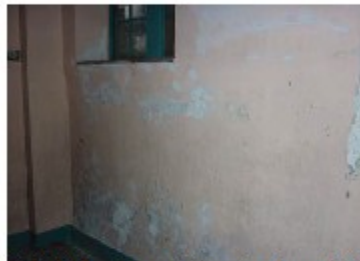
Fig 40. Moisture damage in basement washroom. (ERA)

Moisture damage was noted in both washrooms on the basement level with peeling and bubbled paint.

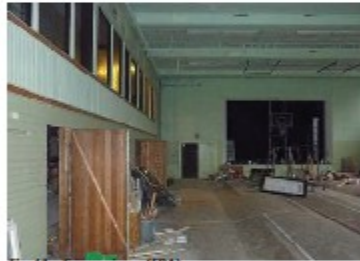
Fig 41. Gymnasium. (ERA)

Floors in the gymnasium have buckled from water damage and are in very poor condition. No present moisture was noted.

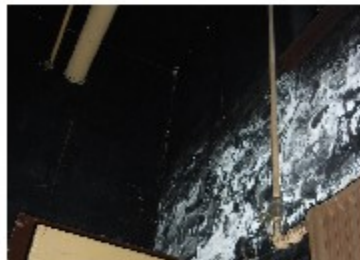
Fig 42. Efflorescence located on S wall in stage area. (ERA)

Efflorescence was noted on the south wall in the stage area.

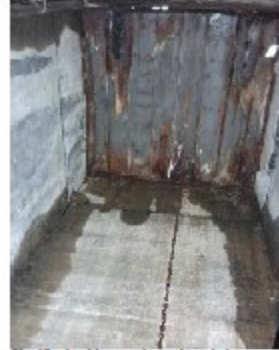
Fig 43. Leaking vent cap in sub-basement. (ERA)

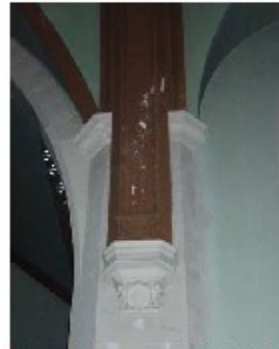
Fig 44. Moisture damage to plaster in sanctuary. (ERA)

There is some moisture damage noted on the north side on the west transept rib and on the west side of the first rib north of the transept.

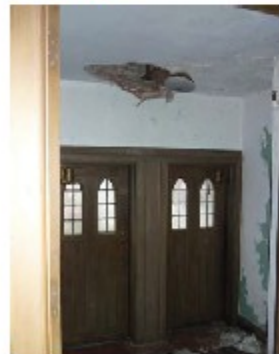
Fig 45. West tower entrance. (ERA)

The west tower entrance is in poor condition with

a medium size hole in the ceiling, cracked plaster throughout, and peeling and bubbled paint as a result of moisture penetration.

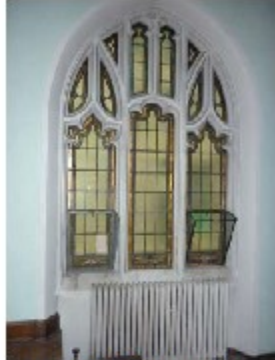
Fig 46. NE window with warped glass and slipped pane. (ERA)

The north east window is in fair condition with some warping and a dropped pane. Buckling was also found in the north west window.

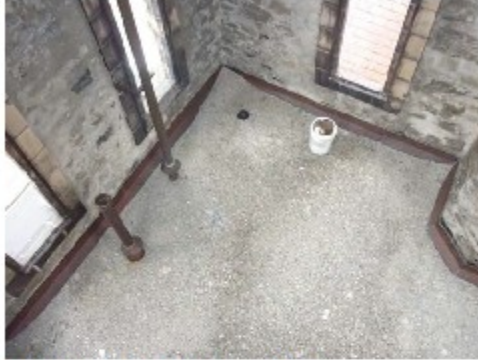
Fig 47. Mortar debris built up in corners of tower interior. (ERA)

There is a build up of spalled material at the base of the roof levels. There is spalling, staining, organic growth and efflorescence on the terra cotta at the interior and exterior.

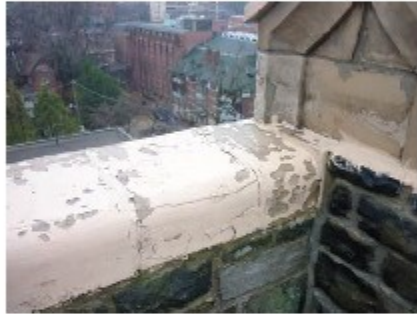
Fig 48. Painted coating and related spalling on tower parapet. (ERA)

At the roof level there are low stone parapet walls with terra cotta caps and finials. The stonework has been repointed in hard mortar and there is a vertical crack through the north parapet. Most of the terra cotta has been coated with a paint finish. The terra cotta is spalling and cracked extensively and is in poor condition.

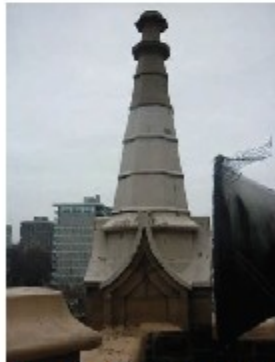
Fig 50. Painted coating on tower finial. (ERA)

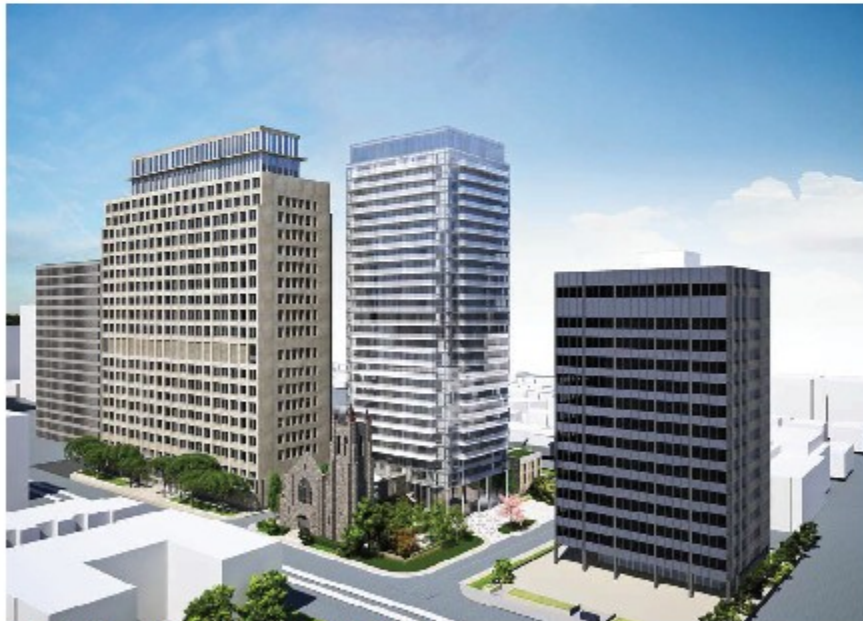
Fig 51. Initial concept rendering of proposed development (DSAI)

The current proposal is a revision of the plans submitted in support of the zoning by-law amendment application dated 13 December 2010. Similar to the previous proposal, the current proposal involves the selective removal of portions of the Deer Park United Church with construction of a high-rise residential tower and a row of townhouses facing south on Foxbar Road. The changes to the scheme were made pursuant to the concerns raised through multiple consultations with a community working group as well as the Foxbar Neighbourhood Association. Changes to the redevelopment proposal include moving the location of the tower seven metres north, encroaching onto the original 1912 structure of the church building. This separates the tower from the proposed townhouses and increases the buffer between the high-rise development and the adjacent low-rise neighbourhood to the south. The revised scheme proposes the creation of an outdoor courtyard by removing a portion of the church roof to create a publically accessible, privately maintained courtyard, and the remaining portions of the church will be programmed for commercial use.

8. The new residential tower is offset from the southeast corner of the adjacent Imperial Oil heritage building to avoid obstruction of views to and from the building from St. Clair Ave West. The new tower is materially distinguishable from the Imperial Oil Building and its simple rectangular massing complements the heritage building (see fig. 51).

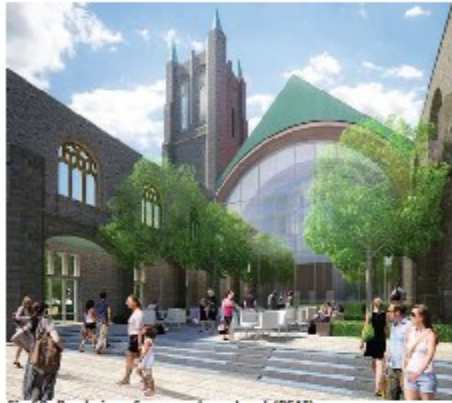
Fig 58. Rendering of proposed courtyard (DSAI).

4. The scale and massing of the remaining church will be maintained. A portion of the roof will be removed to create an outdoor courtyard amenity. Similar strategies have been successful elsewhere in the city, including the Artscape Wychwood Barns and Evergreen Brickworks to frame outdoor amenity space with the remaining structure of a heritage building.

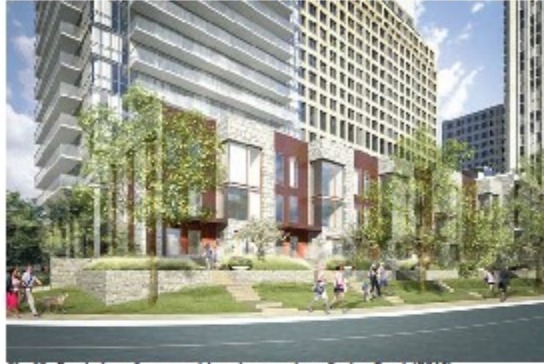
Fig 65. Rendering of proposed townhouses along Foxbar Road (USA1).

7. The proposed townhouses along Foxbar Rd will be clad in salvaged stone from portions of the original church structure that will be removed.

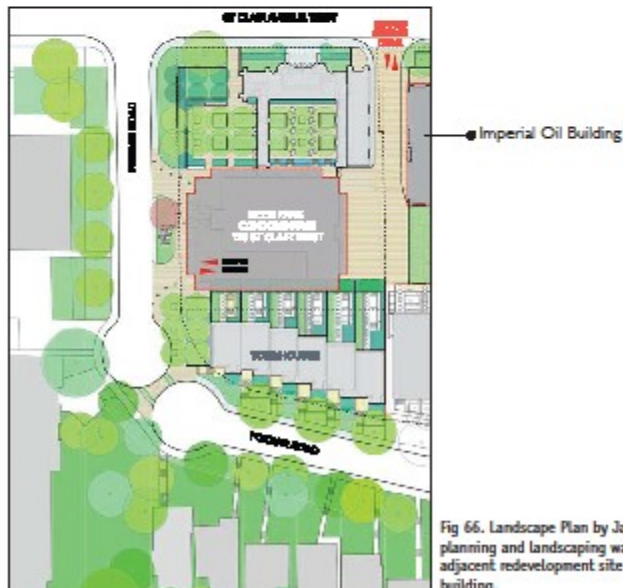
Fig 66. Landscape Plan by Janet Rosenberg & Associates. Site planning and landscaping was done in conjunction with the adjacent redevelopment site with the Imperial Oil heritage building.
