160 Gerrard Street East, Toronto, Ontario

Allan Gardens Palm House (AGPH) Restoration & Functional Upgrade

TORONTO PRESERVATION BOARD MEETING | JUNE 16TH, 2021

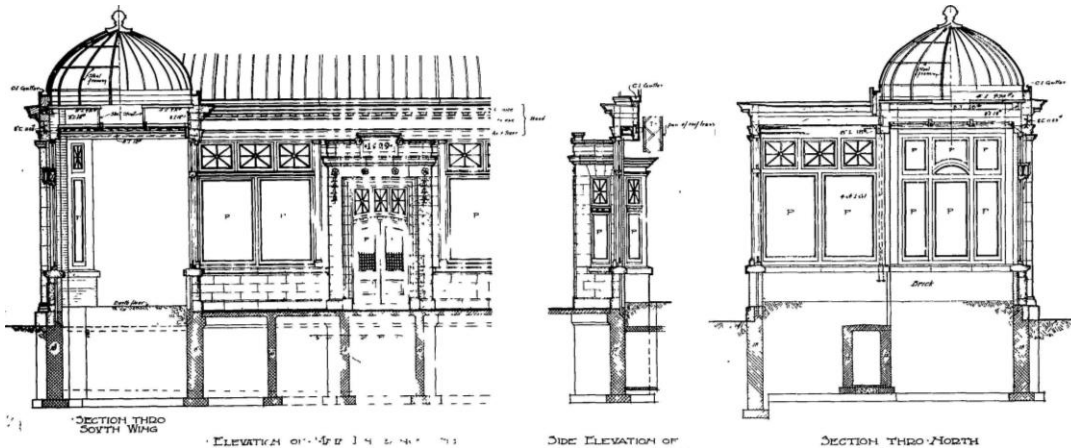
The original Palm House drawings (1909) with side pavilions, in section and elevation, showing only exterior windows & the central entrance portico providing double doors.

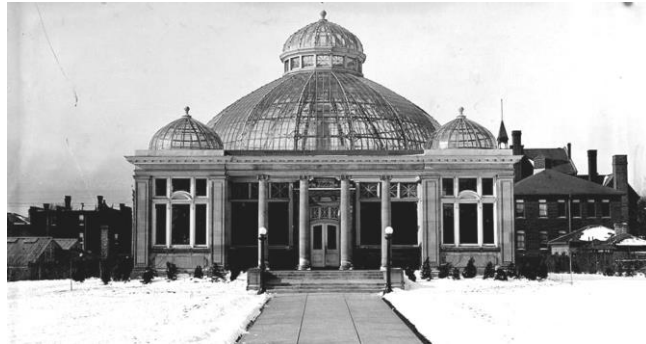
The original constructed Palm House had its front (east) entrance in the middle of the glazed façade between the two side pavilions and behind a free-standing colonnade.

Front view of the Palm House, 1913.

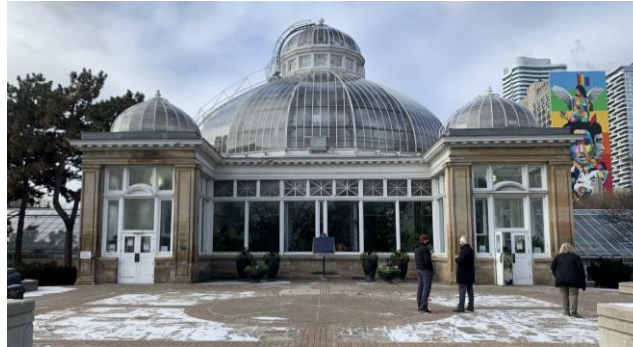
The original central east front entrance was removed and replaced with entrances in the north and south pavilions.

Front view of the GH#3 Palm House.

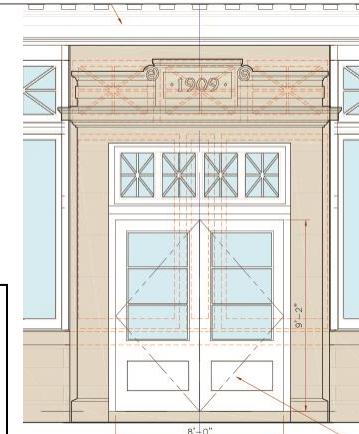
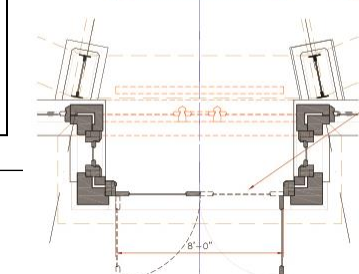
A new projecting entry bay with double doors is proposed to be inserted in the centre of the AGPH east façade emulating and reinstating its original east portico design from 1910.

The stone façade, masonry knee wall and sills will be coordinated with the new inserted portico arch.

The GH #3 Palm House east central entry portico doorway, Palm House 2021.

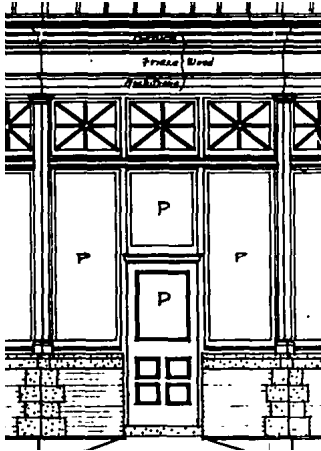
The original north and south elevations of the then-exterior walls of the 1909 Palm House comprised single doors at the centre of their respective facades.

Original North/South Elevation of the then-exterior walls of the 1909 Palm House.

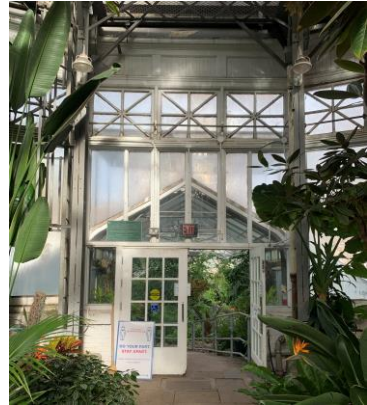
The original doors with their transoms and side lights were altered on both elevations due to the addition of Greenhouses Nos. 2 and 4 in 1956 and 1924, respectively.

Both the doors exhibit signs of damage and deterioration from water leakage and condensation.

Existing North Doorway.

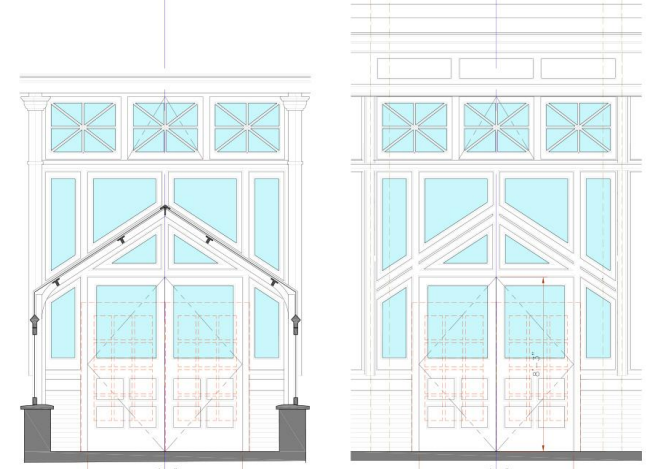
NORTH DOORS
(From Exterior)

The proposed design of the door leafs will incorporate some of the characteristics of the original 1909 design and the 1910 construction.

The door height will be increased which will help in moving machinery and equipment to GH Nos. 2 & 4.

Specialty hardware for large opening with hold-open devices and automatic door operator (ADOs) will be part of the alteration work.

Proposed GH #3 Palm House north entry doorway.

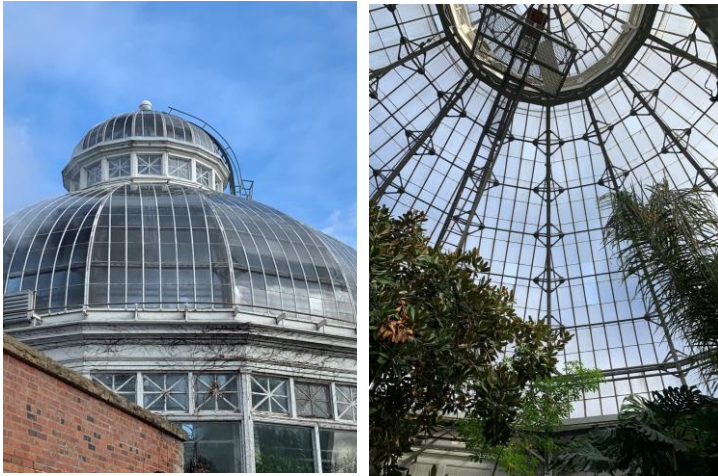
Exterior and interior view of the existing overhead plate glass.

The existing aluminum frames (dating back to 1976) are a replacement of the original wood components.

The existing plate glass panes have at times fallen to the floor below which creates the risk of injury thereby posing safety concerns.

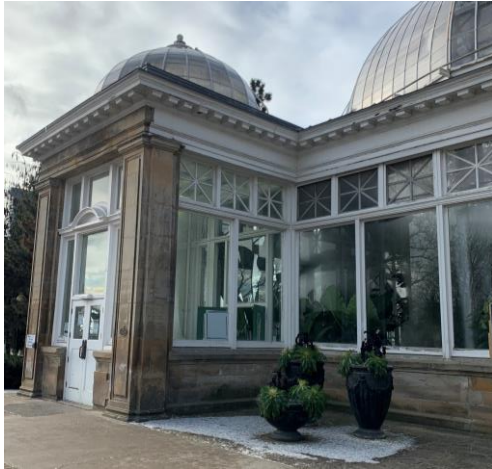
Exterior Elevation of an as-existing window bay.

The wall windows comprise tall windows extending from the masonry knee wall surmounted by clerestory windows.

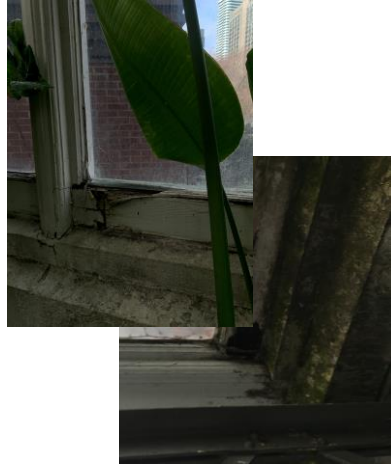
Existing wood windows show deterioration due to humidity, condensation, vegetation & rodents.

These existing wood windows exhibit considerable deterioration from rot, cracking, splitting, warping, etc., due to humidity, condensation, contiguous vegetation and rodents.
