9 Drumsnab Road - Alterations to a Designated Heritage Property in the South Rosedale Heritage Conservation District - Refusal

Date: January 20, 2026

From: Senior Manager, Heritage Planning, Urban Design, City Planning

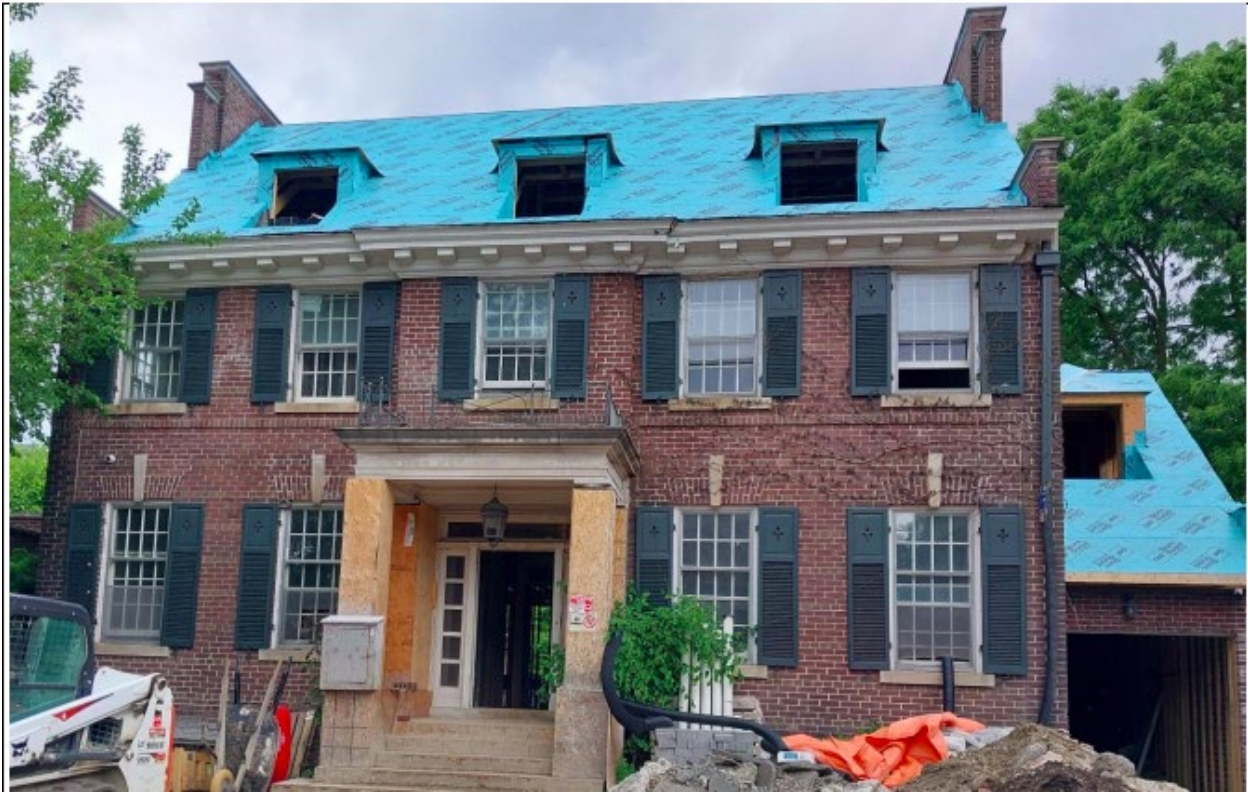
Photograph showing the existing condition of the dwelling (Clifford Restoration Limited).

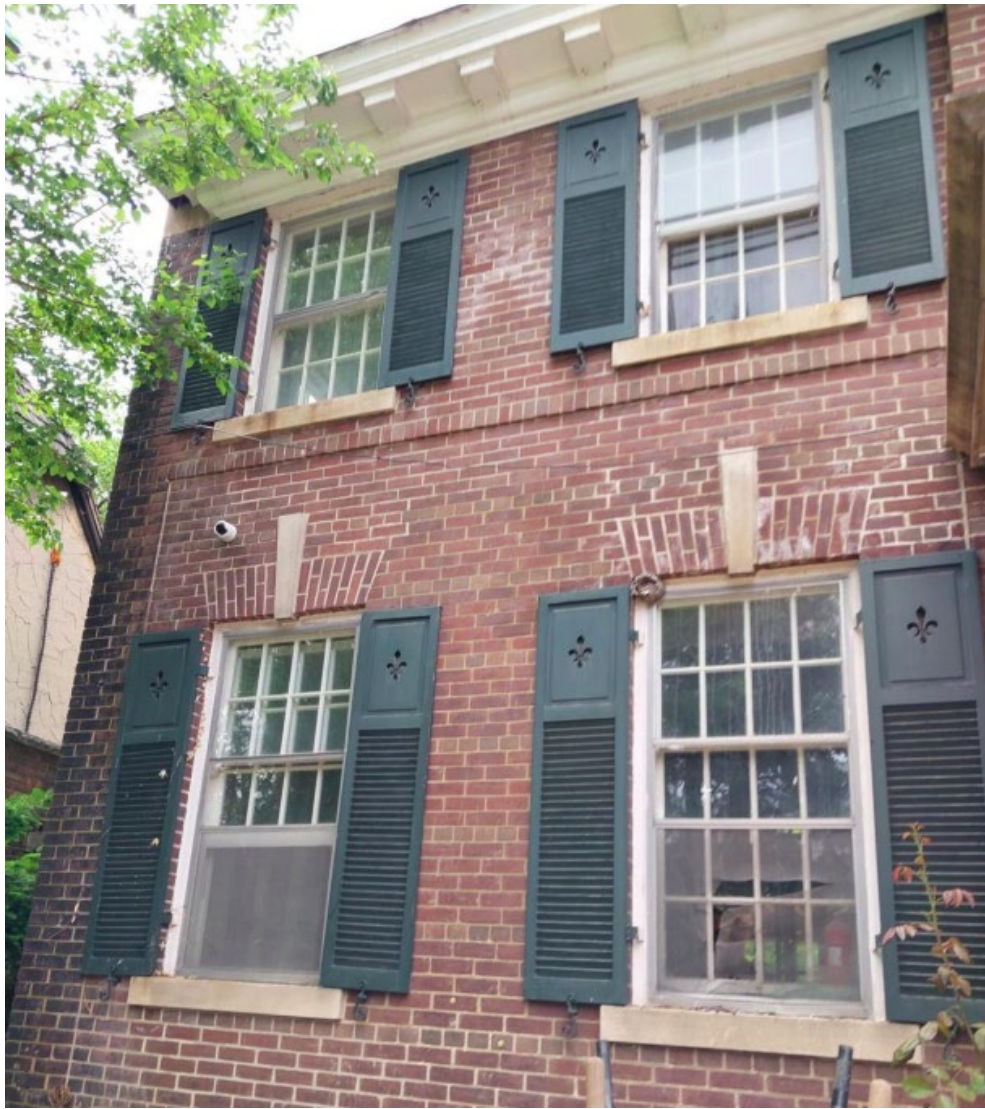
Contextual photo of the existing original windows on the western side of the south elevation.

In August of 2025 Heritage Planning received an updated draft of the conservation strategy, which included a statement of opinion from Clifford Restoration regarding the condition of the original windows. The report indicated that the overall condition of the windows was moderate to poor but that they remained 'substantially intact' and that the windows were not beyond repair. The proposed window replacement was, in part, based on the owner's desire to increase the rebates on the rails, stiles and muntins so that laminated, tempered insulated glass units could be integrated into the window assembly for added security. The consultant's report concluded that the introduction of security glass in the original frames might not be possible because of the increased weight load on the sash assembly. The report also proposed alterations to the front entry that enlarged the entry assembly and replaced the sidelights, transom and front door. This suite of proposed works was not accompanied by a revised permit application.

Heritage Planning staff have reviewed the alterations to the heritage property at 9 Drumsnab Road which include new windows to replace original repairable windows and the reconstruction of the front entry, including the loss of original features, to account for interior floor changes. It is the opinion of staff that the proposal to replace the original windows is not consistent with the Standards and Guidelines for the Conservation of Historic Places in Canada and not in keeping with the design guidelines of the SRHCD Plan, which discourage the replacement of attributes, such as windows, that are demonstrably repairable. The 2023 Heritage Impact Assessment prepared by ERA prior to the interior renovations of the home and submitted by the applicant notes the condition of the windows as "fair". In the condition assessment prepared by Clifford Restoration in 2025, the windows were found to be "not beyond repair and that they could be restored to proper function".

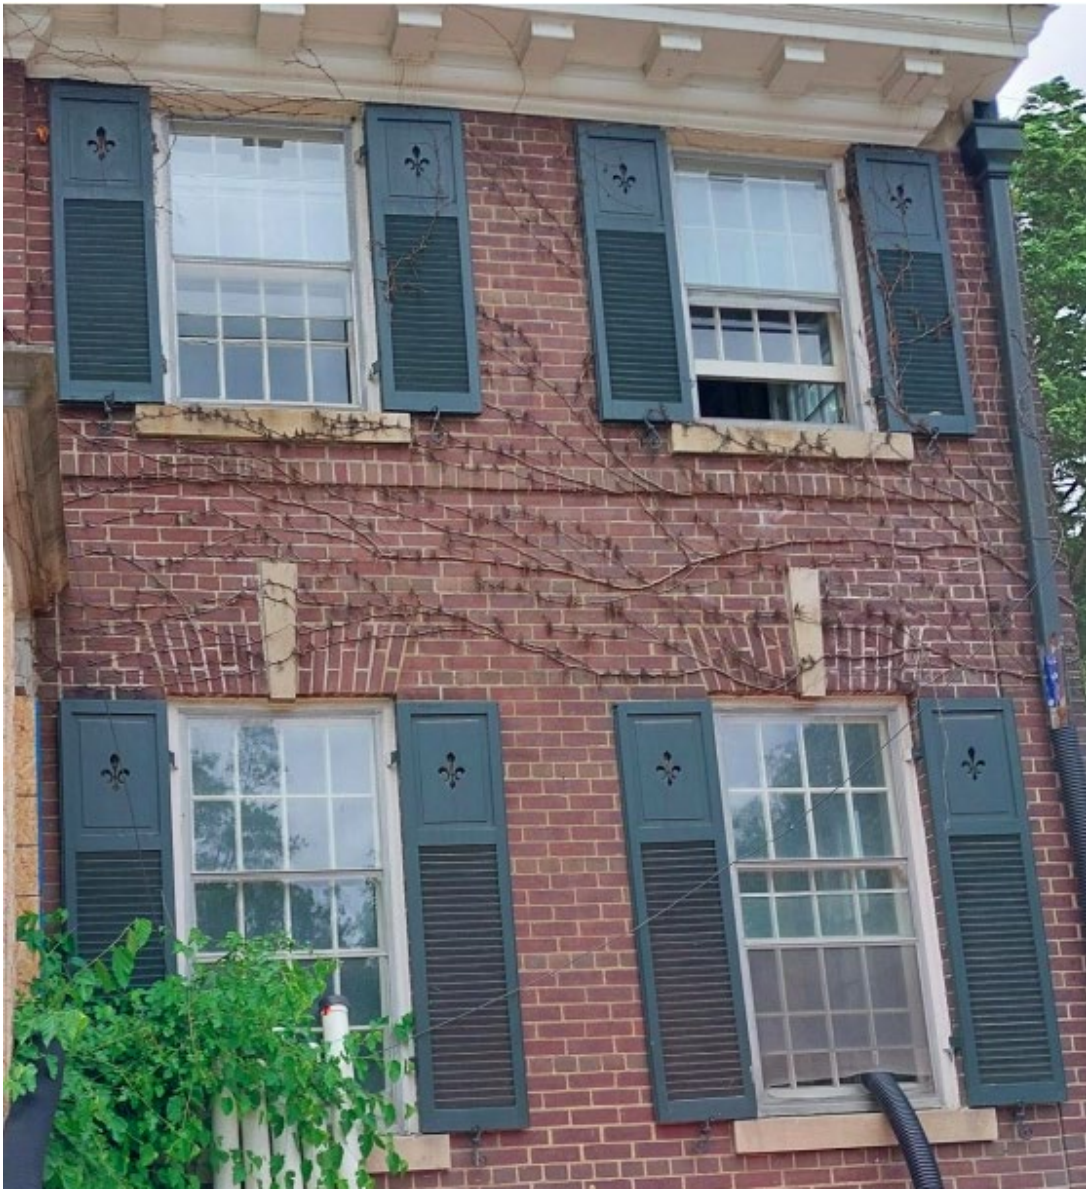
Contextual photo of the existing original windows on the eastern side of the south elevation.

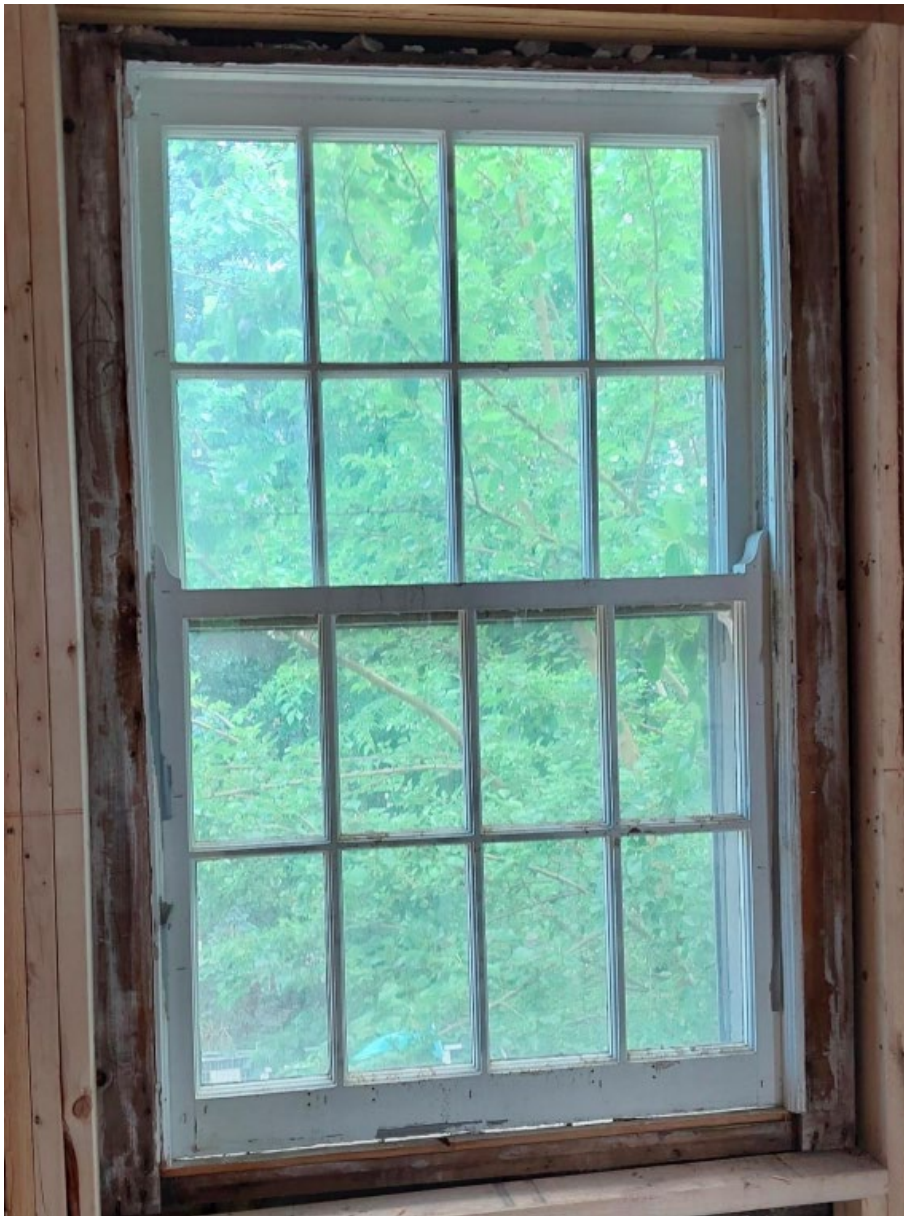
Detail photograph of typical window.

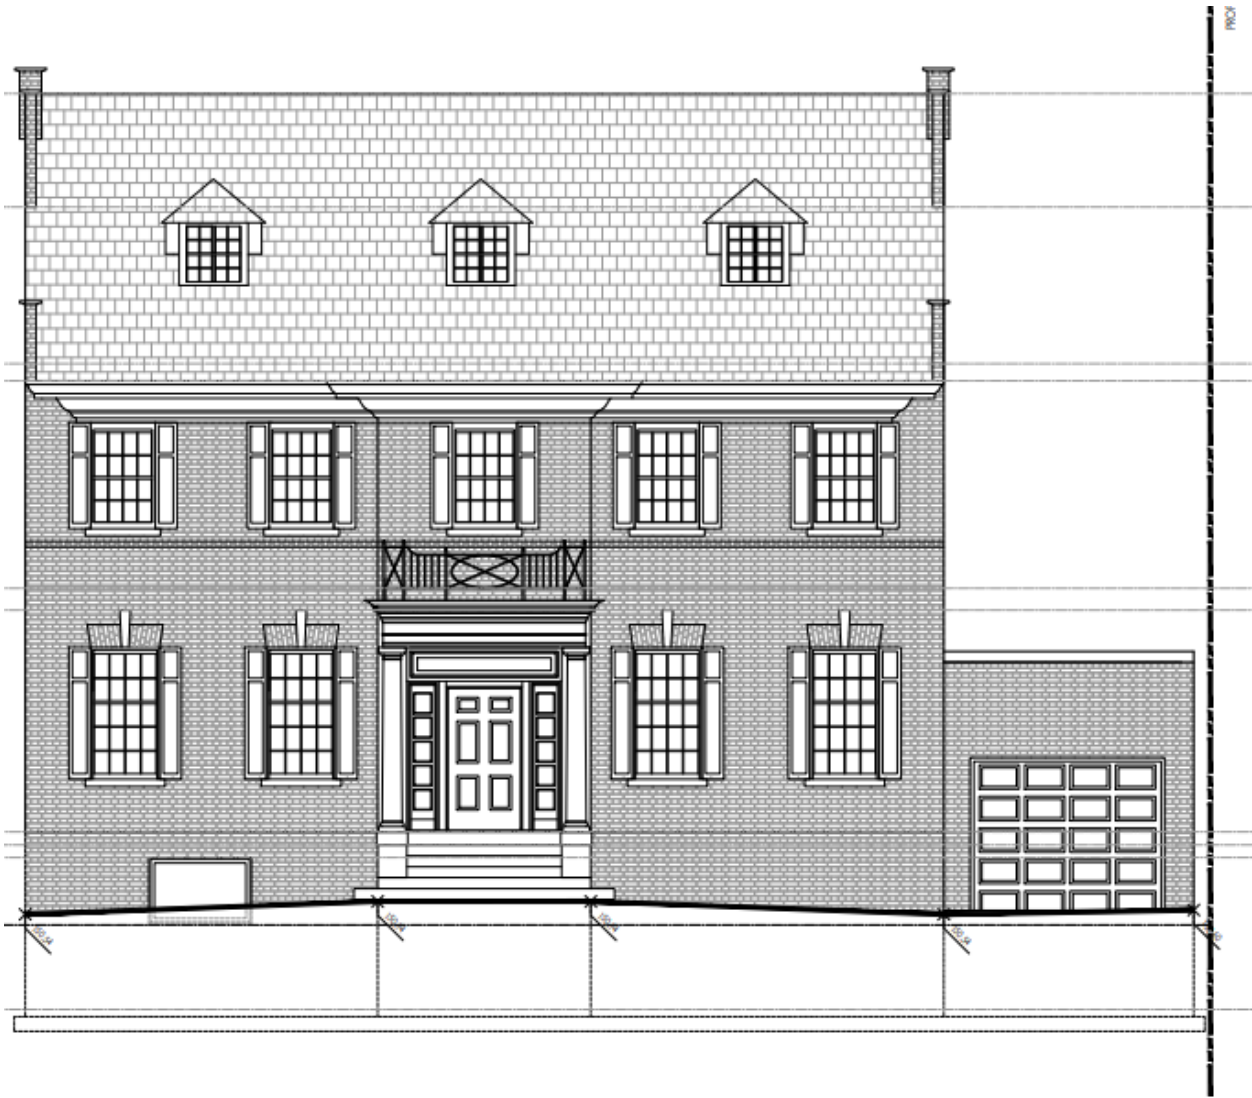
Architectural drawing showing existing front elevation (Boldera Architects).

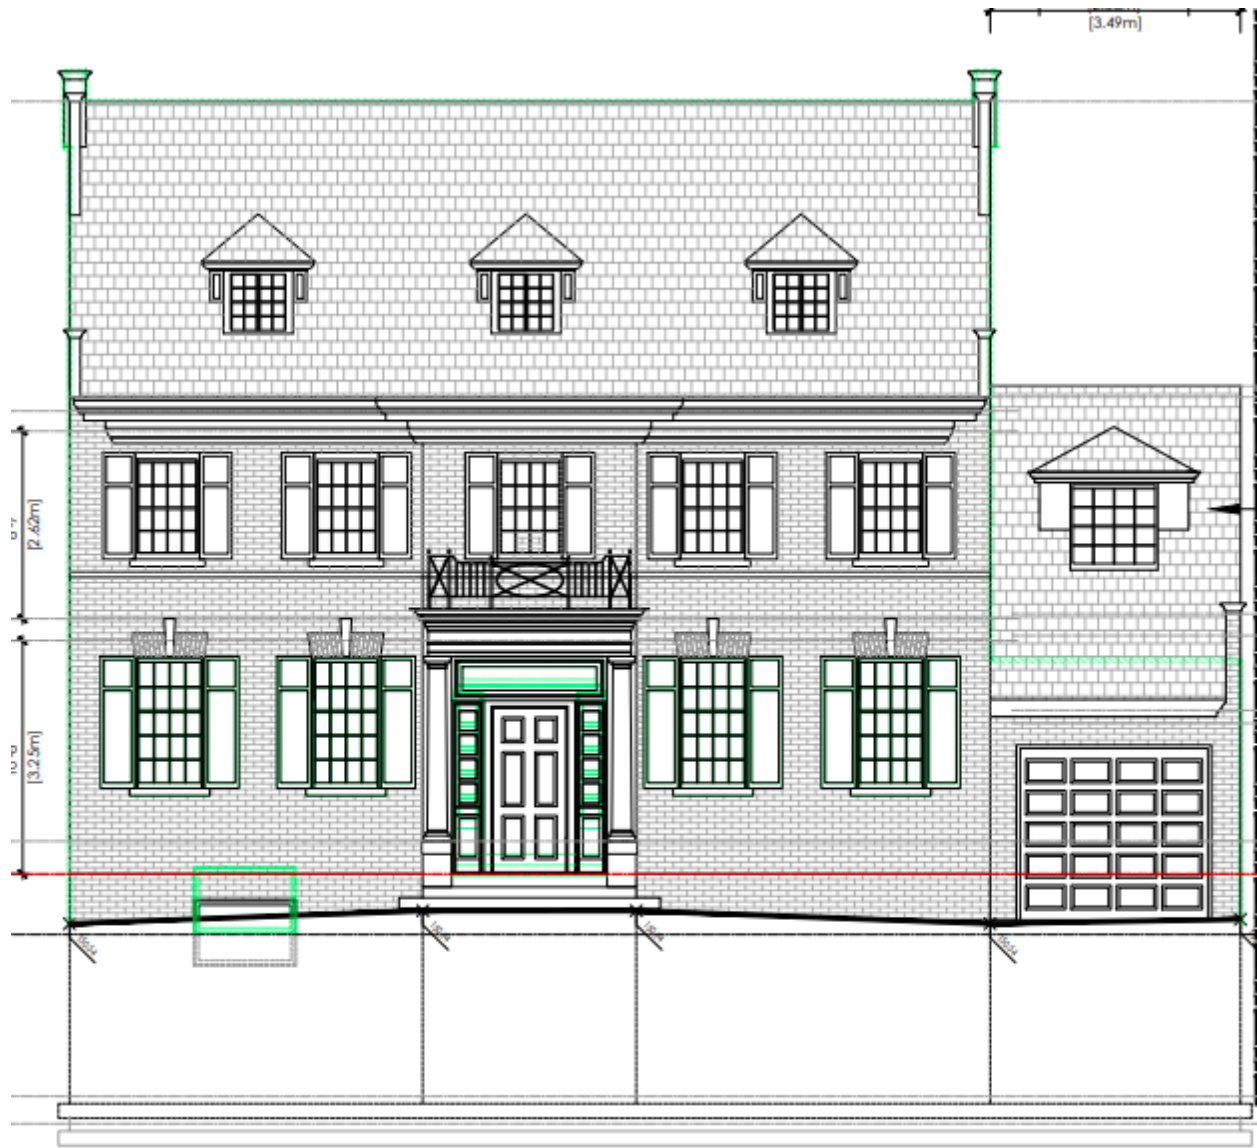
Architectural drawing showing proposed front elevation (Boldera Architects).

In January of 2026 Heritage Planning received an updated heritage permit application and a revised version of the conditions assessment which included a proposal for the alteration of the front entry assembly. This work would include the replacement of the original front door, the original transom and the existing, non-original sidelights. The purpose of the alteration is to lengthen the door and sidelights to provide a level entry into the house because the ground floor had been lowered by approximately 45 centimetres to increase ceiling height in the principle first floor rooms.

openings have been altered. It is Heritage Planning's opinion that the elongation of the centrally featured entryway skews the proportions of the detailing on the front elevation of the residence. It is recommended that the owner explore an interior solution instead.

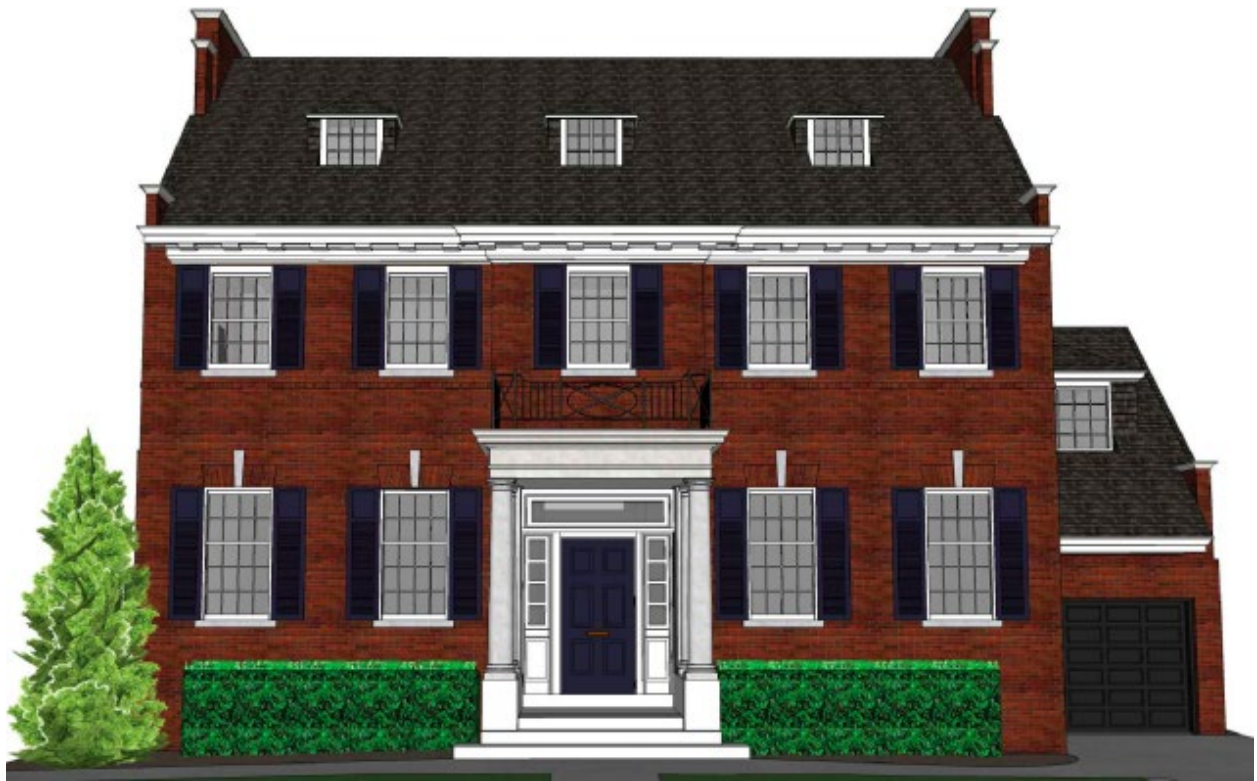
Rendering of proposed front elevation (Boldera Architects).
