Appendix J – yongeTOmorrow Environmental Assessment Study - Geotechnical and Environmental Investigation Factual Geotechnical Report

P.O. NA-1101231
YONGE STREET
FROM RICHMOND STREET TO DAVENPORT ROAD, TORONTO
GEOTECHNICAL AND ENVIRONMENTAL

Factual Geotechnical Report

01-P0013610.201-0101-GS-R-0001-00

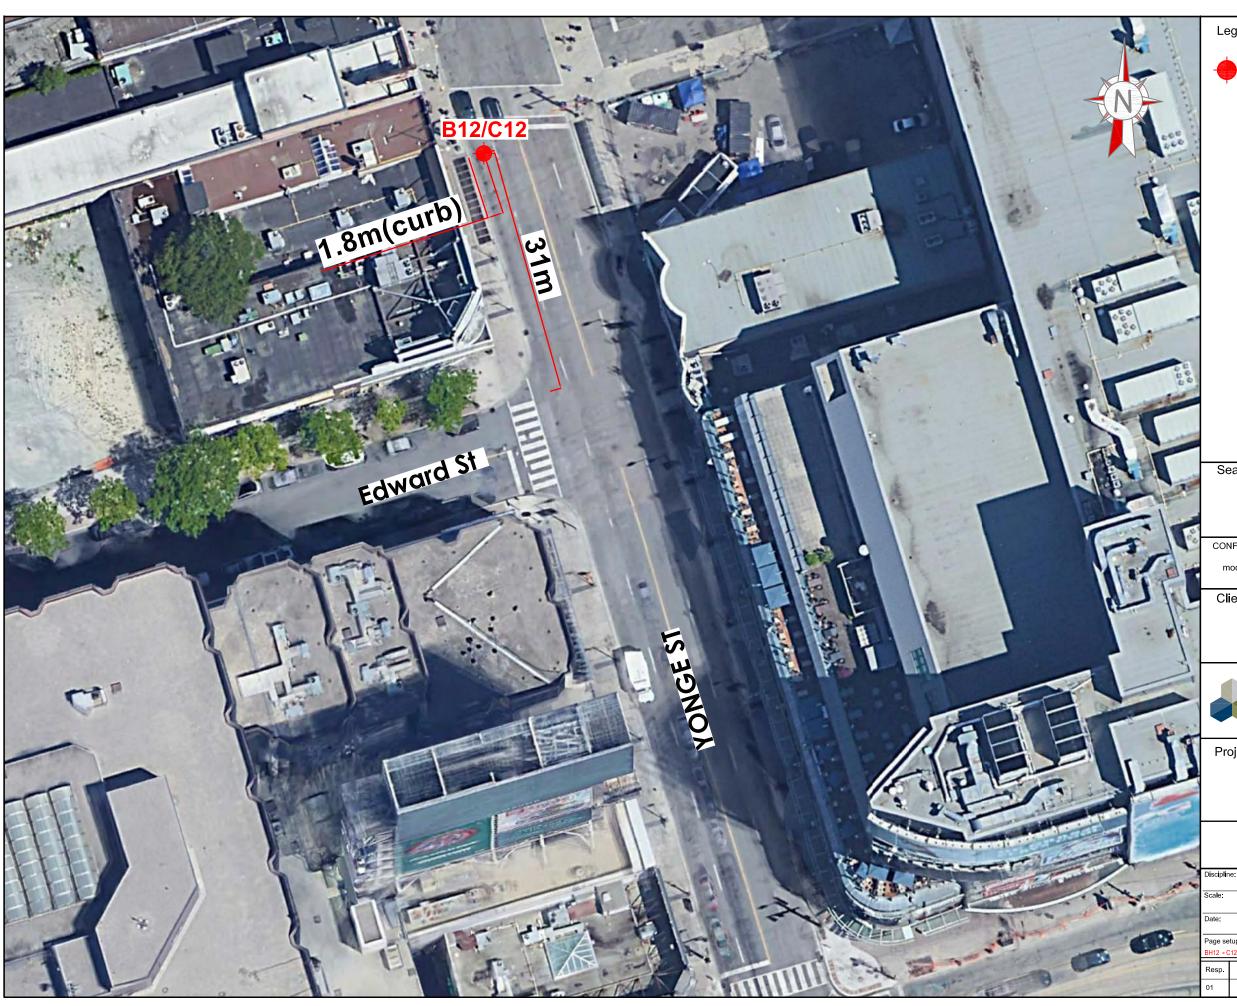
BOREHOLE AND CORE LOCATION PLAN

Discipline: GEOSCIENCES Scale: No Scale Date: 2020/11/27							
6	Disciplin					pared by: . Al-absi		Verified by: S. Ganesh	
Ö	Scale:					wned by: . Al-absl		Approved by: A. Duclos	
į	Date:					Figure n°: 12 of 31			
		Page setup: Paper format: BH12 - C12 ANSI full bleed B (17.00 x 11.00 Inches)			Reg	glster n°:			
i	Resp.	Projet	ОТР	Pro D	jet/ isc	Phase/ Type	Réf. éle	c. / No.Dessin	Rév.
F	01	P0013610.201		G	S	R		01	00

The borehole and core investigations were carried out between June 2019 and October 2020 to determine the existing pavement structure layer thicknesses and subsurface conditions. The location of the boreholes and cores are provided in Appendix 1 and the borehole logs are provided in Appendix 2. The core summary table and the core log photographs are provided in Appendix 3 and Appendix 4 respectively.

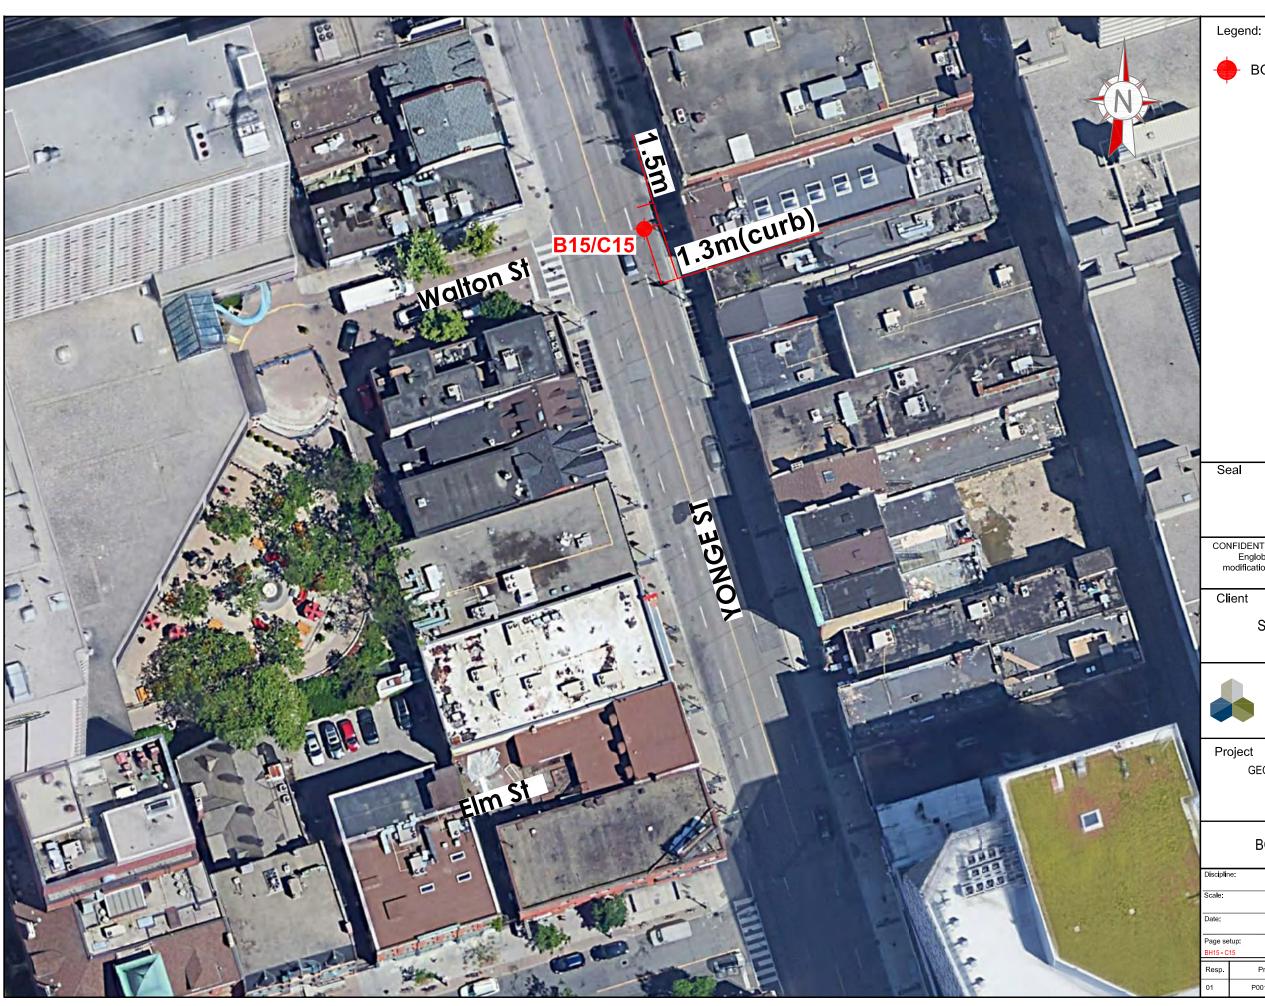
BOREHOLE AND CORE LOCATION PLAN

Disciplin	Discipline: GEOSCIENCES				ared by: Al-absi		Verified by: S. Ganesh	
Scale:	No Scale				ned by: Al-absl		Approved by: A. Duclos	
Date:	Date: 2020/11/27			Figure n°: 15 of 31				
Page se BH15 - C	•	Paper format: ANSI full bleed B (17.00 x 11.00 inches)			ster n°:			
Projet			iet/ I	Phase/	544		·
