Newtonbrook Creek Geomorphic Systems Master Plan Report

Aquafor Beech Limited

Published: December 2025

EXECUTIVE SUMMARY

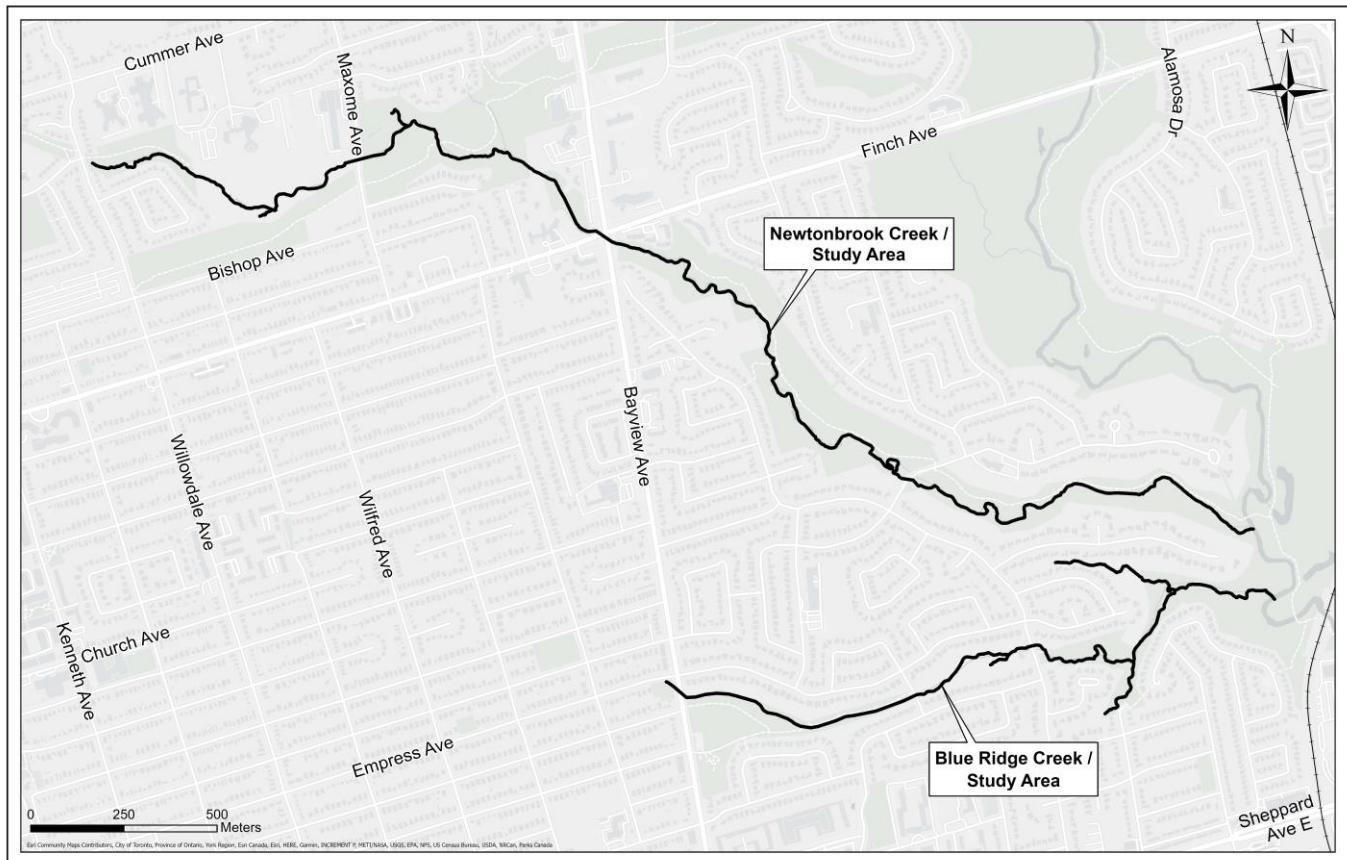
The City of Toronto (City) has commissioned Aquafor Beech Limited to undertake the Geomorphic Systems Master Plan Study for Newtonbrook Creek and Blue Ridge Creek (NCGSMP), in North York. The emphasis of the NCGSMP is on systematically locating and prioritizing erosion related risks to Toronto Water (TW) infrastructure within the Don Valley corridor, including: sanitary sewers, storm sewers, outfalls, watermains and any associated erosion protection works. The study area was found to contain **seventy-two (x72) distinct erosion risks** to Toronto Water infrastructure, including nineteen (x19) vertical erosion risks to watermain and sanitary infrastructure, twenty-two (x22) horizontal erosion risks to watermain and sanitary infrastructure, and thirty-one (x31) erosion risks to storm sewer and outfall infrastructure. The extent of the NCGSMP study area is illustrated in the figure below.

Newtonbrook Creek Geomorphic Systems Master Plan Study Area

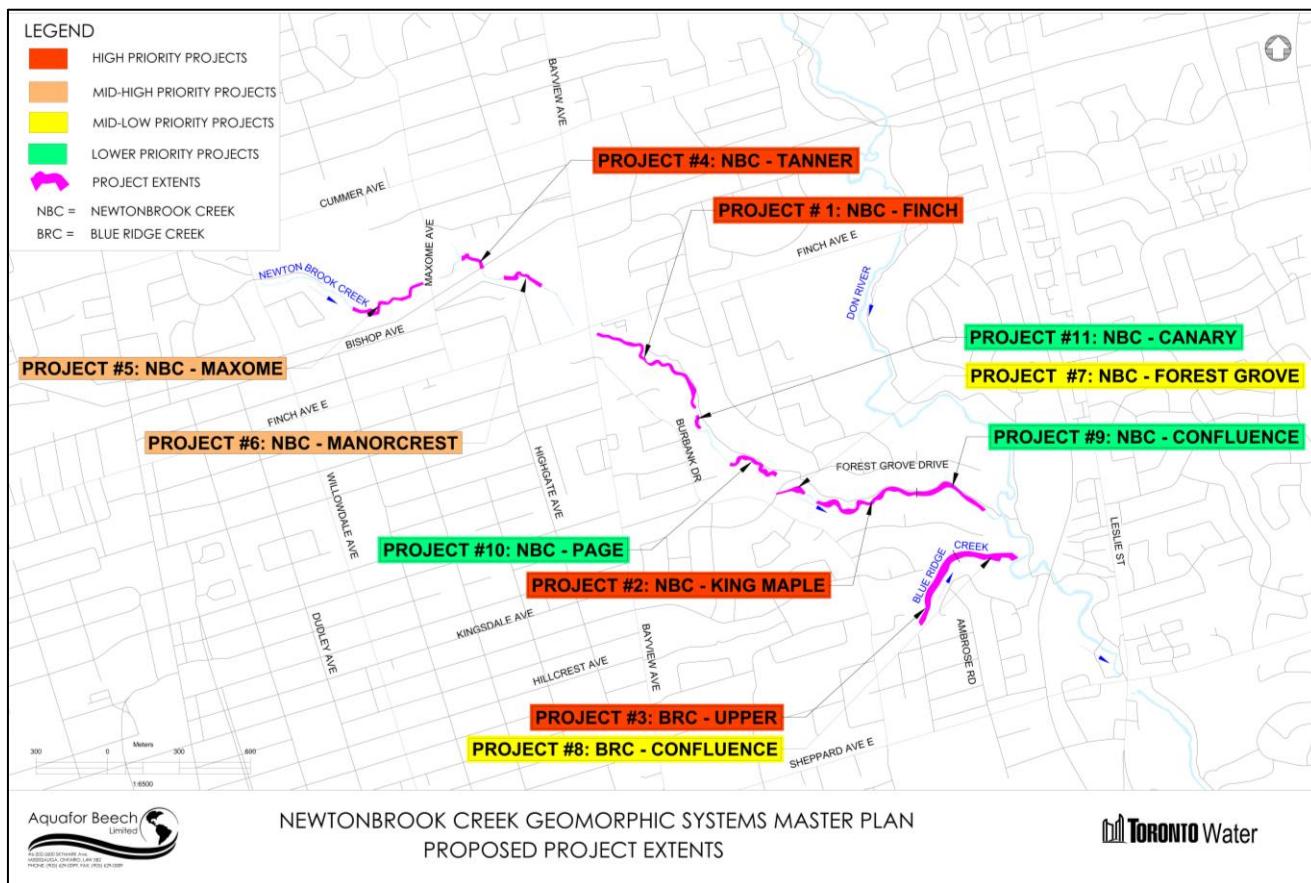
The spatial distribution of the eleven (x11) projects is illustrated in the following figure.

Spatial Distribution of the Eleven NCGSMP Projects
