Application to Remove a Private Tree - 14 Lethbridge Avenue

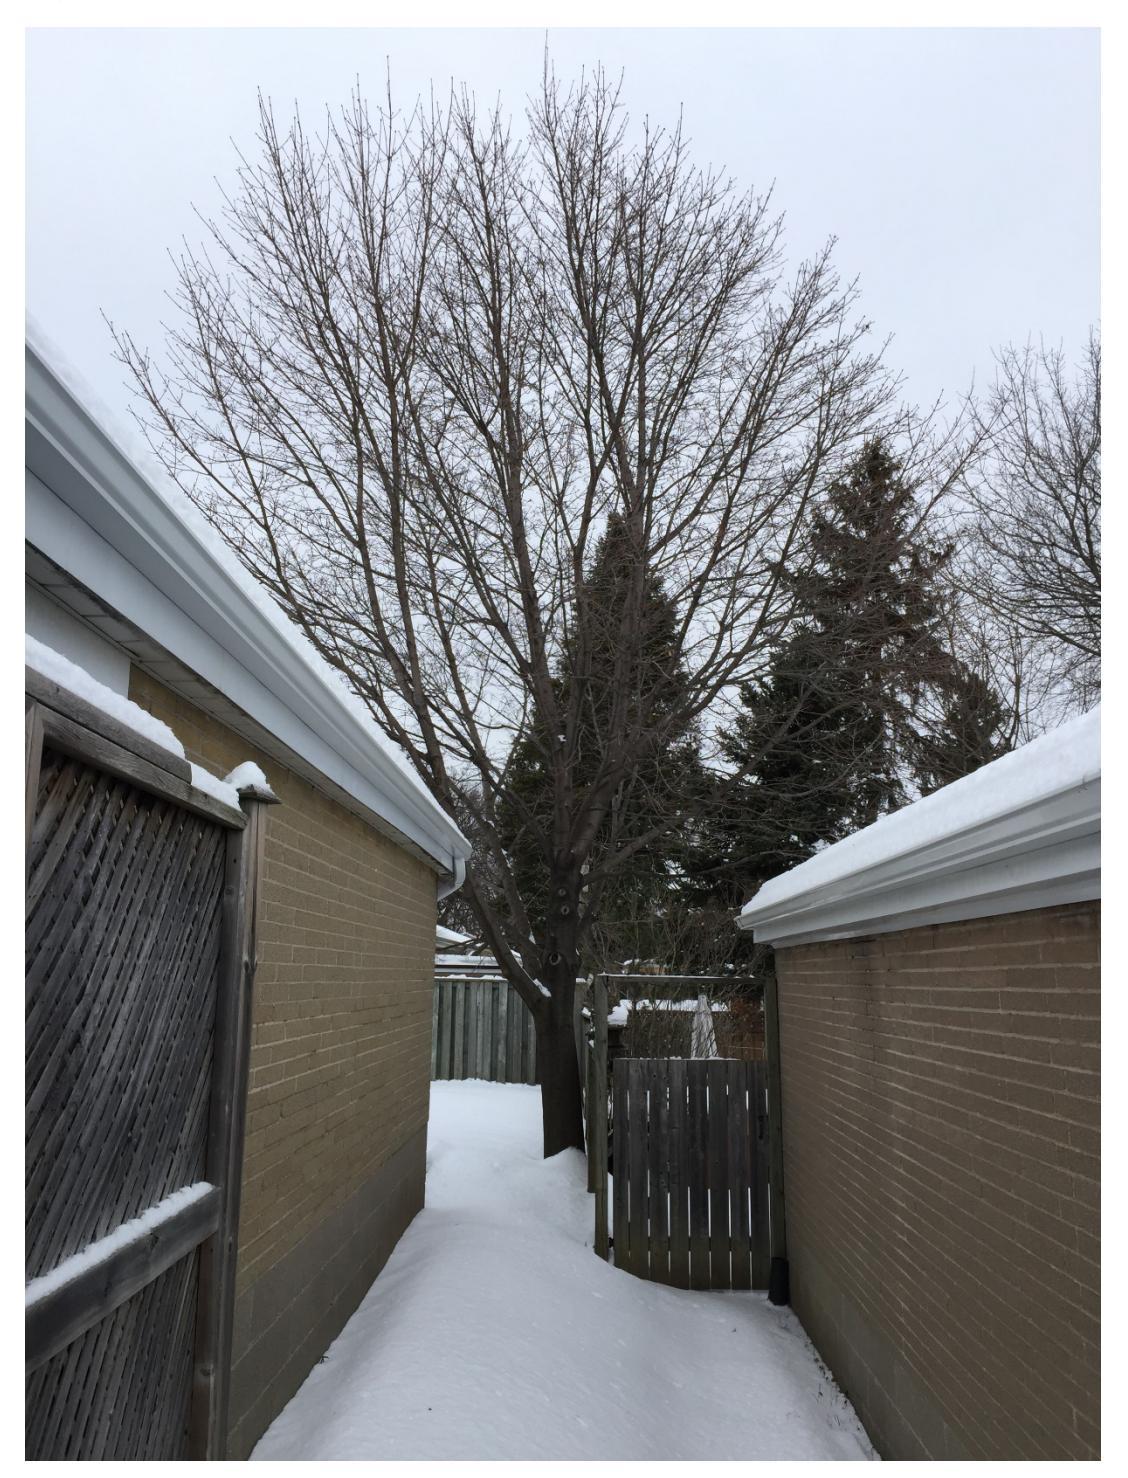
Figure 1: Subject Norway maple tree

Urban Forestry staff inspected the tree and determined that it is healthy and in good condition, both botanically and structurally.

This tree is situated approximately 2.2 meters from the house at 14 Lethbridge Avenue and 2.8 meters from the house at 12 Lethbridge Avenue. No evidence of the tree impacting the house was observed at the time of inspection. The location of the tree is located such that routine maintenance of the tree can be performed.

1. City Council deny the request for a permit to remove one (1) privately-owned Norway maple tree located at 14 Lethbridge Avenue.
