REPORT FOR ACTION

Inclusion on the City of Toronto's Heritage Register – 79, 81, 85 Shuter Street

| Date: | December 2, 2016 |

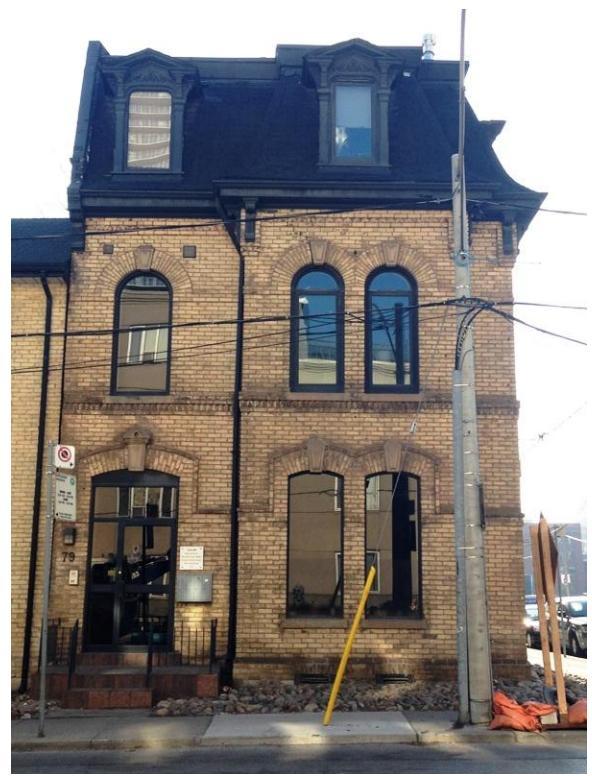
79 Shuter Street showing the north elevation on Shuter Street (HPS, 2016)

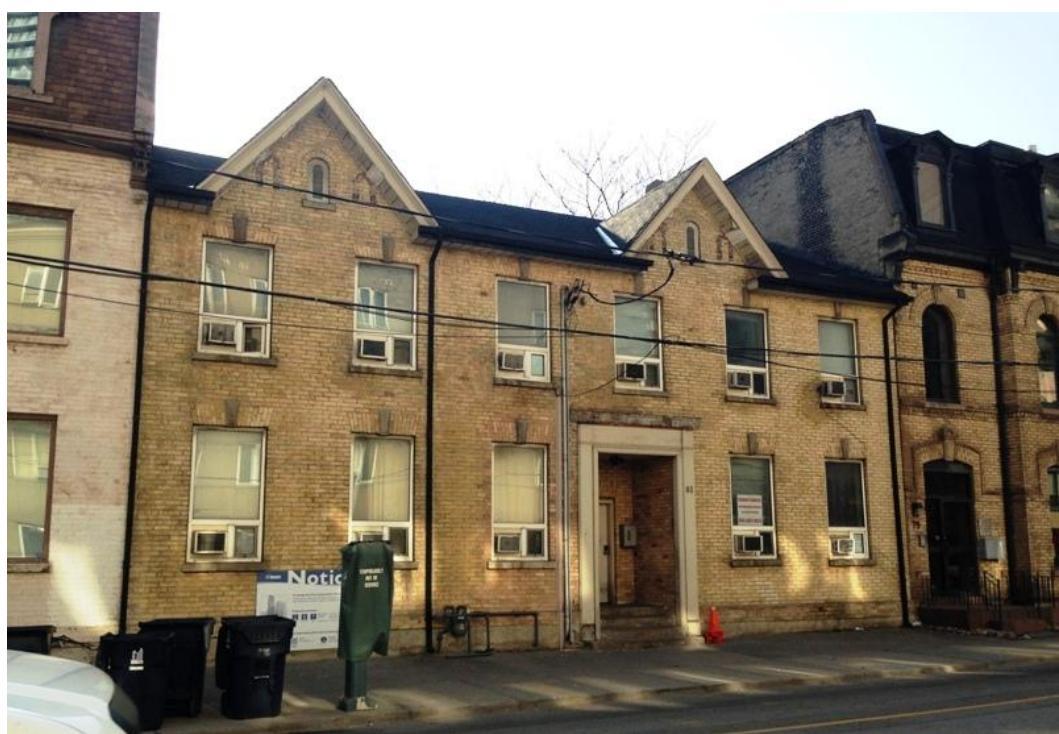
81 Shuter Street, north elevation (including the property originally known as 83 Shuter) (HPS, 2016)

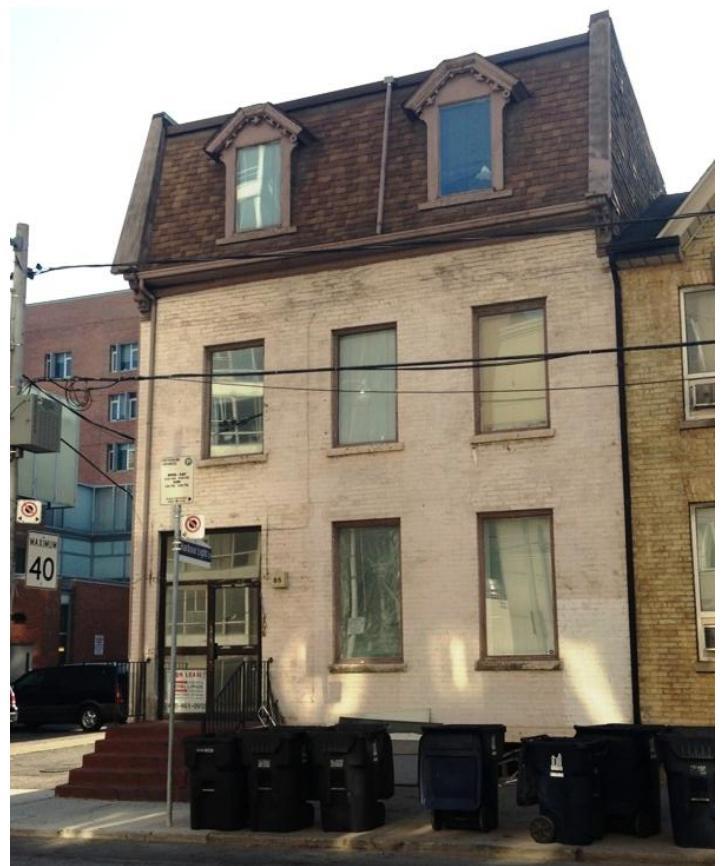
85 Shuter Street, showing the north elevation (HPS, 2016)

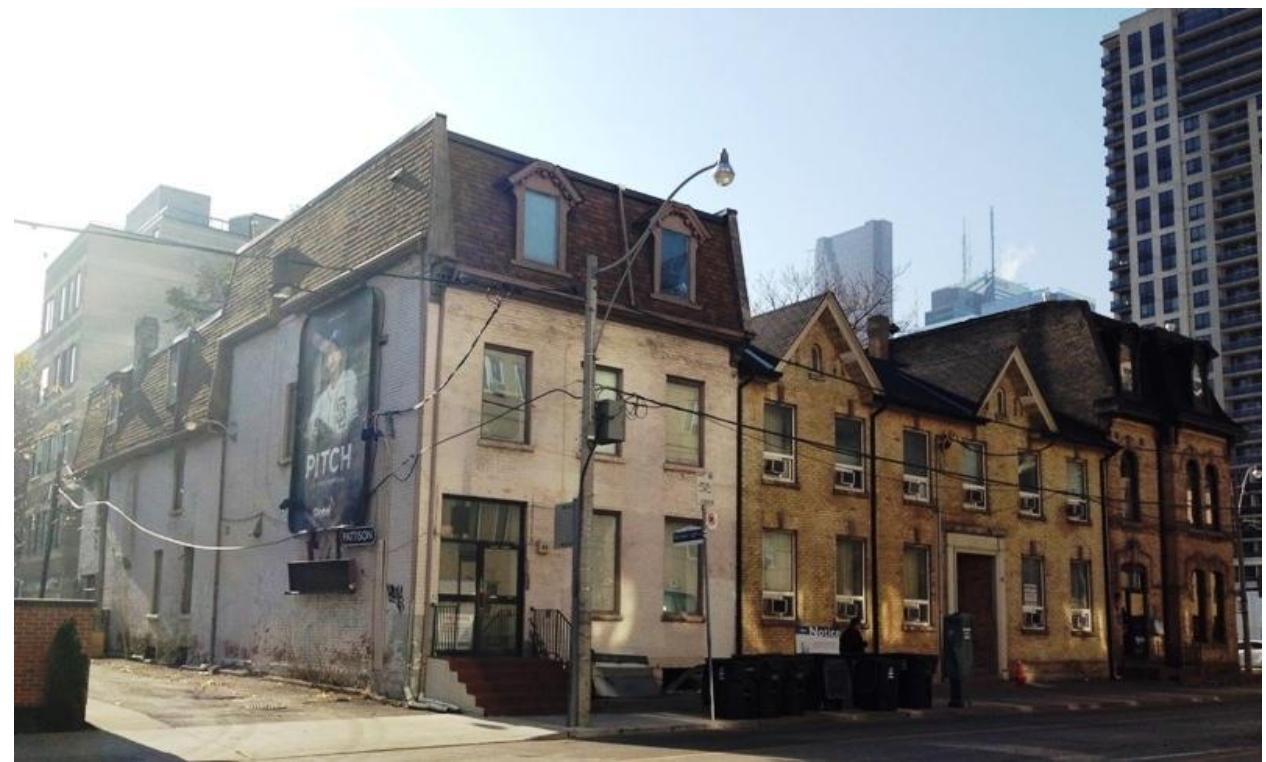
Photograph of the block on the south side of Shuter Street showing the north elevations as well as the east elevation of 85 Shuter Street facing the laneway (HPS, 2016)

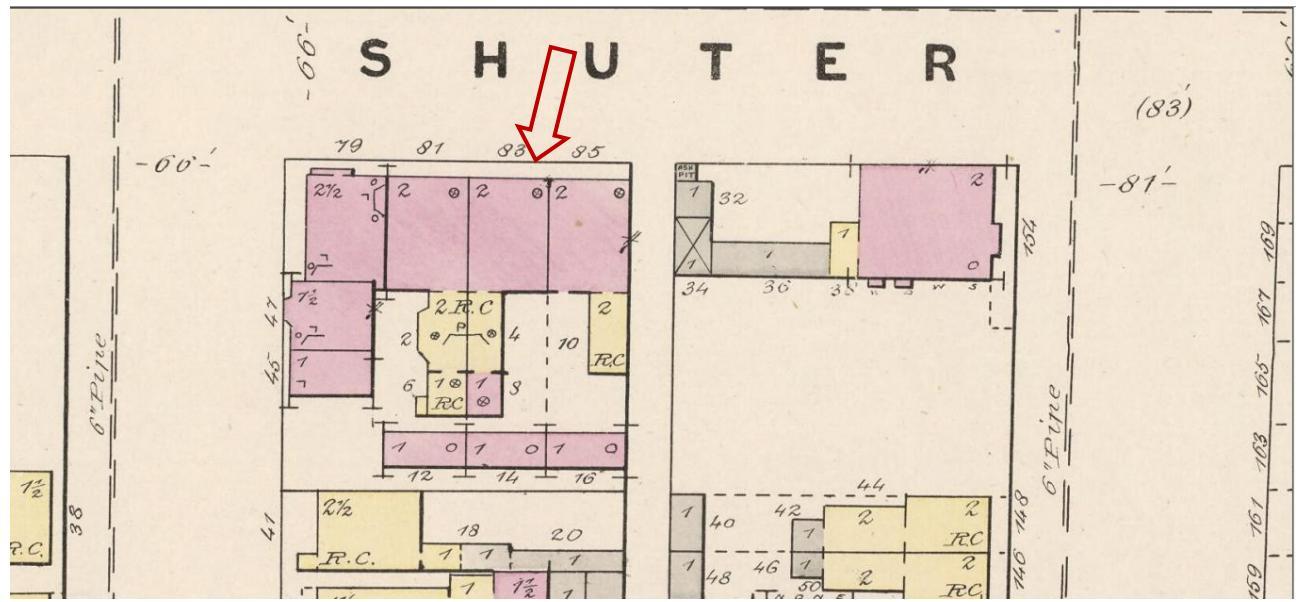
8. Goads Atlas, 1880 (detail): showing the footprint of the current properties. 81-85 Shuter are shown to be 2 storey brick buildings with rear wings of wood and roughcast plaster. The circular symbol with the x indicates that roofs are clad with shingles and mortar. At 81-83 Shuter, the rear 2 storey additions and one-storey additions have mansards with shingles on their side elevations with the flat top section built of metal, gravel or "composition" material. The roof on the rear addition at 85 has not been marked which means it has a shingle roof. The one-storey buildings at the rear of 81-85 Shuter are built of brick with slate roofs. 79 Shuter is indicated to have a mansard roof with slate shingles. (CTA)

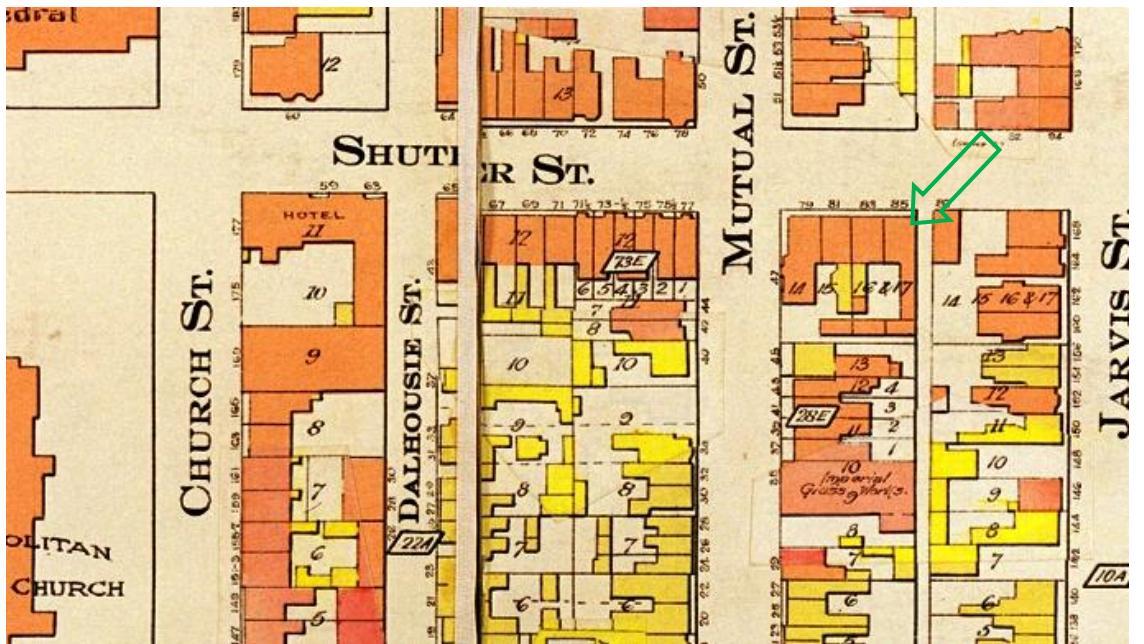
9. *Goads Atlas*, 1913 (detail): showing the first change on the properties as the rear extension at 85 Shuter Street is extended along the lane way to join with the rear out buildings. Lots 14, 15, 16 + 17 are identified on the four properties. (CTA)

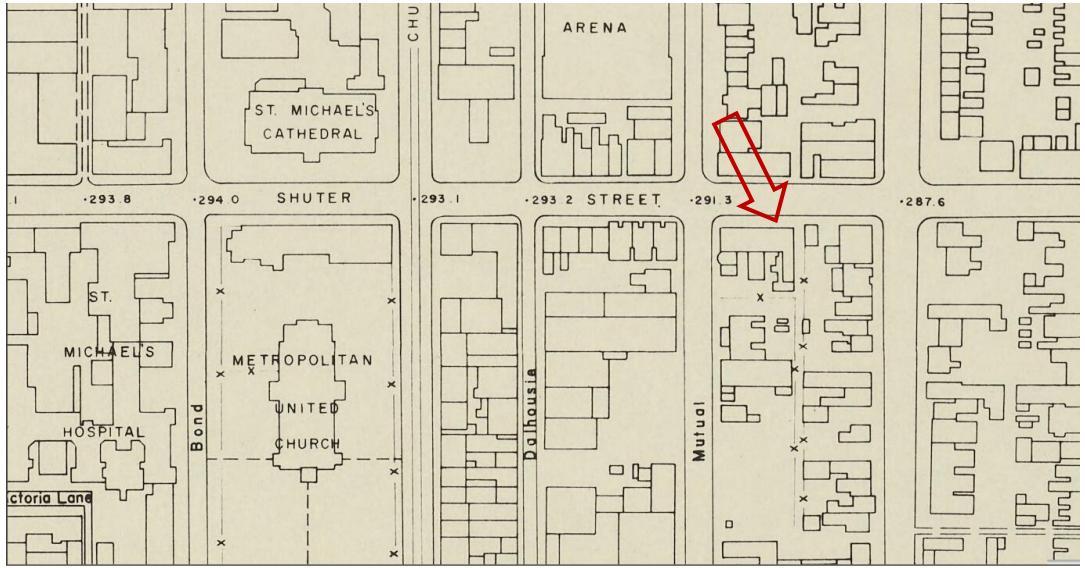
10. *City of Toronto Planning Board Atlas*, 1957 (detail): showing the same configuration of the three properties apart from the series of accretions at the rear of 85 Shuter and the removal of the outbuildings that originally extended behind 81, 83 and 85 Shuter Street. (CTA, Sheet 12, Section D)

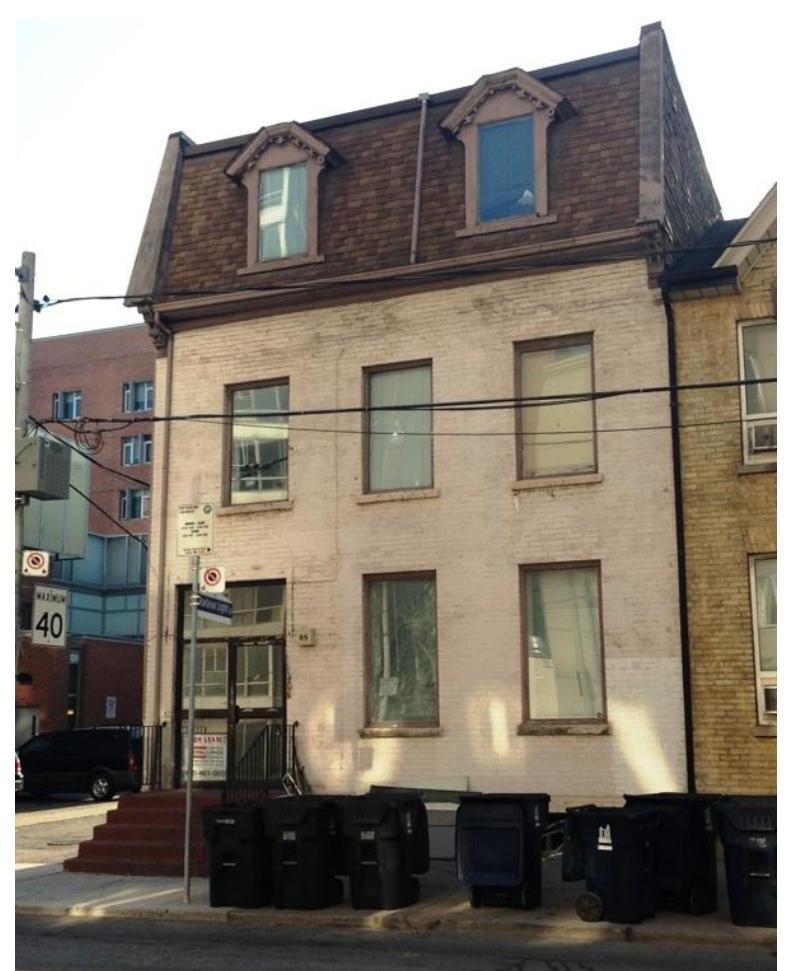
11. 85 Shuter Street (Catherine Scott house) showing the principal (north) elevation at the south-west corner of Shuter and the laneway. (HPS, 2016)

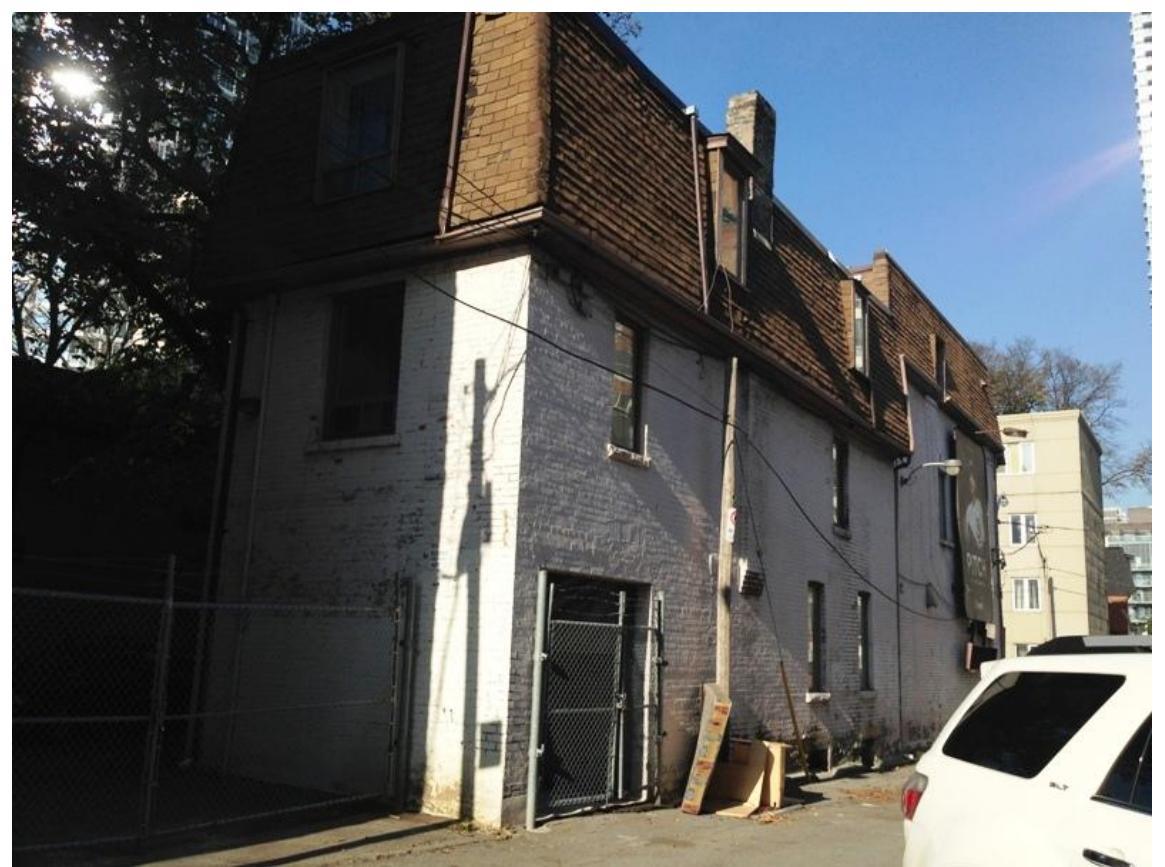
16. 85 Shuter Street: showing the east and rear south elevation with the entrance to the passageway. (HPS, 2016)

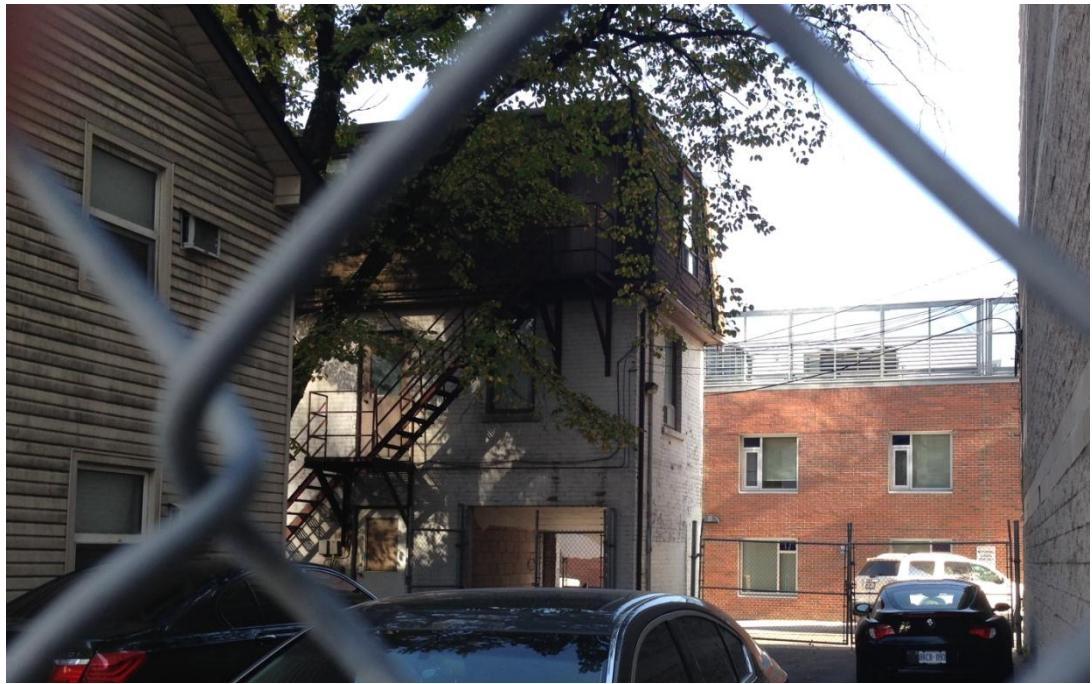
17. 85 Shuter Street: looking east towards the west rear elevation of 85 Shuter showing the passageway constructed between 1903 and 1913. (HPS, 2016)

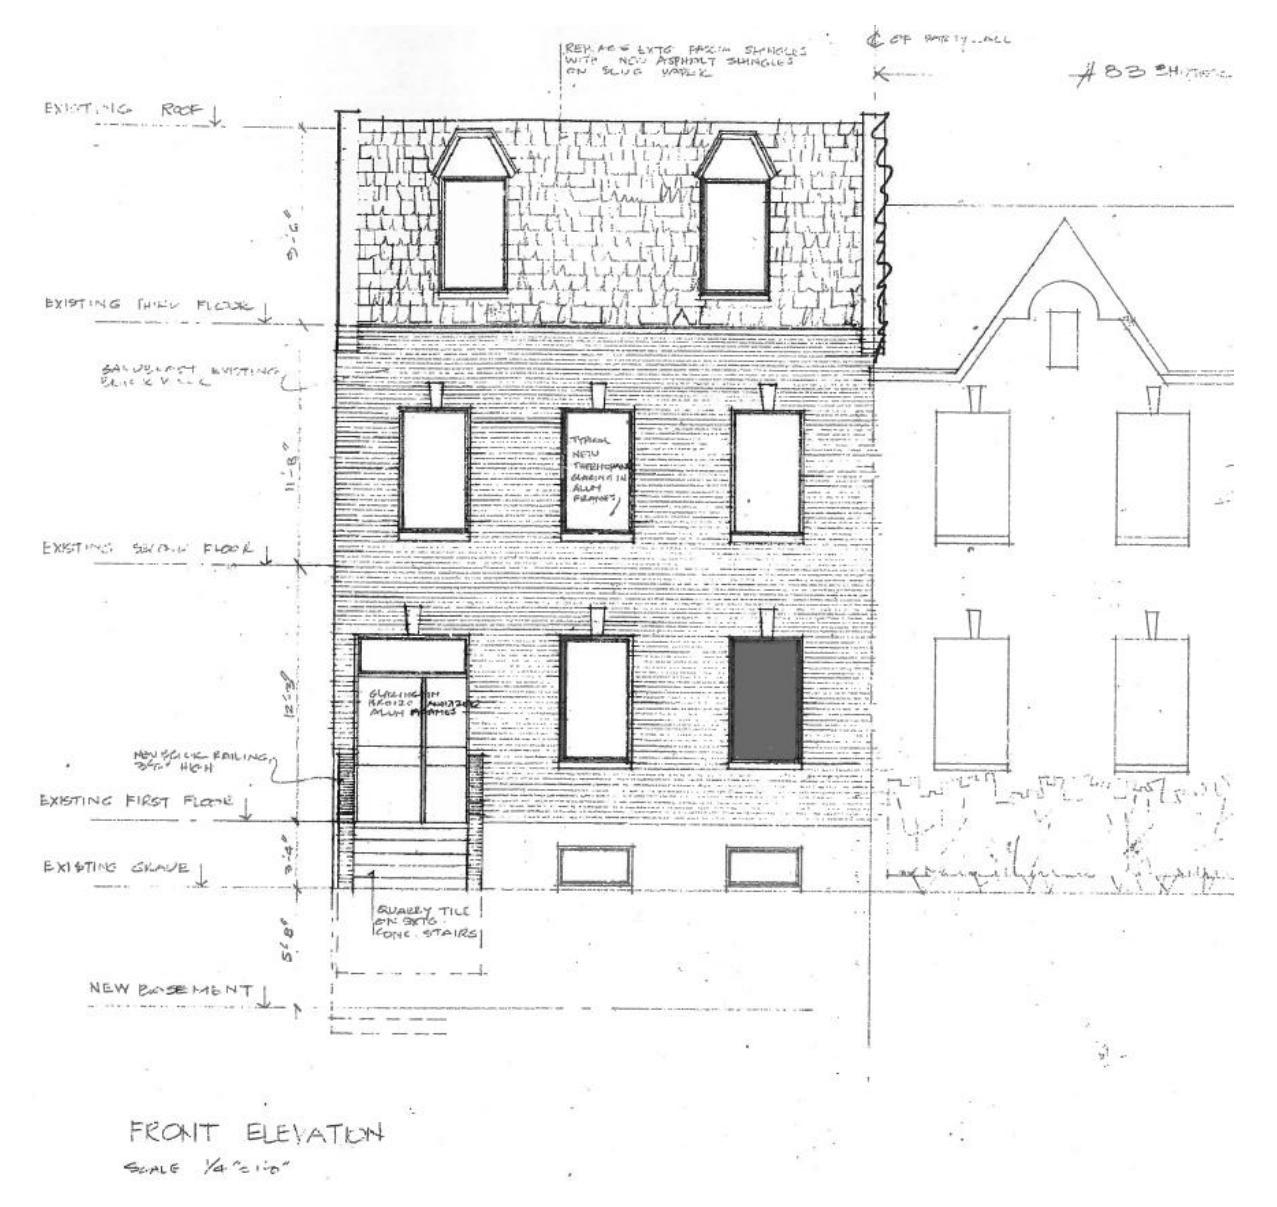
18. 85 Shuter Street, North Elevation: showing the façade with keystones matching those at 81 Shuter Street. (City of Toronto Building Records, Building Permit 08730)

Building permit drawings submitted indicate that these headers and keystones were removed after 1976⁷ and evidence of this alteration is apparent in the façade. (Images 18-19) The original door has been replaced with a double-leafed metal and glass door with a high transom.

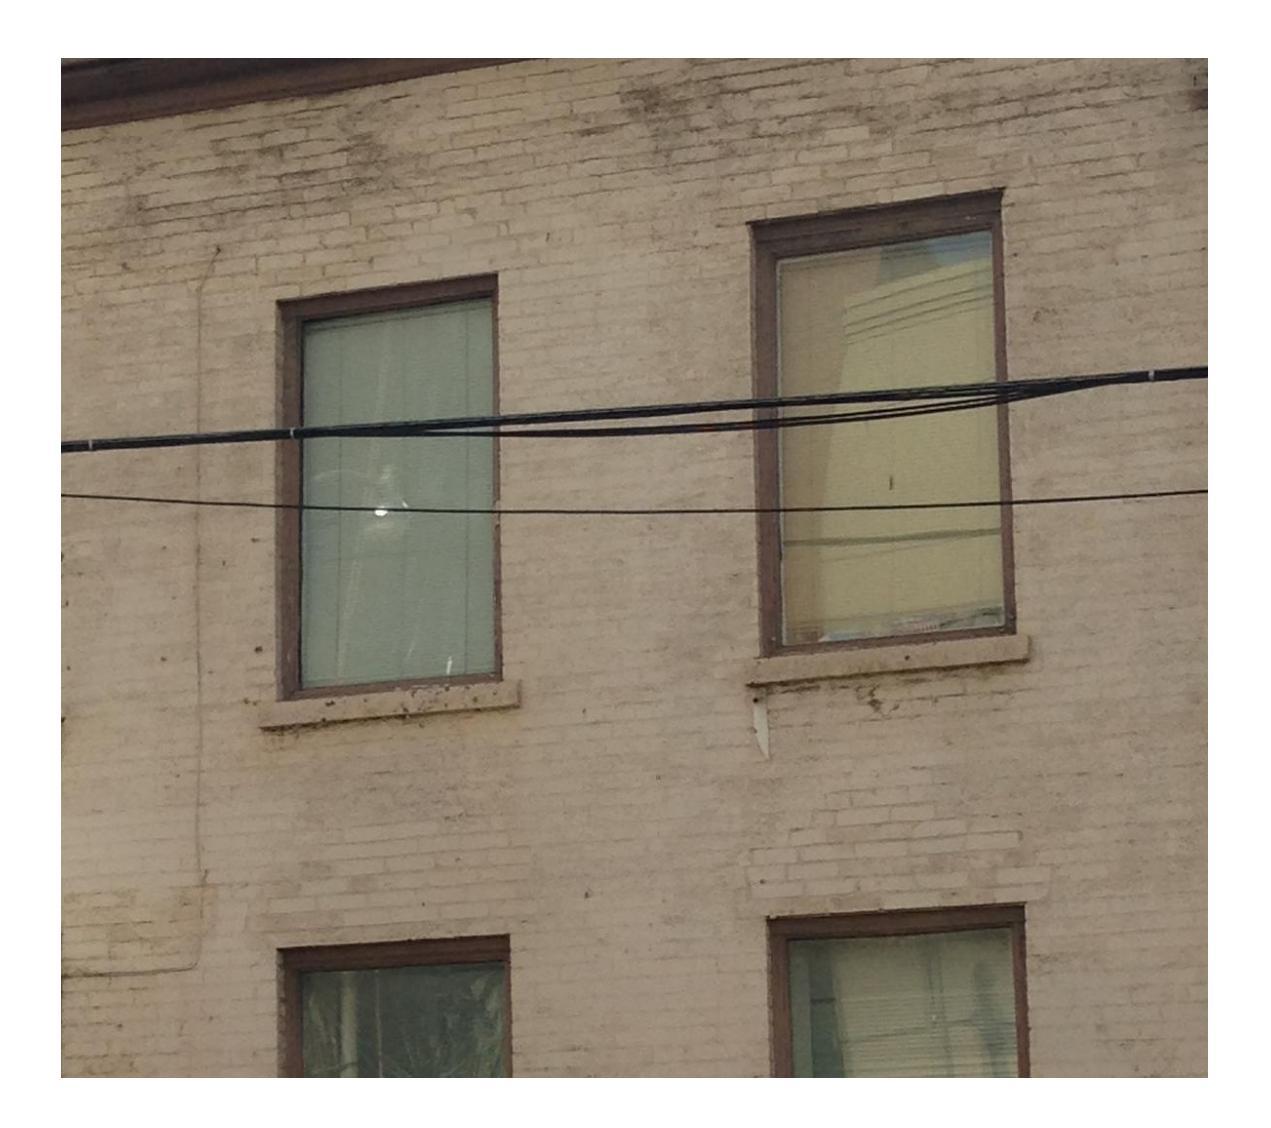
19. 85 Shuter Street, North elevation, detail: showing the new brick work above the windows where the original keystones and vertical header bricks had been. (HPS, 2016)

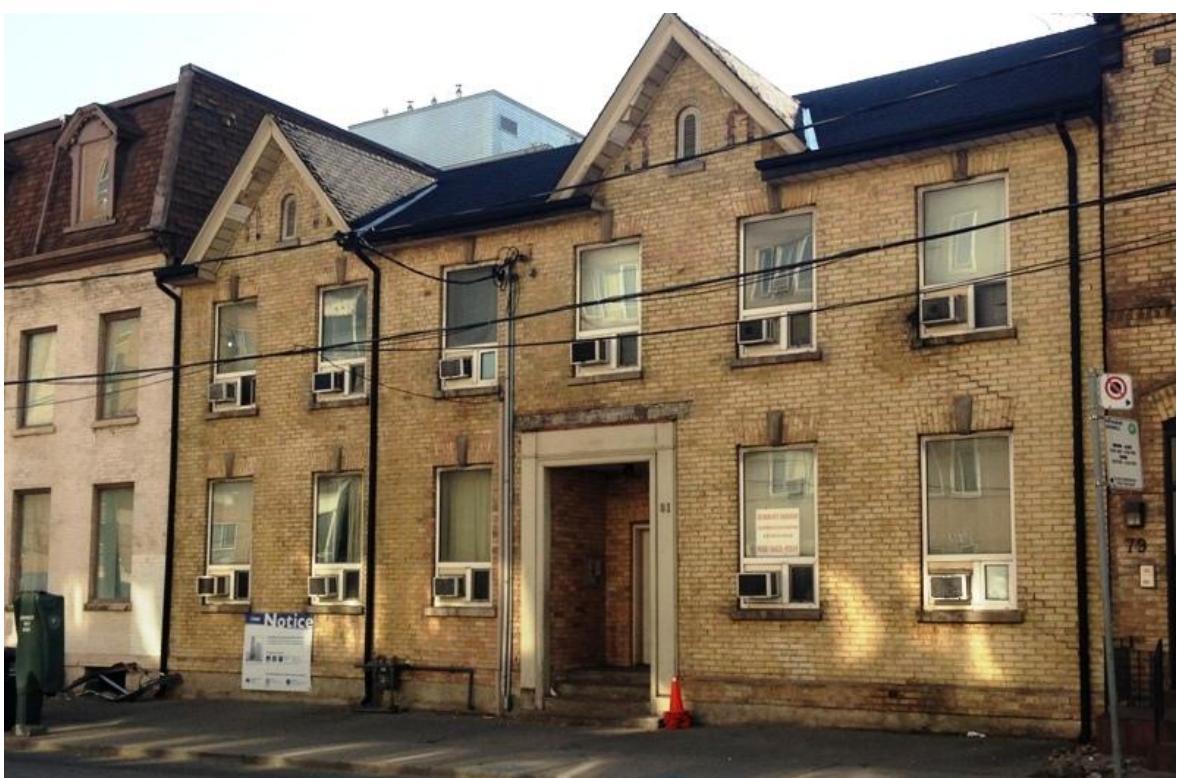
20. 81 Shuter Street, North elevation: showing the current condition of the former 83 and 81 Shuter Street, now united with a single entrance and the replacement to the left of the entrance with a window whose proportion matches the existing windows. (HPS, 2016)

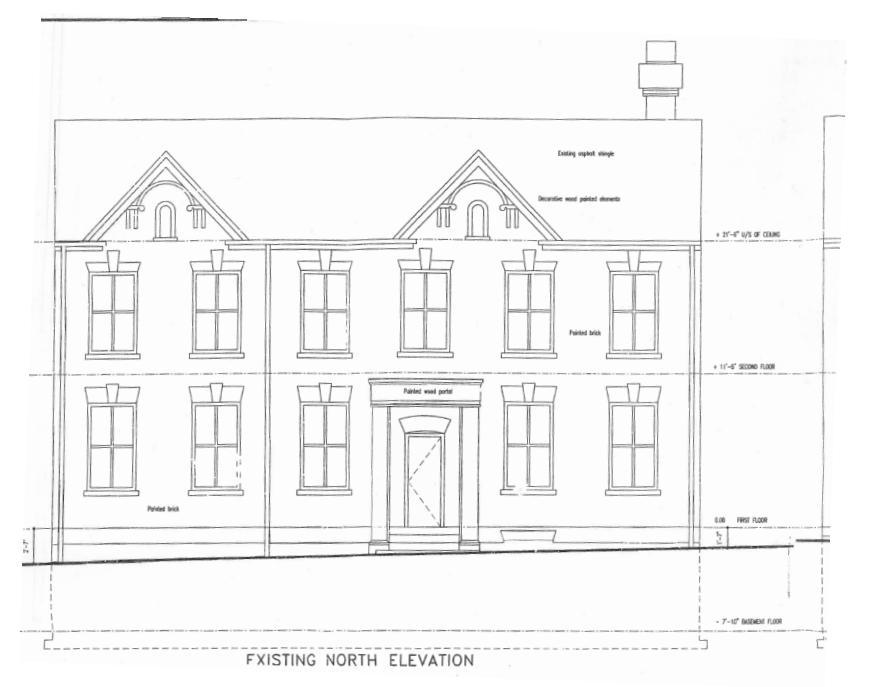
21. 81 Shuter Street, Existing North Elevation Drawing 1999: showing the property as it existed in 1999 with two-over-two sash windows, a prominent classical door case (added after 1941) and the decorative details in the dormer gables. (Building Permit 425838)

replaced with a window which matched the others in size. Drawings submitted in 1999 indicate that at that date the windows were two-over-two double-hung sash, typical of the 3rd quarter of the 19th century. (Image 21) The brick was noted as being painted at that time and a small extension was made to the rear wing. Sometime after May 2015, the decorative wood elements in the gables and the cornice on the door case were removed. (Images 22-25) However the essential form and qualities typical of the 1860s remain.

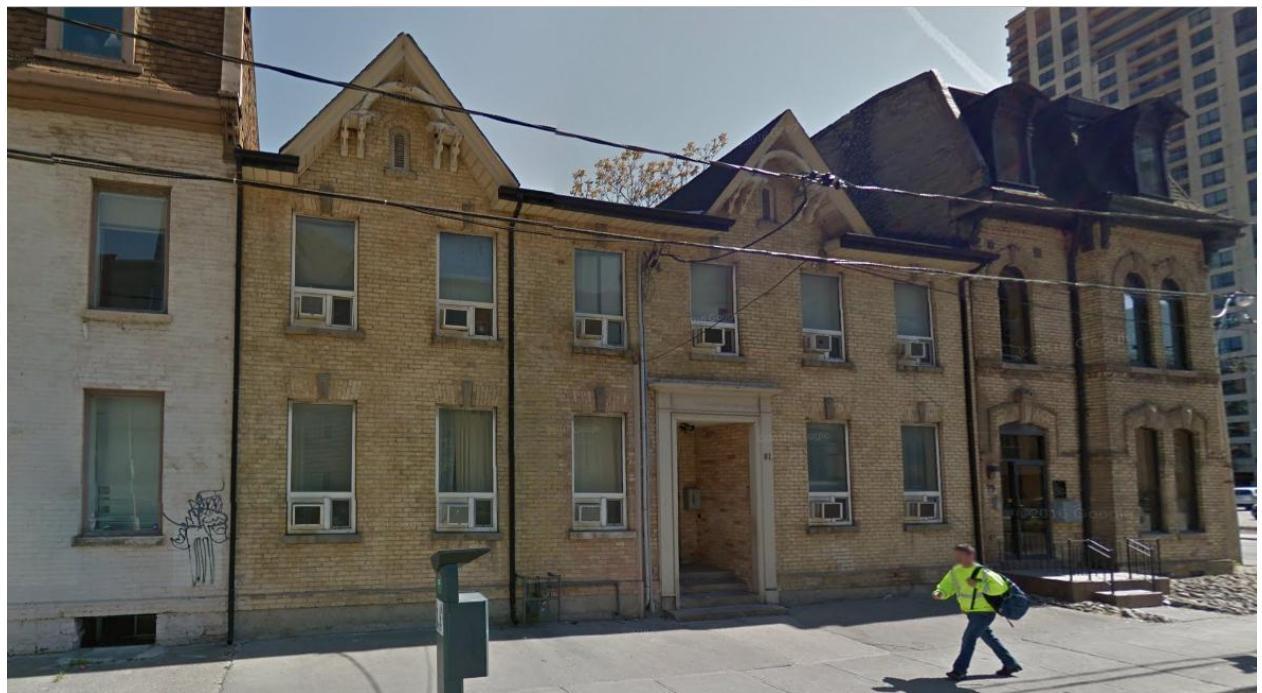
22. 81 Shuter Street, North elevation: showing the north elevation with the full door case and the decorative woodwork and bracket in the gables.(Google Street view, May 2015)

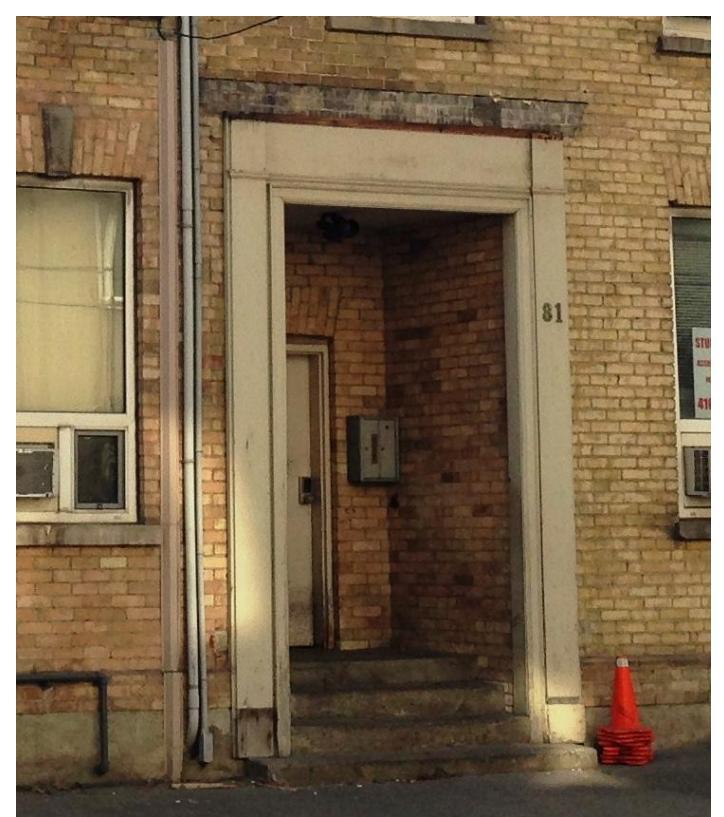
23. 81 Shuter Street, North elevation, detail of door case: showing the current condition of the door case with the missing cornice detail. (HPS, 2016)

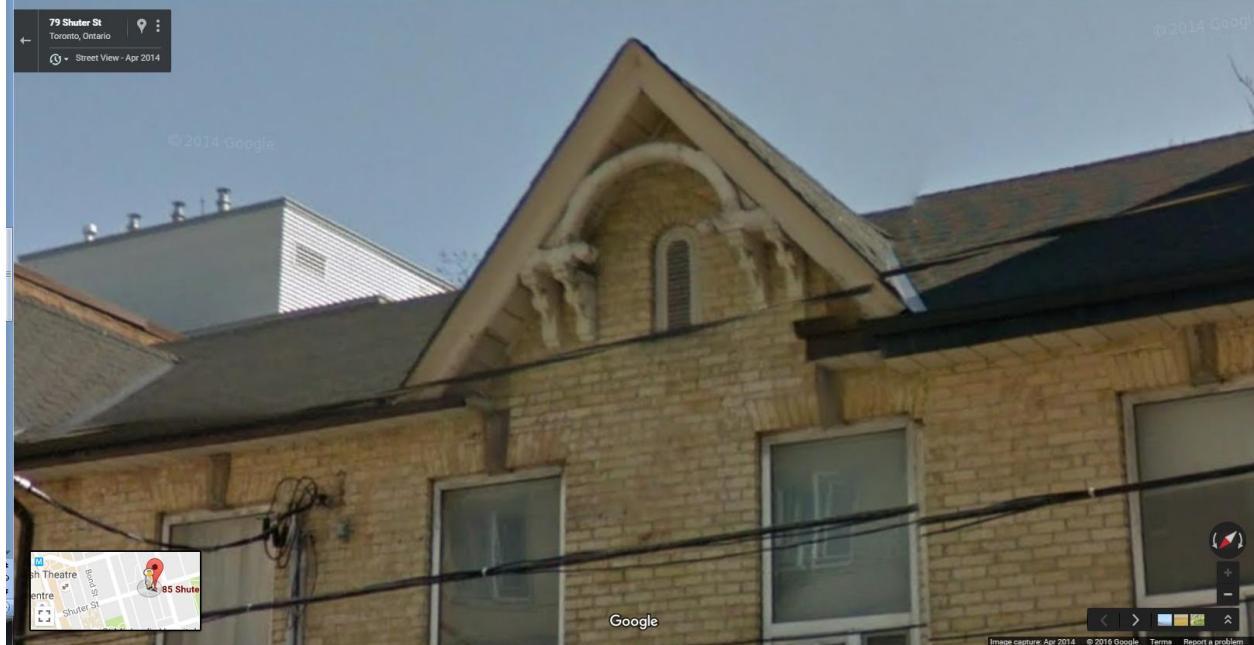
24.81 Shuter Street, North elevation, gable details. (Google Street view, April 2014)

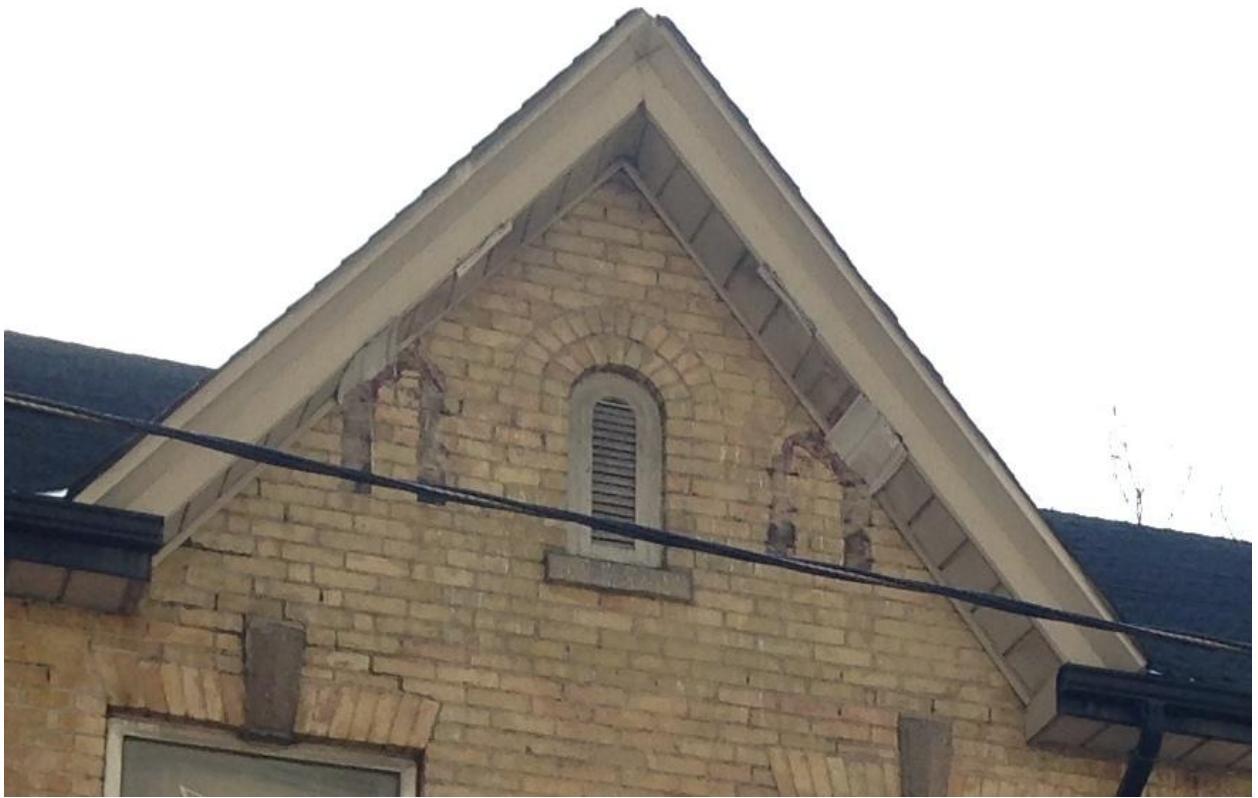
25. 81 Shuter Street, North elevation, gable detail: showing location of former wood brackets. (HPS, 2016)

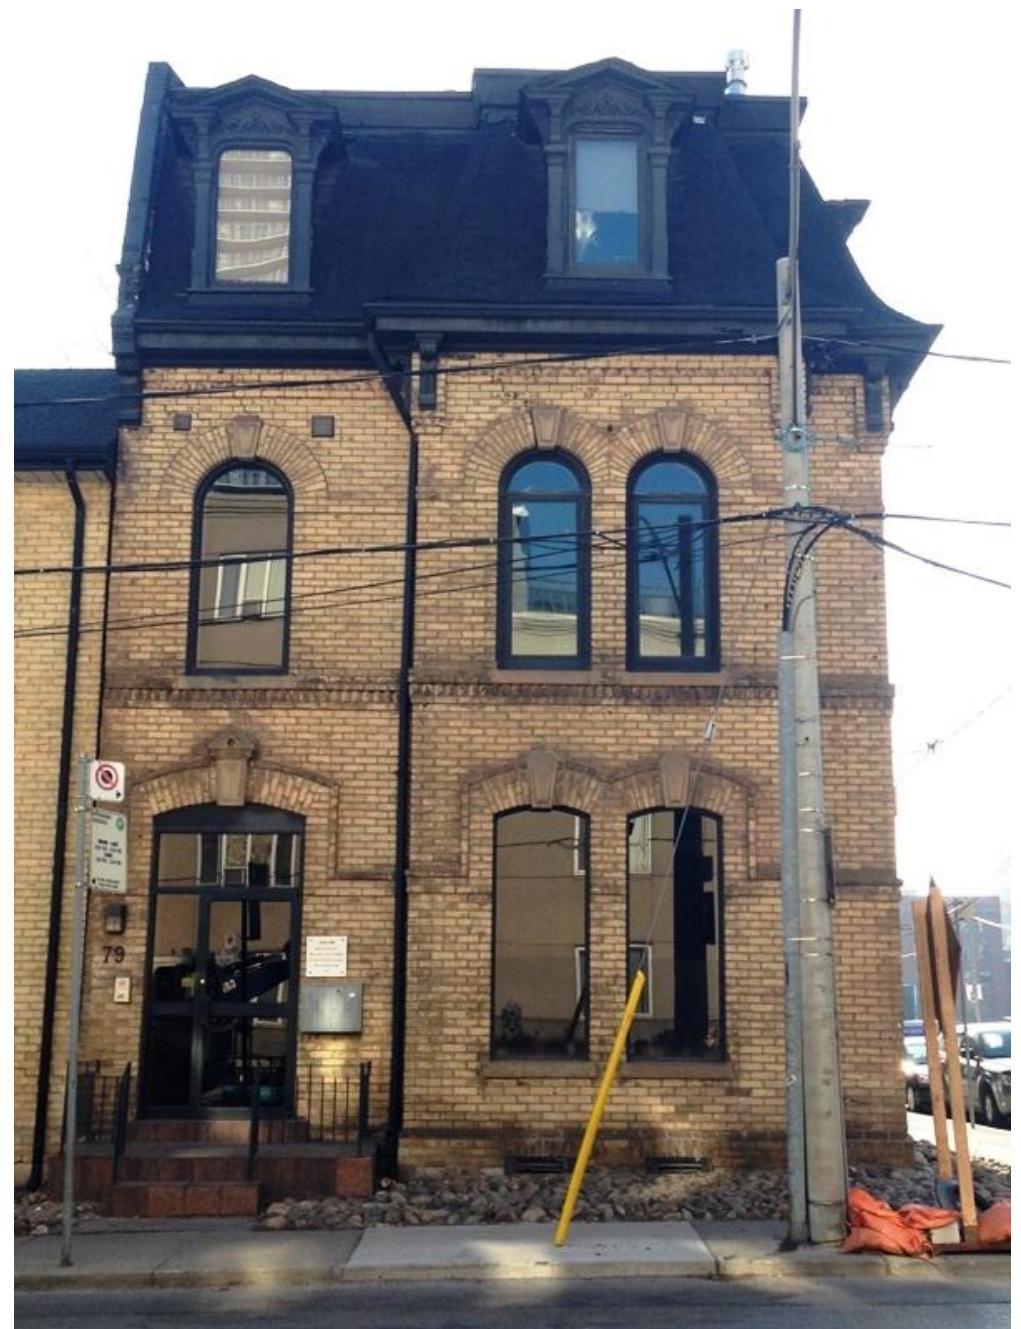
26. 79 Shuter Street: showing the north elevation the various window head types, caststone keystones, and brick courses. (HPS, 2016)

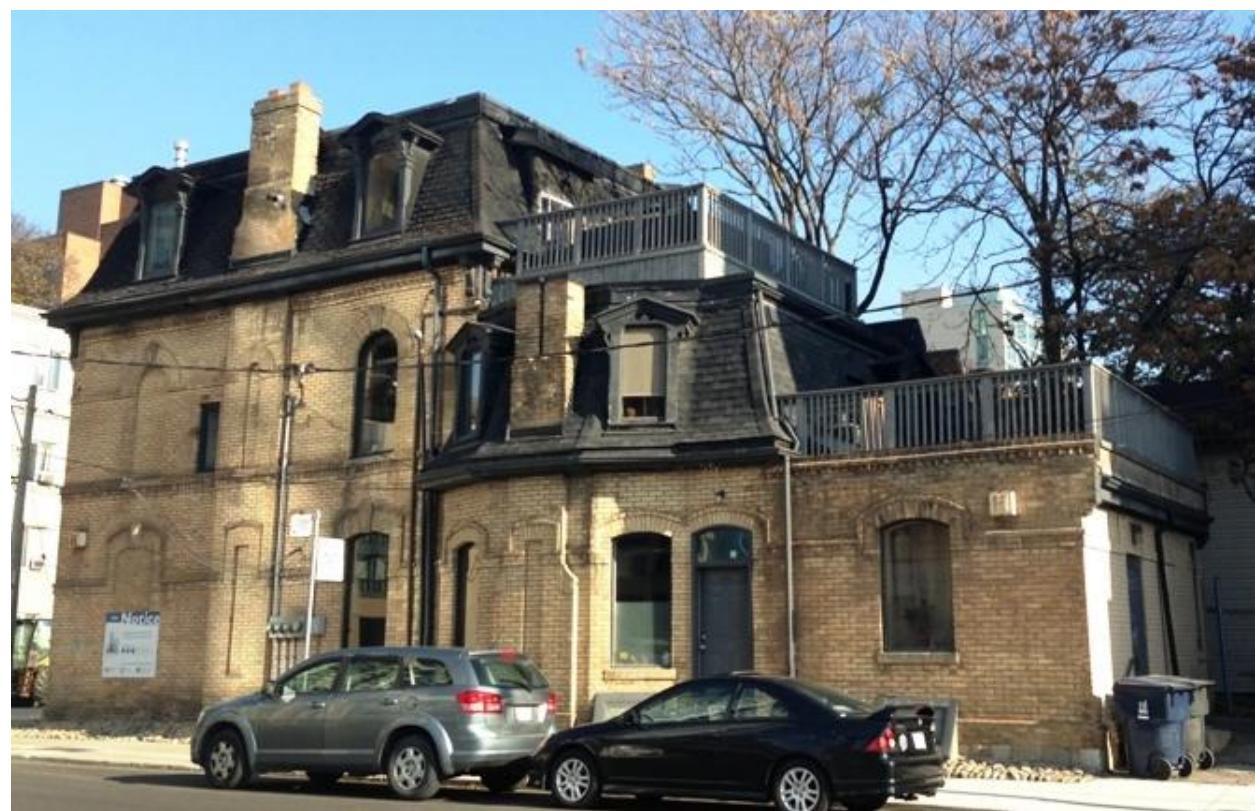
27. 79 Shuter Street: showing the west elevation facing Mutual Street with the composition of the varying heights of the main block, and two rear wings. (HPS, 2016)

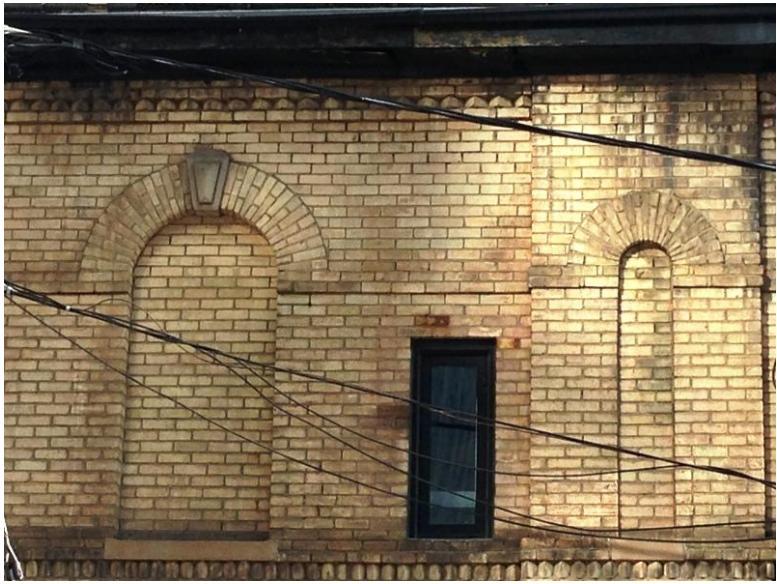
29. 79 Shuter Street, West elevation: showing the decorative brick work, the saw tooth courses, string courses and blind panels as well as the cast stone keystone. (HPS, 2016)

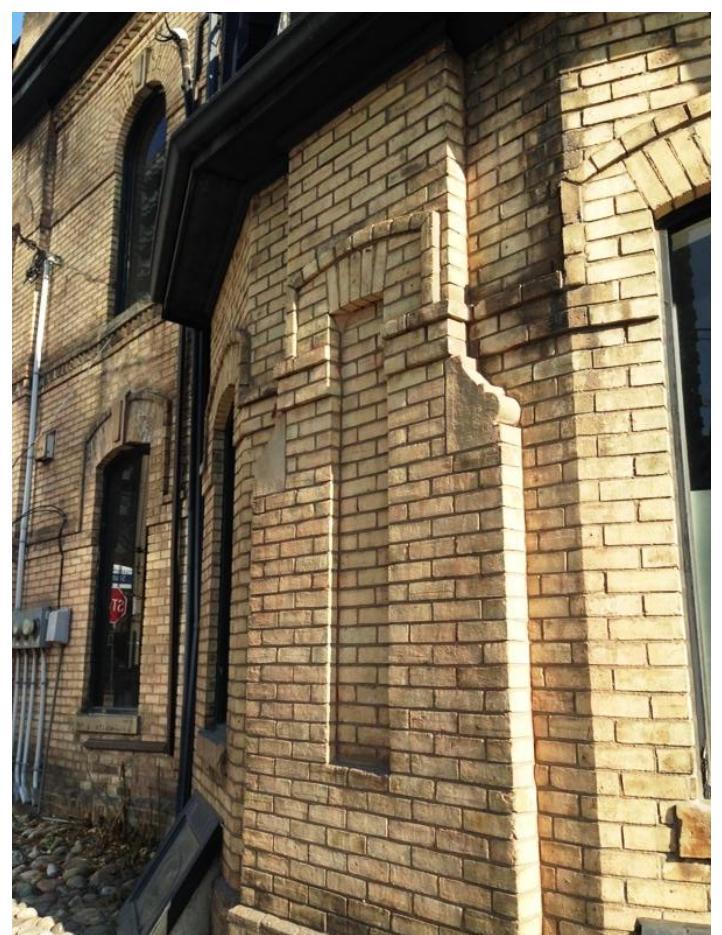
30. 79 Shuter Street, west elevation: showing the brick details, string courses, and the stone keystones, relief panels and chimney mouldings. (HPS, 2016)

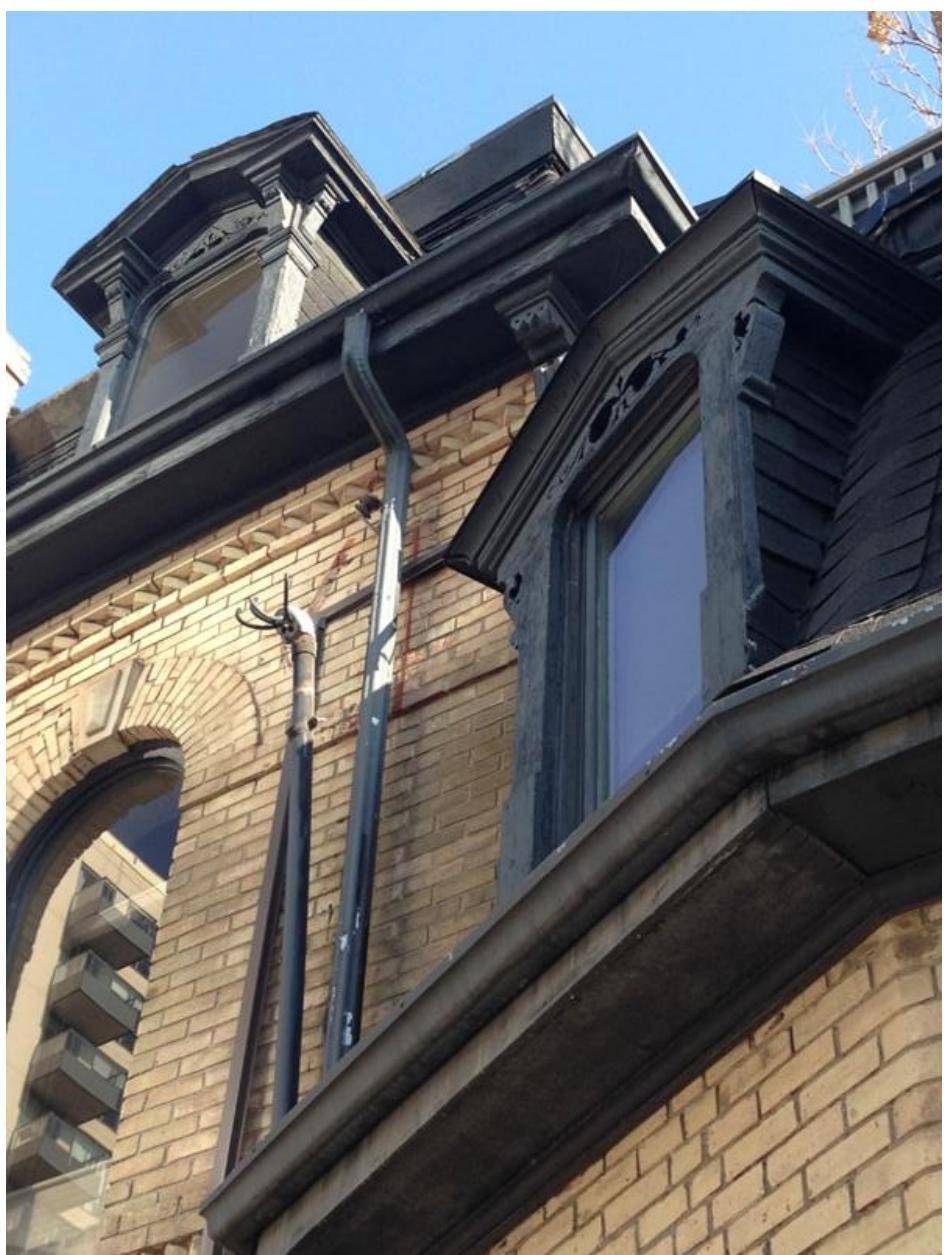
31. 79 Shuter Street, west elevation: showing the details in the mansard dormer window casings as well as the brick details. (HPS, 2016)

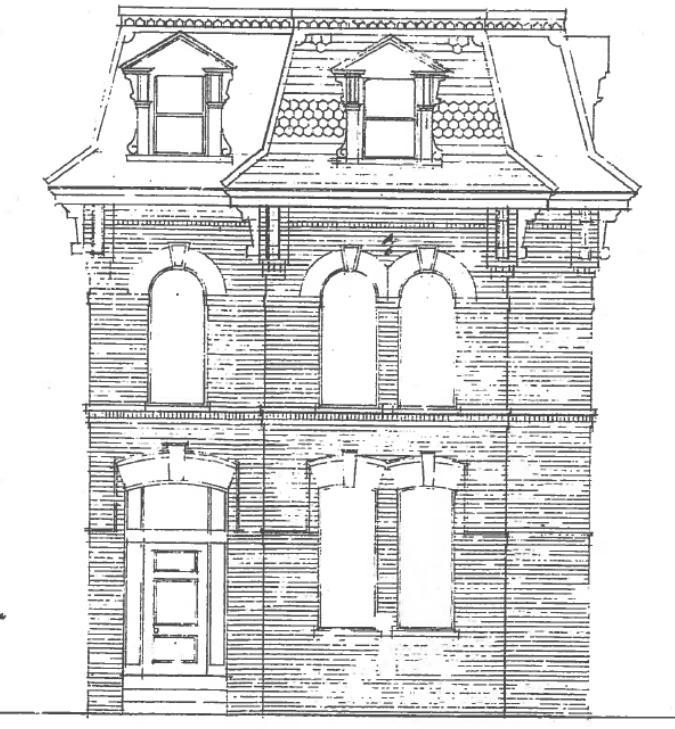
Elevation to Shuter Street (north)

32. 79 Shuter Street, North Elevation Drawing, Robbie Williams Partnership, 1974: showing the band of fish scale pattern slates on the roof. (Building Permit 051513, 1974)
