13 CONDITION ASSESSMENT

ERA has conducted multiple site visits and assessments through between 2015-2023. ERA undertook a condition assessment of the Site which included visual inspections of the interior and exterior on August 6, 2021, March 3 and 17, 2022 and July 11, 2023. Our assessment, unless otherwise noted, was carried out from grade and included no destructive testing. Refer to Section 17 for comments regarding the existing building's foundation and structural stability. For this condition assessment, the building components were graded using the following terms:

Appendix G: Retention Letter by Read Jones Christoffersen Ltd., dated August 21, 2023

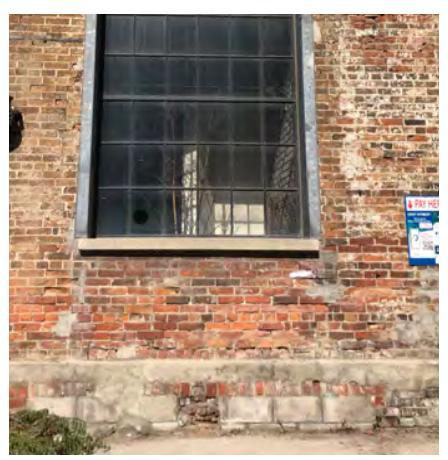
Minor staining is visible on the facade, concentrated under the stone sills. Minor efflorescence is also visible at grade level. The east side of the facade adjacent entries shows significant efflorescence as well. There are deteriorated jambs on the large window on the east side of the facade with significant efflorescence. The existing metal lintel on east side appear to have spalling masonry around the leading edge of steel. The south portion of the remaining Broom Factory wall is in poor condition with significant masonry deterioration throughout with efflorescence and recessed mortar joints visible.

Figure 74. Detail of staining beneath the stone sill (ERA, 2023).

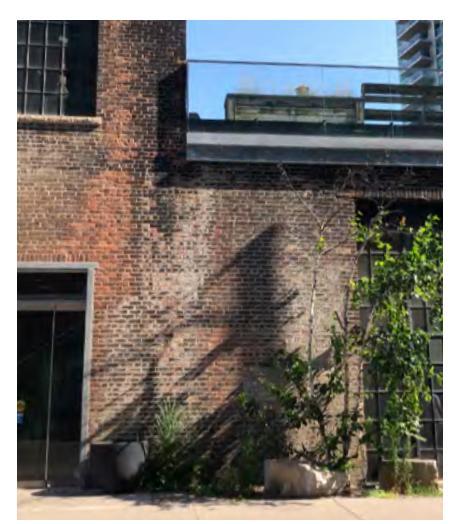
Figure 75. Detail of facade efflorescence (ERA, 2023).

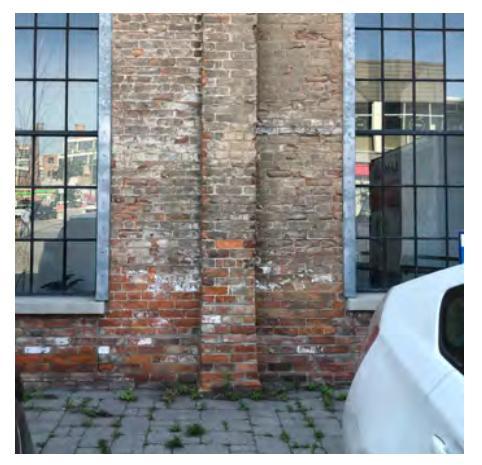
There are step cracks which have been previously infilled, some with caulking. There is consistent spalling and joint deterioration visible at-grade and selective spalling apparent throughout the facade which has exposed the softer red interior body of the bricks. Efflorescence was present at localized areas and paint remnants are visible on the facade in selective locations. Graffiti was also visible in some locations. Roofing bituminous coatings are visible at the parapet level. Galvanized metal jambs also appear to be in good condition.

Figure 77. Detail of spalling and joint deterioration (ERA, 2023).

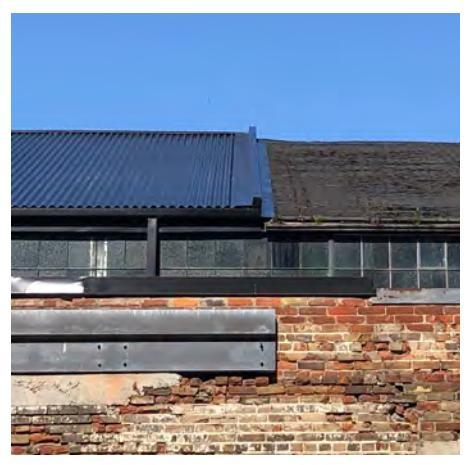
Figure 78. Detail of step cracking and bituminous coating at the parapet level (ERA, 2023).

Bituminous roof coatings were observed on the facade. There also appears to be severe deterioration of masonry at roof level.

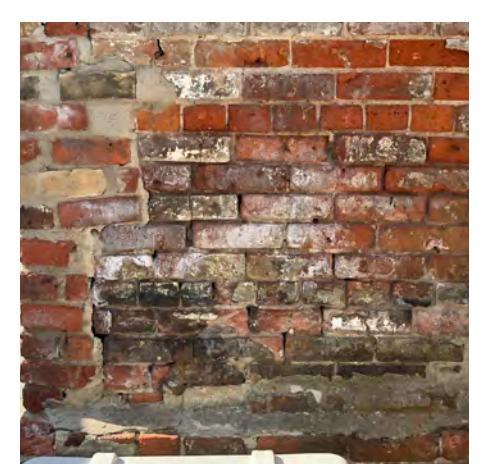
The single-storey west wing and elevation was built with the gable end wall in 1929 and matches its brick construction. The masonry has been repaired previously and the replacement masonry appears to be in orange brick, inconsistent with the original bricks. There are also localized areas of recessed mortar joints as well as metal fasteners visible in the masonry.

Figure 79. Detail of masonry with remnants of paint and recessed mortar joints (ERA, 2023).

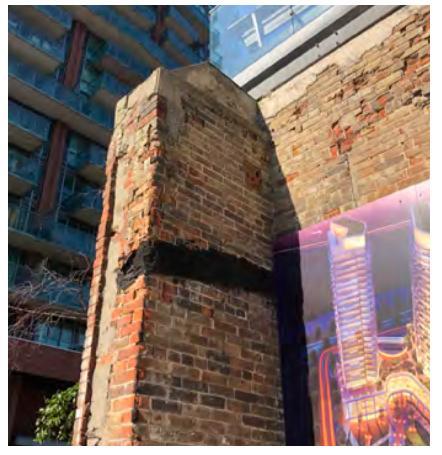
A concrete cap has been added to the top of the wall. Given that concrete does not have the same material properties as brick in terms of movement due to expansion and contraction and level of porosity, areas of brick adjacent to the concrete cap show accelerated deterioration.

Figure 80. Detail of remnant of Broom Factory wall with a cast concrete cap (ERA, 2023).

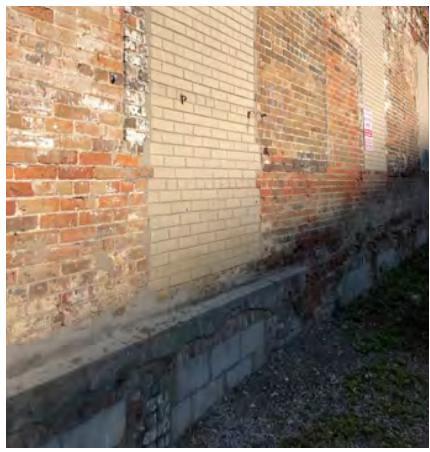
This single-storey, east elevation is the former interior face of the west wall of the Central Prison Broom Factory. The east elevation's brick face was not built to be exposed to the weather, but it is in poor condition. The red bricks have spalled heavily allowing moisture into the wall. There appears to be significant deterioration through the facade with spalling, efflorescence and recessed mortar joints. There are also remnants of white paint visible on the masonry. Scattered holes in the facade were observed and some of the holes contained metal anchors. Step cracking is also apparent throughout the east facade with severe deterioration of mortar joints at grade along length of the facade. The remaining Broom Factory wall is in poor condition. Caulking in mortar joints is also visible in select locations and grout infill of deteriorated masonry is apparent at the south half of the facade. Significant cracking was observed next to the entrance door jambs. Rusting metal fasteners are visible. Sill parging appears to be in poor condition and deteriorating. Concrete block infill at-grade appears to be in fair condition.

Figure 81. Detail of concrete block infill at-grade (ERA, 2023).

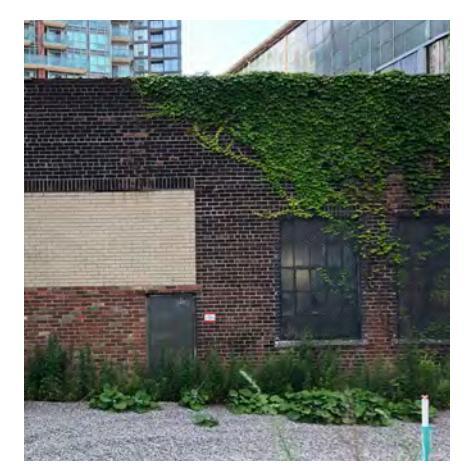
The north gable end wall is part of the 1929 construction, built with brown facing brick. The brick is in poor condition, with selective spalling throughout the facade and efflorescence present in localized areas. The spalling has exposed the softer interior body of these bricks.

Figure 82. Detail of brown facing brick (ERA, 2023).

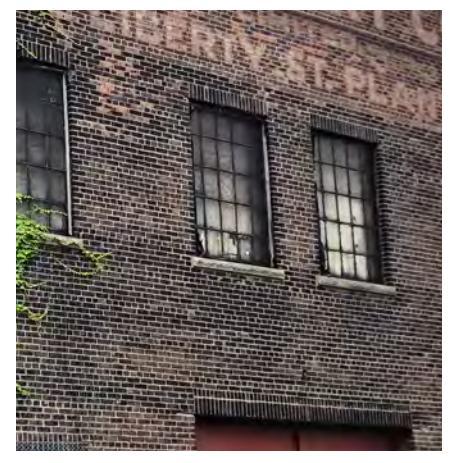
The original windows survive intact and are metal, singleglazed, full divided industrial glazing units, with an arrow shaped glazing bar (muntin) typical of the period. The windows appear to be in poor condition.

Figure 83. Original metal, single-glazed windows (ERA, 2023).

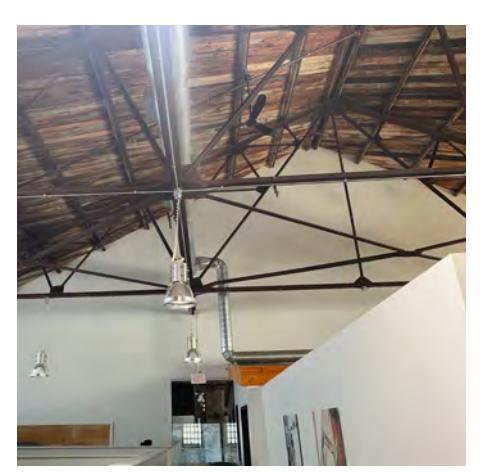
The roof structure is visible from the mezzanine. The original light-weight steel structure, with plated and riveted connections appears to be in sound condition and its heritage integrity well protected.

Figure 84. Interior detail of original steel structured roof (ERA, 2023).

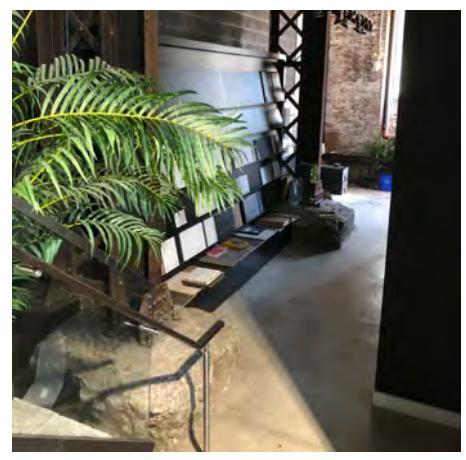
The ground floor is a concrete slab on grade, which is approximately 500 mm above the original floor elevation. The new elevation is flush with the sidewalk elevation on Lynn Williams Street indicating that exterior grades have been substantially raised and have concealed the base of the exterior wall. This may account for localized rising damp at the base of the walls, particularly on the west side, which has caused some brick spalling.

Figure 85.Interior detail of concrete slab flooring and footings (ERA, 2023).

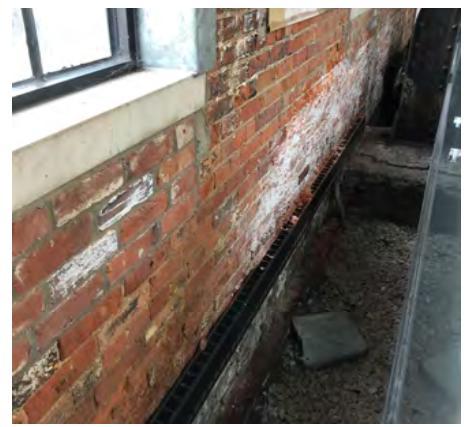
Figure 86.Interior detail of localized brick spalling at-grade (ERA, 2023).

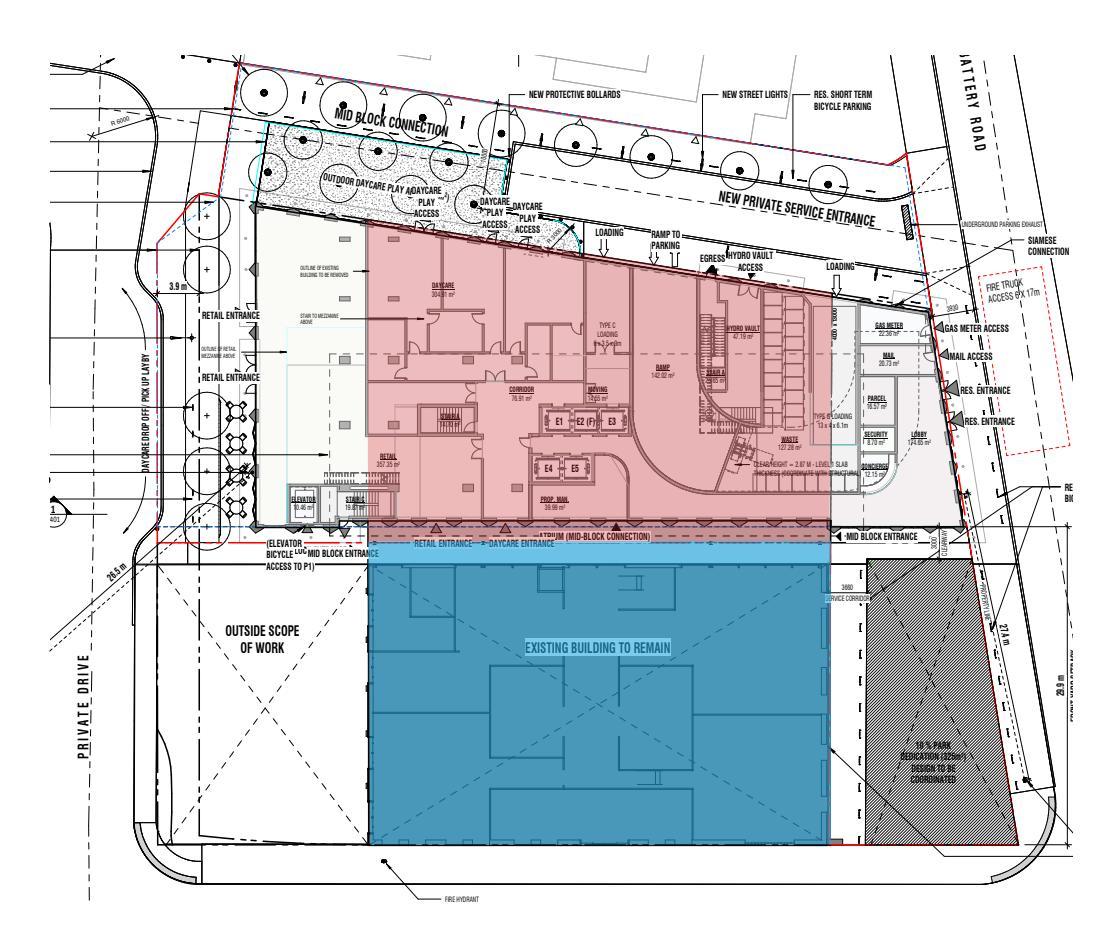
Figure 96. Proposed ground floor plan showing the retained building in blue and the footprint of the demolished portion in red (gh3, 2024; annotated by ERA).

Impact: Demolition of the northern portion of the existing building.

Rationale and Mitigation: The northern portion of the building will be demolished in order to construct the new mixed-use development. The partial demolition of the existing building will be mitigated by the in-situ retention and conservation of the southern portion of the building. This approach to the redevelopment and conservation of the Site is consistent with previous approvals. Existing material from the northern portion will be salvaged for use in the conservation of the southern portion.

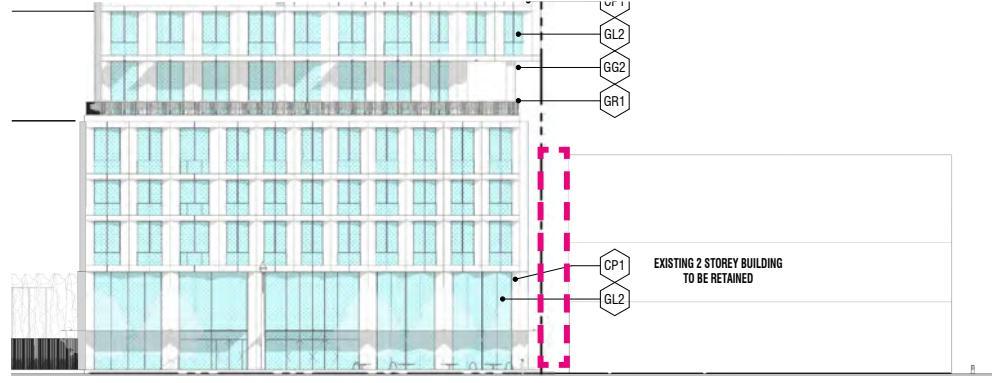
Figure 97. West elevation with the location of the proposed atrium in pink (gh3, 2024; annotated by ERA).

Impact: Partial demolition of east and west walls at ground floor level at the northern extent of the retained building.

Rationale and Mitigation: The approximate two-metre wide band running east-west will be modified in order to allow for a new atrium that will function as a mid-block pedestrian connection and provide access points to the retained building and the proposed development. The atrium will be accessible from the east and west elevations. The partial demolition of the east and west walls will be mitigated by the retention and conservation of the steel structure, including columns and truss, clerestory windows, and low and high roof profile.

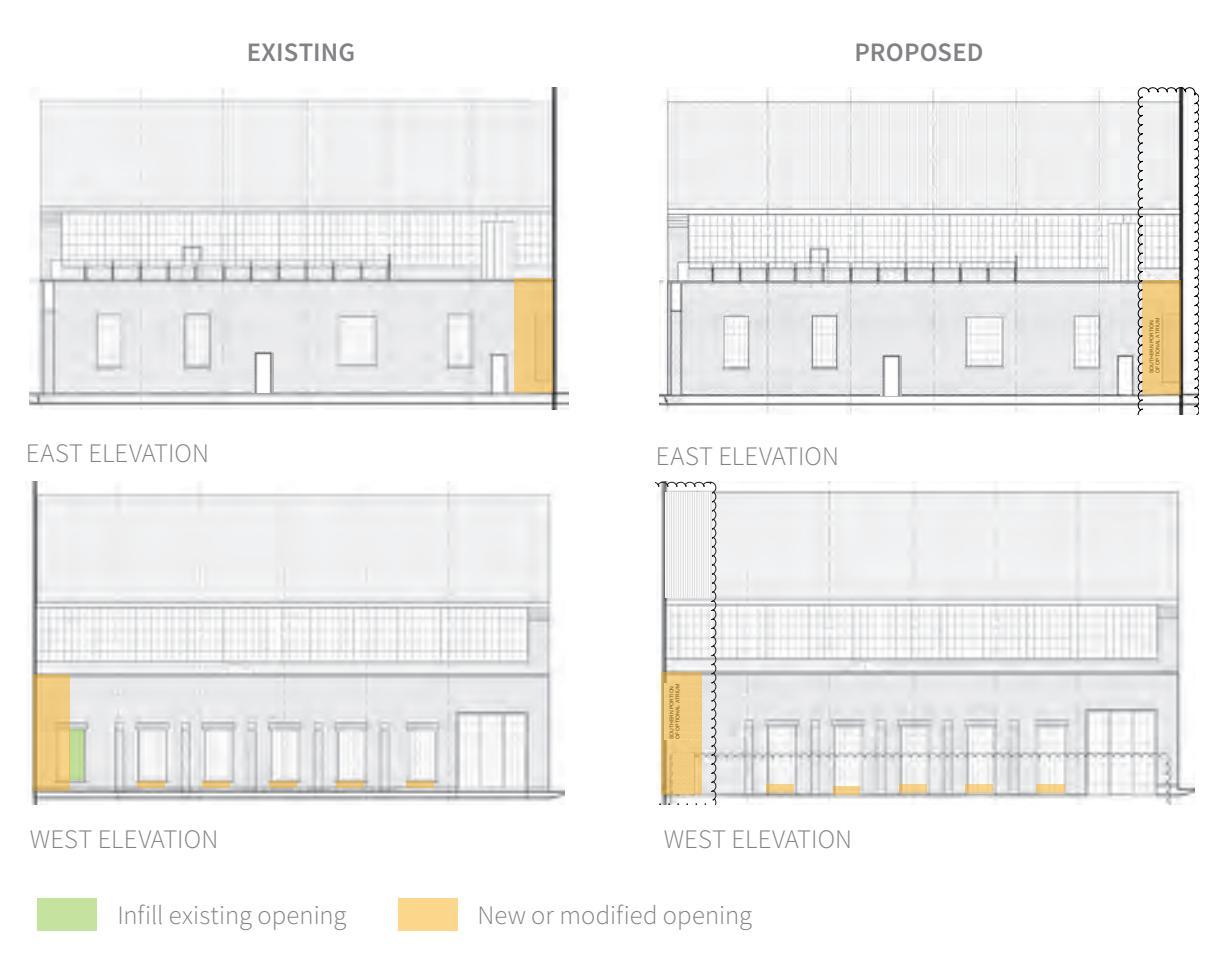
Figure 99. Existing and proposed elevations showing modifications to the openings for the retained building (Arcadis, 2024; annotated by ERA).

Impact: Modification to select openings on the east and west elevations of the retained building.

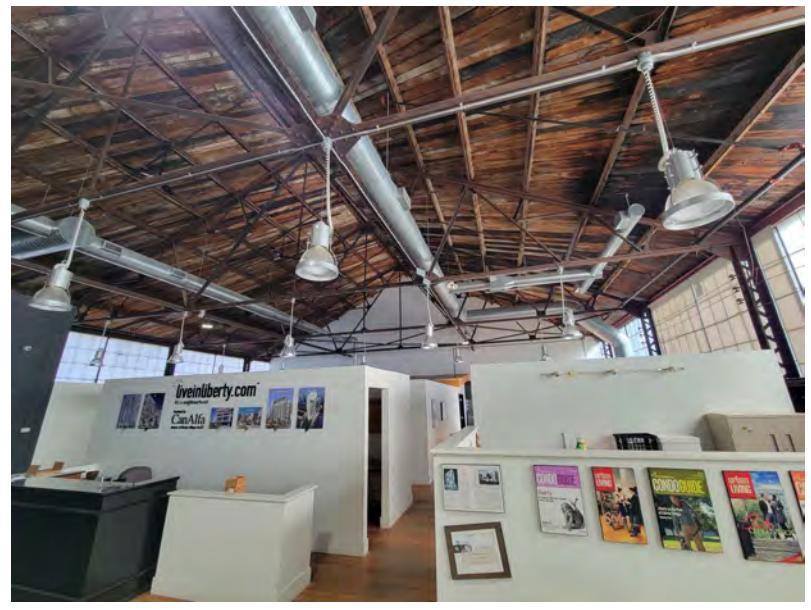
The roof over the central bay is framed with steel trusses spanning the full 19.5 m span, which is covered with two layers of wood decking laid diagonally over each other in opposing directions. The sloped roof decking is supported by steel channels with wood-nailed plates. The steel roof trusses are supported on steel columns with chords constructed with double angles and latticed together with steel plates.

Photo 4: View of the interior at mezzanine level looking north

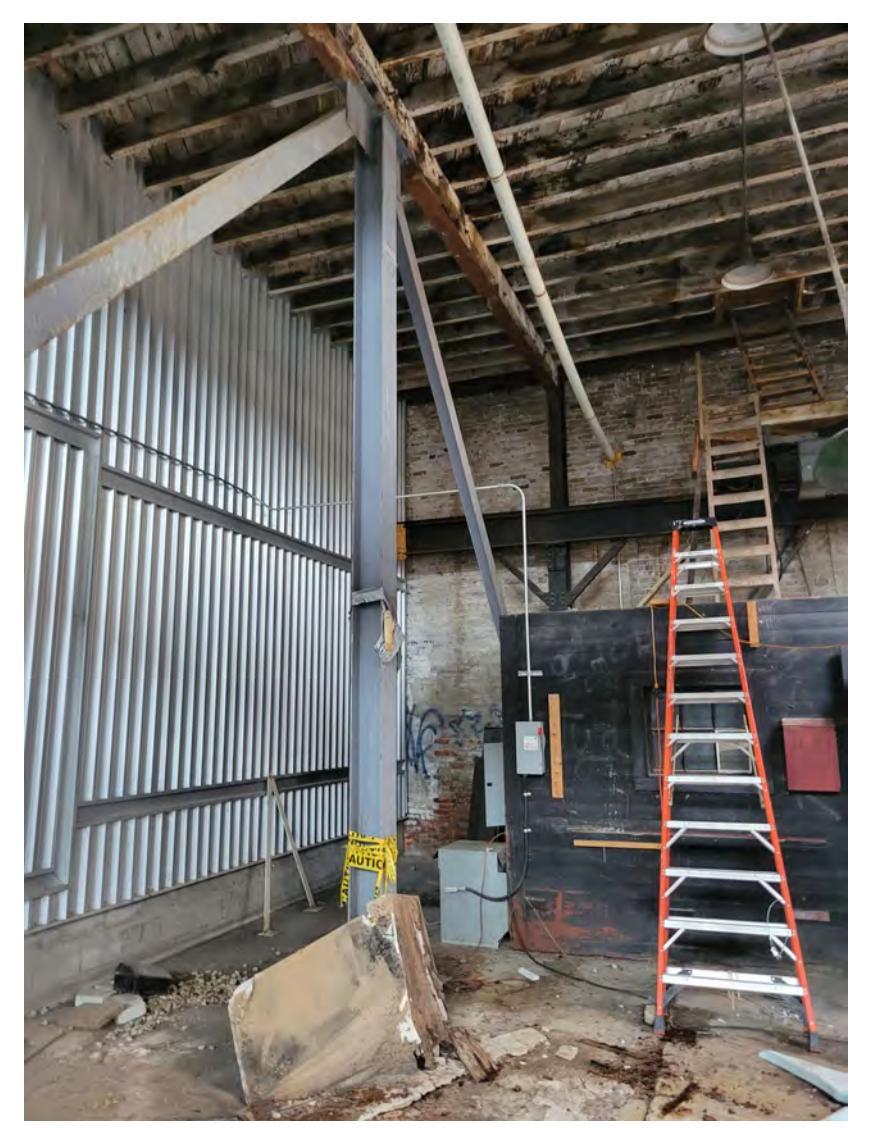
Photo 6: Existing vertical bracing installed in 2005 along grid line 7

- The existing building structure to remain should be a stand alone structure from the new building construction with a continuous separation and expansion joint.

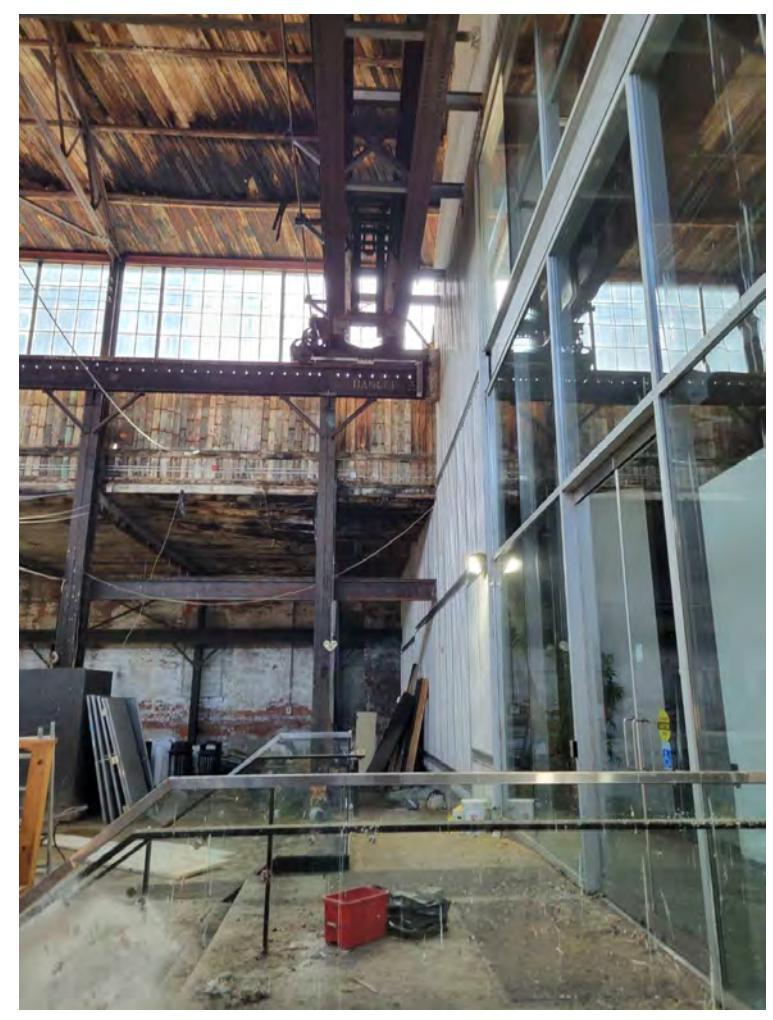
Photo 7: Existing gantry crane located just south of grid line 7

We recommend to consider maintaining the gantry crane in its current location. We understand the design intent is to have existing crane beams extend slightly north of grid line 7. Short stub column supports could be added between the underside of the gantry crane north girder and the top of crane beam supports in line with the columns on grid line 7. This would allow the beams north of grid line 7 to be cut and removed beyond approx. 1m north of grid line 7.

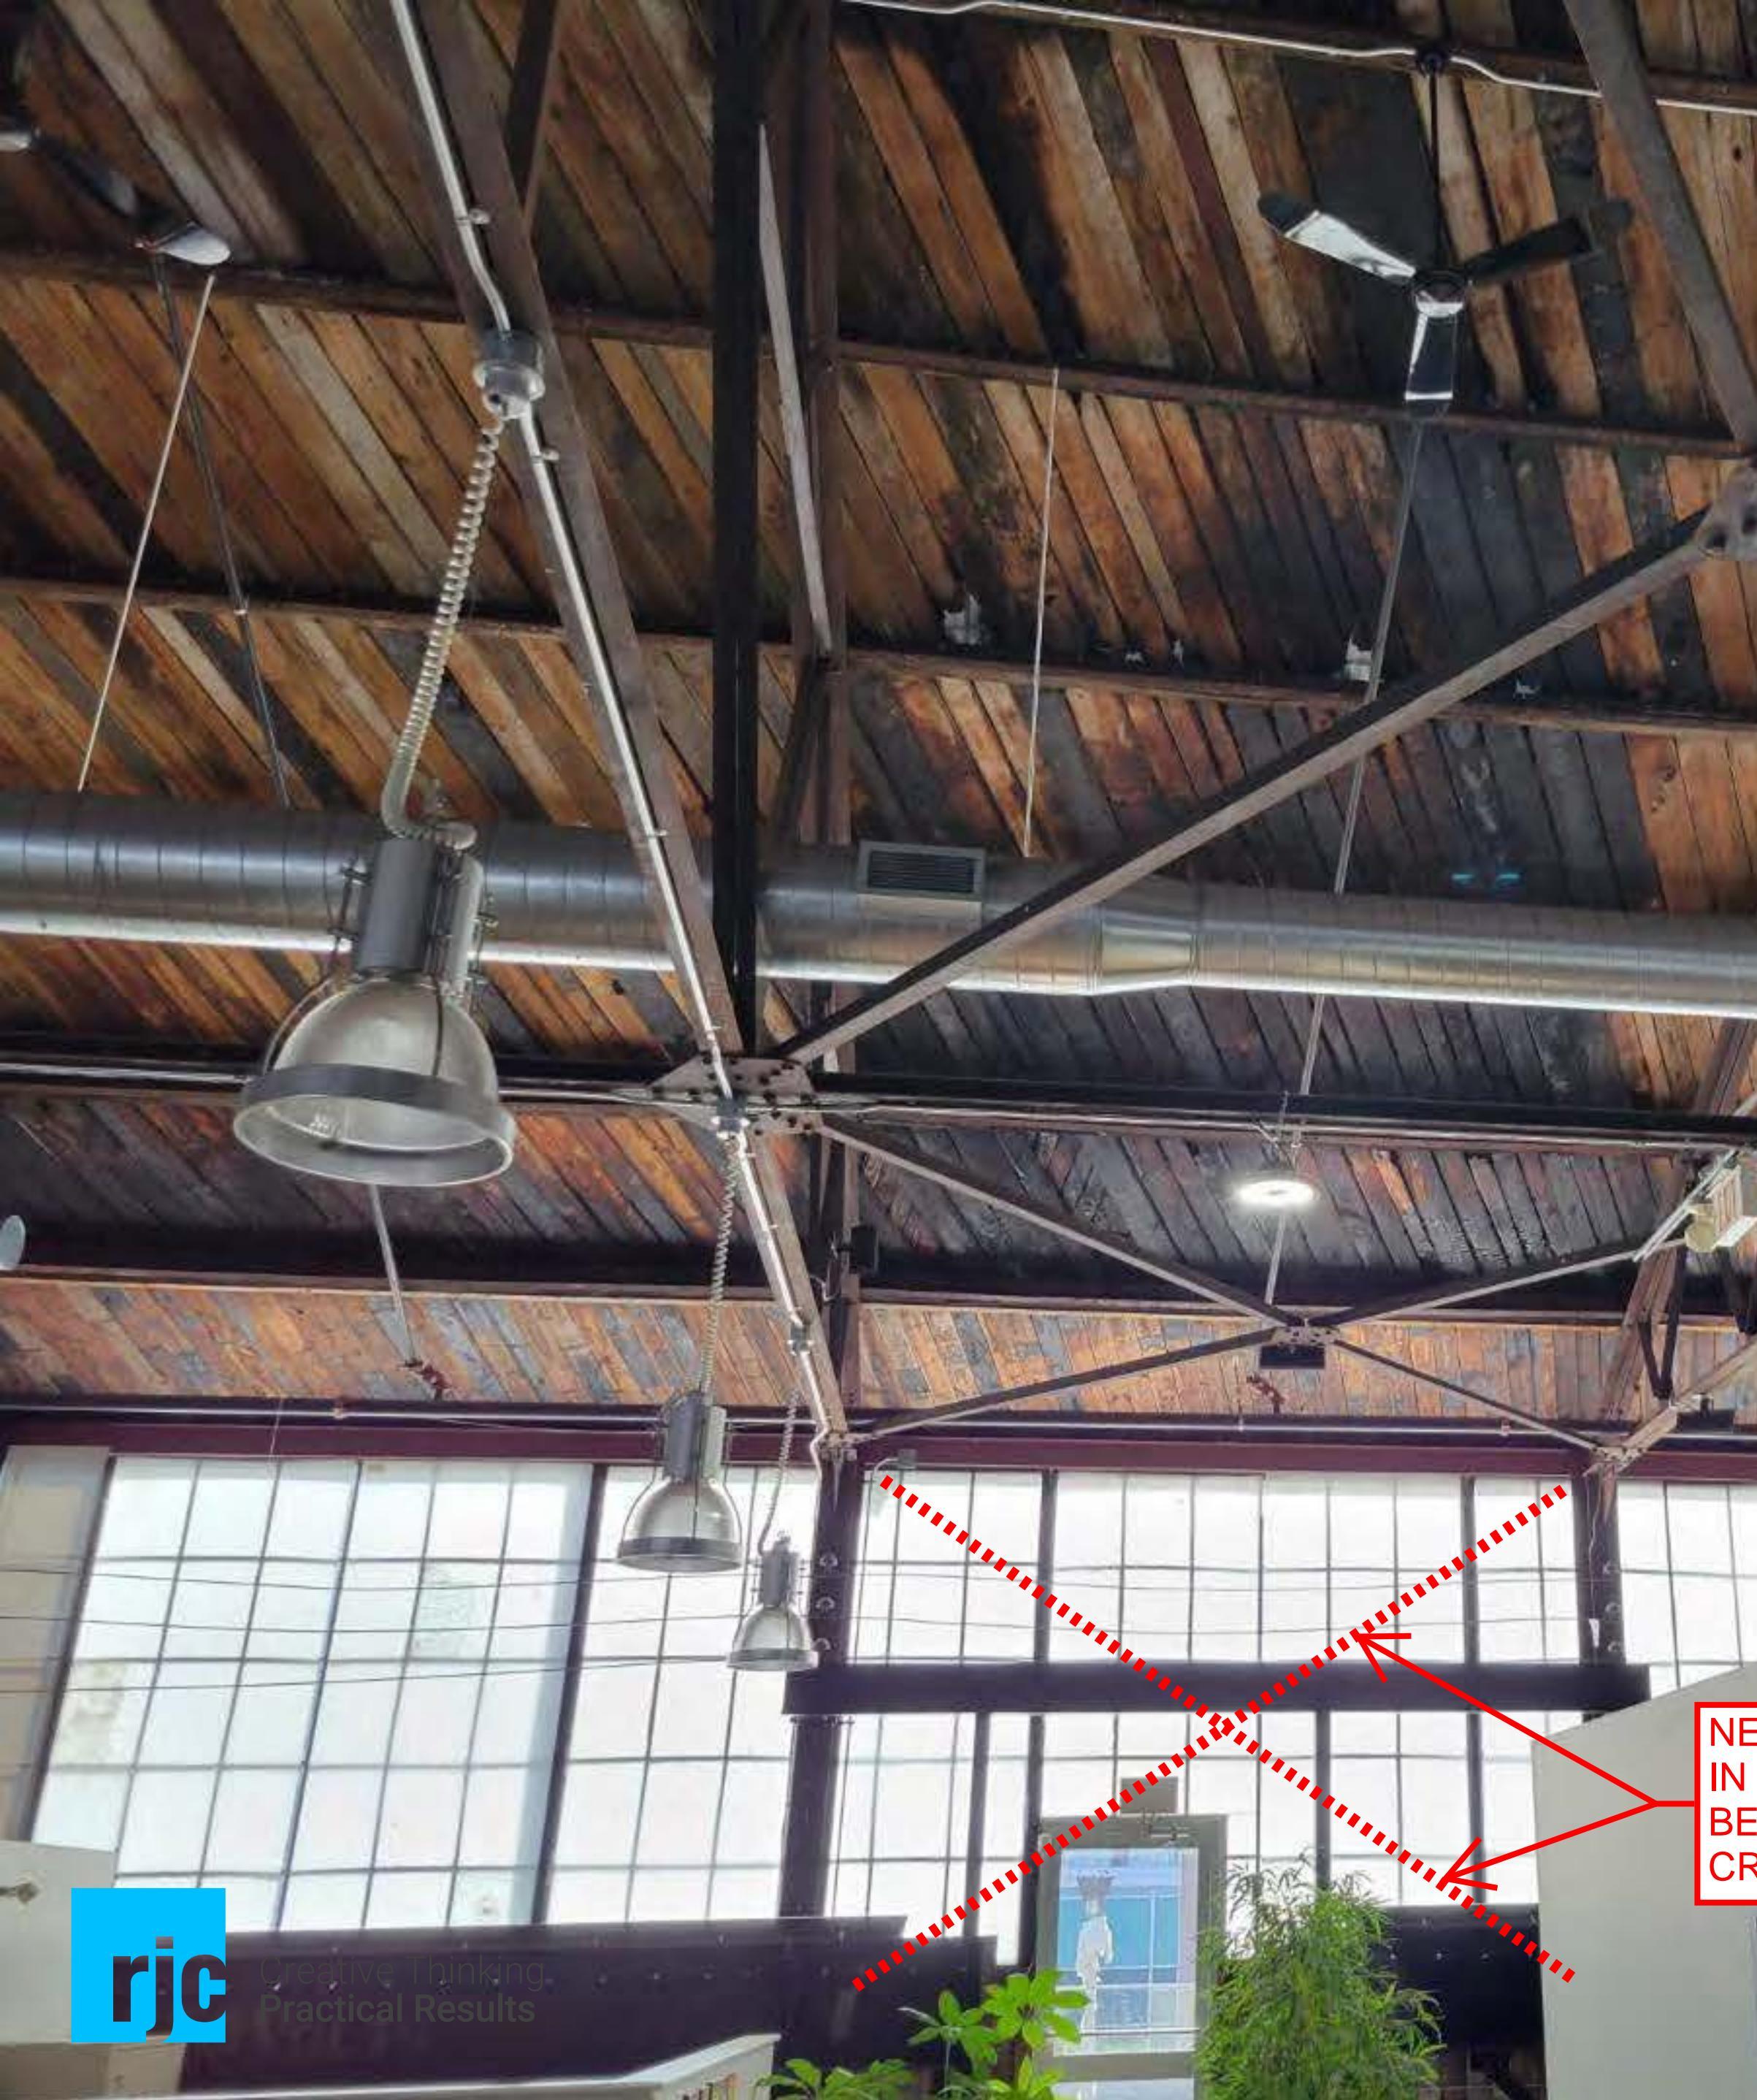
NEW VERT. X-BRACING IN LINE WITH COLUMNS, BEHIND EXISTING CRANE RAIL BEAM.

> RJC SITE PHOTO: PROPOSED BRACING AUG. 21, 2023

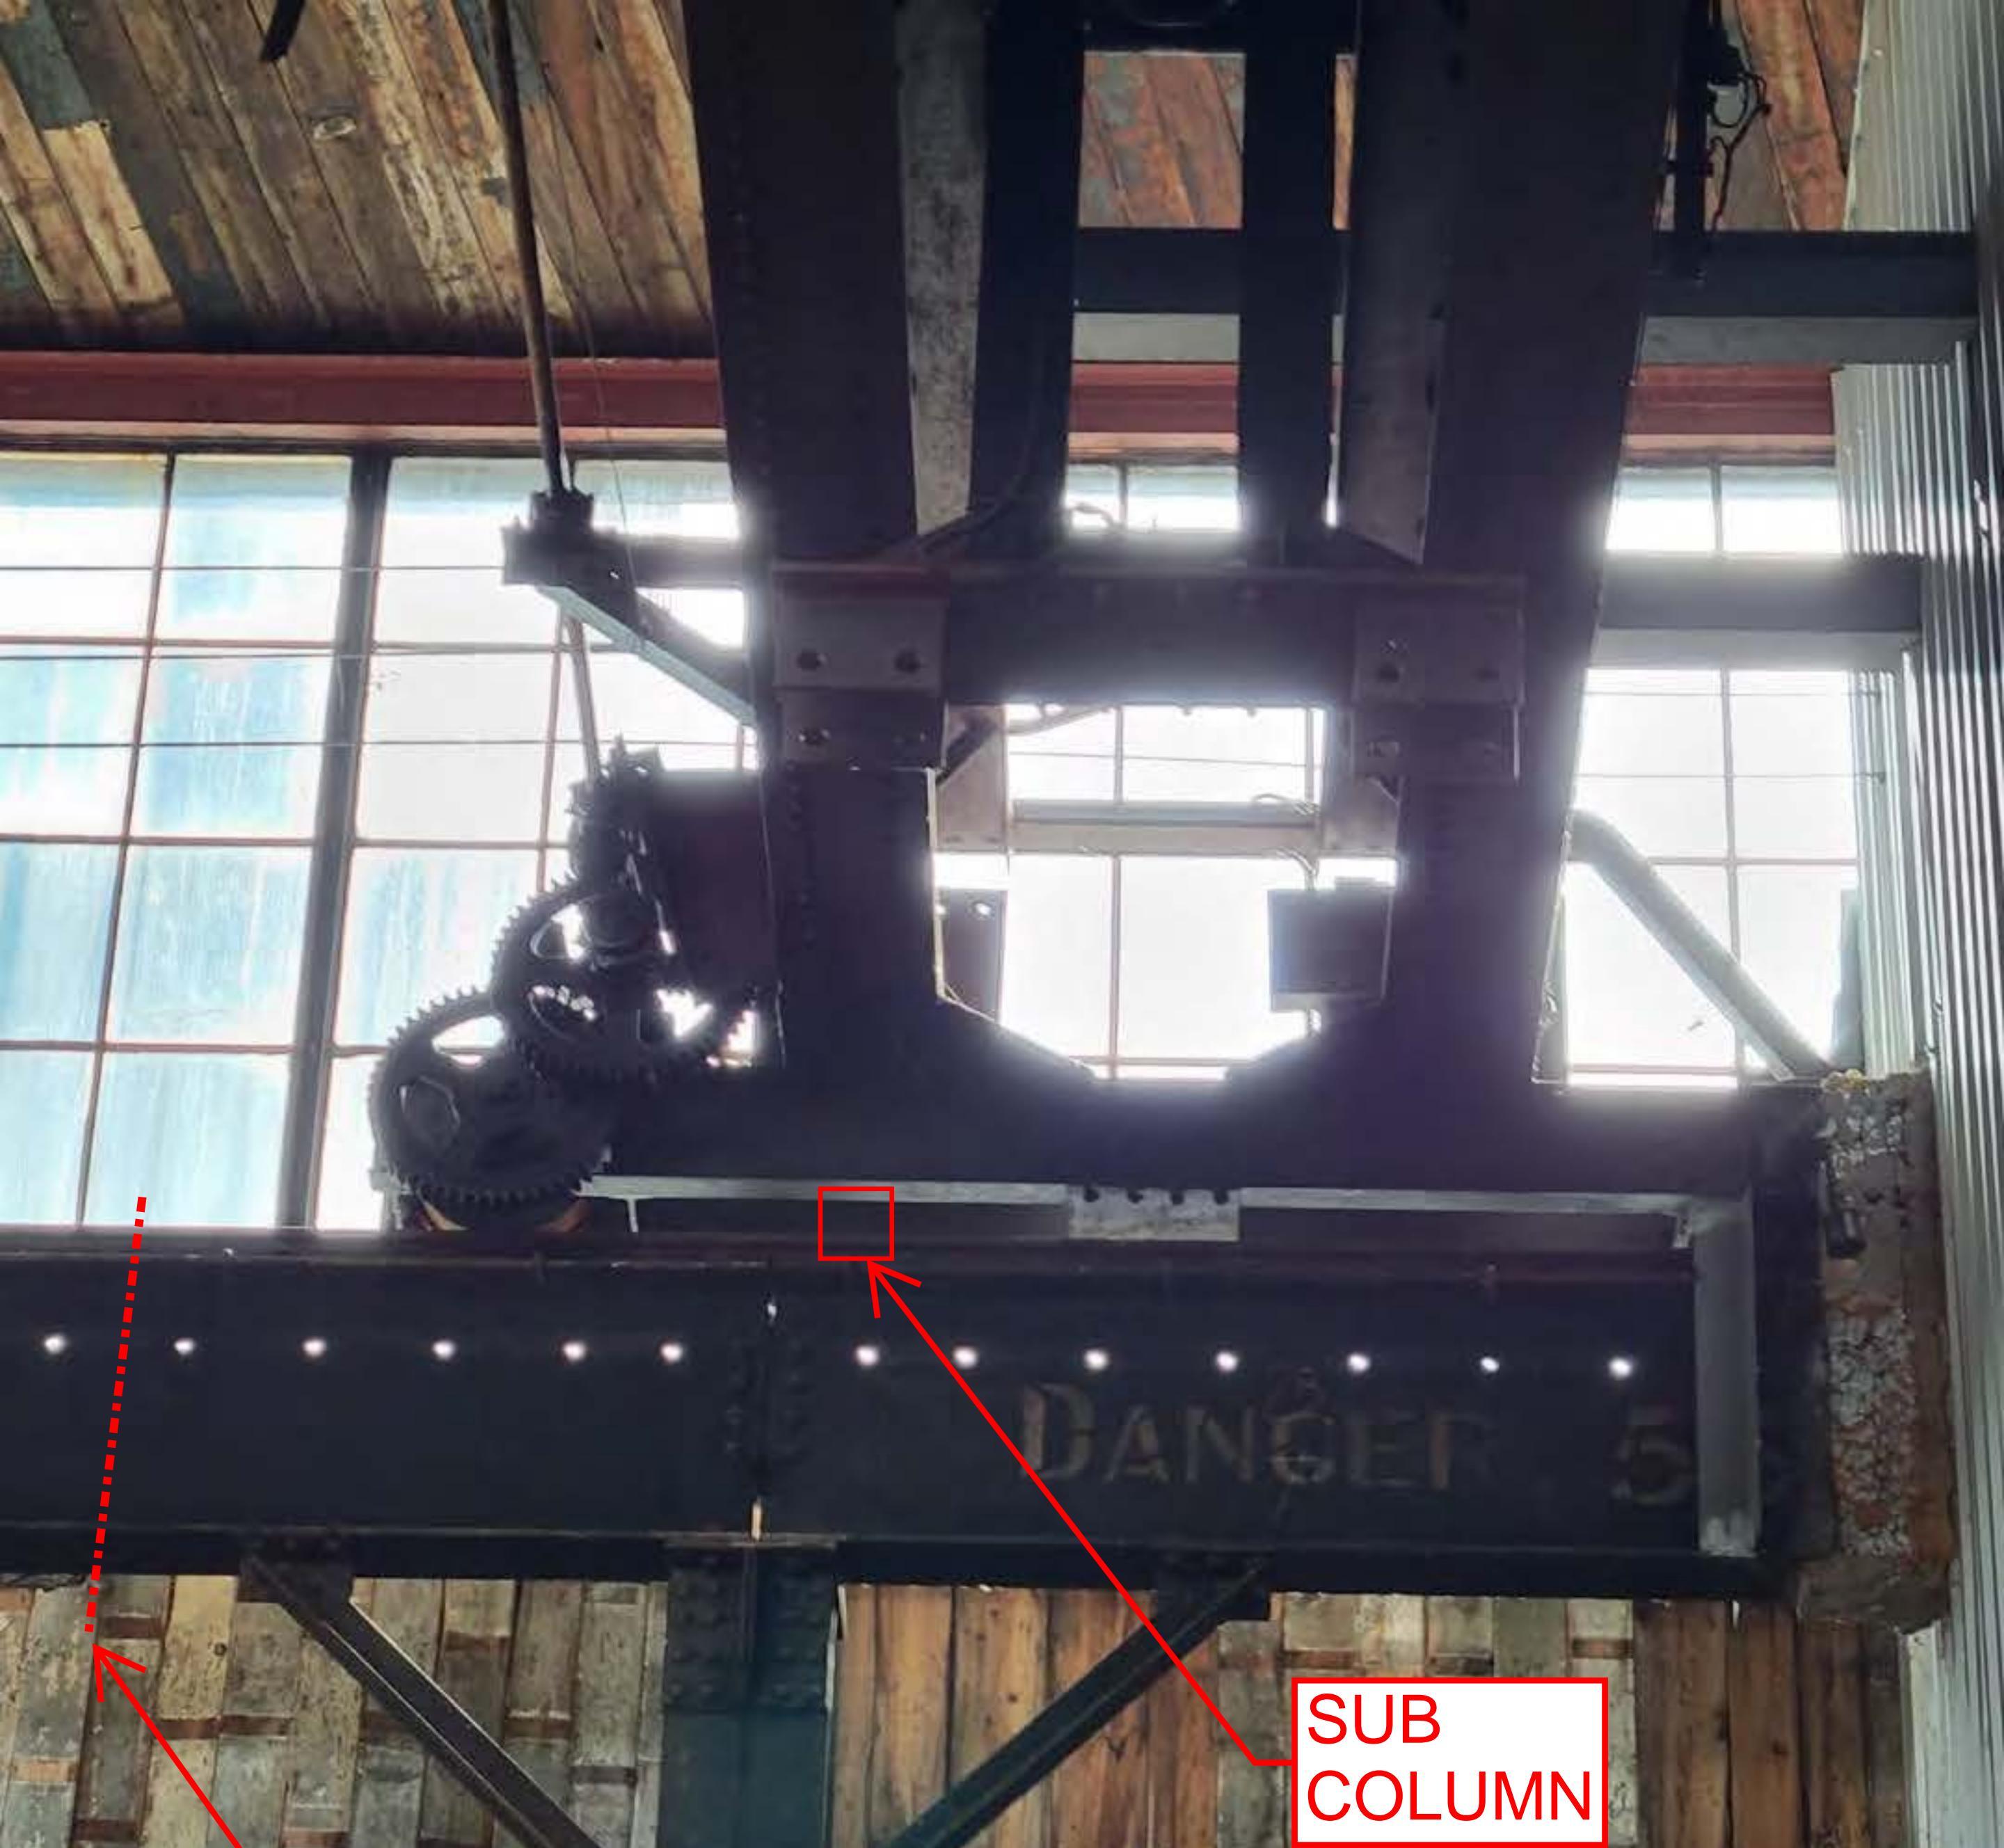
PROPOSED CUT LINE

RJC SITE PHOTO: GRID LINE 7, EXISTING GANTRY CRANE PROPOSED WORKS AUG. 21, 2023
