Investigation of Basement Flooding (Area 20) &

Road Improvement Study

**Class Environmental Assessment**

Public Information Centre

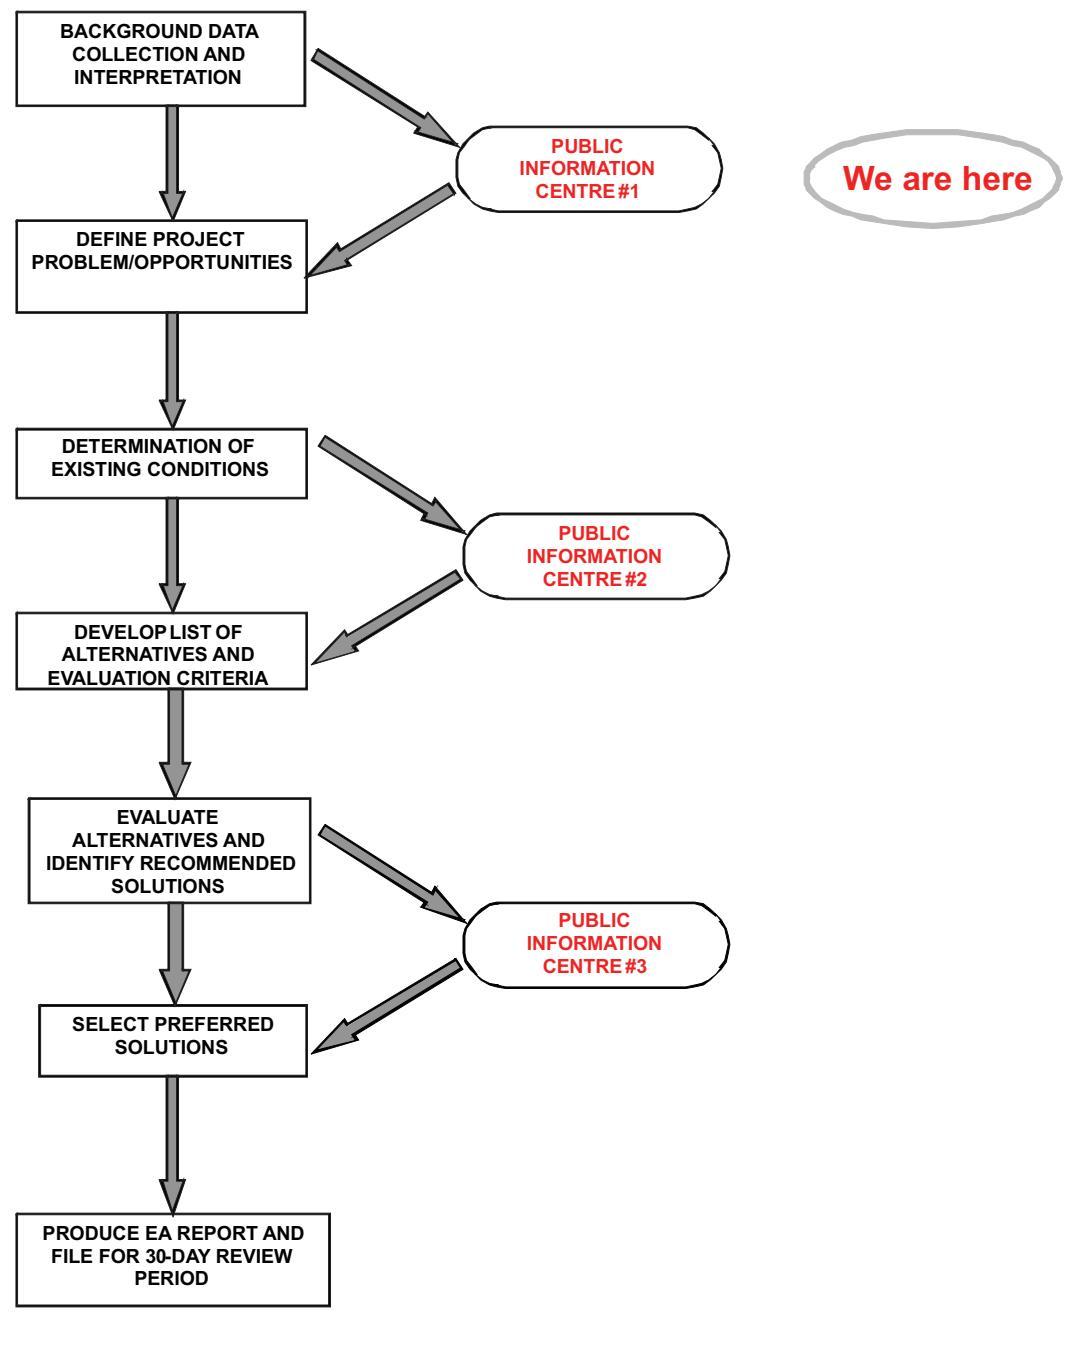
This study is being undertaken as a Schedule B project under the Municipal Class Environmental Assessment (EA) process. The flow chart illustrates the key steps to be undertaken as part of the EA process.

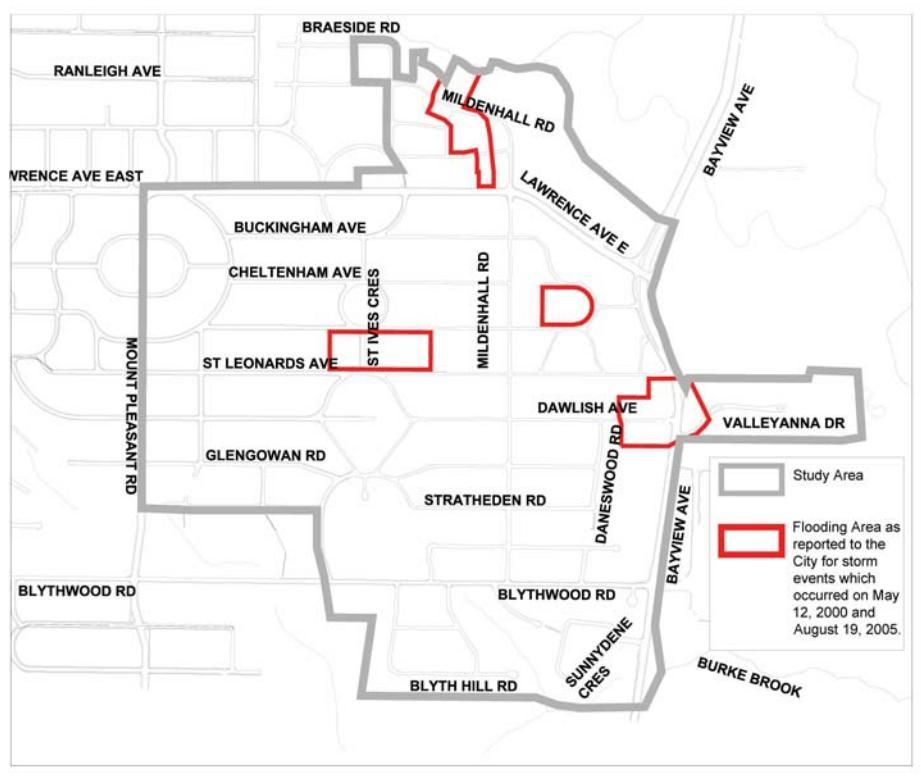
During normal rainfall events, the storm and sanitary sewer systems operate as designed. However, during extreme storms, the following takes place:

- Stormwater flow exceeds the storm sewer capacity and overloads the system;
- Directly connected roof drains, especially flat roofs, contribute significant volumes to the sewer system;
- Water remains on the surface and flows overland along roads;
- At low lying areas, water accumulates (ponds) and enters the sanitary sewer through manhole covers. This causes the sanitary sewers to surcharge and potentially back-up into the basement.

During these heavy rainfalls, the ground becomes extremely wet and water enters the sanitary system through cracks or broken pipes, cracked maintenance hole walls and loose joints underground. This contributes to back-up of the sanitary sewers.

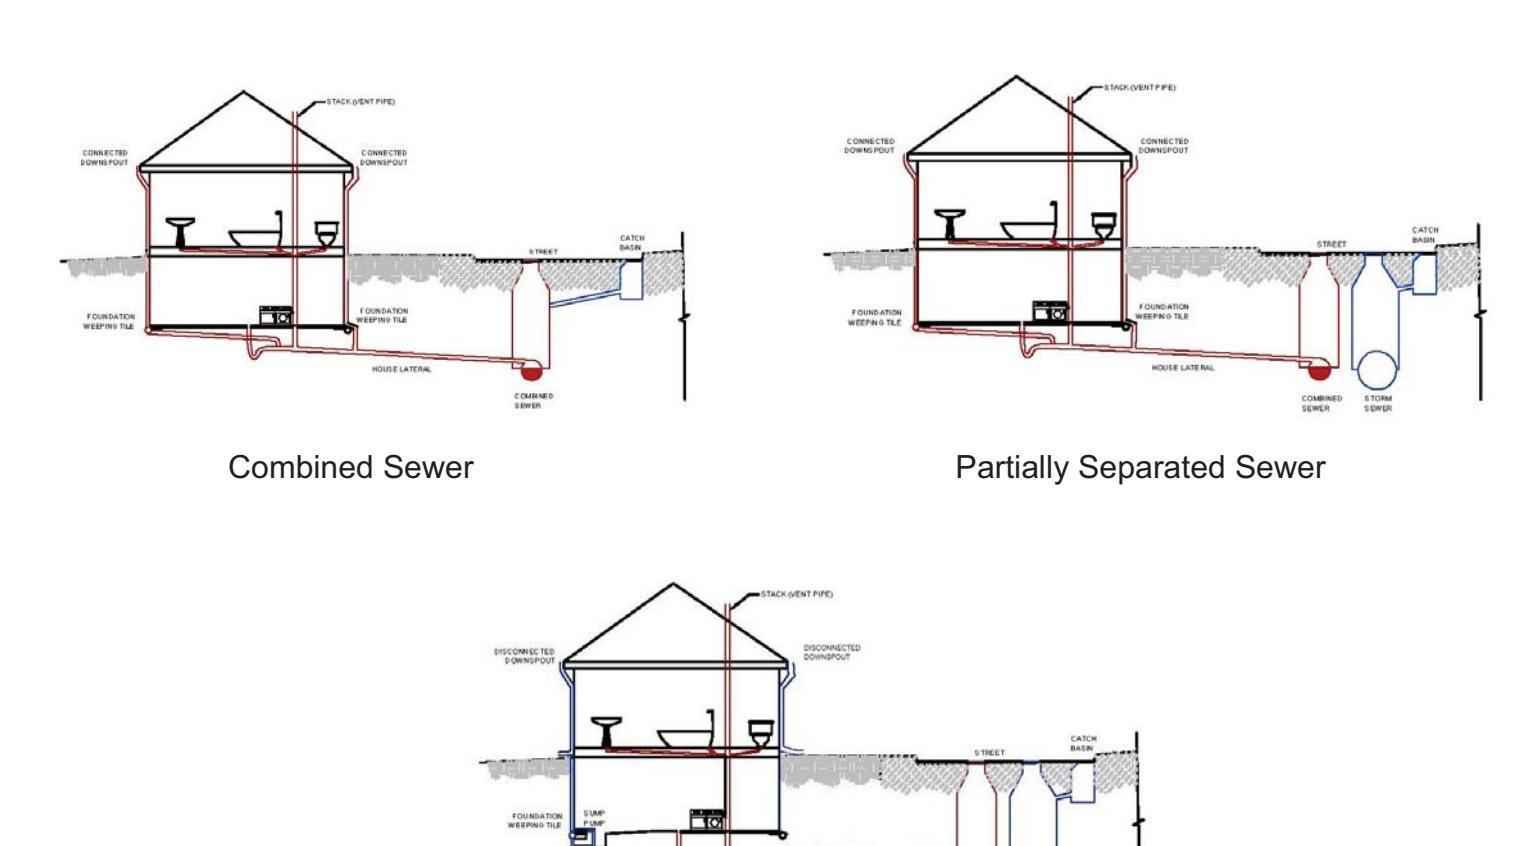
Separated Sewer

SANITA SEWER

The Lawrence Park area is currently serviced by two types of sewer systems. The western portion of the area was originally serviced by a combined sewer system. Over the years the City undertook a program to remove a portion of the stormwater that was entering the system. This area is now serviced by a partially separated system.

The eastern part of the area is serviced by a combination of open ditches, driveway culverts and, in some areas, storm sewers (separated sewer).

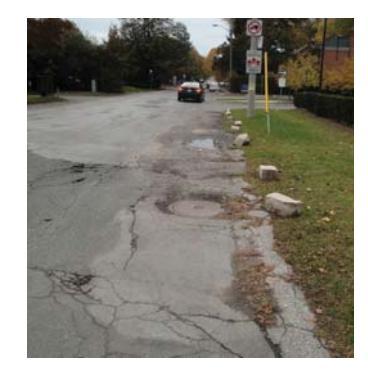
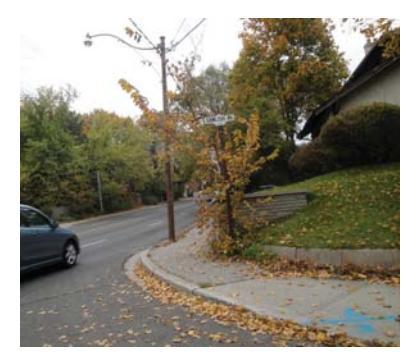
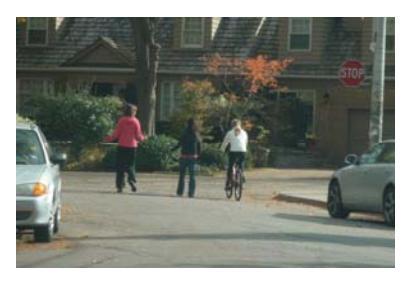
#### **Poor Pavement Conditions**

Pavement cracking, spalling, and pot holes noted throughout the neighbourhood. The conditions are especially poor in the north-east portion (e.g. at Dawlish Avenue and Rochester Avenue east of Mildenhall Road)

#### Sight Line Problems (Lack of visibility to incoming traffic)

- The westbound traffic on Dawlish Avenue at Mount Pleasant Road does not have a good sight line to the approaching southbound traffic on Mount Pleasant. The intersection is not signalized and the traffic on Mount Pleasant Road approaches the intersection at a high speed.
- Sight line problems at other locations include skewed intersections along St. Ives Road

#### Lack of Pedestrian / Cycling Facilities

- A lack of sidewalks in the local streets within the neighbourhood, especially in the north-south direction
- No cycling facilities within the neighbourhood

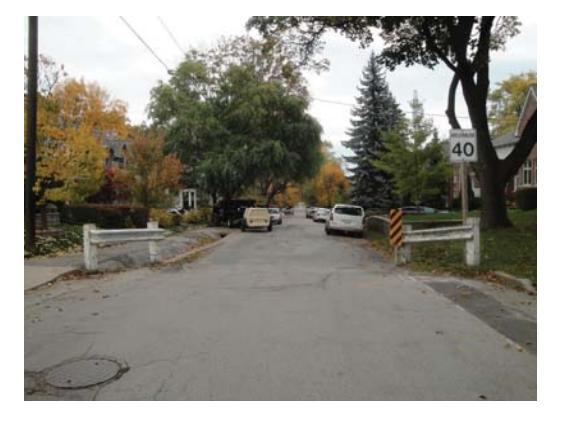
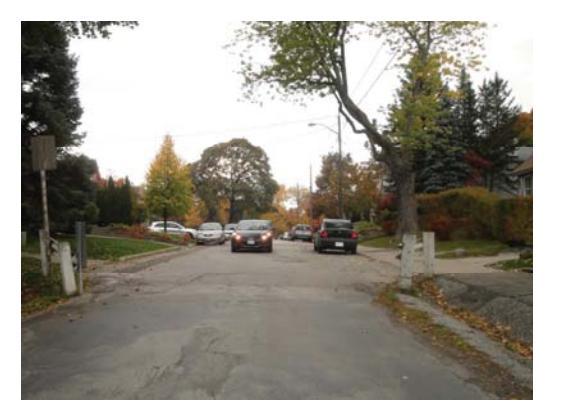
#### Narrow Road Right-of-Way

- A typical two lane roadway should be approximately 6.5 to 8.0 m, plus 1.5 to 2.0 m shoulders. The streets within the neighbourhood are generally narrower. For example, sections of St. Leonards Avenue east of Mount Pleasant, and Dawlish Avenue have a defined roadway width of less than 6.5m.
- Wide asphalt ditches on roadways and pedestrians on the road often reduce the available road width
- Any potential street improvements may impact private properties

#### **Street Parking**

• Street parking also reduces the available roadway to less than two lane widths, especially on Rochester, Mildenhall, Dawlish, and St. Leonards.

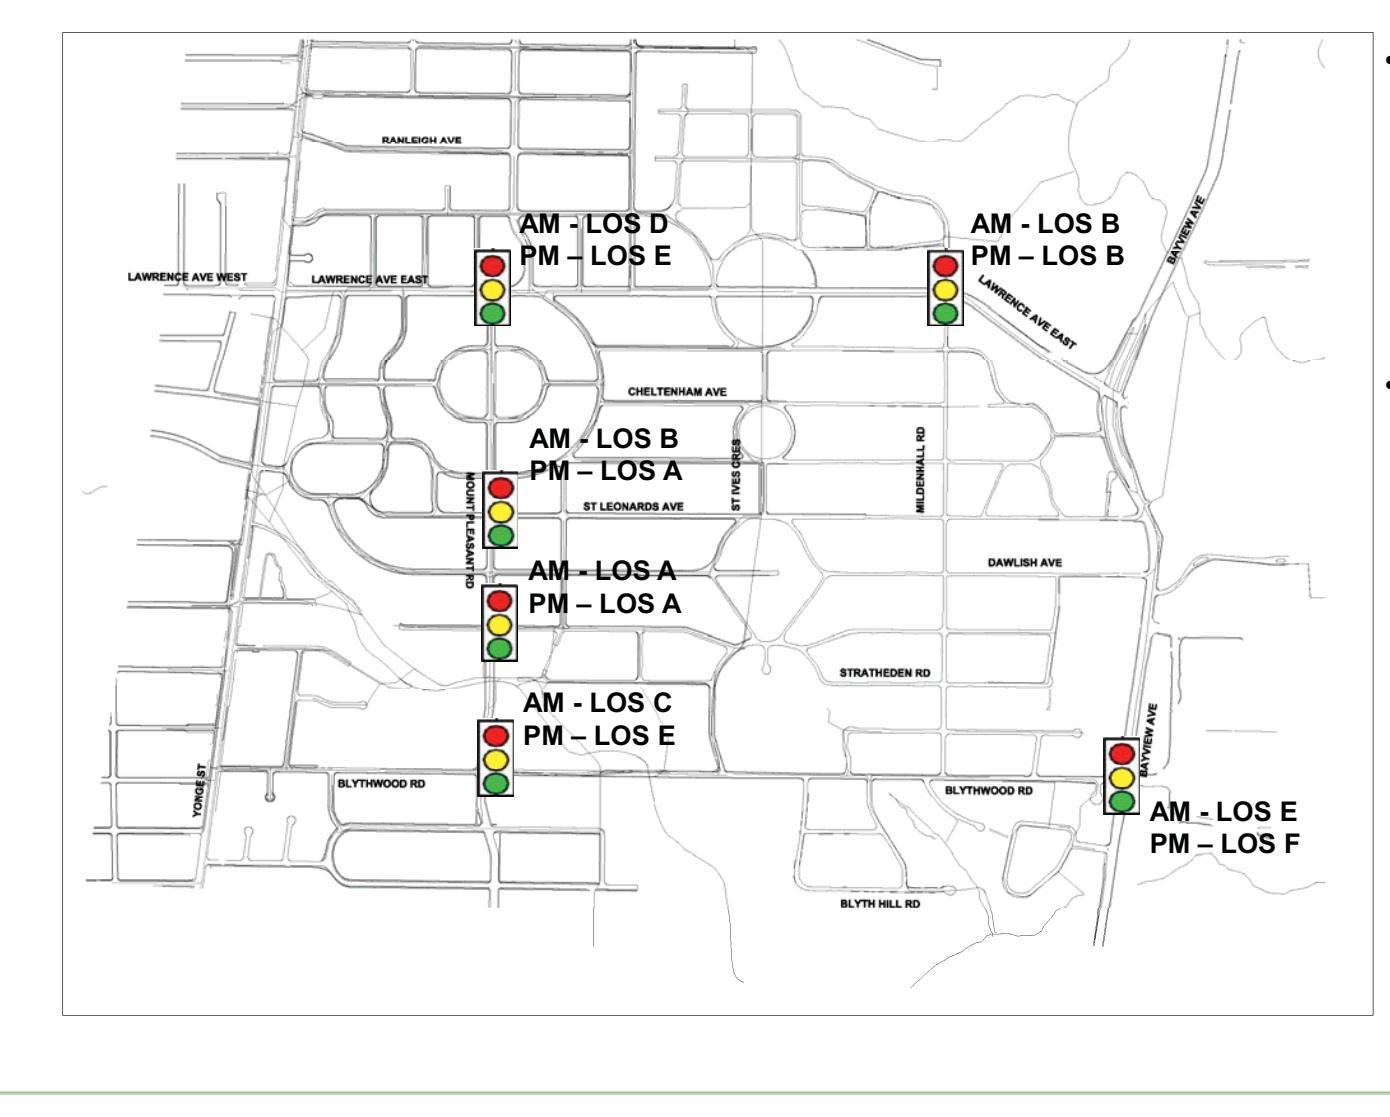
- The operations of the intersections, based on delays, queue lengths and times, and volumes, was analyzed using existing turning movement counts conducted in November 2012.
- The level of operation of an intersection is measured by its Level of Service (LOS), that ranges from "A" to "F" with LOS "A" being the best and LOS "E" the worst.
