Lawrence Park Neighbourhood Investigation of Basement Flooding & Road Improvement Study Class Environmental Assessment

> Public Information Centre 3 Presentation 13 May 2015

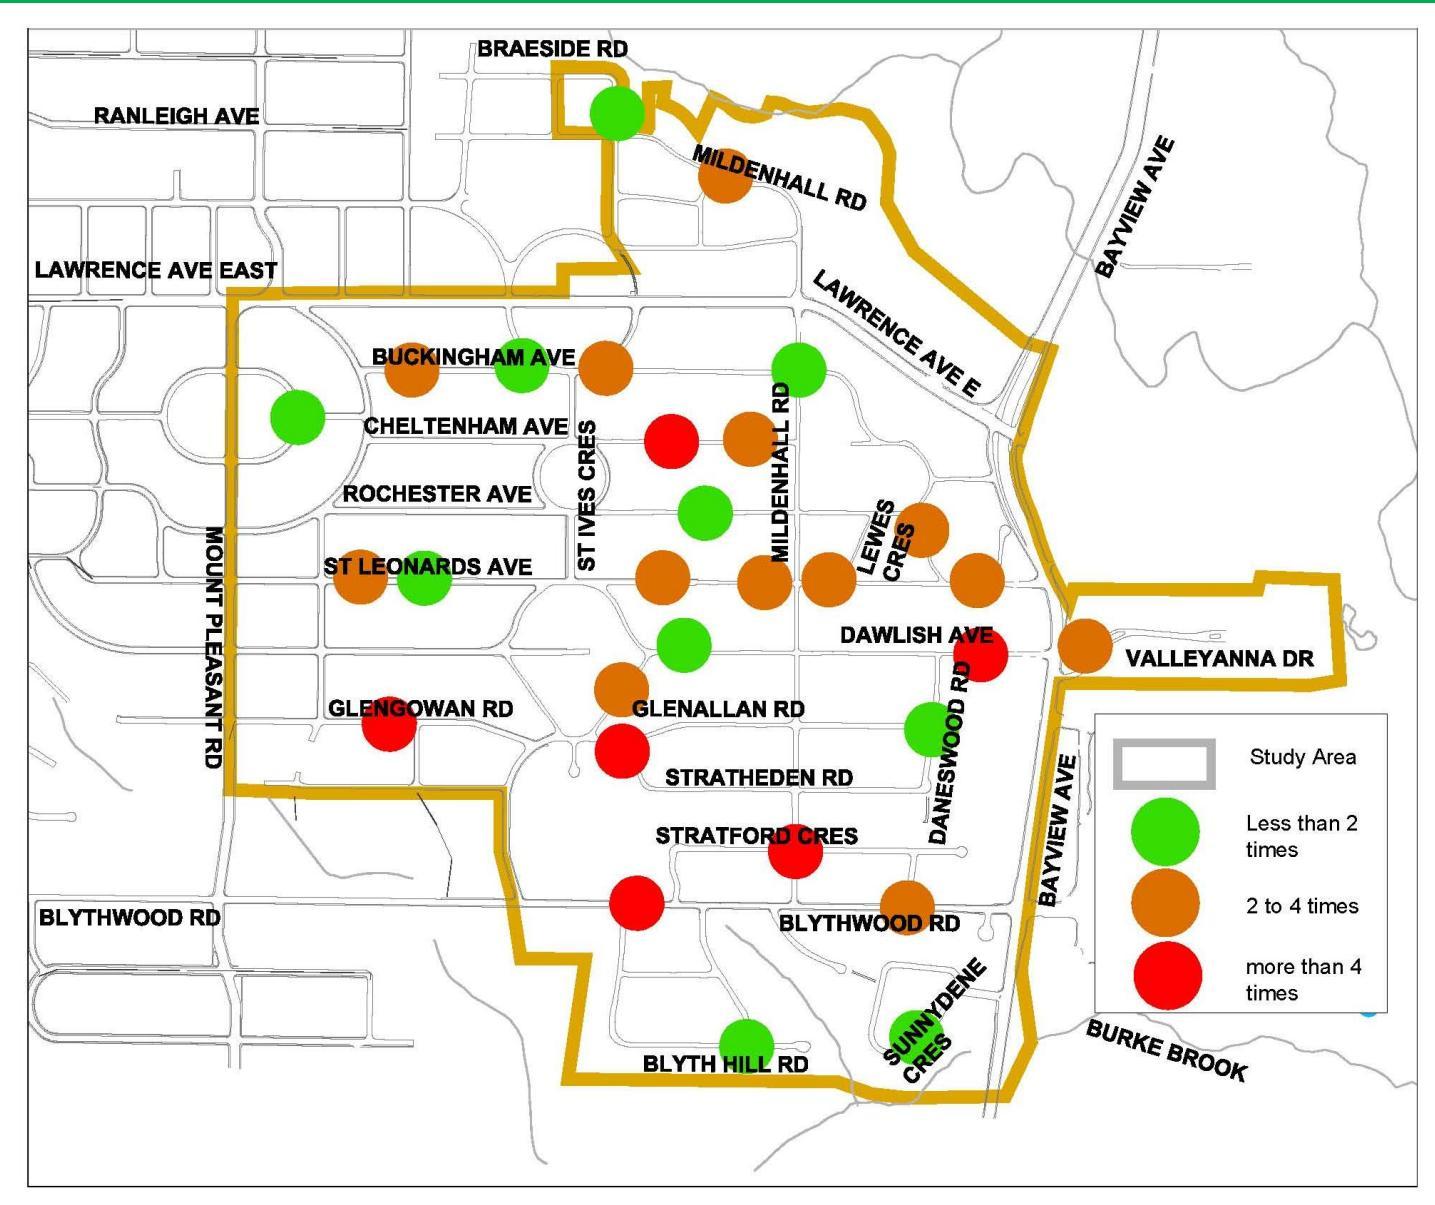
EXISTING CONDITIONS: BASEMENT FLOODING

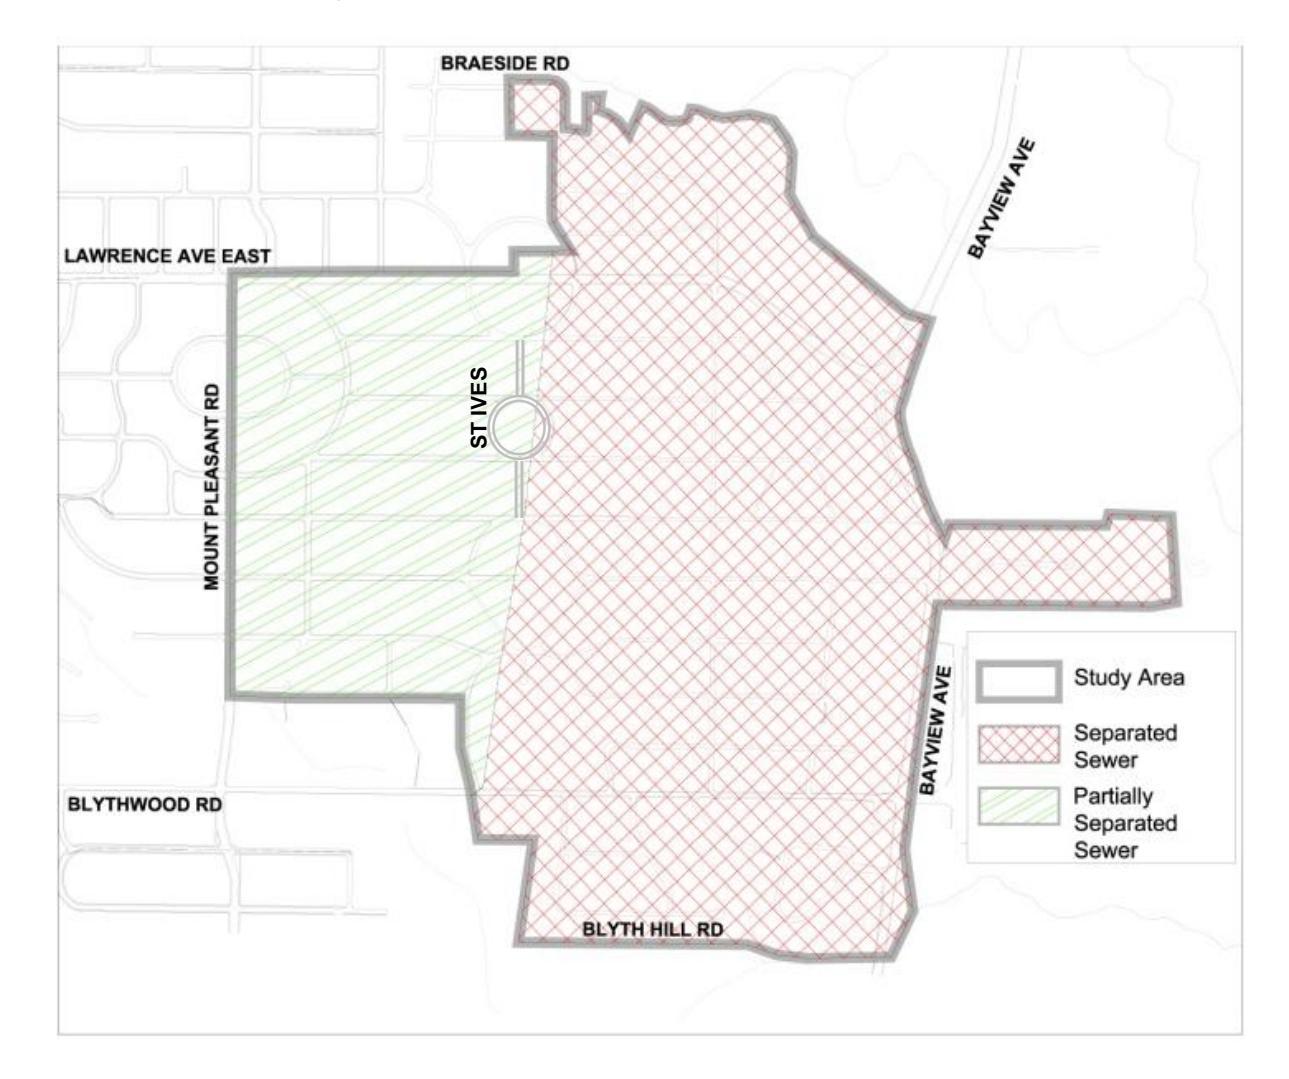
SEWER SYSTEM STUDY AREA

A separate set of alternatives was developed and evaluated for the **partially separated** and **separated areas**

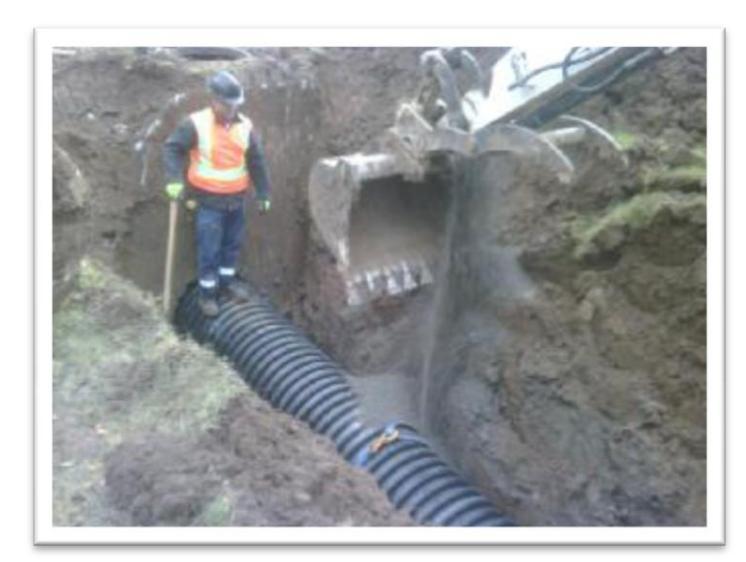
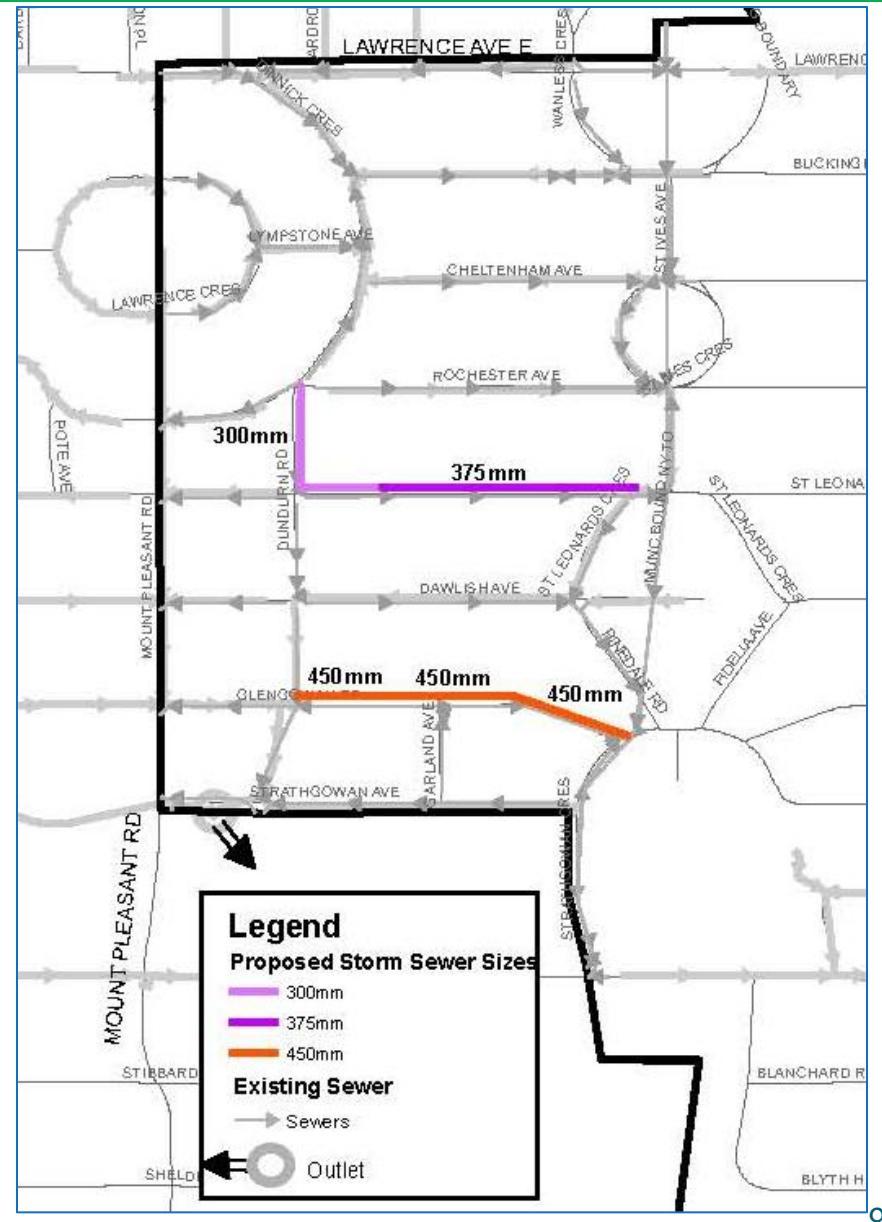
RECOMMENDED ALT. SOLUTIONS: PARTIALLY SEPARATED AREA

- Downspout disconnection
- Adding storm sewers to provide adequate capacity on St. Leonards Avenue, Glengowan Avenue and Dundurn Road (total length = 830 m)

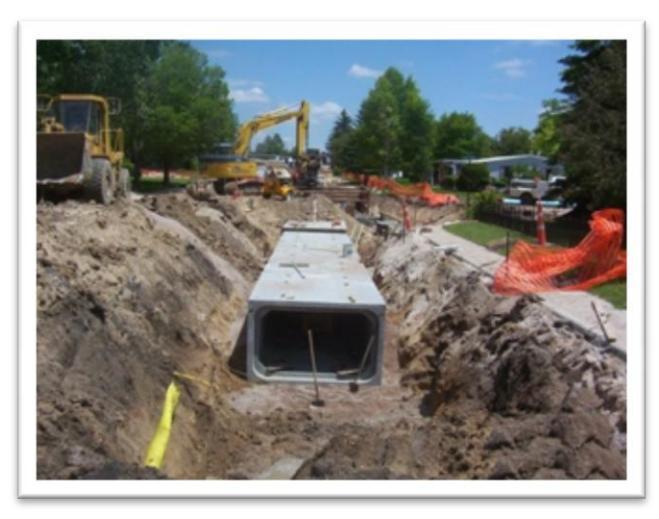
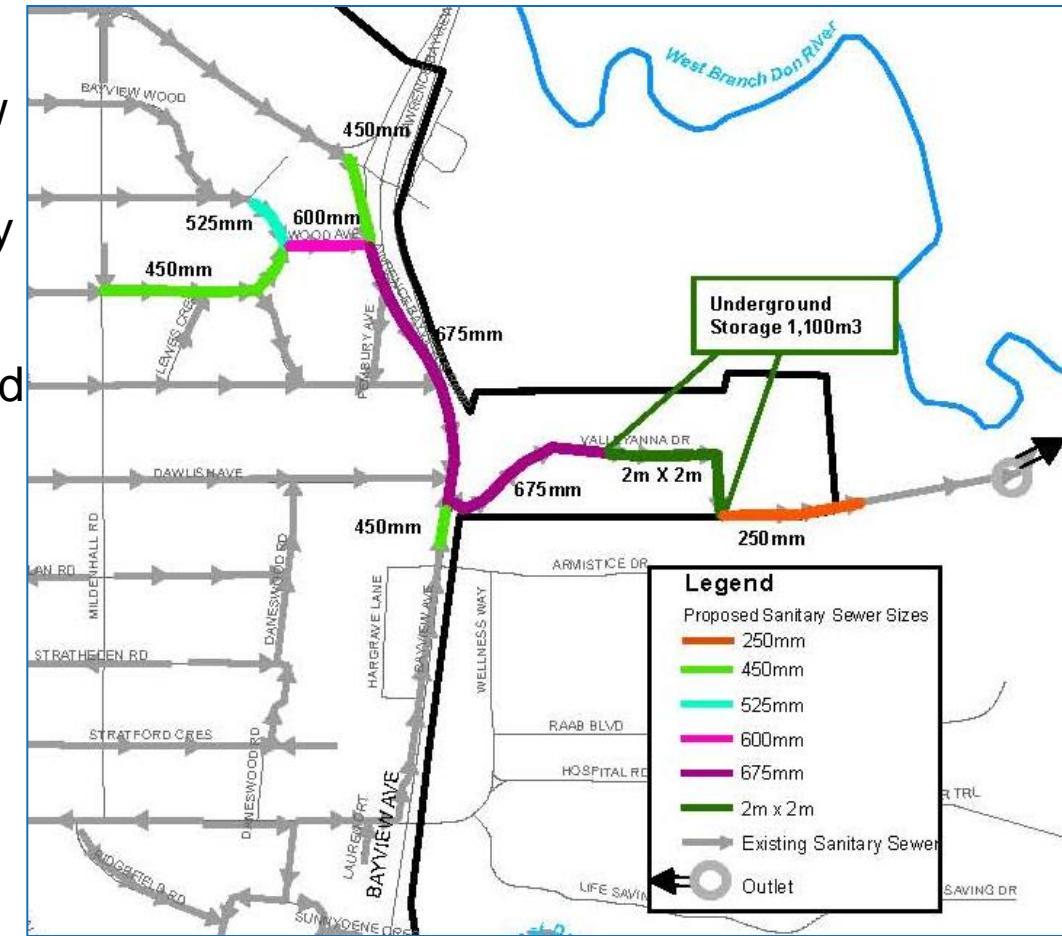
RECOMMENDED ALT. SOLUTIONS: FULLY SEPARATED AREA

- Downspout disconnection
- Sealing of sanitary manholes in low lying areas
- Replacement of 1,020 m of sanitary sewers with larger sewers on Bayview Wood, Rochester Avenue, Wood Avenue, Bayview Avenue and Valleyanna Drive
- Construction of a 1,100 m³ underground storage facility on Valleyanna Drive

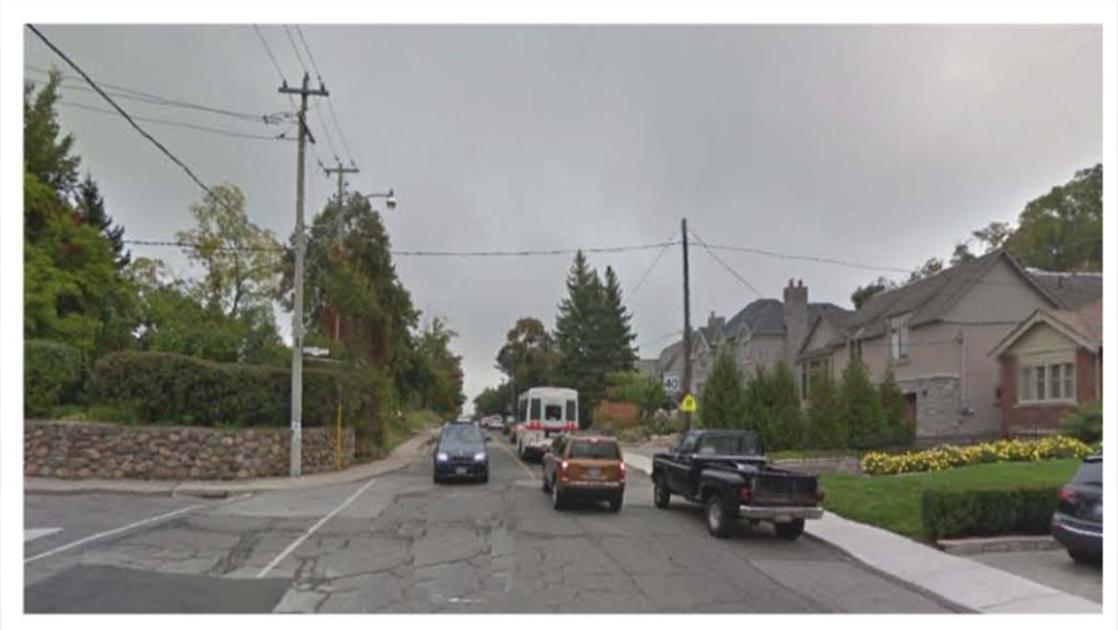
Blythwood Road at Strathgowan Crescent, facing East

- Locations with a potential lack of sight distance were identified and examined
- Recommendations include:
 - Remove or relocate stone wall for Blythwood Road / Strathgowan Crescent
 - Undertake minor works (trimming of tree branches) at Mount
 Pleasant Road / Lawrence Crescent and Mount Pleasant Road /

St. Leonards Avenue

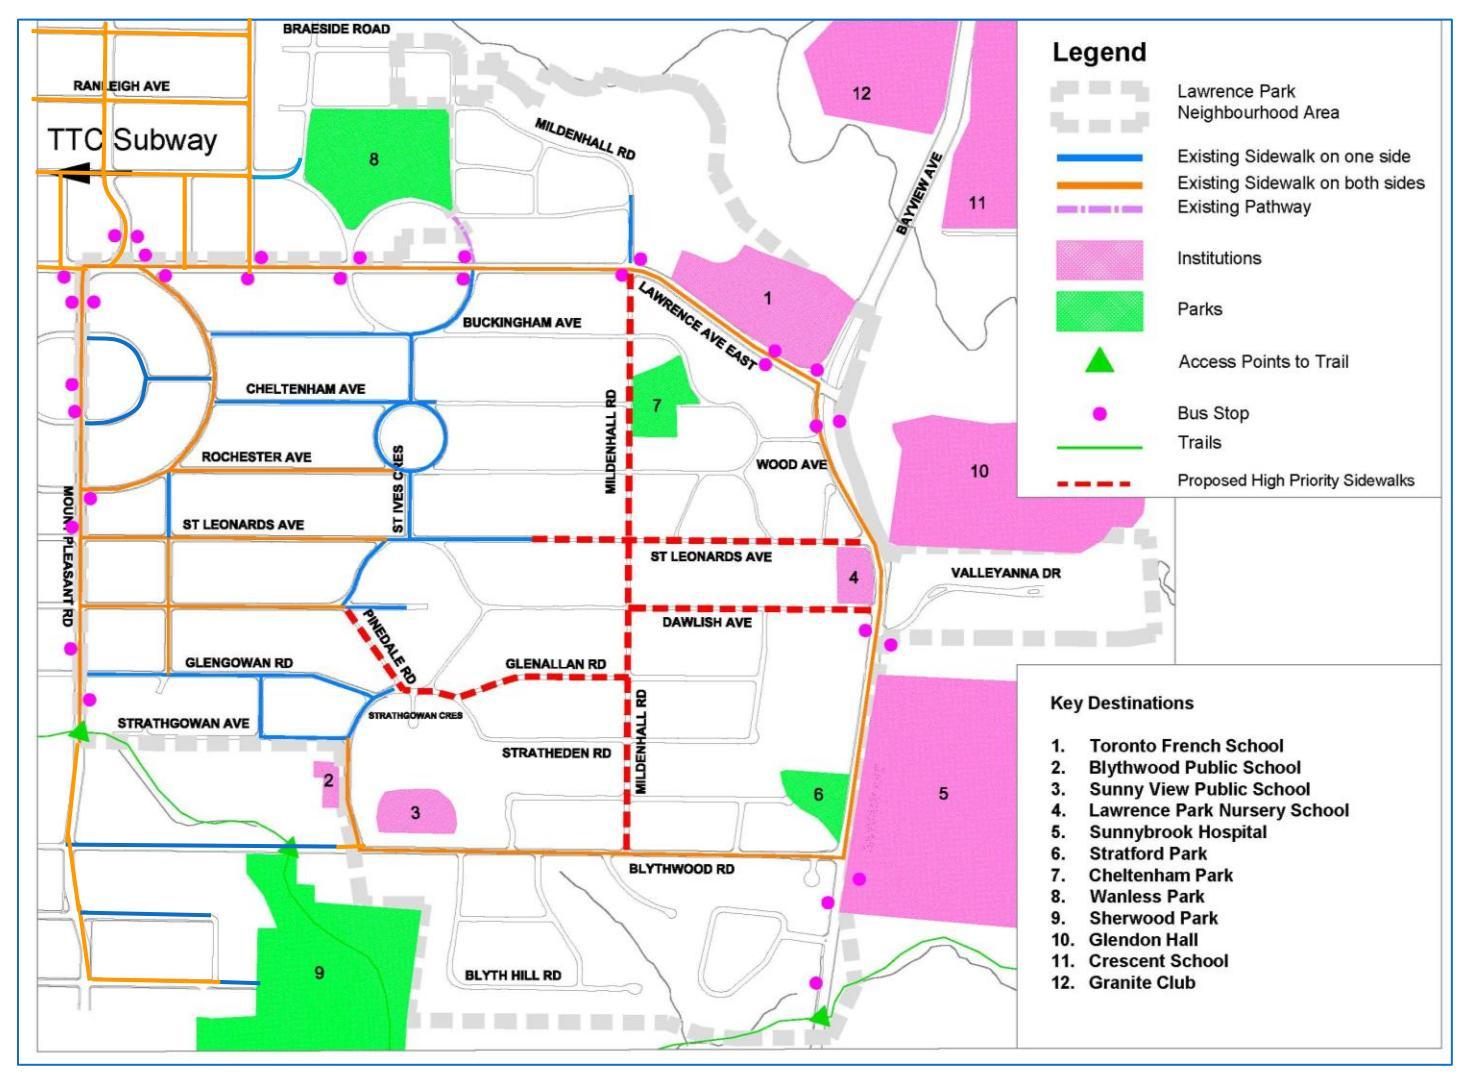
PEDESTRIAN LINKAGES

Priority is on creating pedestrian linkages to key destinations in the neighbourhood and connecting existing sidewalks

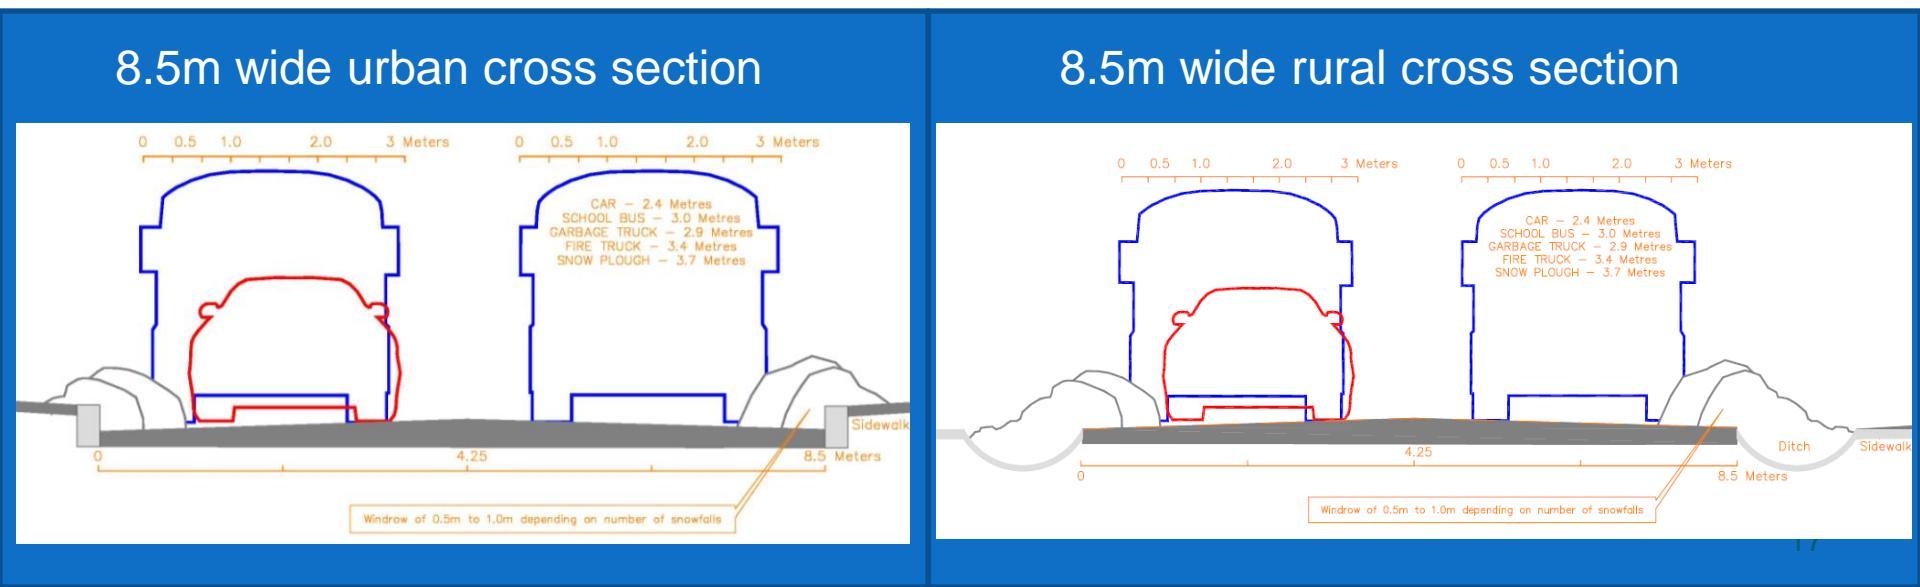
City Policy for Local Residential Roadway requires:

• 8.5 m paved surface, concrete curb and 1.7-2.0 m sidewalk on one or both sides

A local residential roadway must account for the following:

- Emergency and service vehicle access
- Space for pedestrians, cyclists and vehicles
- Safe two way traffic flow
- Width for winter road maintenance
- Parking
- Width for underground structures

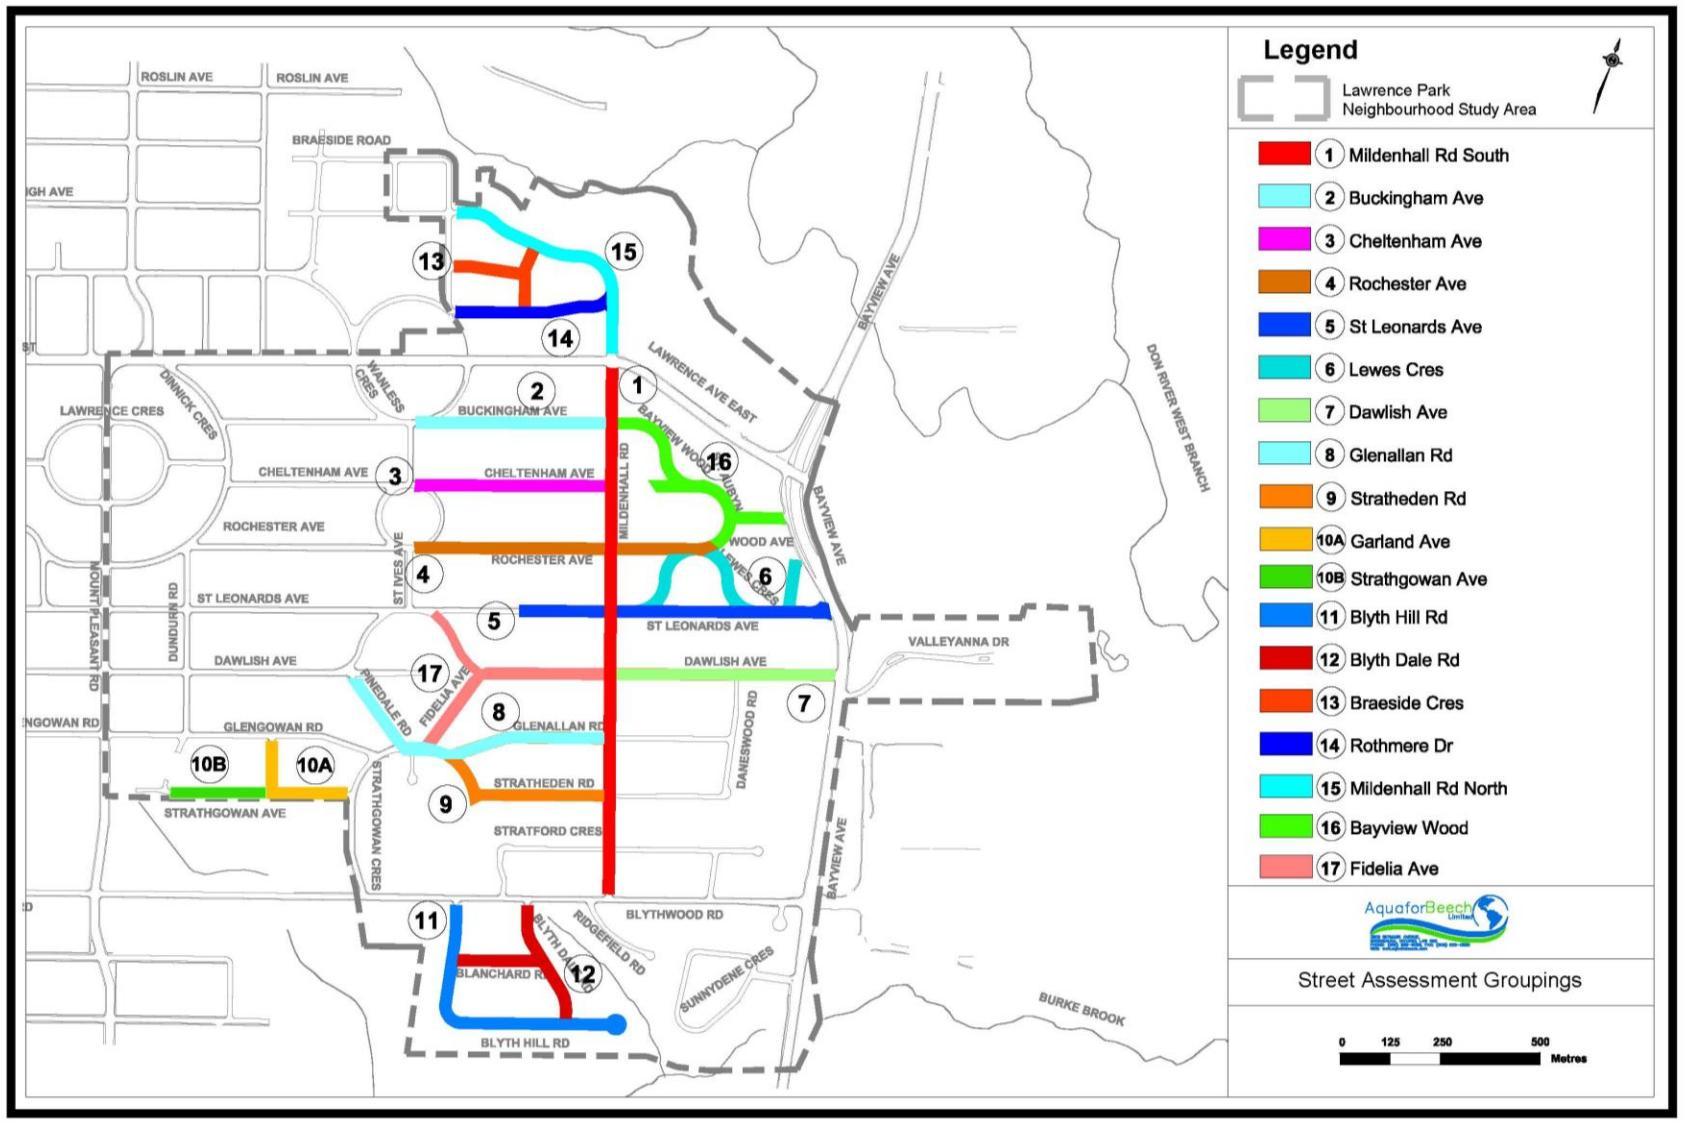
KEY MAP: ROADS EVALUATED

Roadway cross-sections developed and evaluated only for streets which have issues with respect to the existing road width, drainage or lack of sidewalks

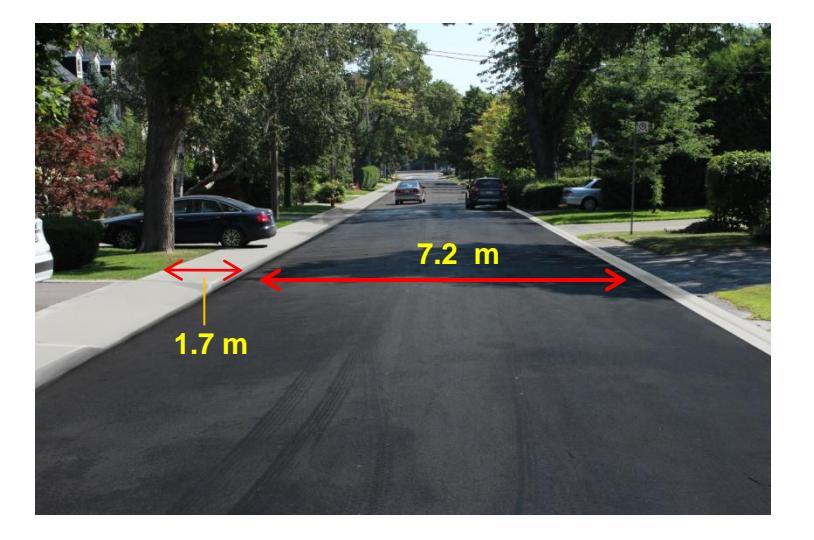
7.2 metre road + 1 sidewalk + urban cross section

- 7.2m road width would have parking limited to one side of road
- Location of sidewalk determined during detailed design stage

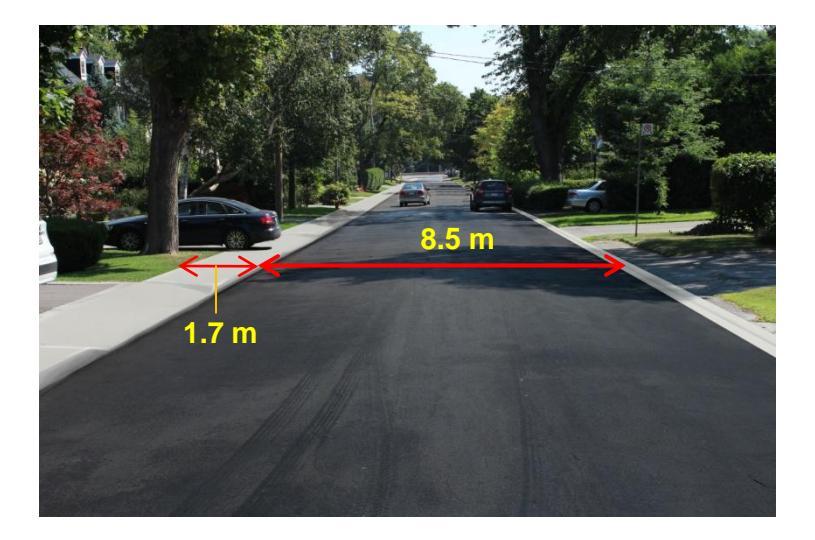
8.5 metre road + 1 sidewalk + urban cross section

- Location of sidewalk determined during detailed design stage
- Existing parking restrictions would remain

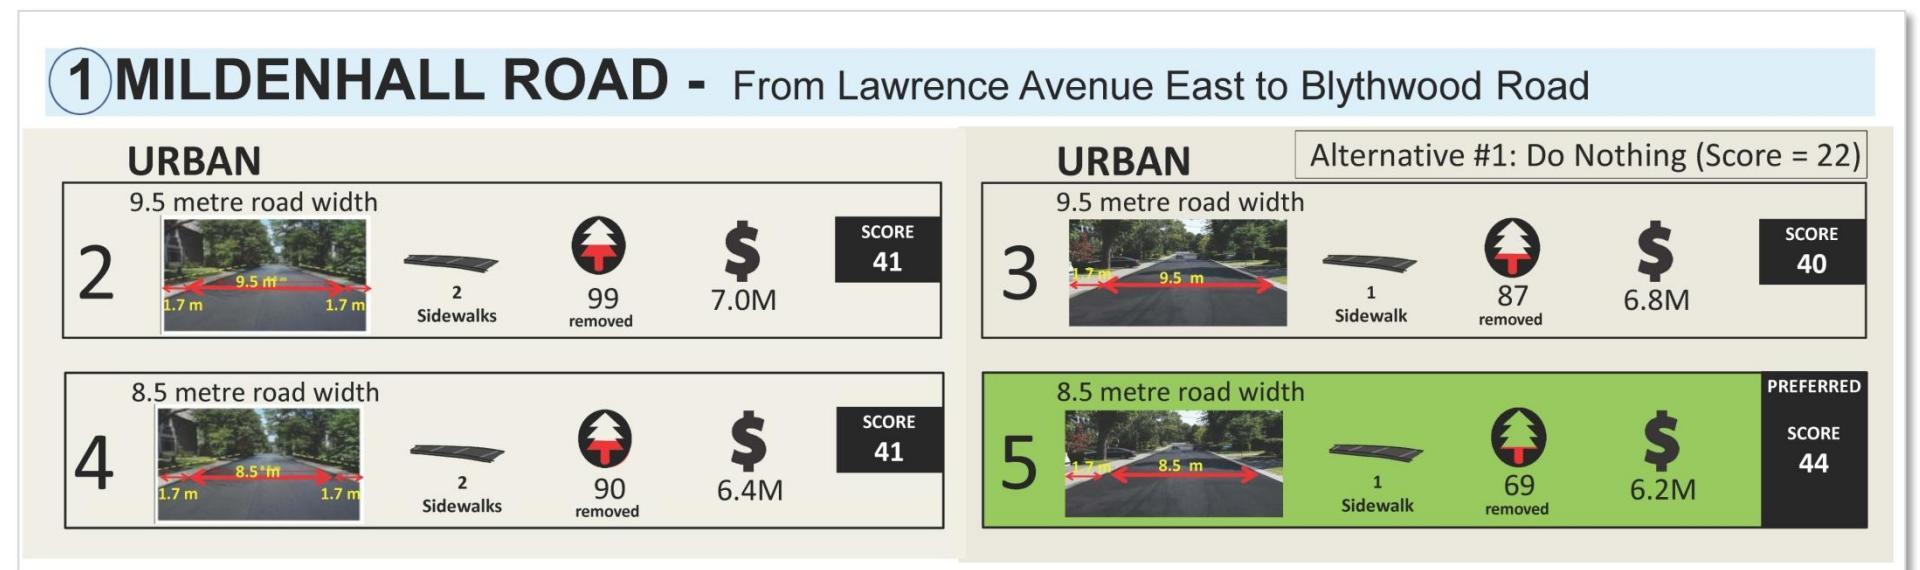
Street Assessment Group ID: 1 – Mildenhall Road South (EXAMPLE 1)

Alternative 5 has been identified as the Preliminary Preferred Alternative for following reasons:

- · Results in the least impact to street trees
- A sidewalk is included because this is a collector road. It will provide a priority pedestrian linkage to key destinations in the neighbourhood
- Surface flooding is addressed by providing a storm drainage system to prevent ponding
- Meets the requirements for an improvement of roadway structure, improvement in stormwater quality and ability to provide safe conditions for emergency and operational vehicles

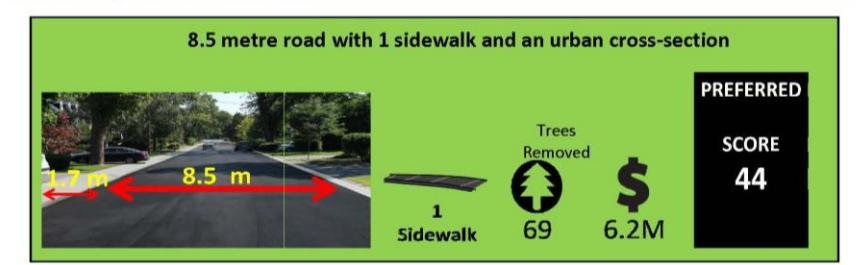
Preliminary Preferred Alternative

Preliminary Preferred Alternative:

- Results in the least impact to street trees
- ☑ Includes a sidewalk helping to establish a pedestrian linkage to key destinations in the neighbourhood
- ☑ Addresses surface flooding by providing a storm drainage system to prevent ponding
- Meets the requirements for an improvement of roadway structure, improvement in stormwater quality and ability to provide safe conditions for emergency and operational vehicles

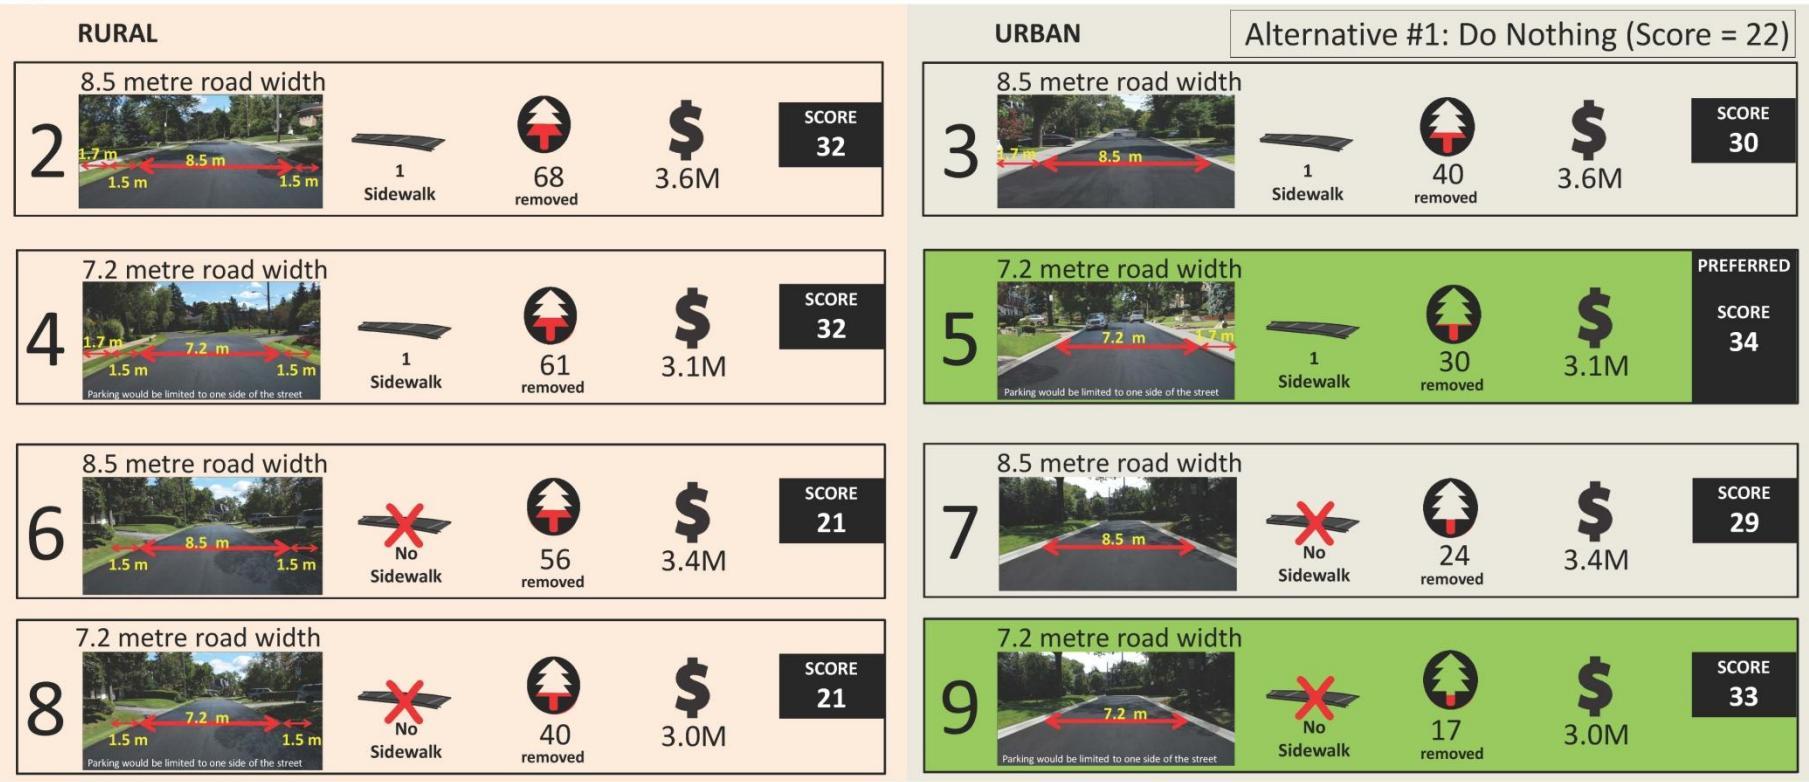
5 ST. LEONARD'S AVENUE - East of St. Ives Avenue

The scores for Alternative 5 and Alternative 9 are closely matched and were further compared.

Alternative 5 has been identified as the Preliminary Preferred Alternative for following reasons:

- · Results in the moderate impact to street trees
- A sidewalk is included as this will provide a priority pedestrian linkage to key destinations in the neighbourhood
- · Surface flooding is addressed by providing a storm drainage system to prevent ponding
- Meets the requirements for an improvement of roadway structure, improvement in stormwater quality and ability to provide safe conditions for emergency and operational vehicles

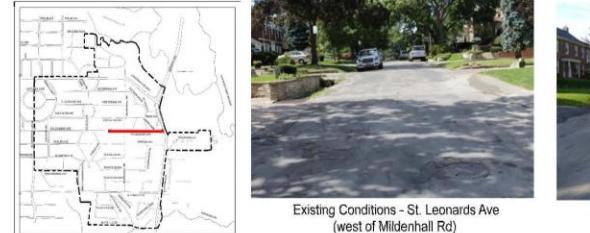
Existing Conditions - St. Leonards Ave (east of Mildenhall Rd)

Existing Conditions

- Surface flooding and insufficient ditched drainage system
- · Poor quality road structure and pavement widths ranging from 6m 8m
- Approximately 100 mature trees within public right-of-way
- No sidewalks

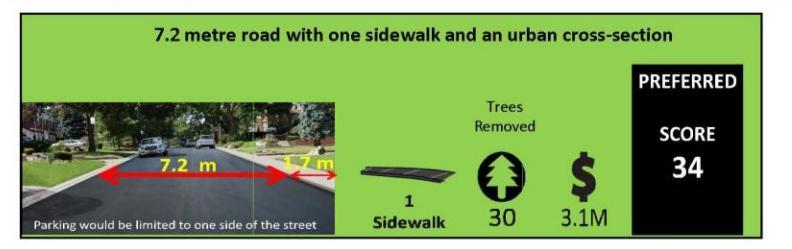
Preliminary Preferred Alternative

Preliminary Preferred Alternative:

- Results in the moderate impact to street trees
- ${\ensuremath{\overline{\mathbf{U}}}}$ Includes a sidewalk helping to establish a pedestrian linkage to key destinations in the neighbourhood
- Addresses surface flooding by providing a storm drainage system to prevent ponding
- Meets the requirements for an improvement of roadway structure, improvement in stormwater quality and ability to provide safe conditions for emergency and operational vehicles

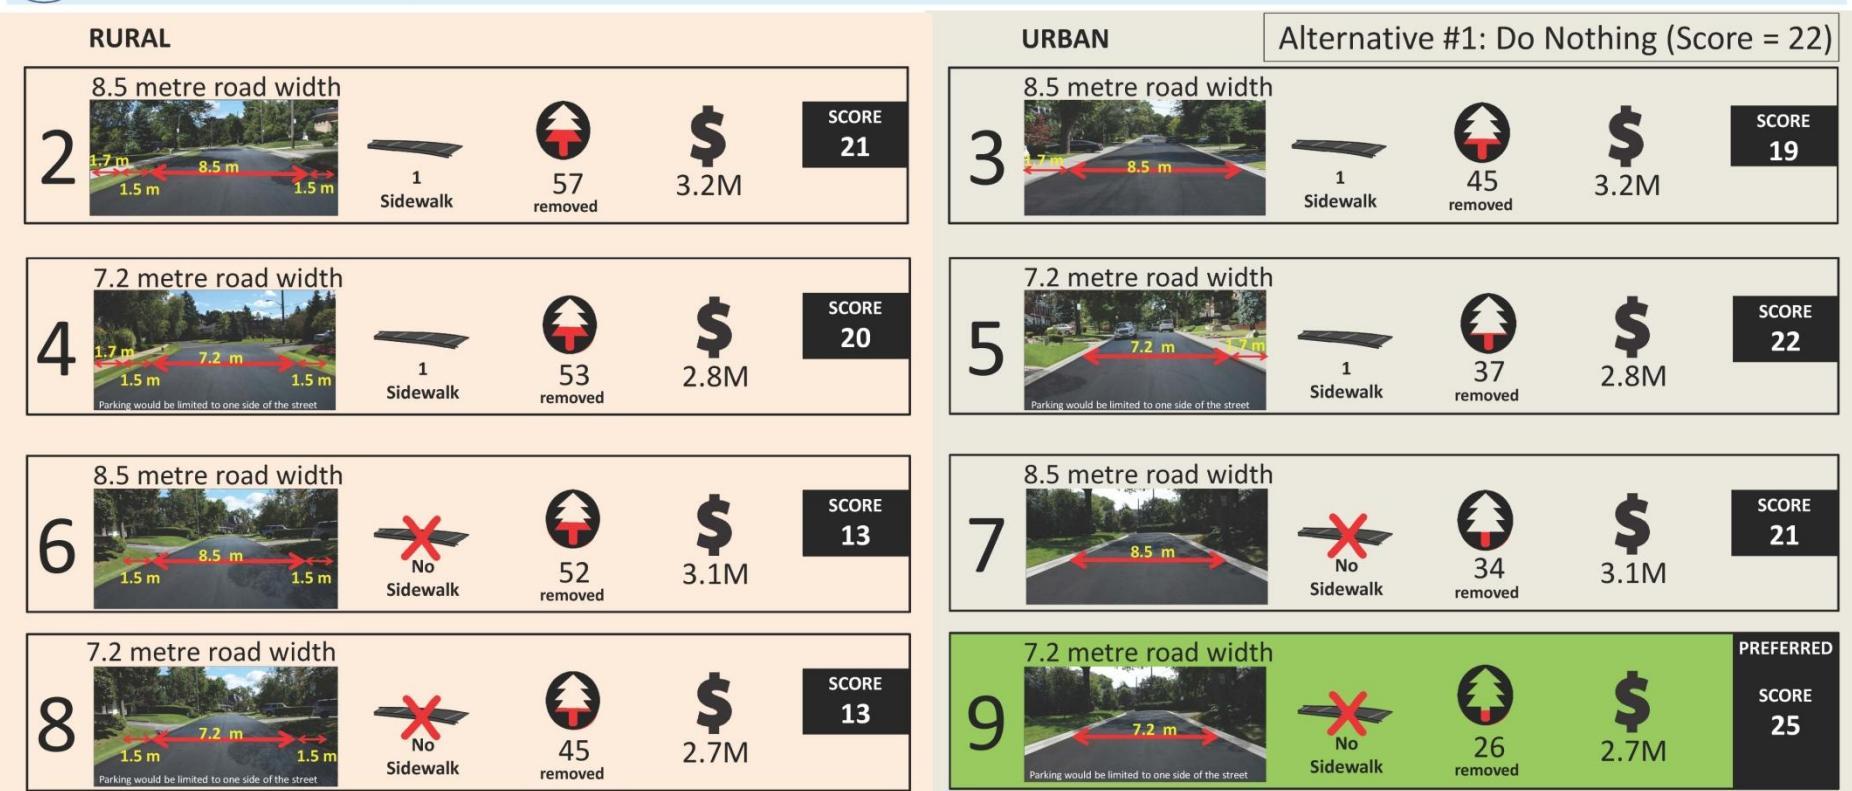
17 FIDELIA AVE, DAWLISH AVE, ST. LEONARDS CRES – West of Mildenhall Rd

Alternative 9 has been identified as the Preliminary Preferred Alternative for following reasons:

- · Results in the least impact to street trees
- Meets the requirements for an improvement of roadway structure, improvement in stormwater quality and ability to provide safe conditions for emergency and operational vehicles

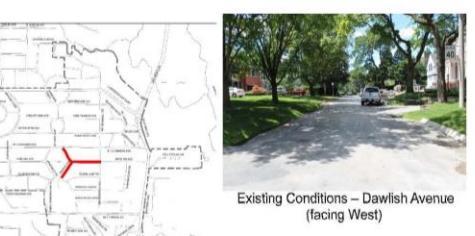
Existing Conditions - Dawlish Avenue (facing West)

Existing Conditions

- Insufficient ditched drainage system
- Poor quality road structure and pavement widths 6m 8m
- Approximately 90 mature trees within public right-of-way
- No sidewalks

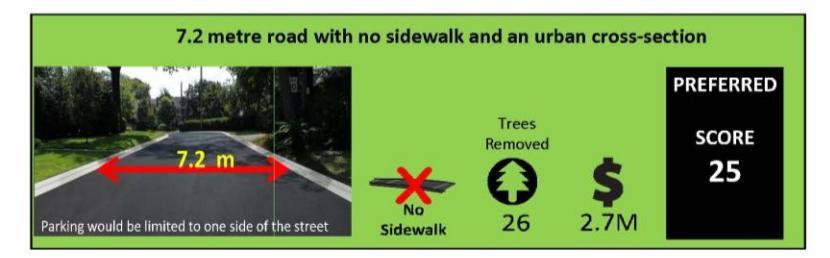
Preliminary Preferred Alternative

Preliminary Preferred Alternative:

- ☑ Results in the least impact to street trees
- Meets the requirements for an improvement of roadway structure, improvement in stormwater quality and ability to provide safe conditions for emergency and operational vehicles
