# SCARBOROUGH CENTRE TMP

Quantitative Multi-Modal Assessment

JANUARY 2017

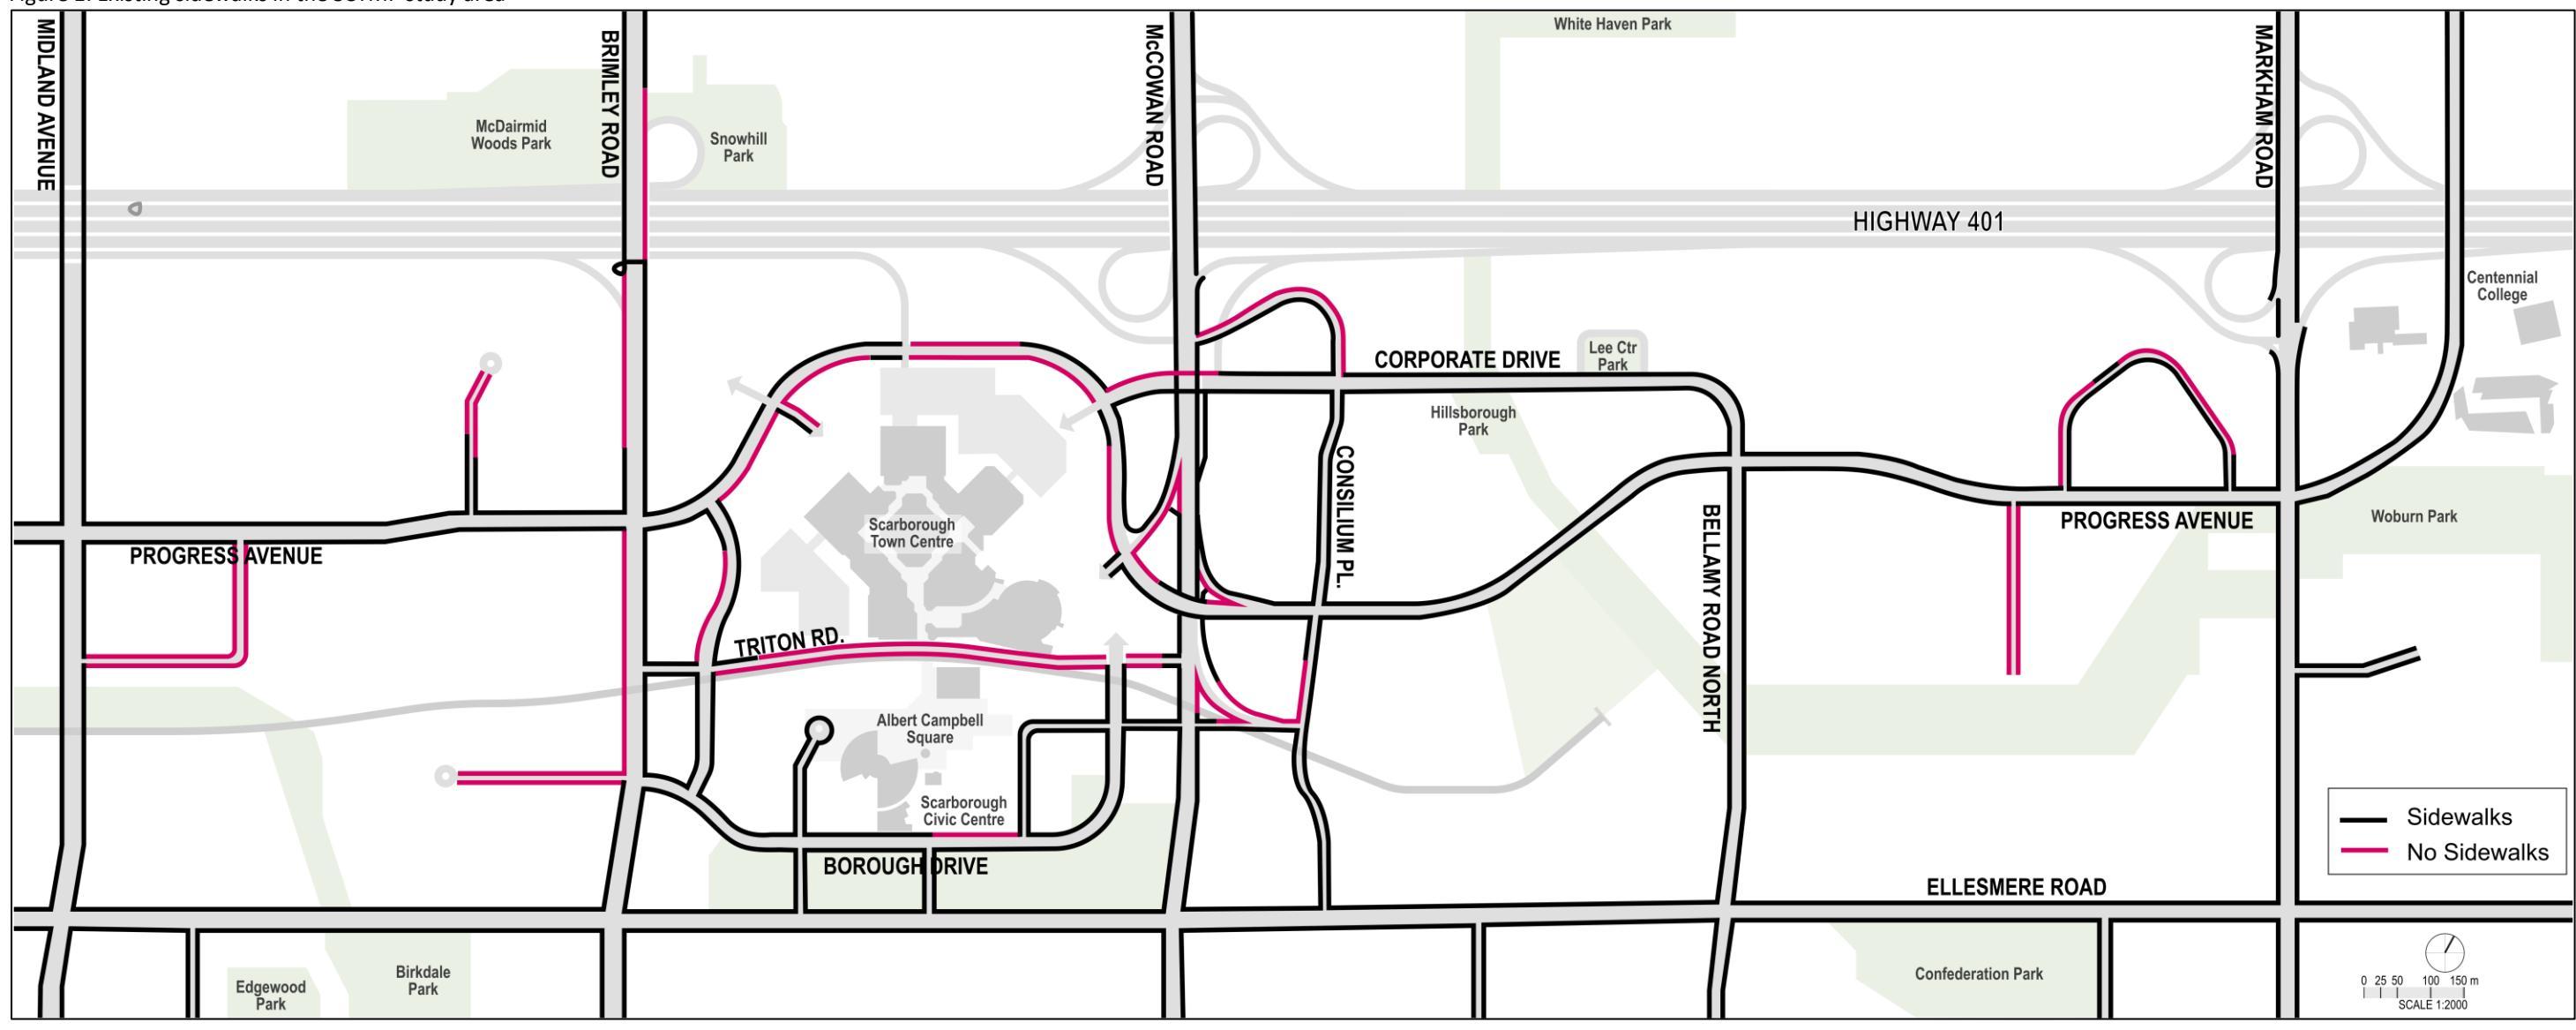
Figure 2: Pedestrian level of service in the SCTMP study area

As shown in **Figure 2**, the majority of pedestrian infrastructure in the Centre is an LOS E. LOS E is largely characterized by fragmented and disconnected sidewalk infrastructure, narrow sidewalks, high traffic speeds, and lack of physical separation between sidewalks and streets.

The Town Centre Commercial Precinct, which mainly encompasses the Scarborough Town Centre shopping mall, is predominately an LOS F, which indicates the absence of safe pedestrian infrastructure. LOS F streets signify that sidewalks are either entirely absent or are less than 1.5 metres in width. Examples of absent sidewalks are found on the west side of Brimley Road, Triton Road (Figure 3), and many segments of Progress Avenue near the Scarborough Town Centre shopping mall. Road channelization and lack of designated pedestrian crossings compound the negative impact of missing sidewalks and therefore limit pedestrian activity throughout the Centre.

The street segments where sidewalk improvements have been made are marked with an asterisk in Figure 2. For example, the northeast corner of Brimley Road and Ellesmere Road (Figure 5) provides a large open space for pedestrians that is not accounted for in the pedestrian LOS table found in Appendix A.
