#### CITY OF TORONTO

#### Southwest Agincourt Transportation Connections Study Environmental Assessment PROPOSED SERVICING ANALYSIS

#### Southwest Agincourt Transportation Connections Study PROPOSED SERVICING ANALYSIS

PROJECT NO.: 19M-01888-00 DATE: SEPTEMBER 2023

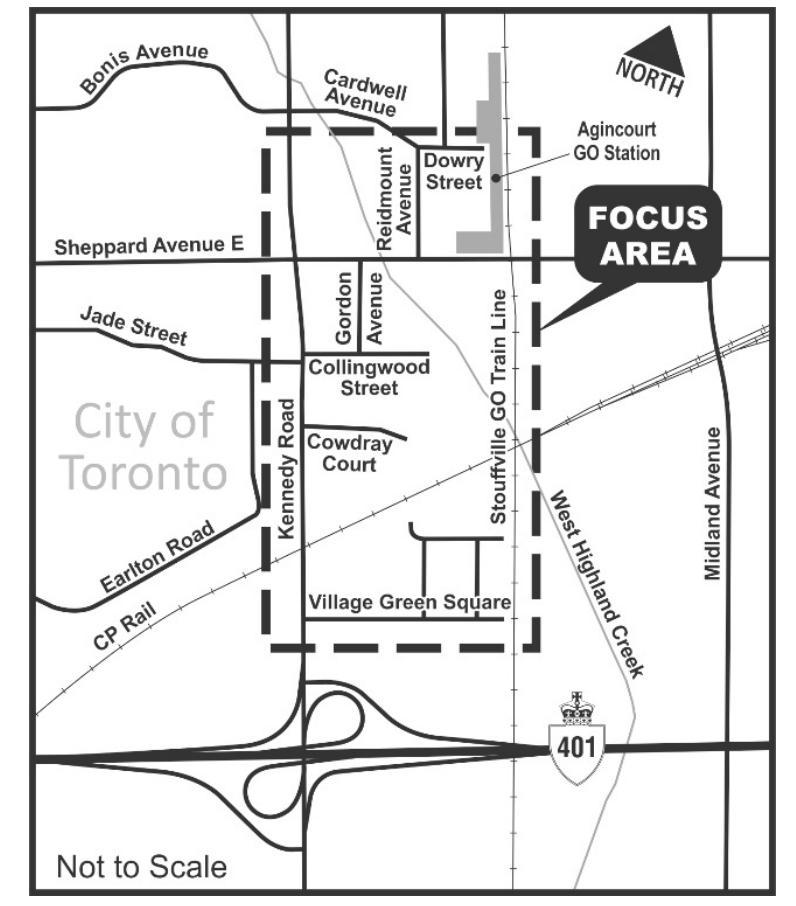
#### Figure 1: Map of Southwest Agincourt Transportation Connections Study Focus Area

Under the post-development conditions, new development(s) are being proposed along Cowdry Court and the existing Gordon Avenue will be extended approximately 350 m south, under the existing railways via a grade separation project, to connect to existing Village Green Square. As part of the SW Agincourt EA, this report will analysis the proposed sanitary sewer, storm sewer and water distribution network along the proposed Gordon Avenue extension and how it will impact the surrounding areas. Please note the existing sanitary, storm and watermain on Cowdry Court may be removed or upgraded based on the decisions of the subdivision consultant(s).

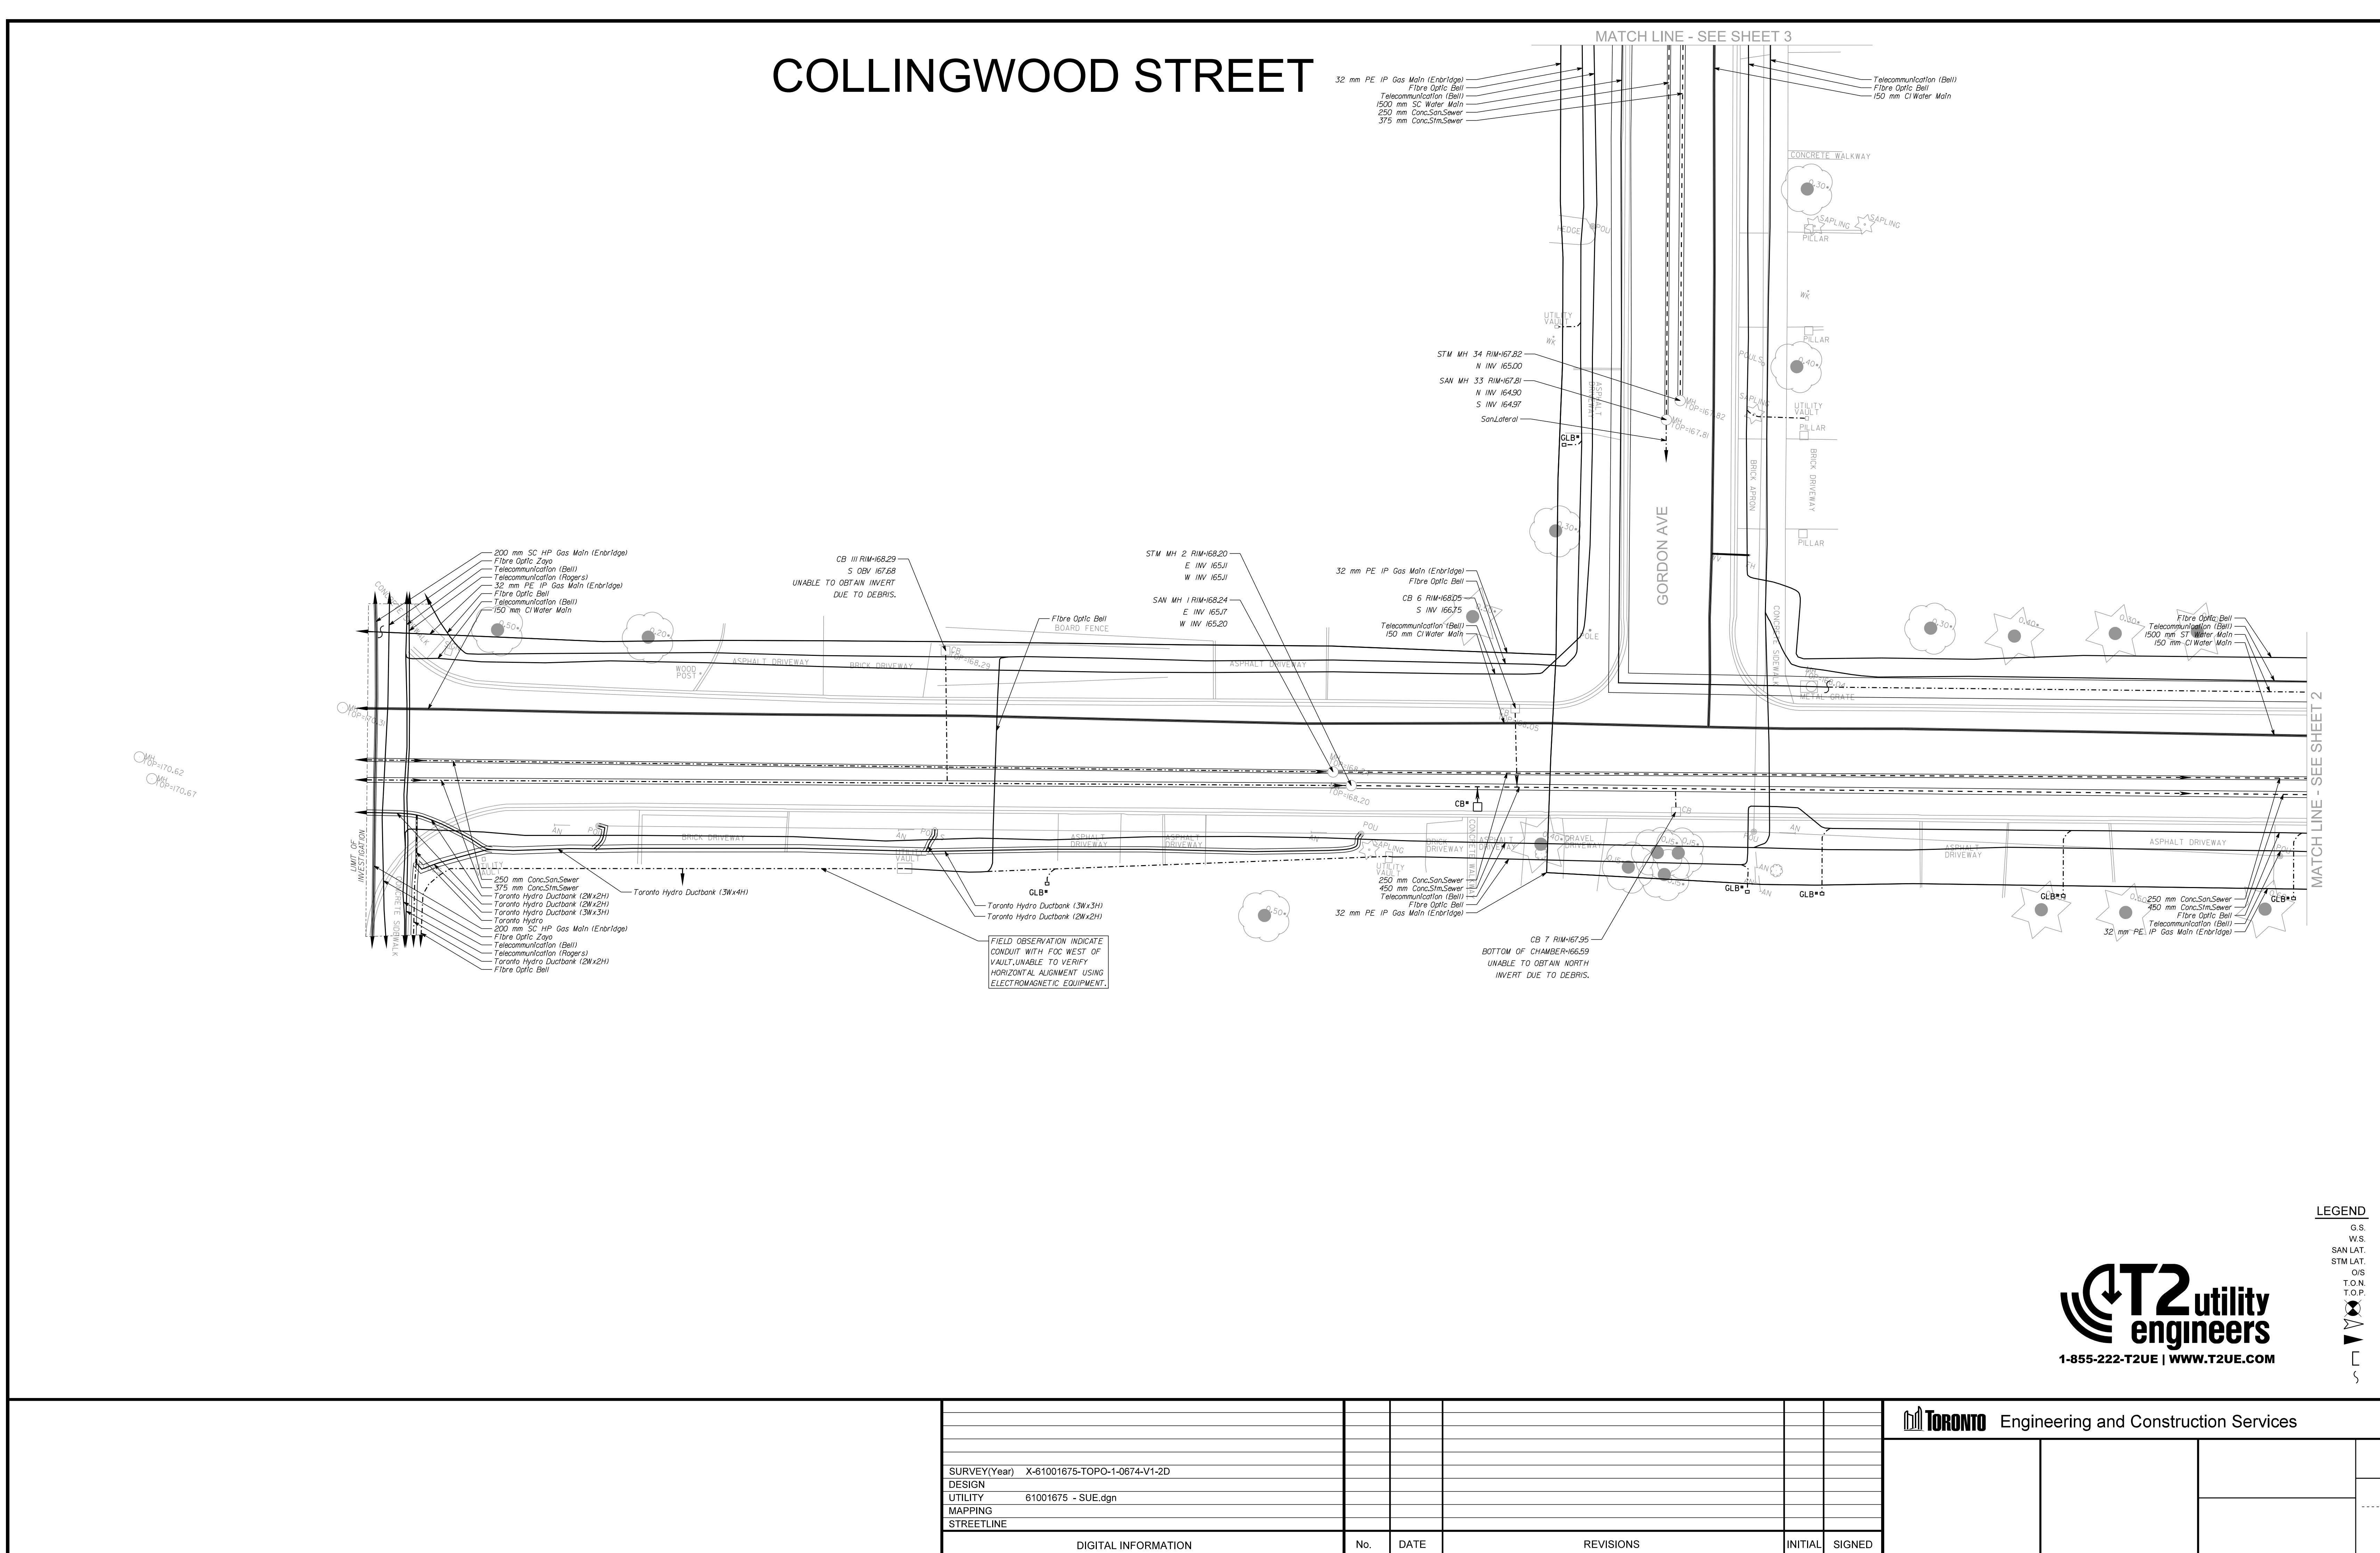
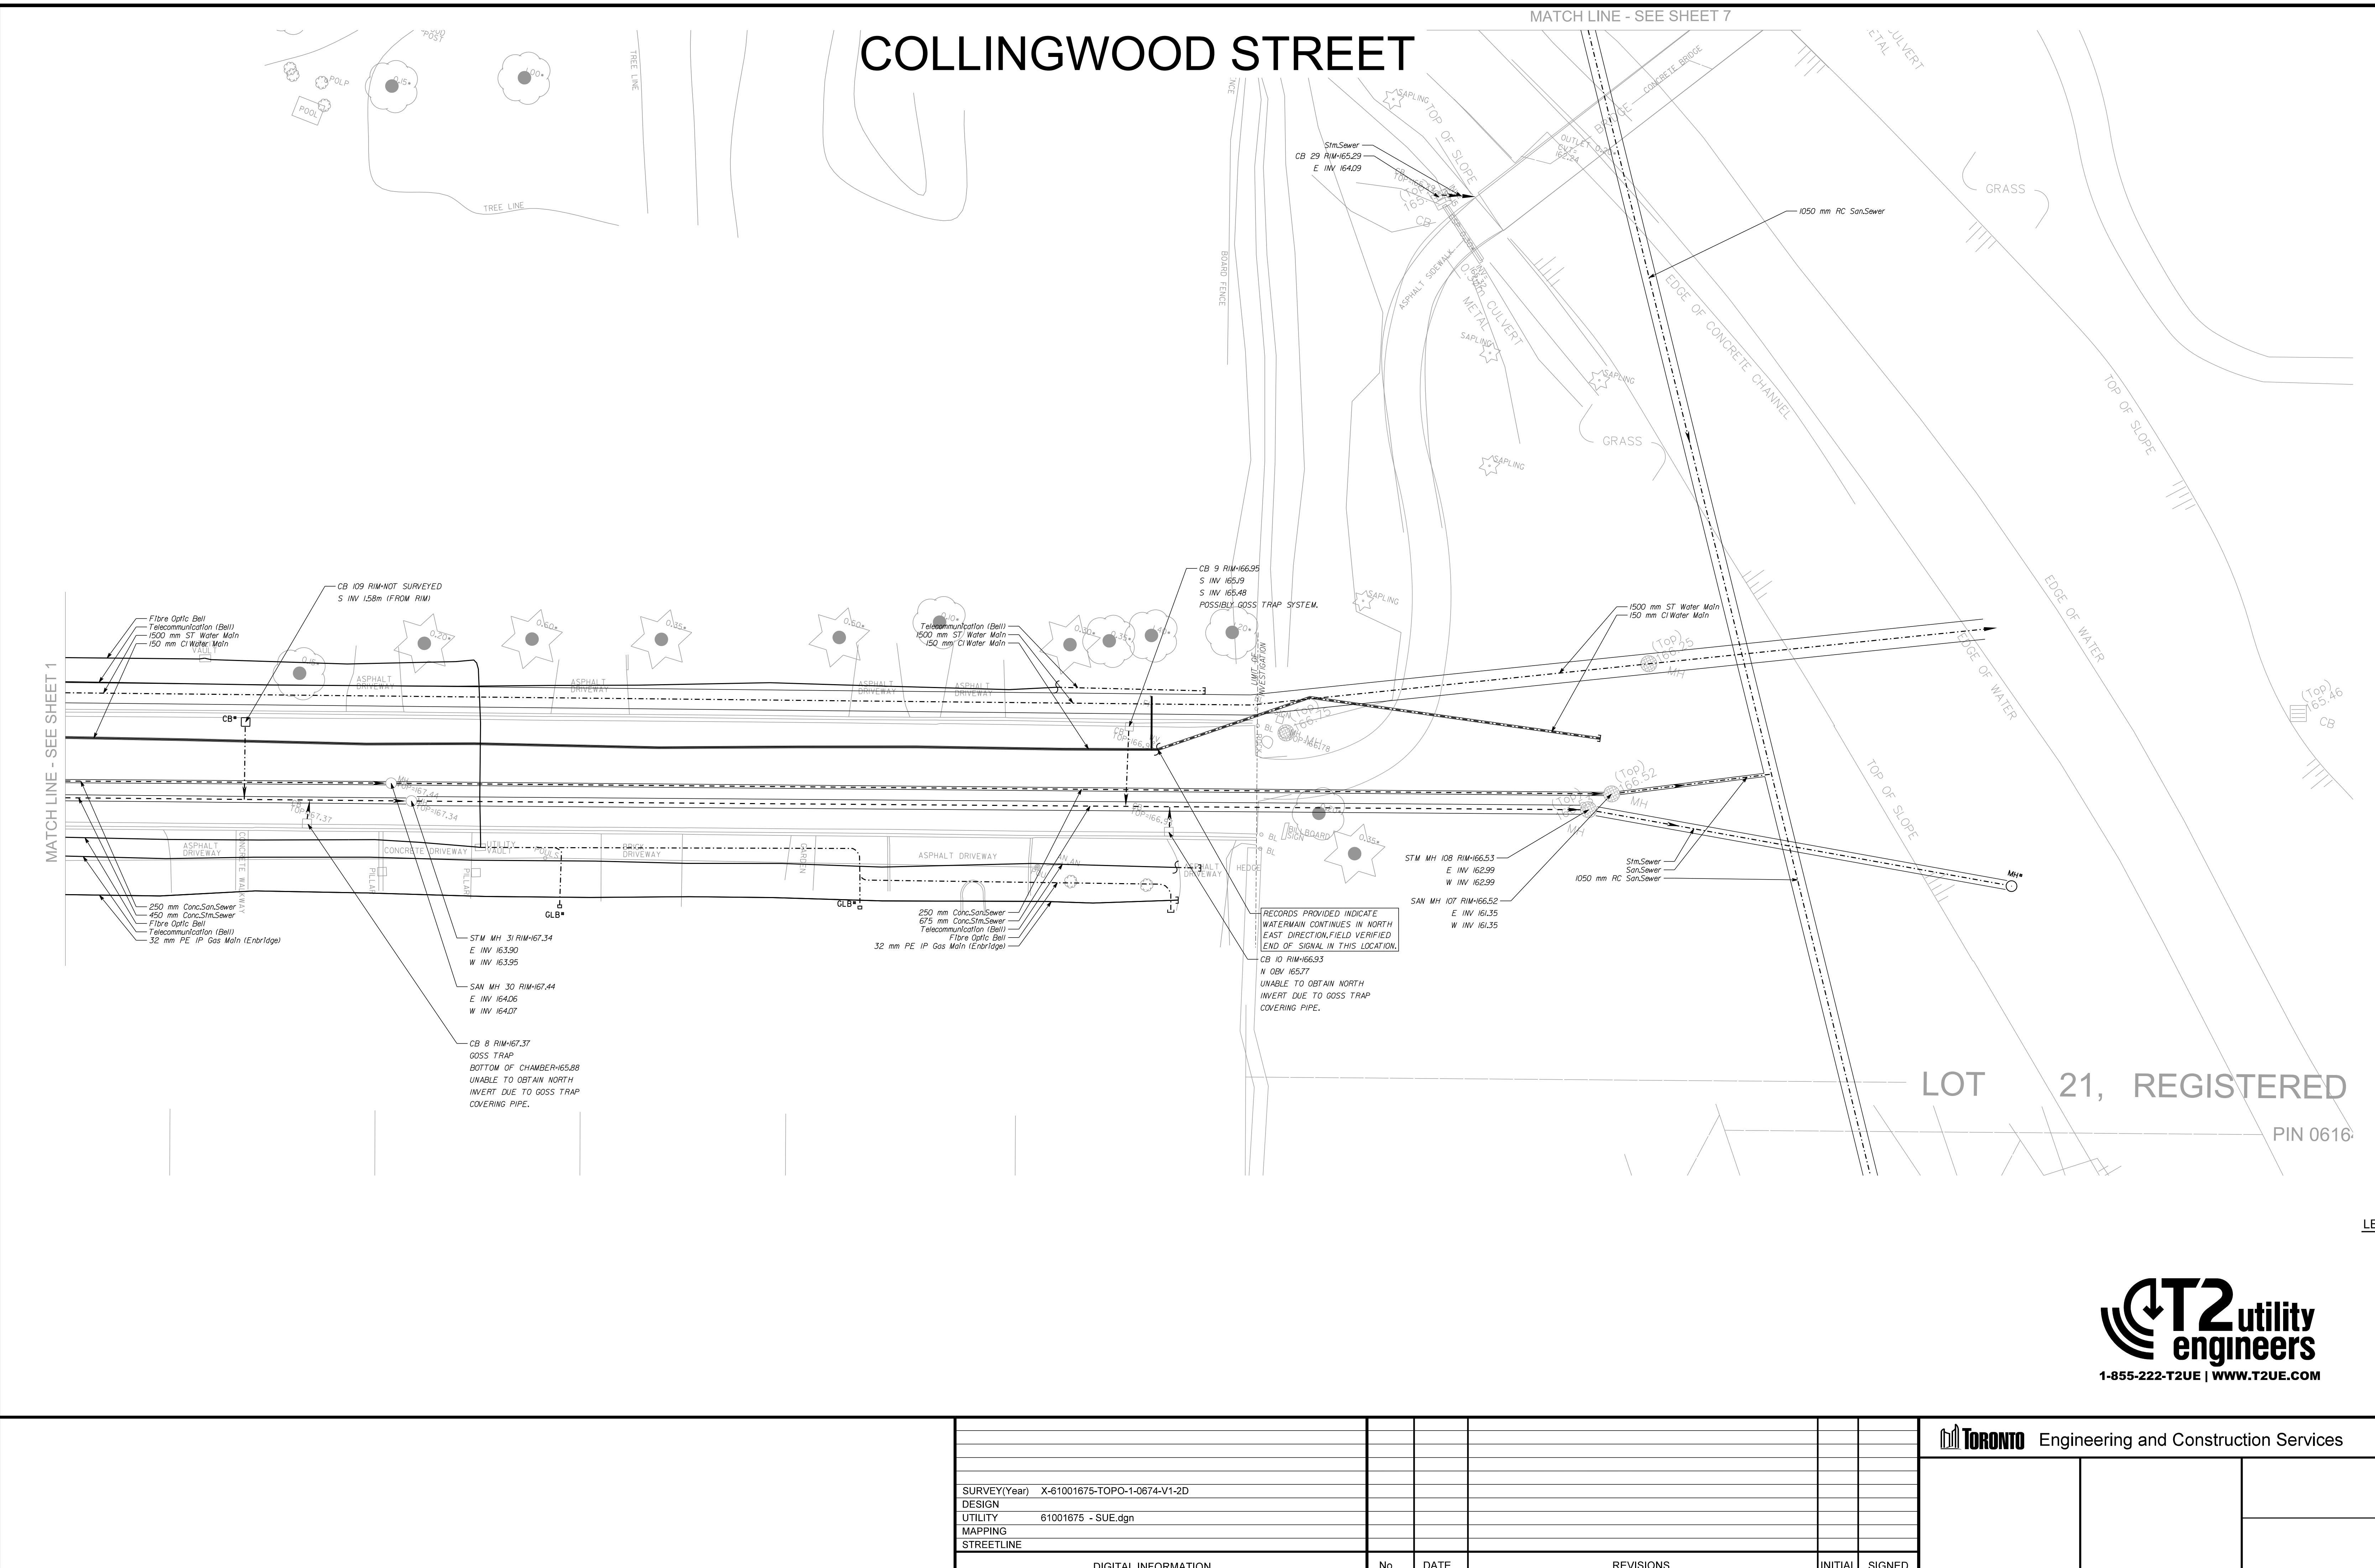
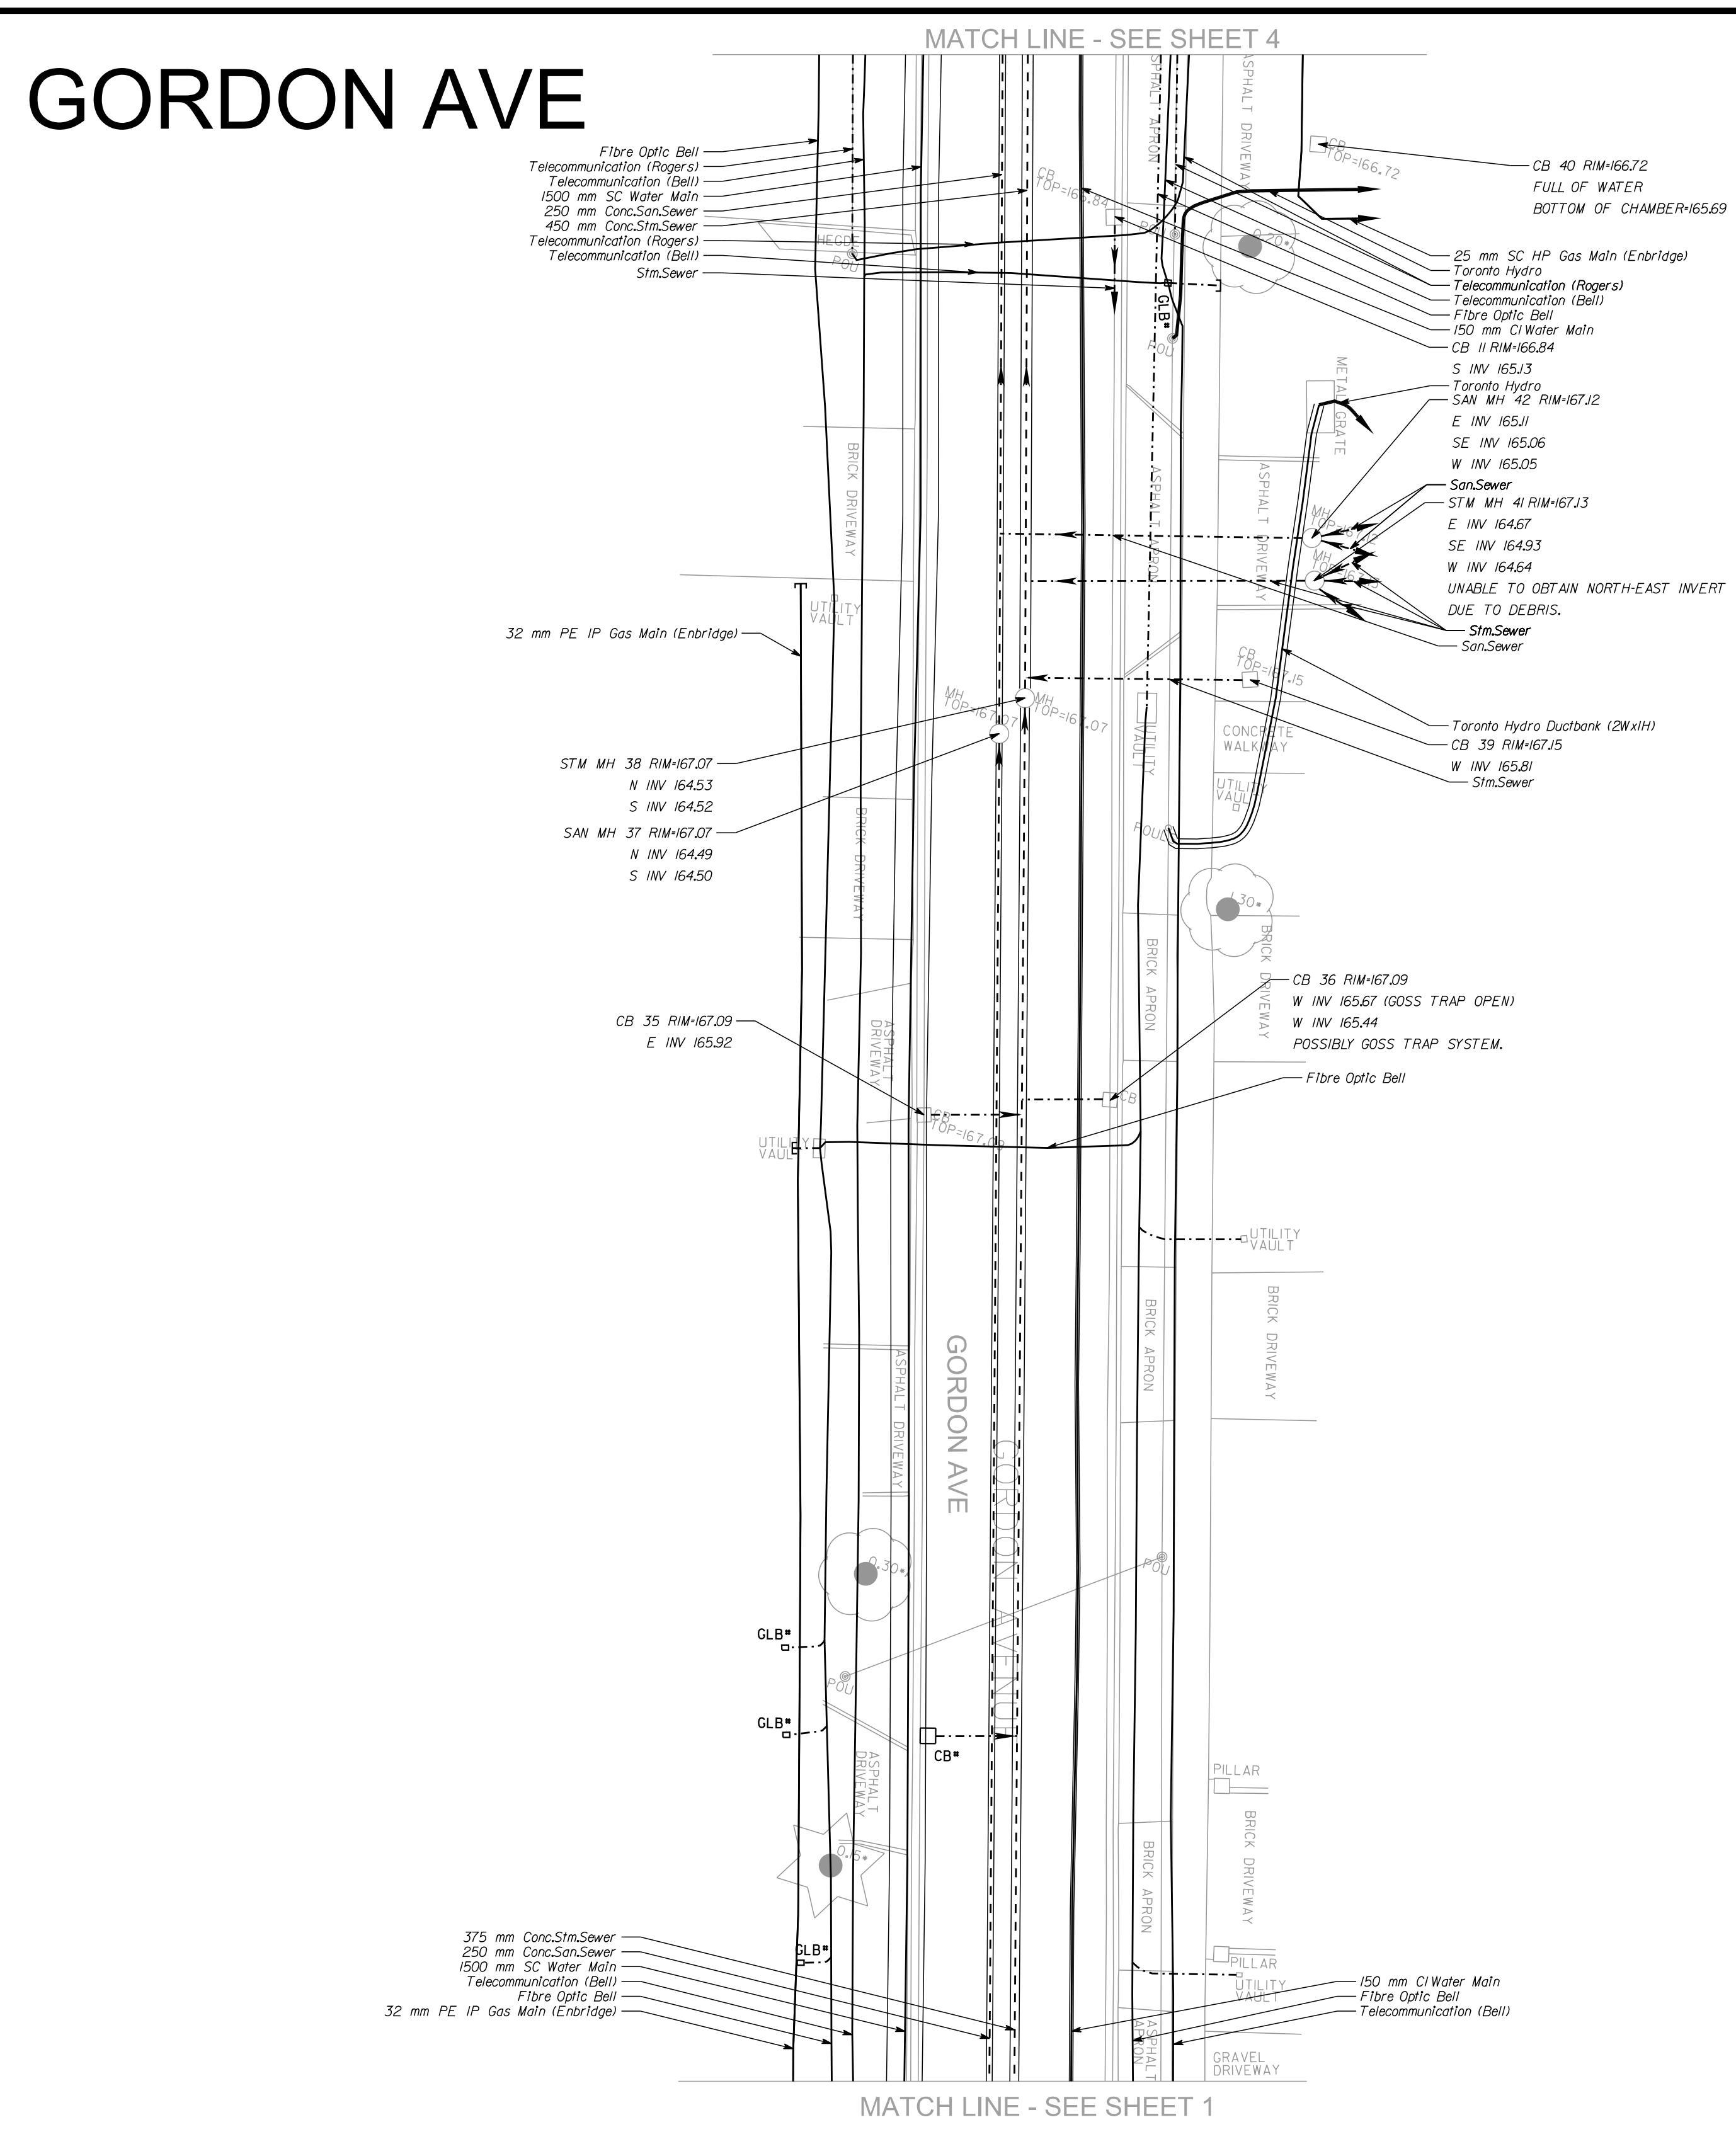
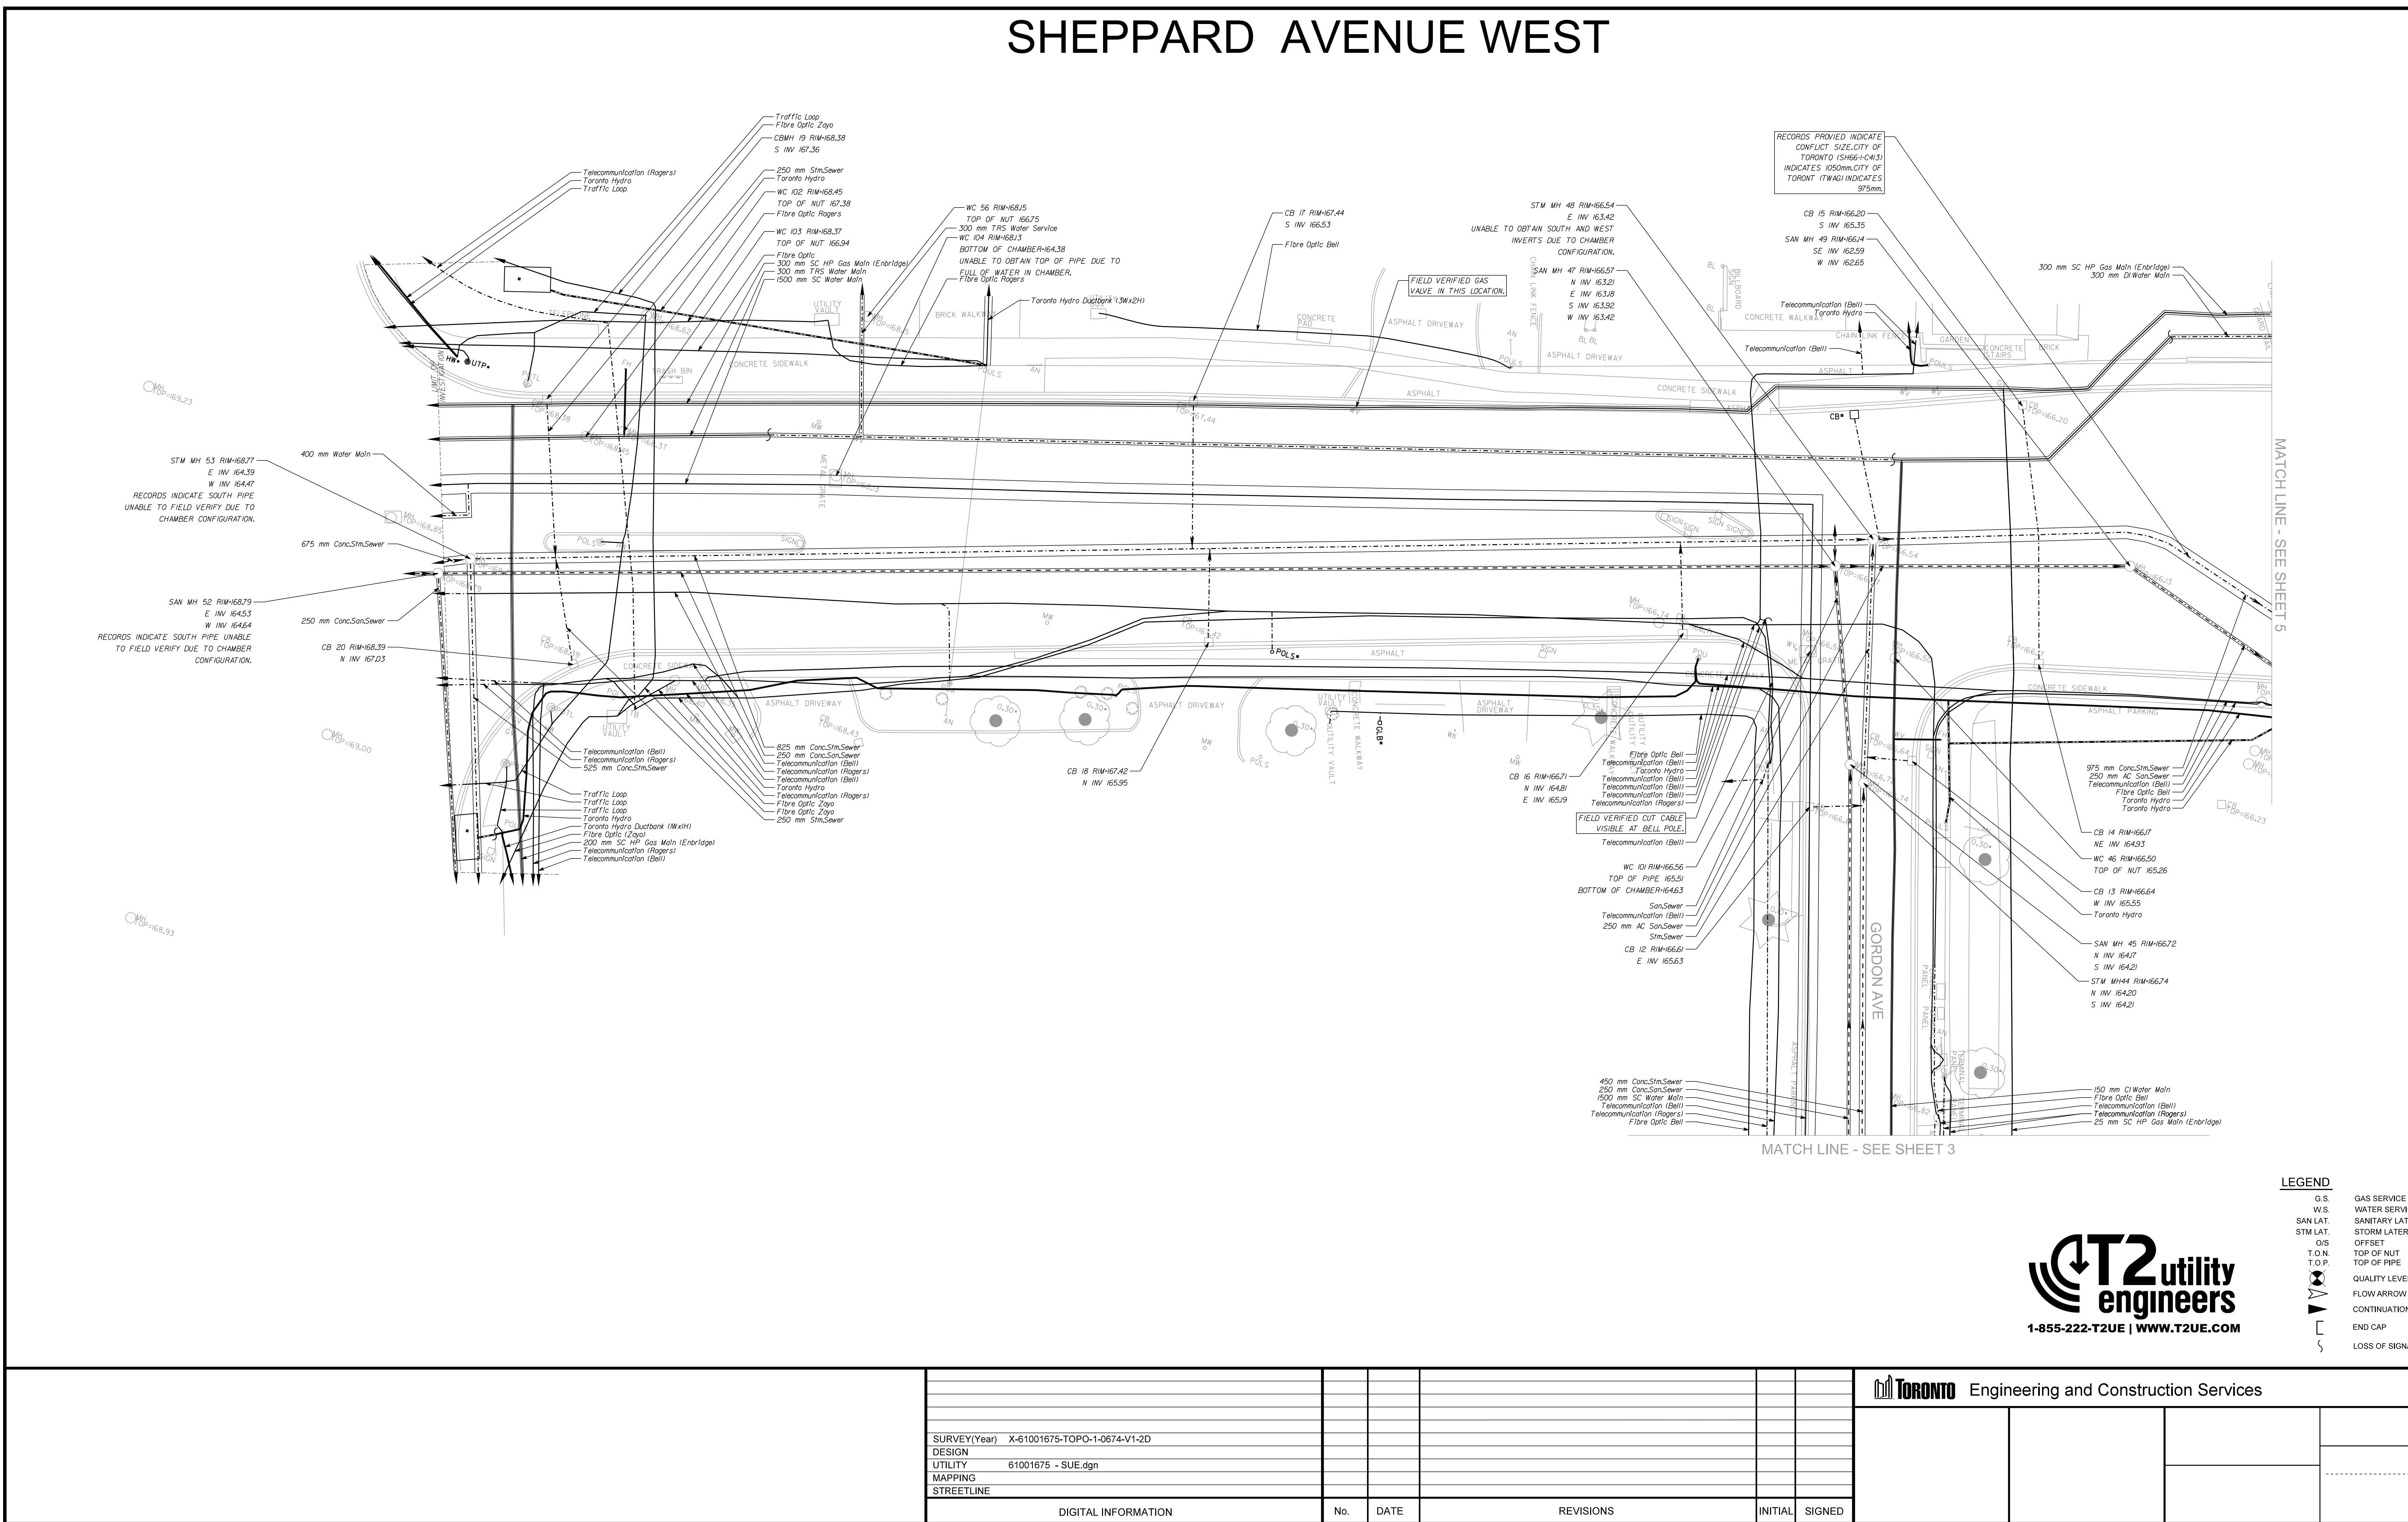
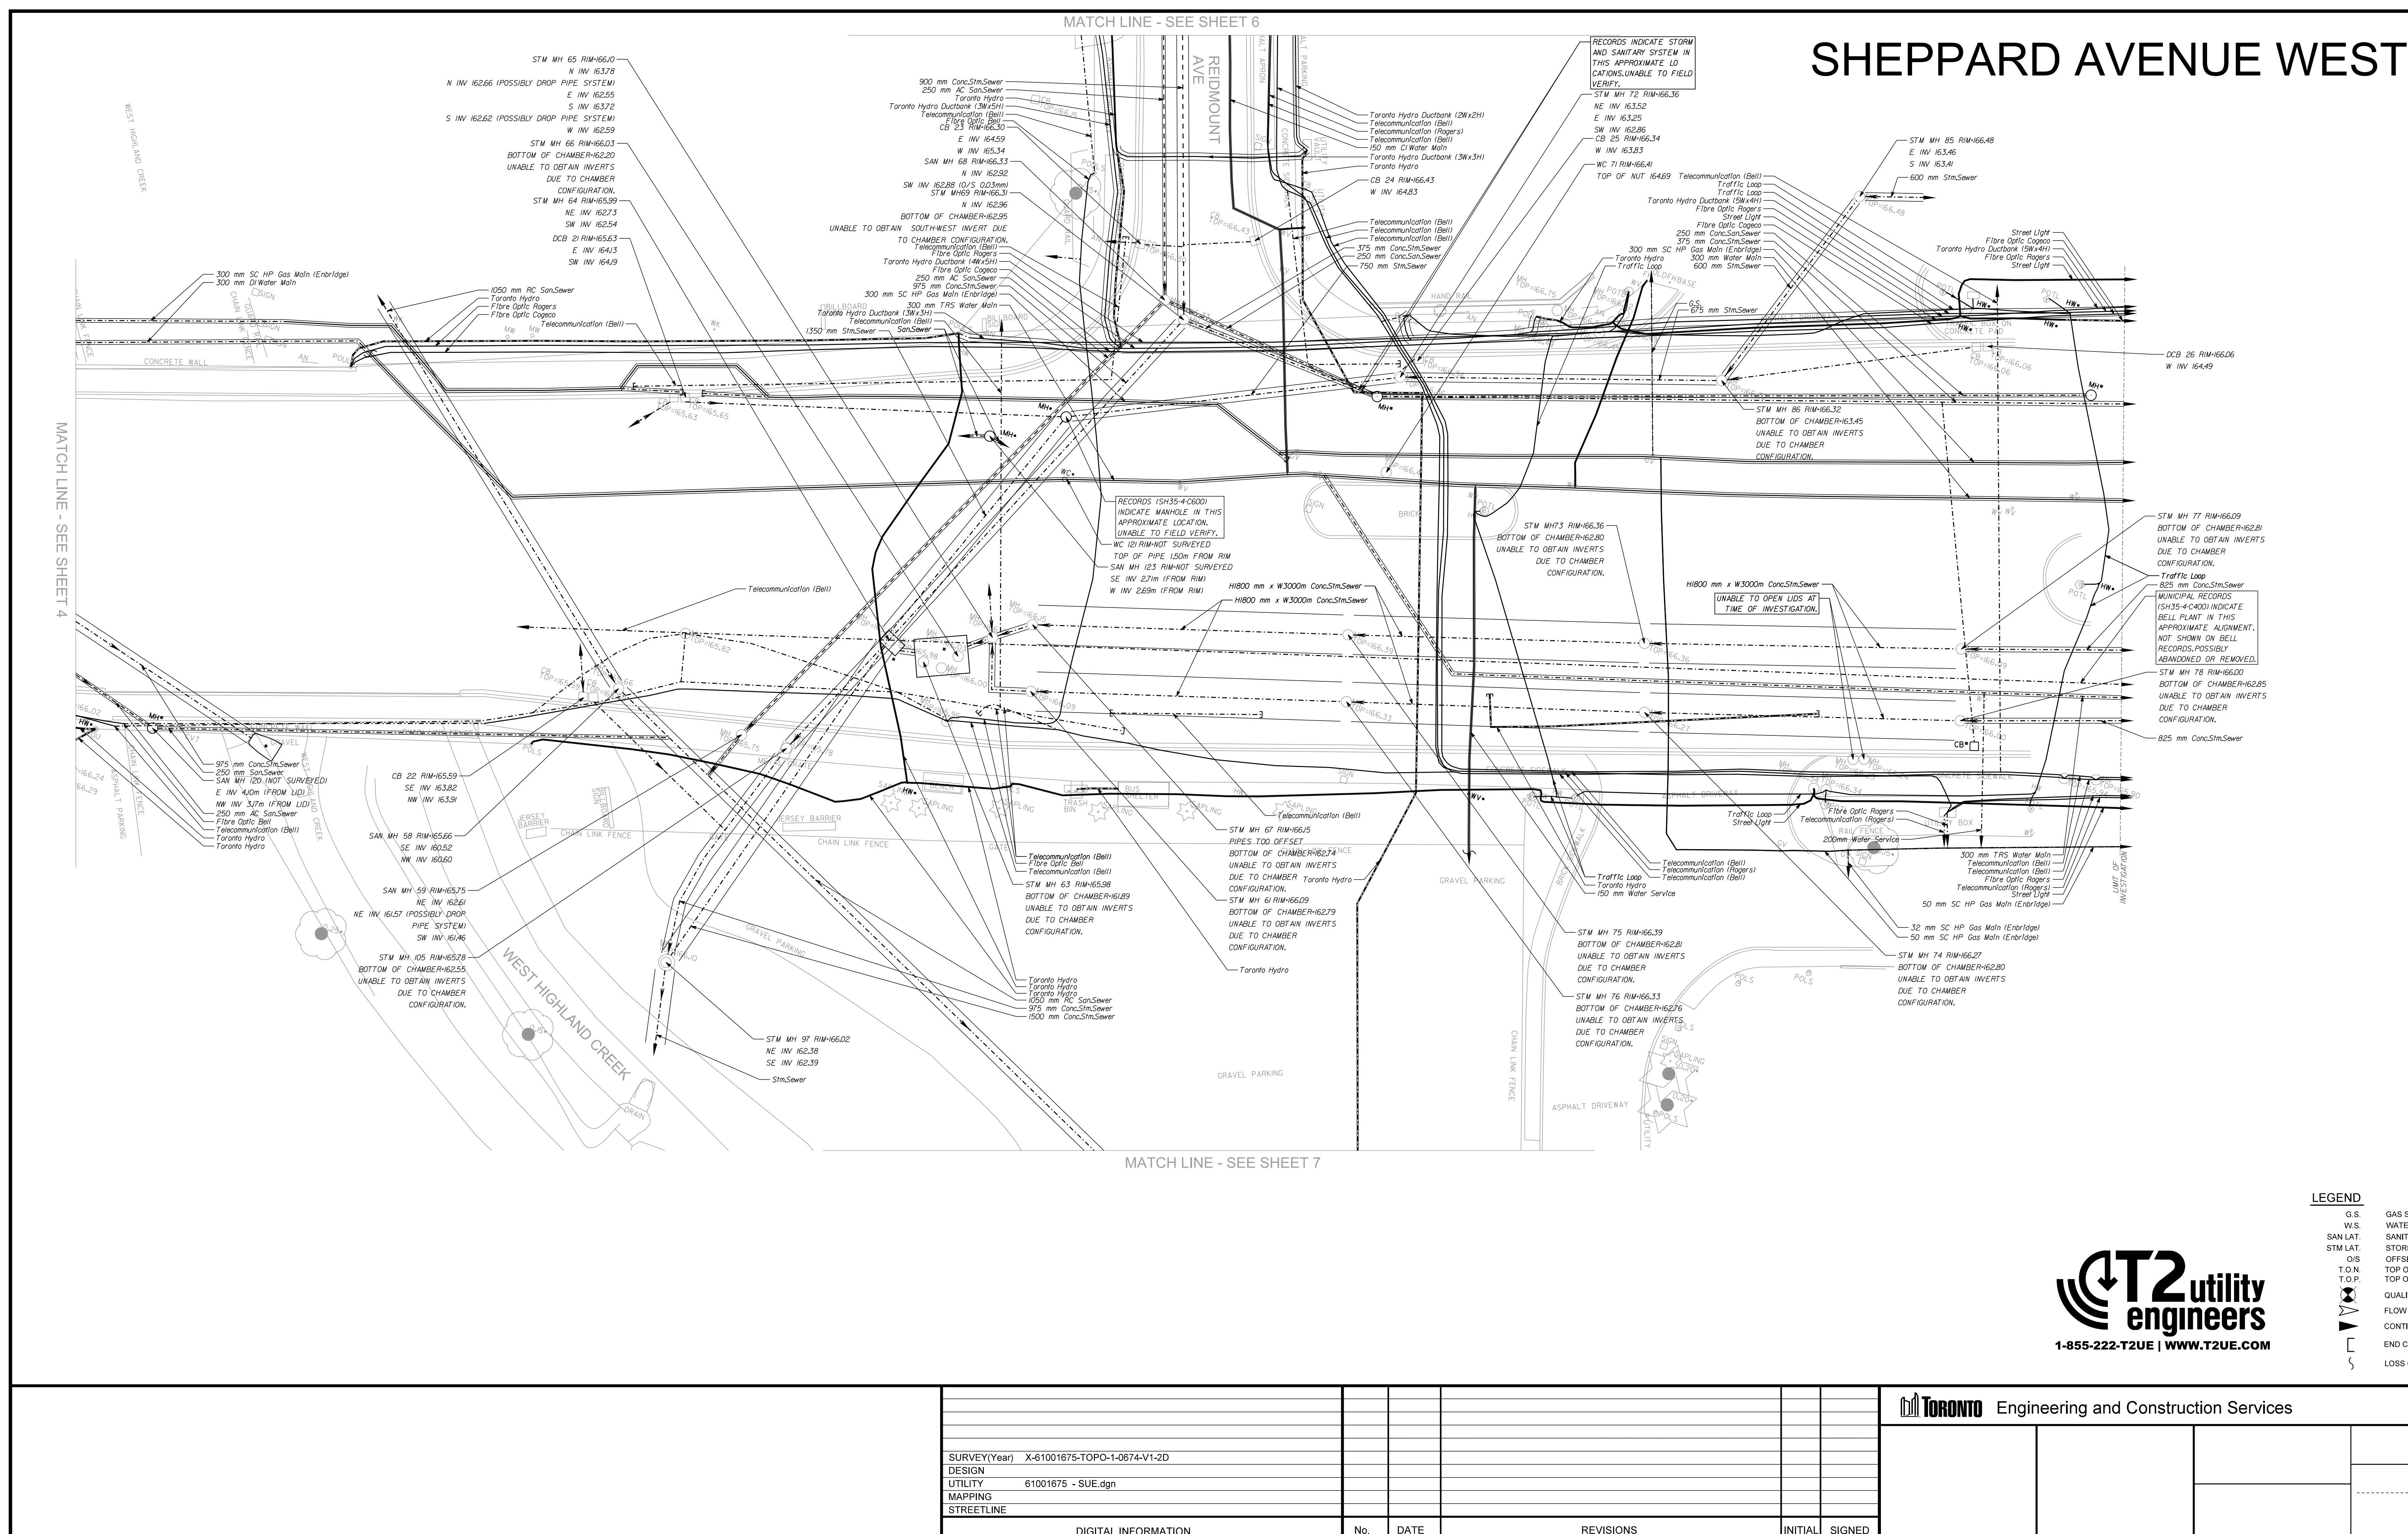
A topographic survey was provided by IBW Surveyors which was the base of the SUE Investigation. Field verifications of utilities were completed using a combination of electromagnetic pipe and cable locate equipment. Inverts of existing sewers were confirmed by field depth measurement. The SUE drawings prepared by T2 Utility Engineers can be found in **Appendix A.**
