#### CITY OF TORONTO

#### Southwest Agincourt Transportation Connections Study Environmental Assessment PROPOSED SERVICING ANALYSIS

#### Southwest Agincourt Transportation Connections Study PROPOSED SERVICING ANALYSIS

PROJECT NO.: 19M-01888-00 DATE: SEPTEMBER 2023

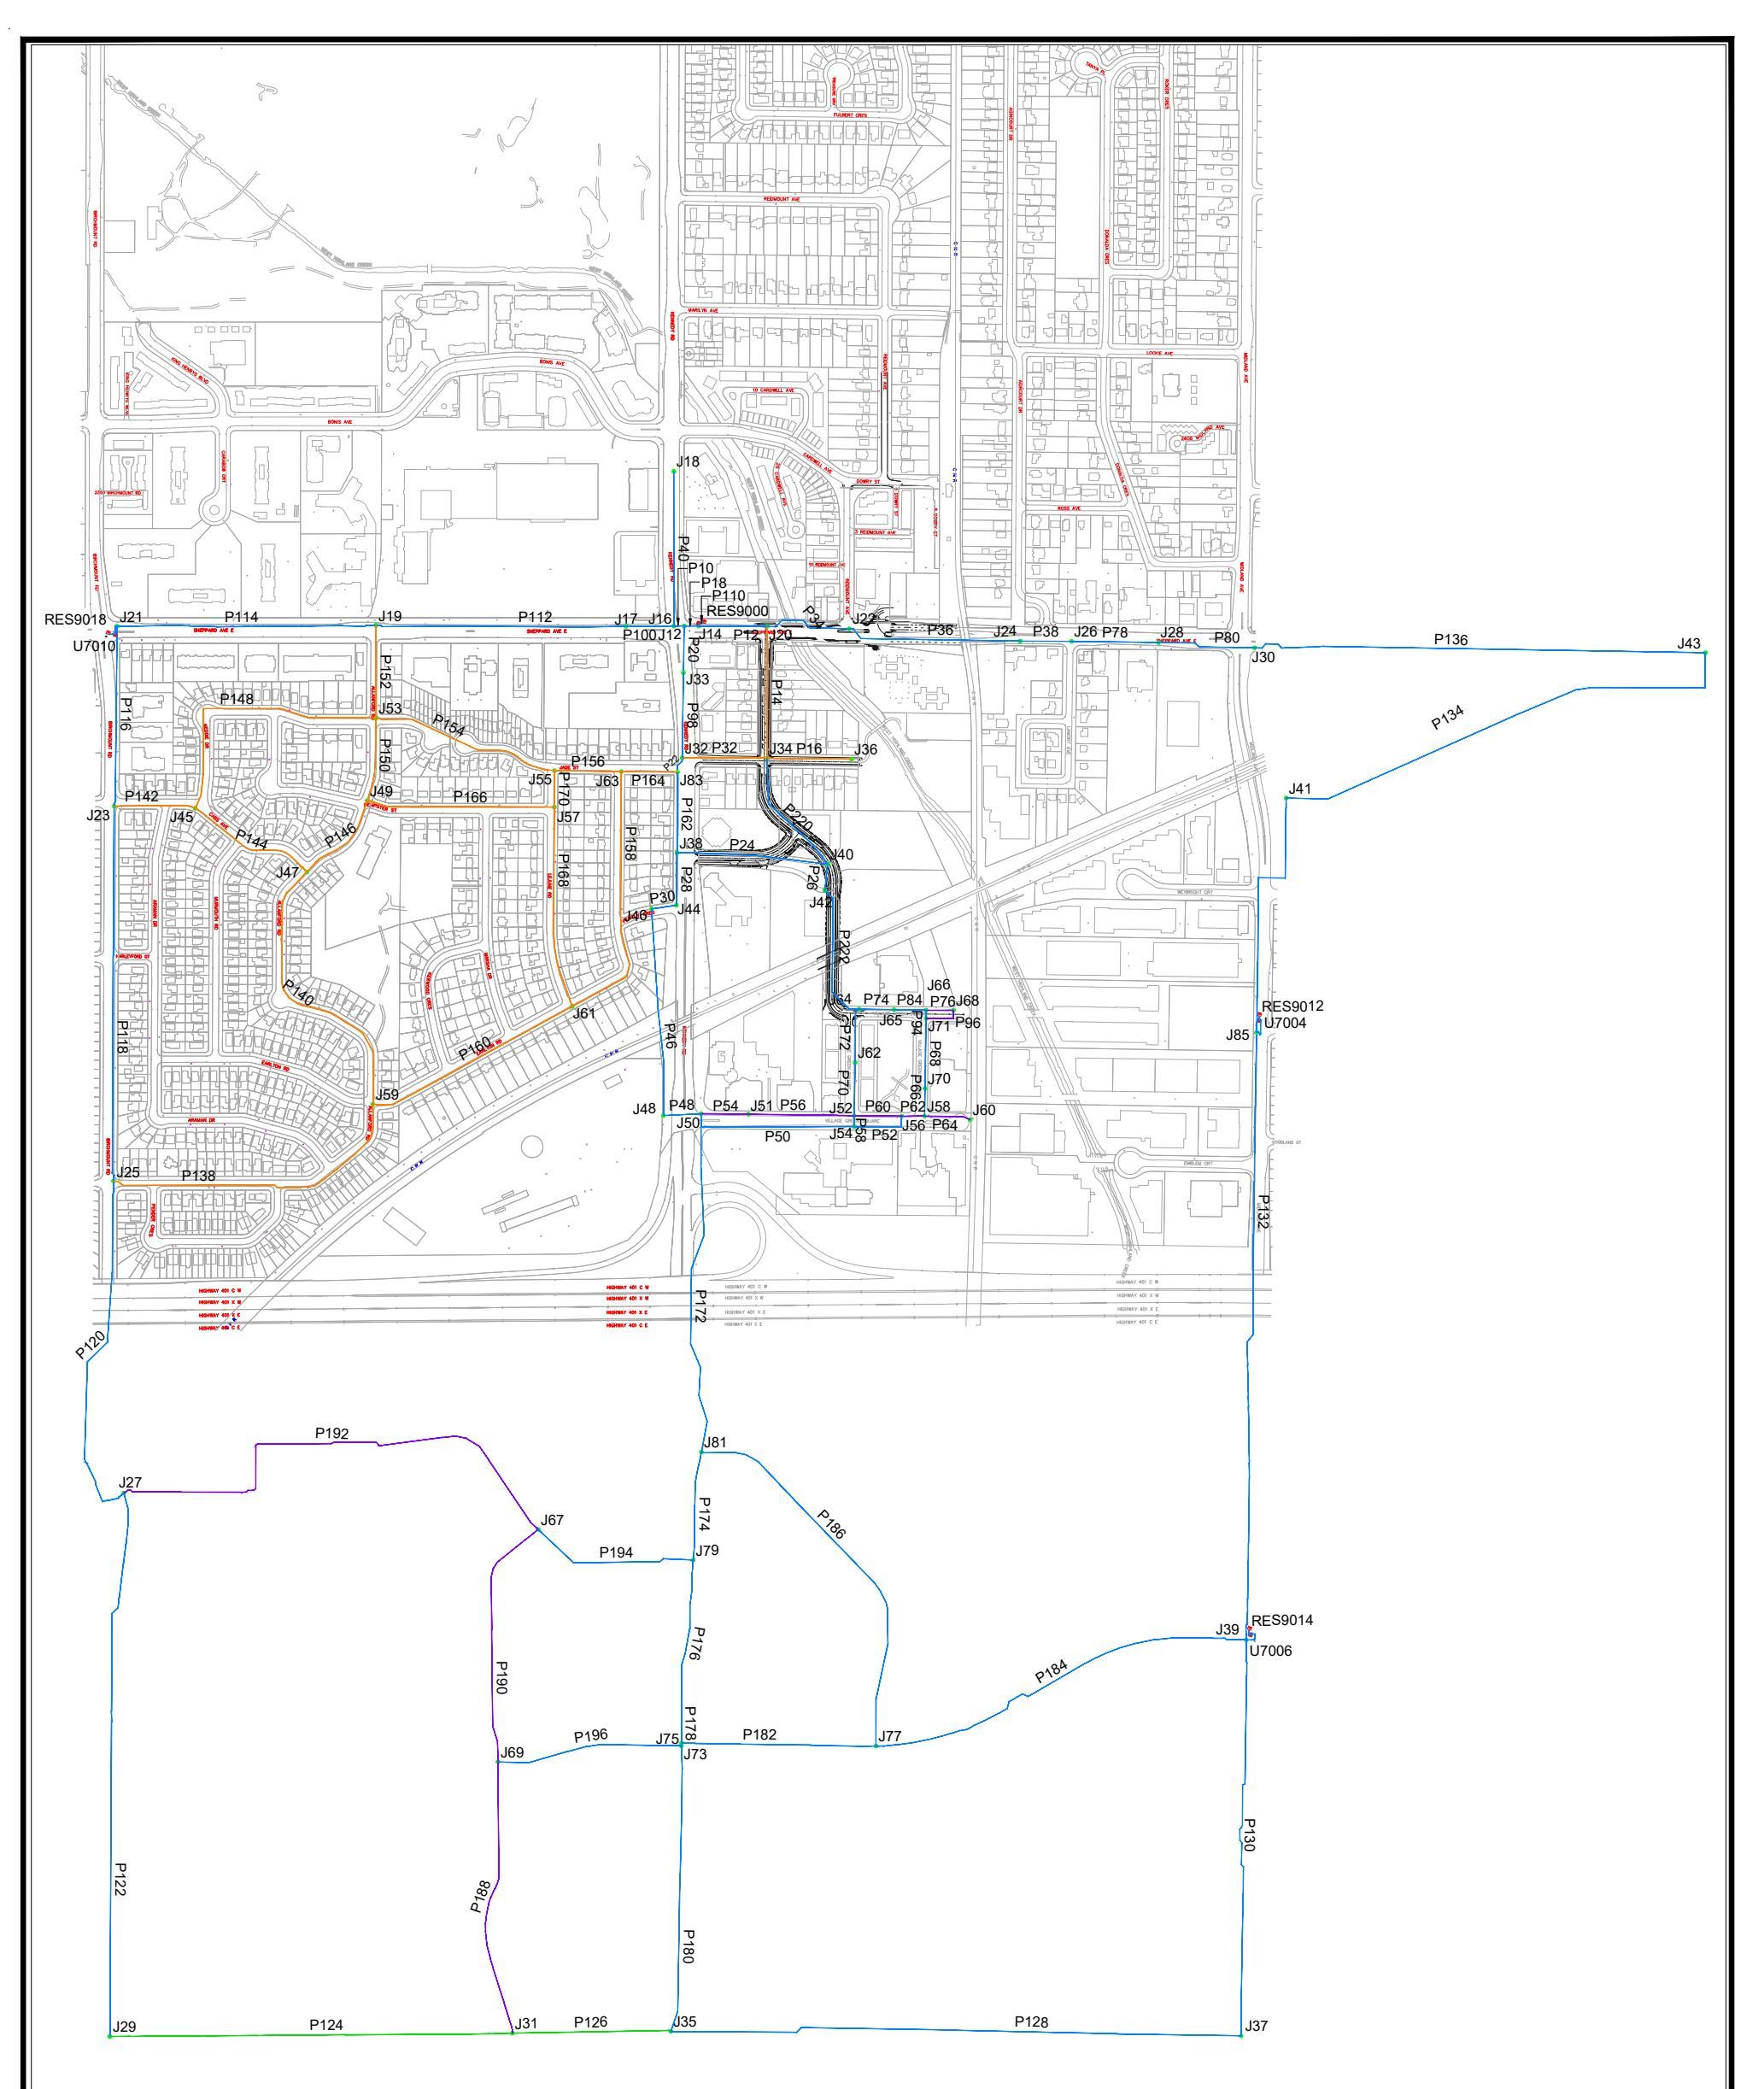
Pipe Input View PIPEHYD->DIAMETER 150mm	CLIENT		- 11 '	5	
200mm	TITLE ROBINSON GLEN COMMUNITY CITY OF MARKHAM	100 Co t: 905.0	ommerce Valley Dr. W 882.1100 f: 905.882	est, Thornhill, 2.0055	, ON Canada L3T 0A1 www.wsp.com
<b>300mm</b>	PROPOSED WATER	Checked	M.M.	Drawn	I.B.
		Date	DEC 2022	Proj. No.	19M-01888
		Scale	N.T.S.	Figure No.	WM-2

Under post-development condition, a new 300mm watermain is proposed along the proposed N-S road south of Gordon Avenue, which will connect to the existing 150mm watermain on Collingwood Street, 300mm watermain on Cowdry Court and 300mm watermain on Village Green Square. The exact layout and design of the water distribution network within Cowdray Court will be determined by the subdivision consultant. This proposed watermain will provide more looping and redundancy in the system which will improve the performance of the water distribution network within the study area. The details of this watermain such as plan and profile design, sizing etc. is to be determined at the detailed design stage. See Figure WM-1 in Appendix D for the conceptual design for the proposed watermain looping.

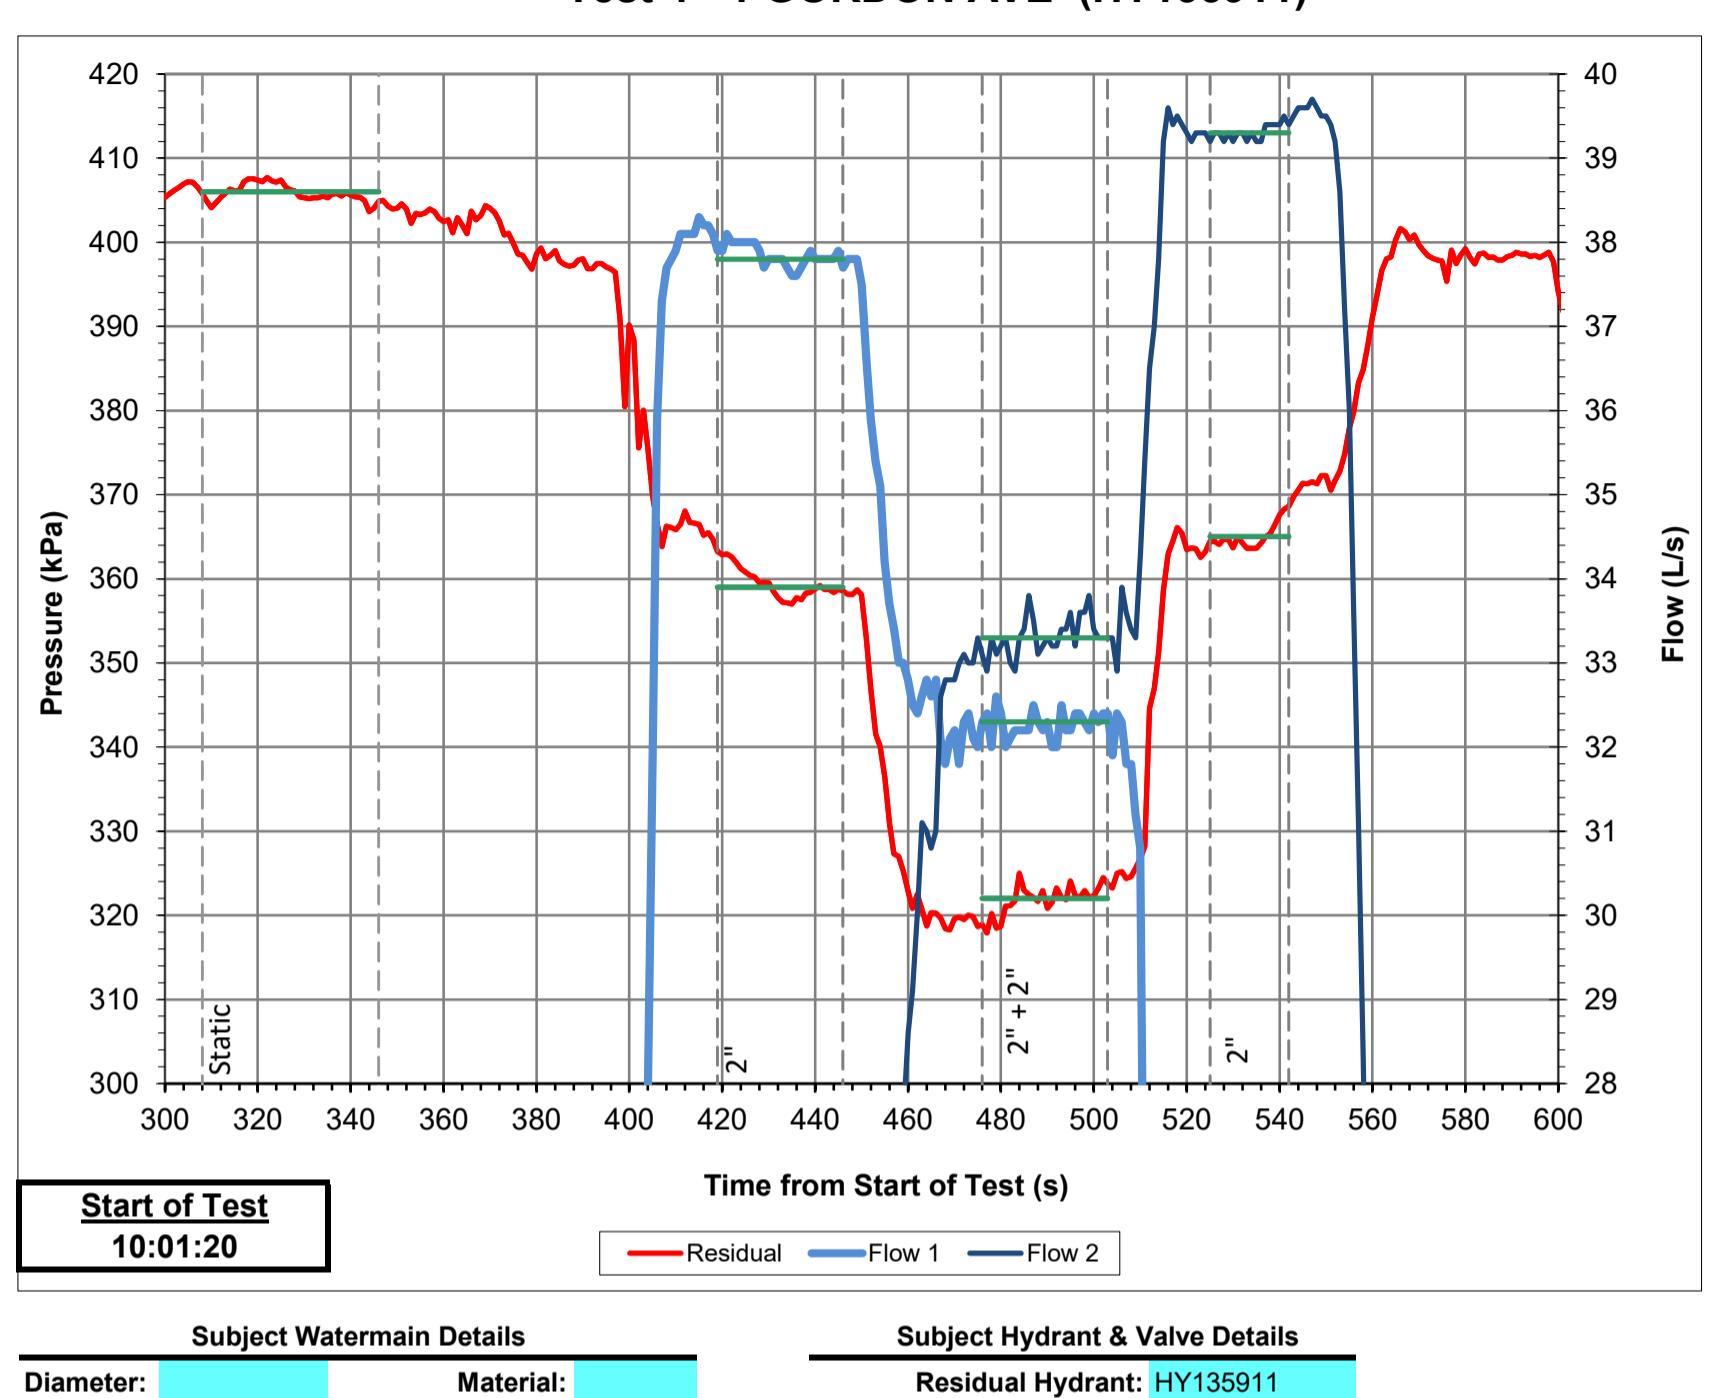
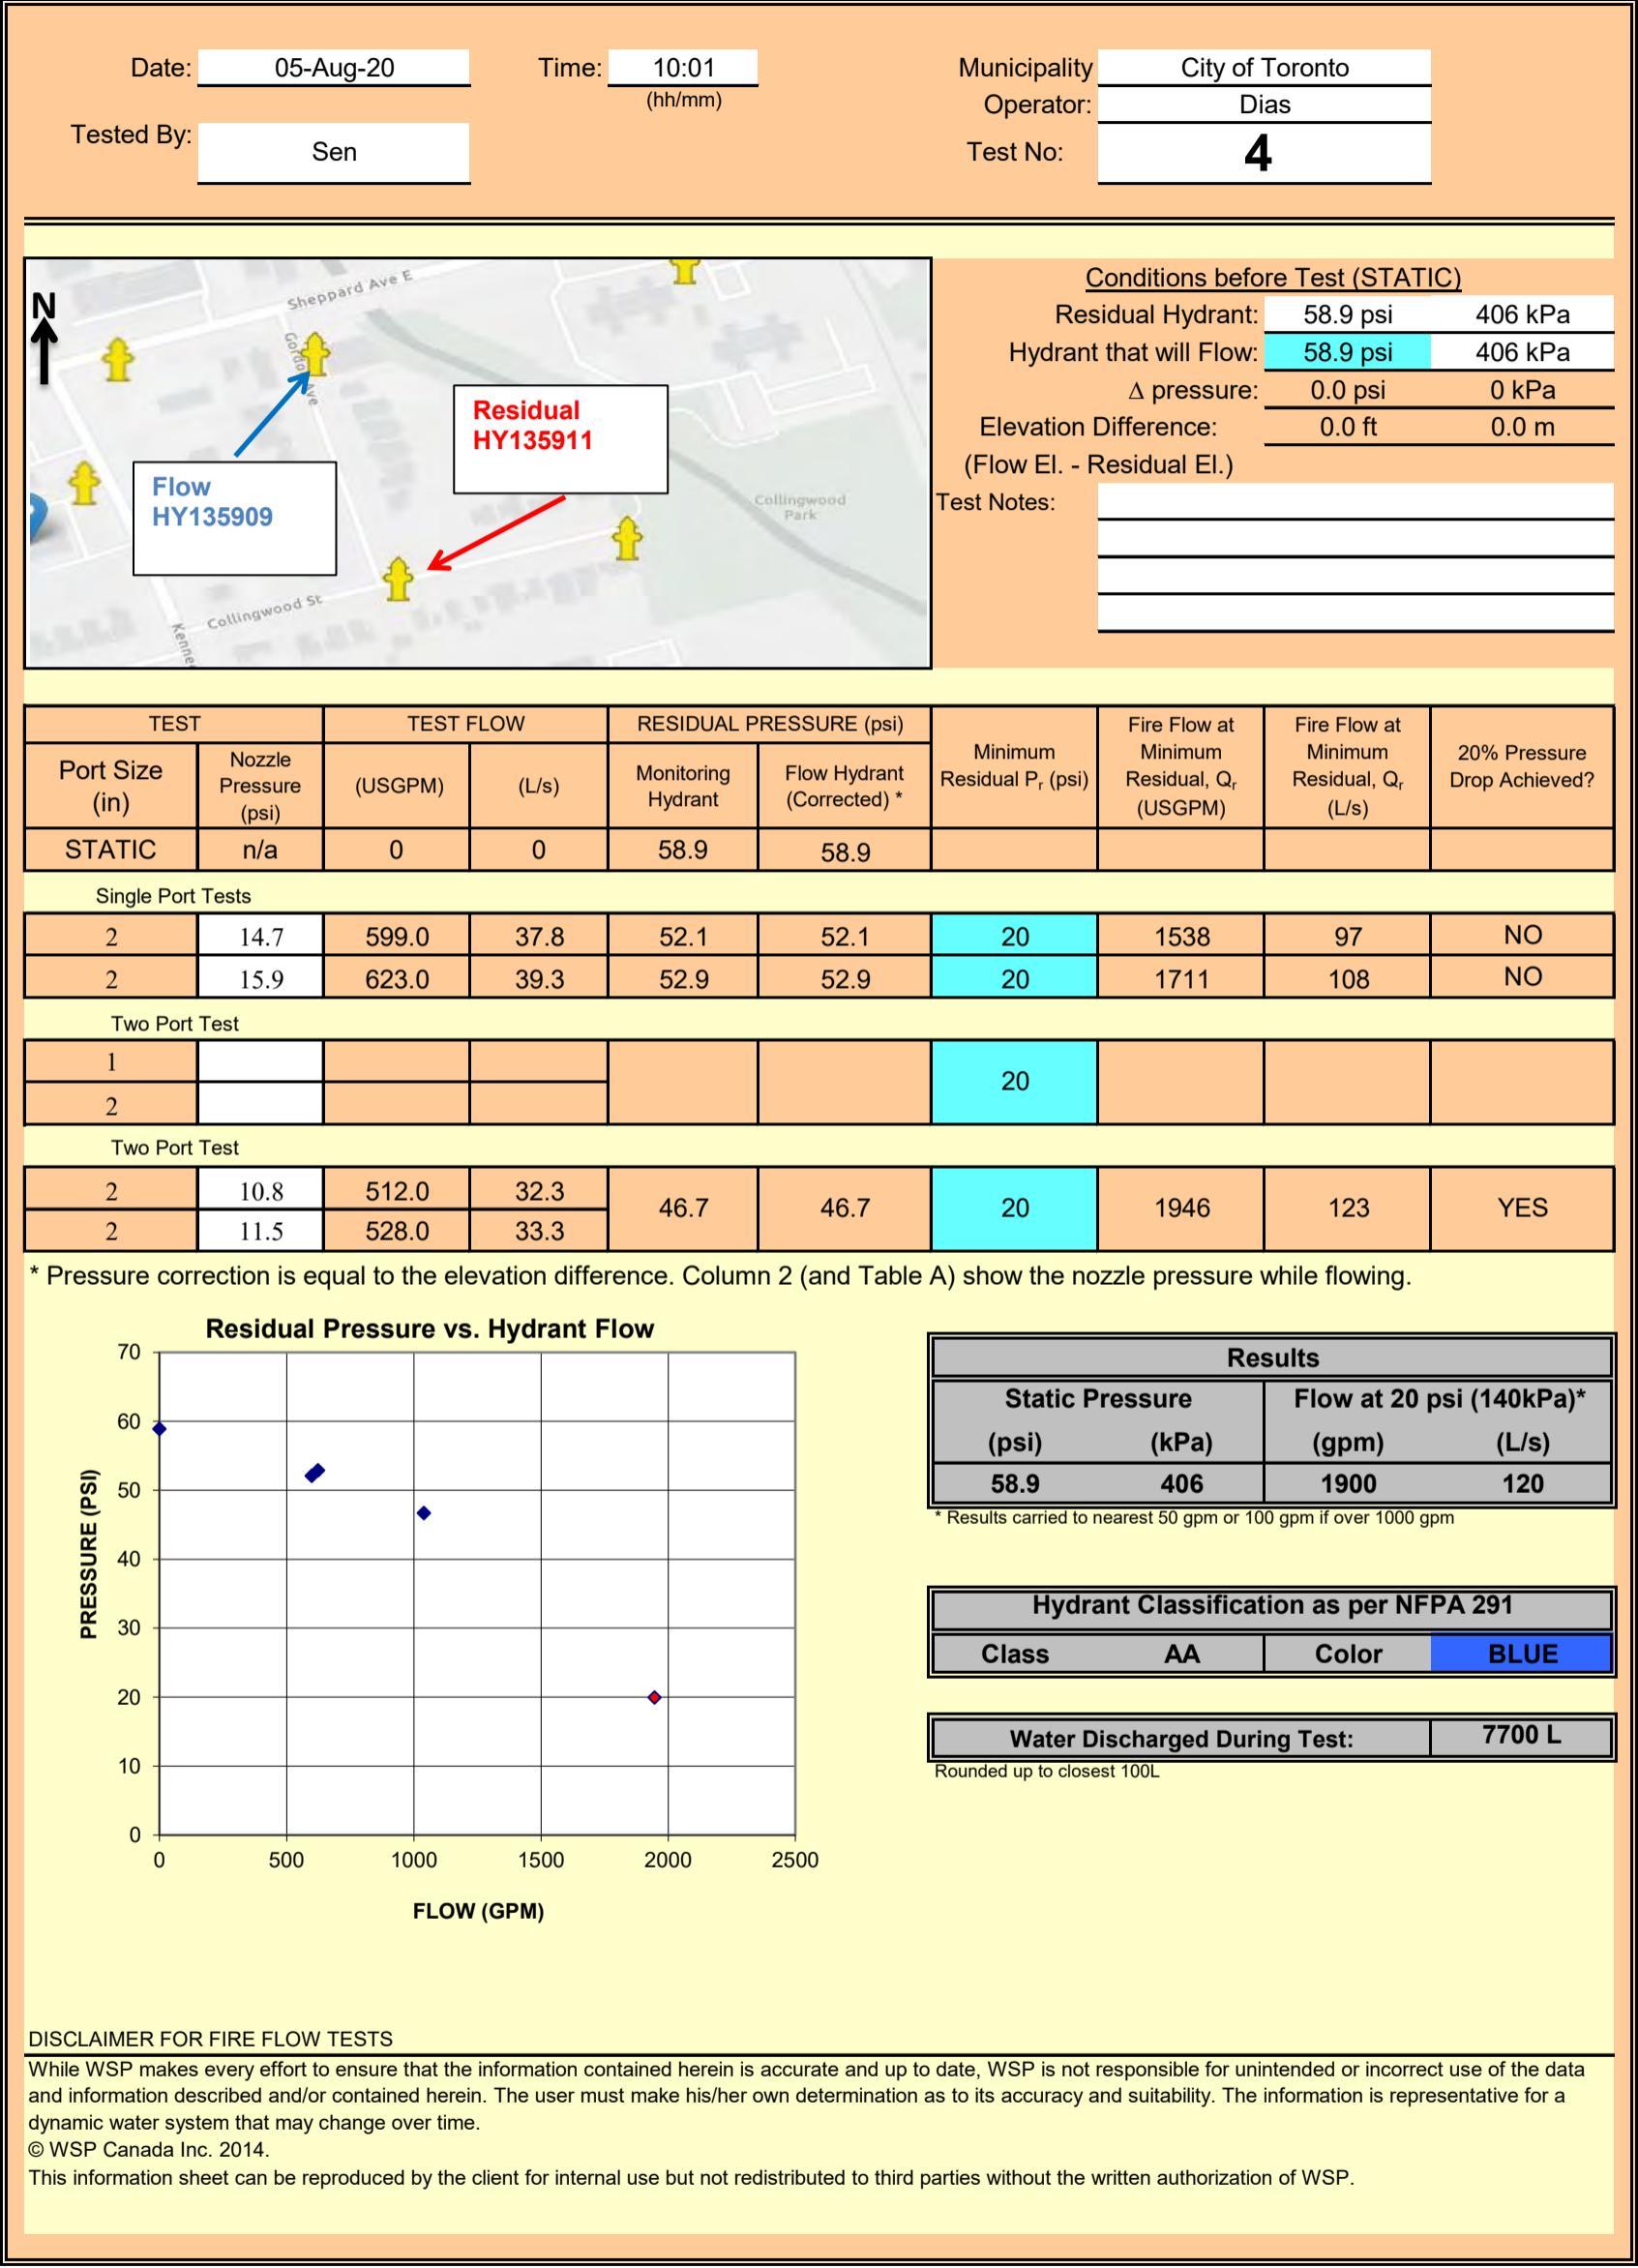
HYDRANT FLOW TEST RESULTS

Test 4 - 1 GORDON AVE (HY135911)

### 1 GORDON AVE (HY135911)

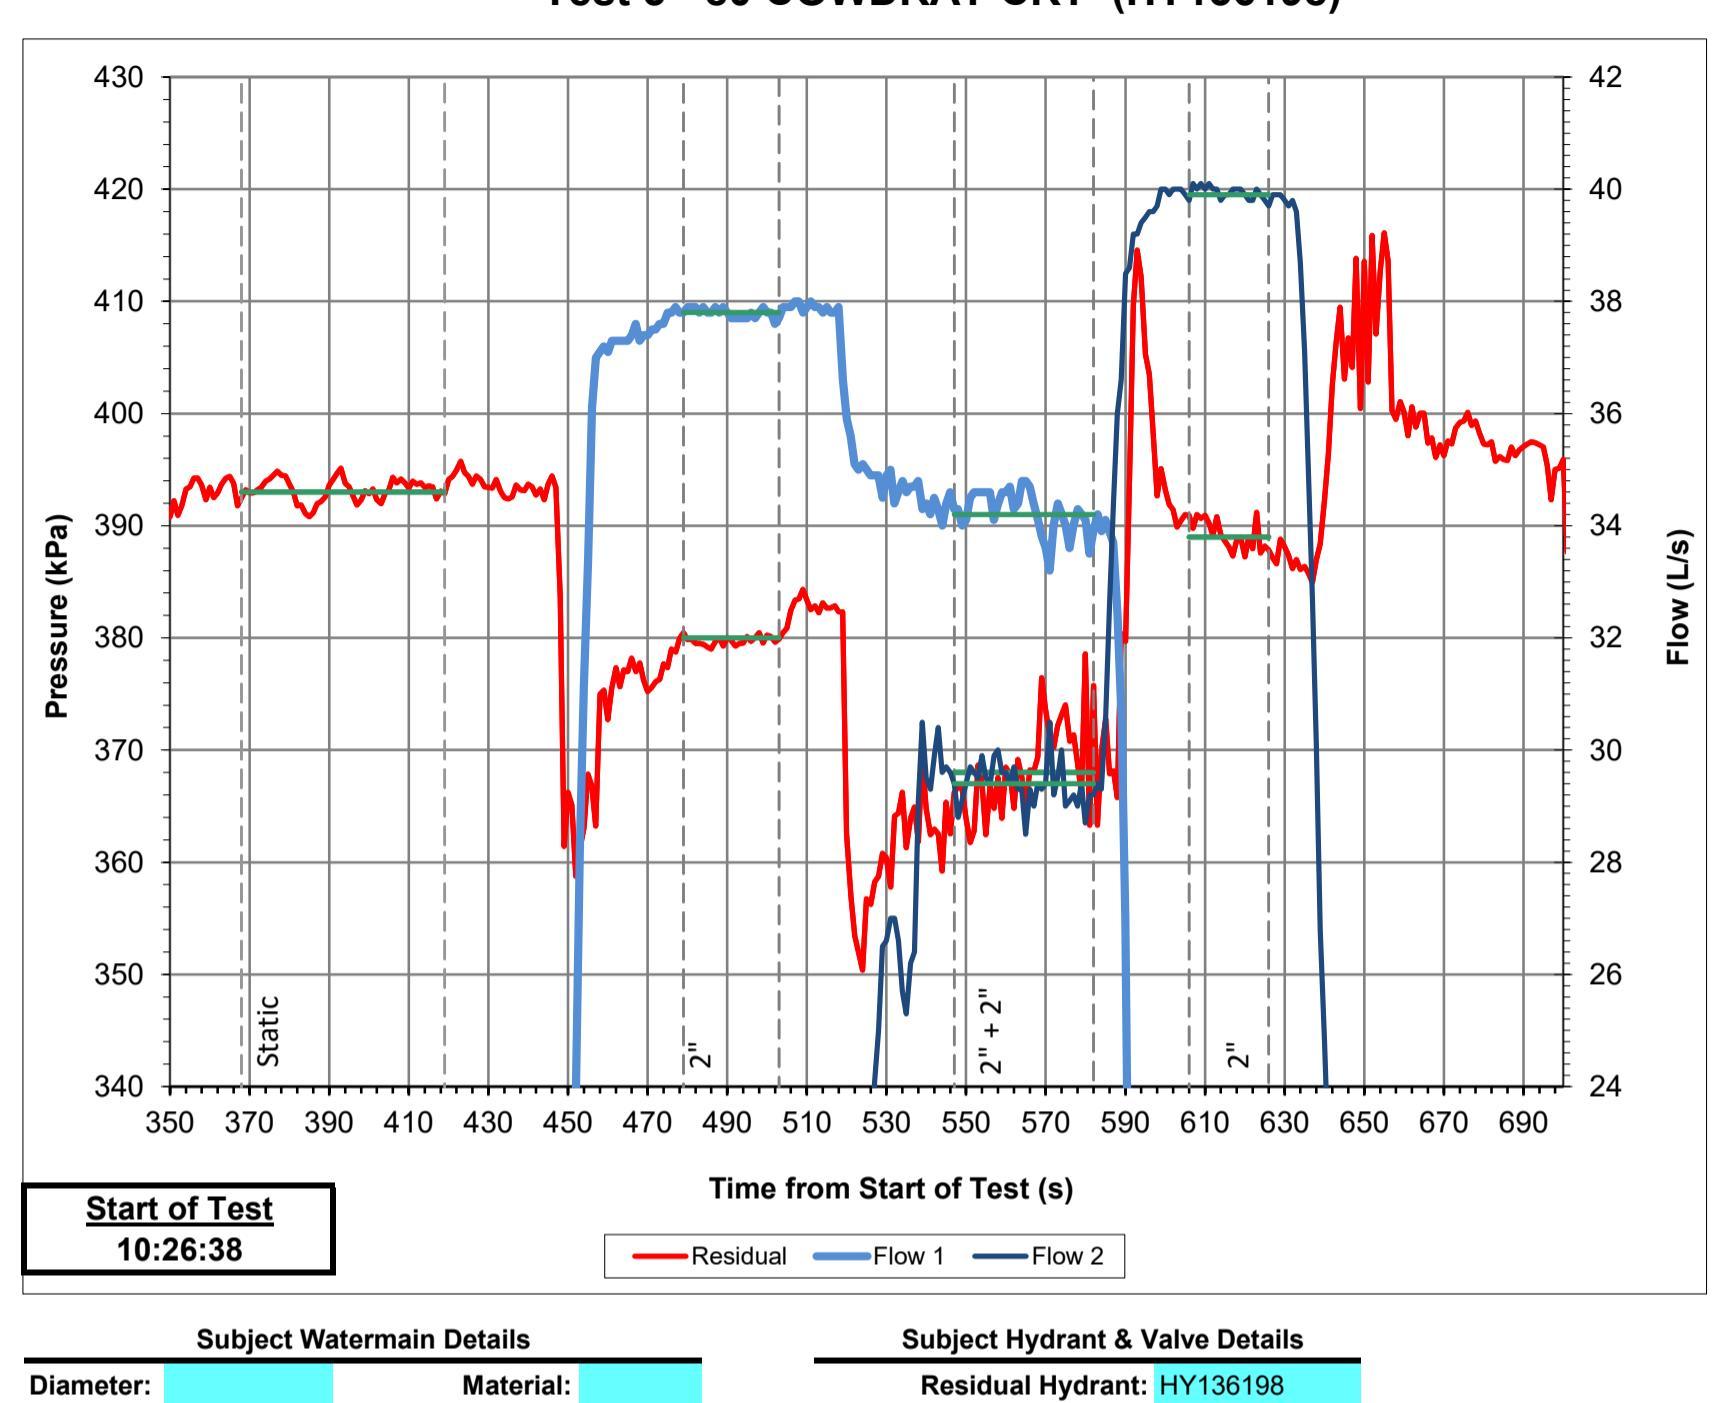
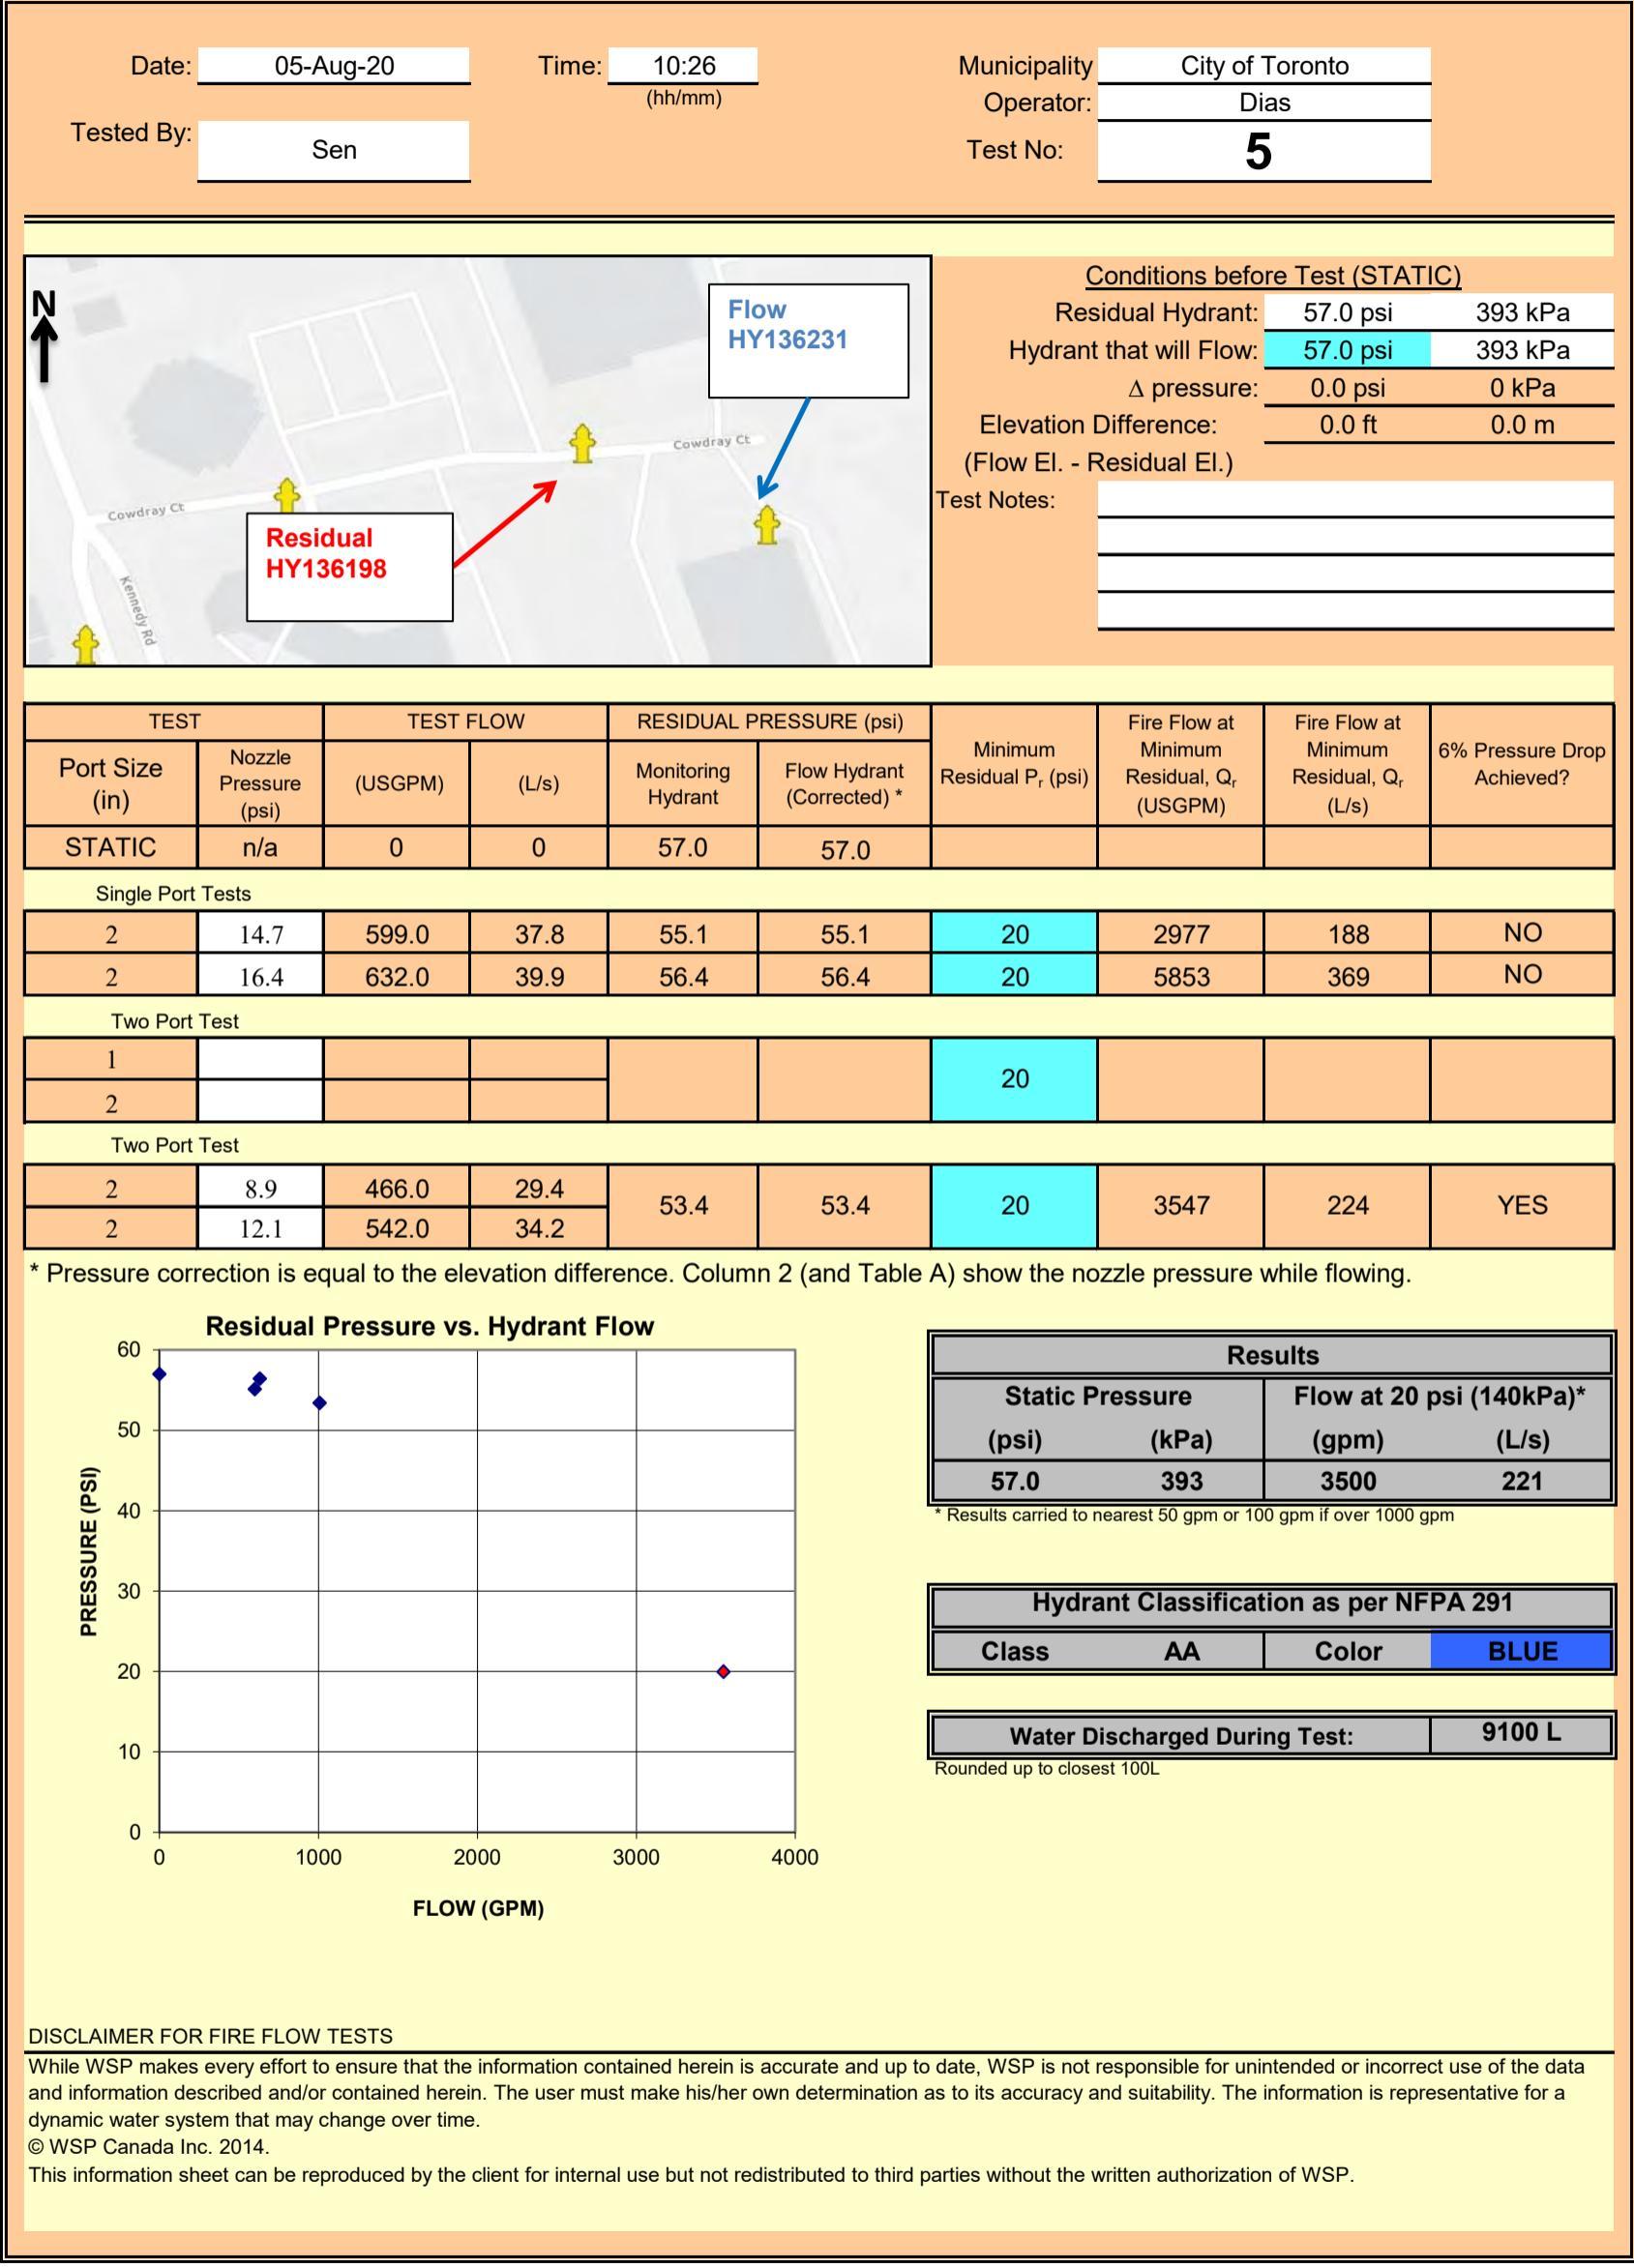
HYDRANT FLOW TEST RESULTS

Test 5 - 80 COWDRAY CRT (HY136198)

#### 80 COWDRAY CRT (HY136198)
