# **CITY OF TORONTO**

# Hydraulic Report

Rouge Park Bridges Transportation Master Plan

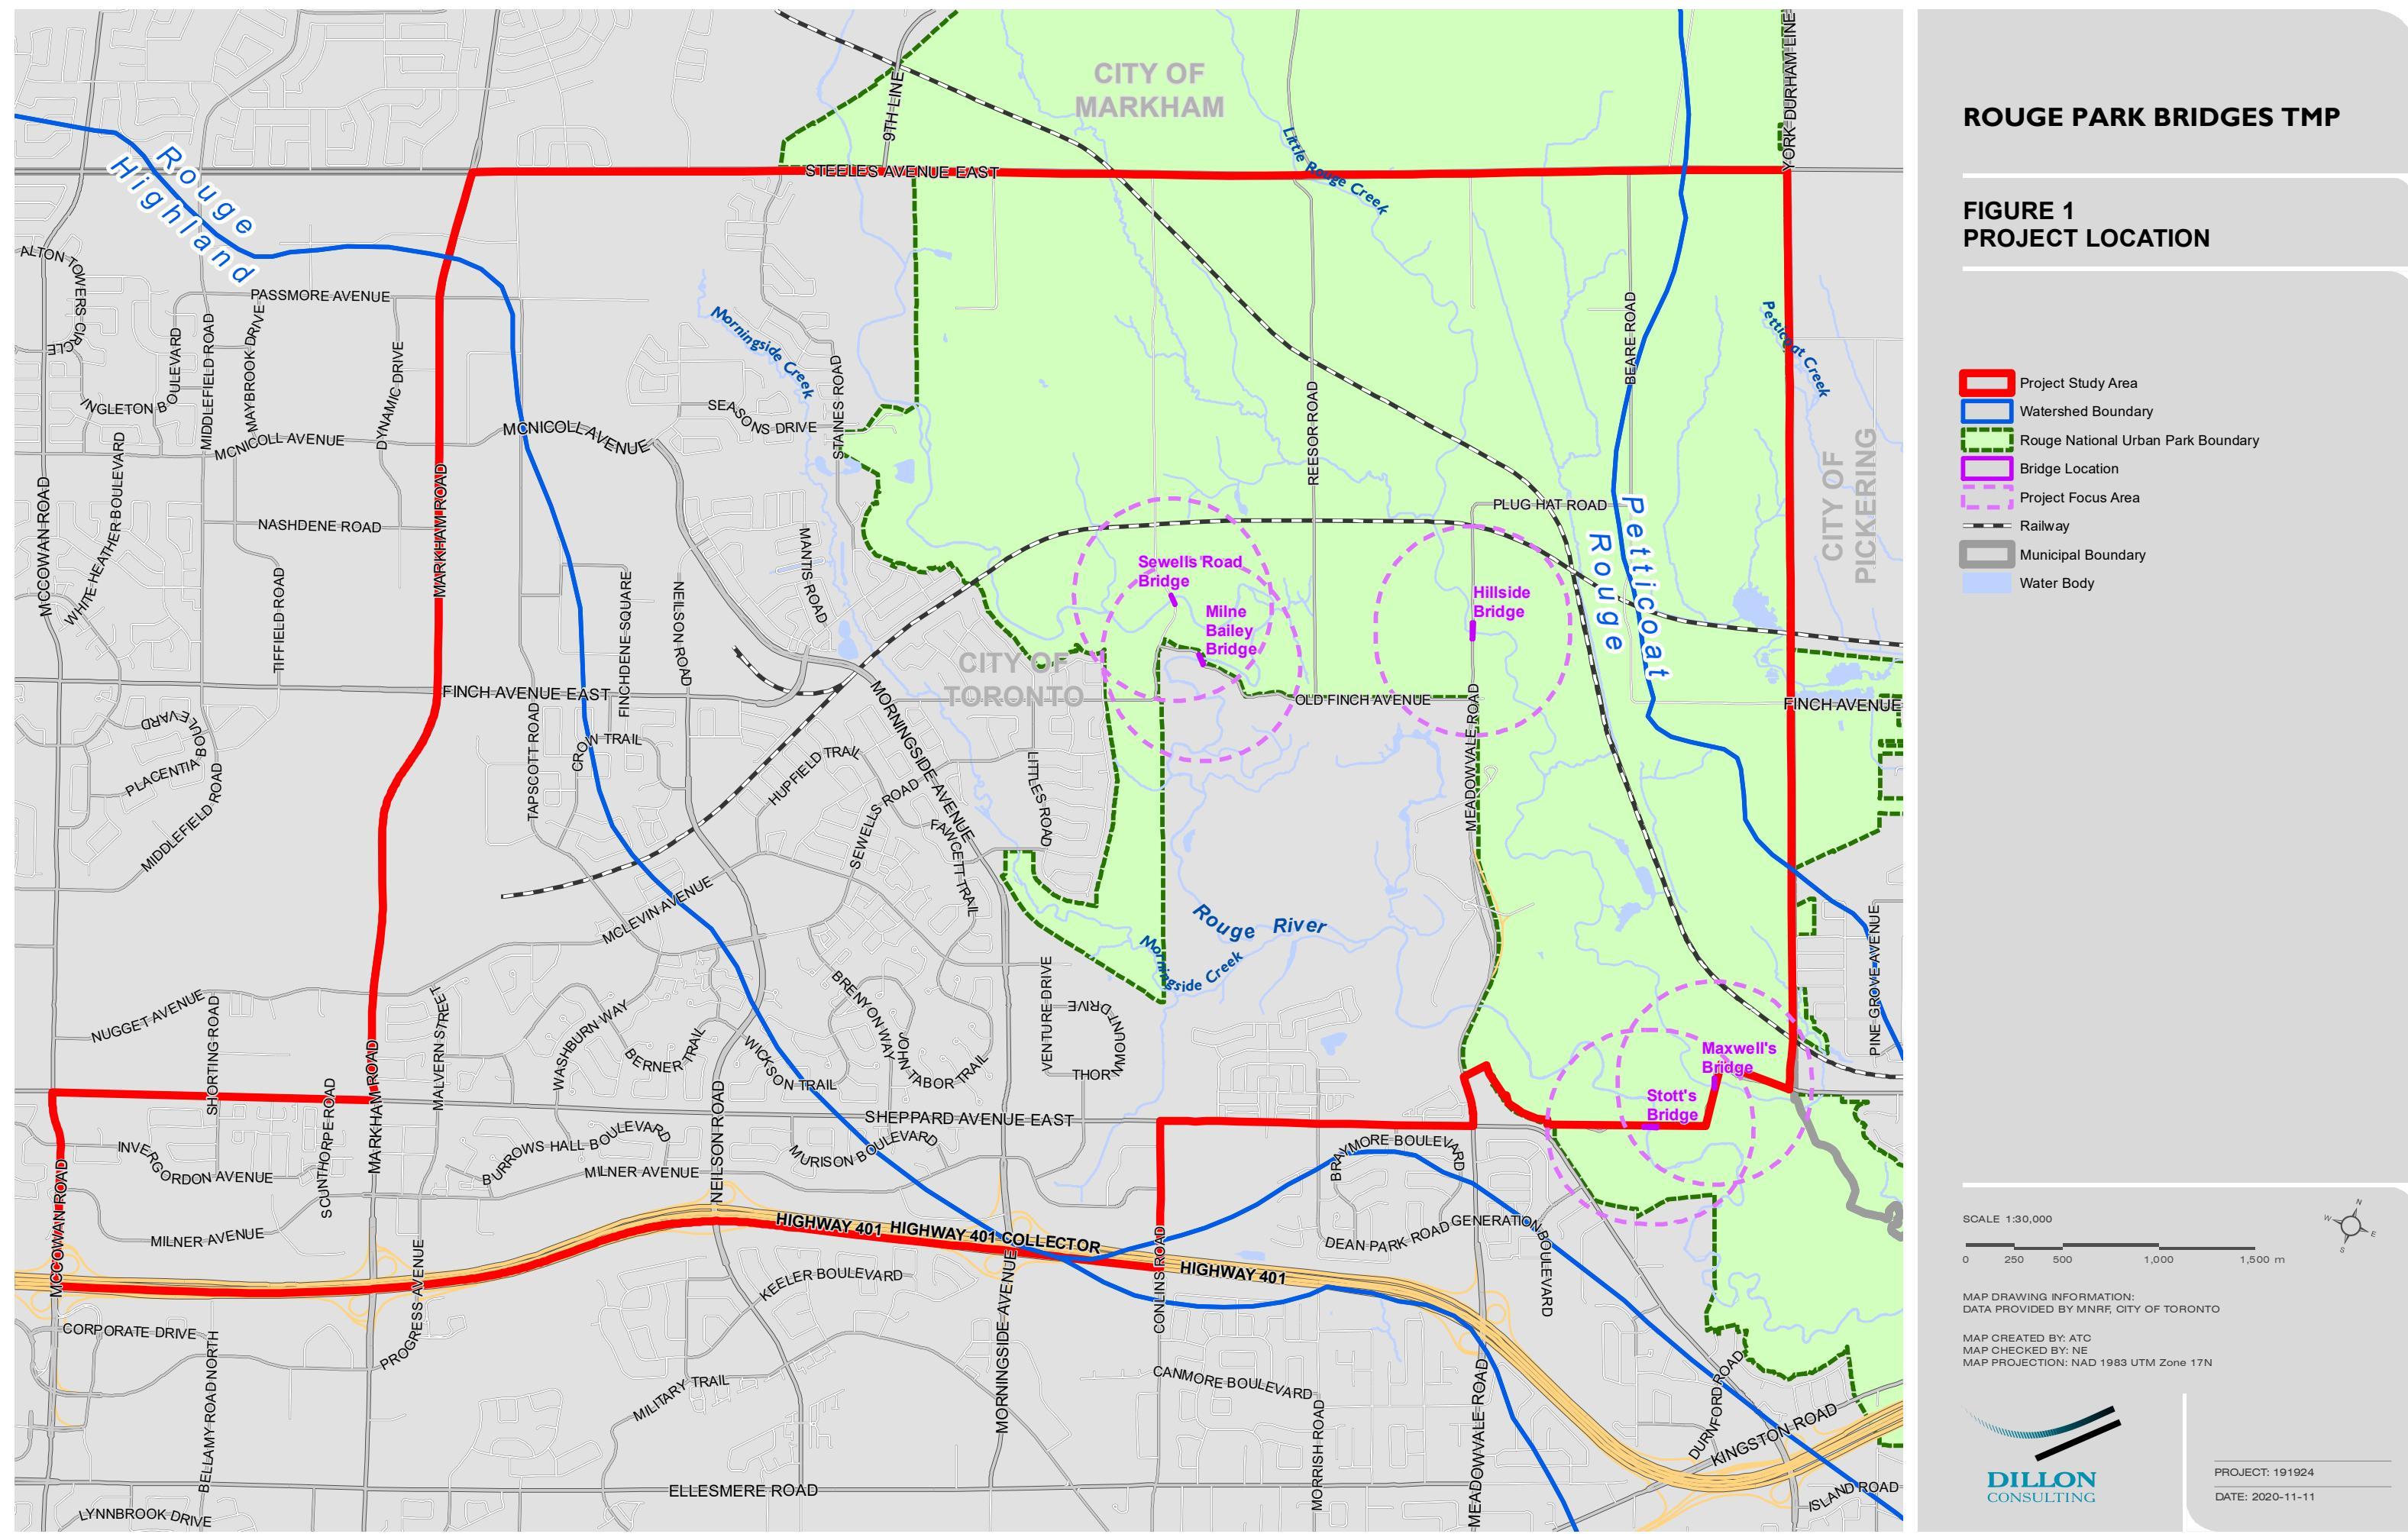
The five watercourse crossings within the study area are located in the Rouge River Watershed. TRCA divides the Rouge River watershed into five subwatersheds – Little Rouge, Middle Tributaries, Upper Rouge/Beaver Creek, Morningside Creek, and Lower Rouge. Sewell's Road Bridge, Milne's Bridge and Stott's Bridge are located in the Lower Rouge River subwatershed, while Hillside Bridge and Maxwell's Bridge are located in the Little Rouge River sub-watershed. The locations of the five crossing are presented on **Figure 1**.

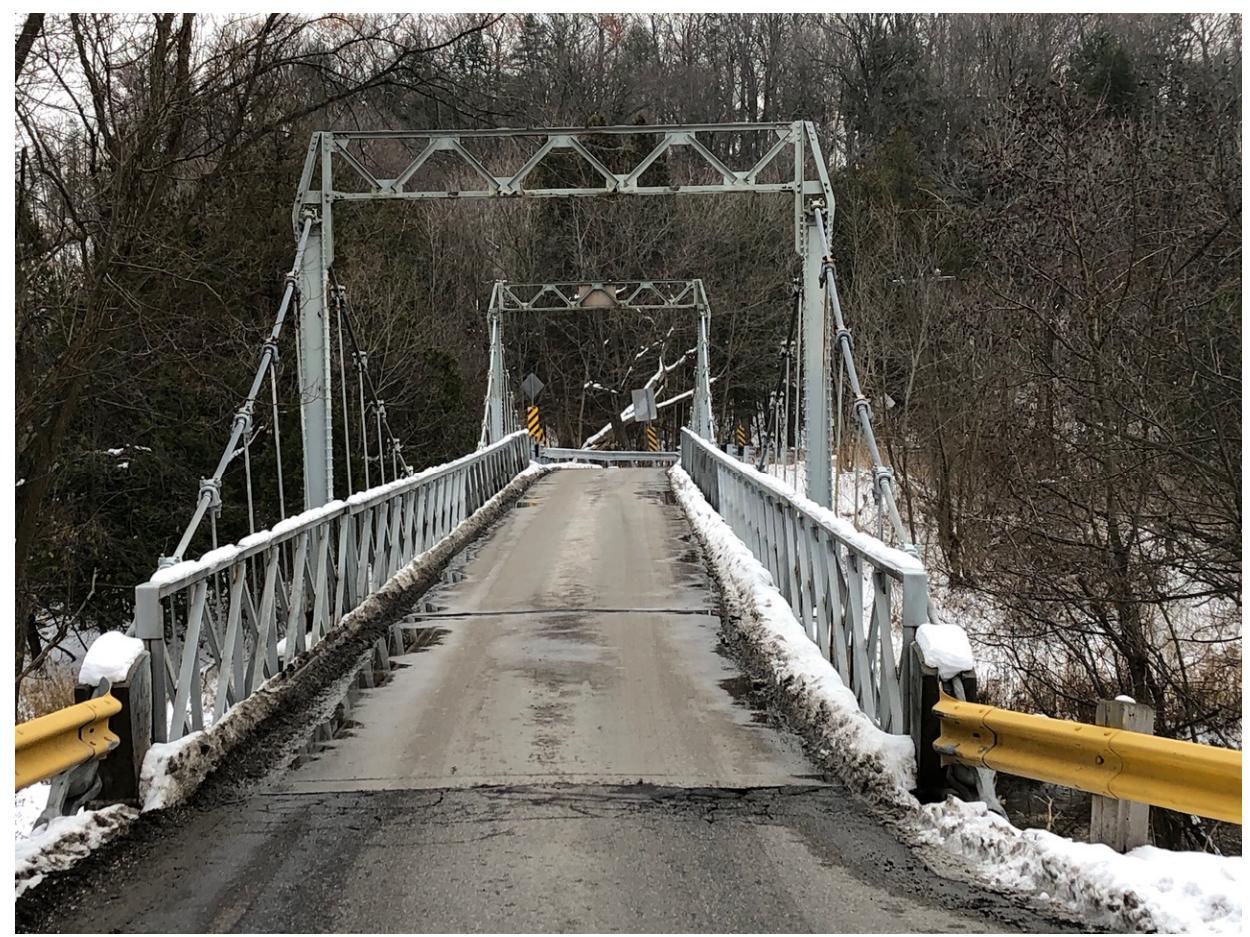
Figure 2 - Sewell's Road Bridge (November, 2019)

The Sewell's Road Bridge is located on Sewell's Road between Steele's Avenue East and Old Finch Avenue and spans the Rouge River. The Sewell's Road Bridge, constructed in 1912, is a three span "stiffened" suspension bridge with pinned tower bases and an exposed concrete deck that carries one lane of Sewell's Road over the Rouge River (Associates Engineering, 2013a). The existing structure is shown on Error! Reference source not found..

The 2020 Natural Heritage Existing Conditions Memo notes that the bankfull width of the Rouge River at the crossing is approximately 25 m, with a bankfull depth of approximately 3 m. In addition, the

information presented in the inspection report suggest that sediment deposition is occurring on the southern bank, while the northern bank downstream of the bridge was observed to be heavily eroded.

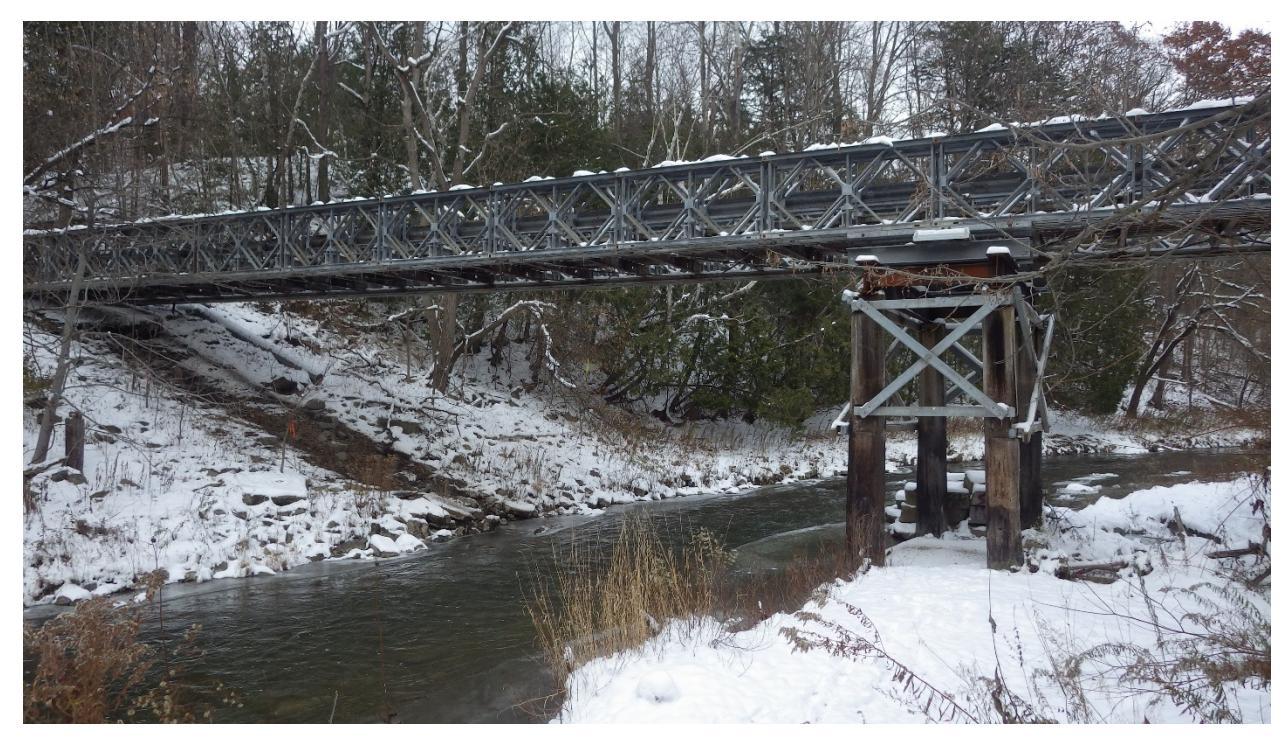
Figure 3 – Milne's Bridge (November, 2019)

Milne's Bridge is located on Old Finch Avenue between Sewell's Road and Reesor Road, over the Rouge River. Milne's Bridge, constructed in 1988, is a two span Bailey truss bridge with re-enforced concrete abutments and a timber bent pier supported by timber piles. The steel grated deck carries one narrow lane of traffic from Old Finch Avenue Drive over the Rouge River, the one lane is controlled by traffic lights on either end of the crossing (Associates Engineering, 2013b). The existing structure is shown on **Figure 3**.

The 2020 Natural Heritage Existing Conditions Memo notes that the bankfull width of the Rouge River at the crossing is approximately 15 m, with a bankfull depth of approximately 2 m. In addition, both banks appeared to be protected from erosion.

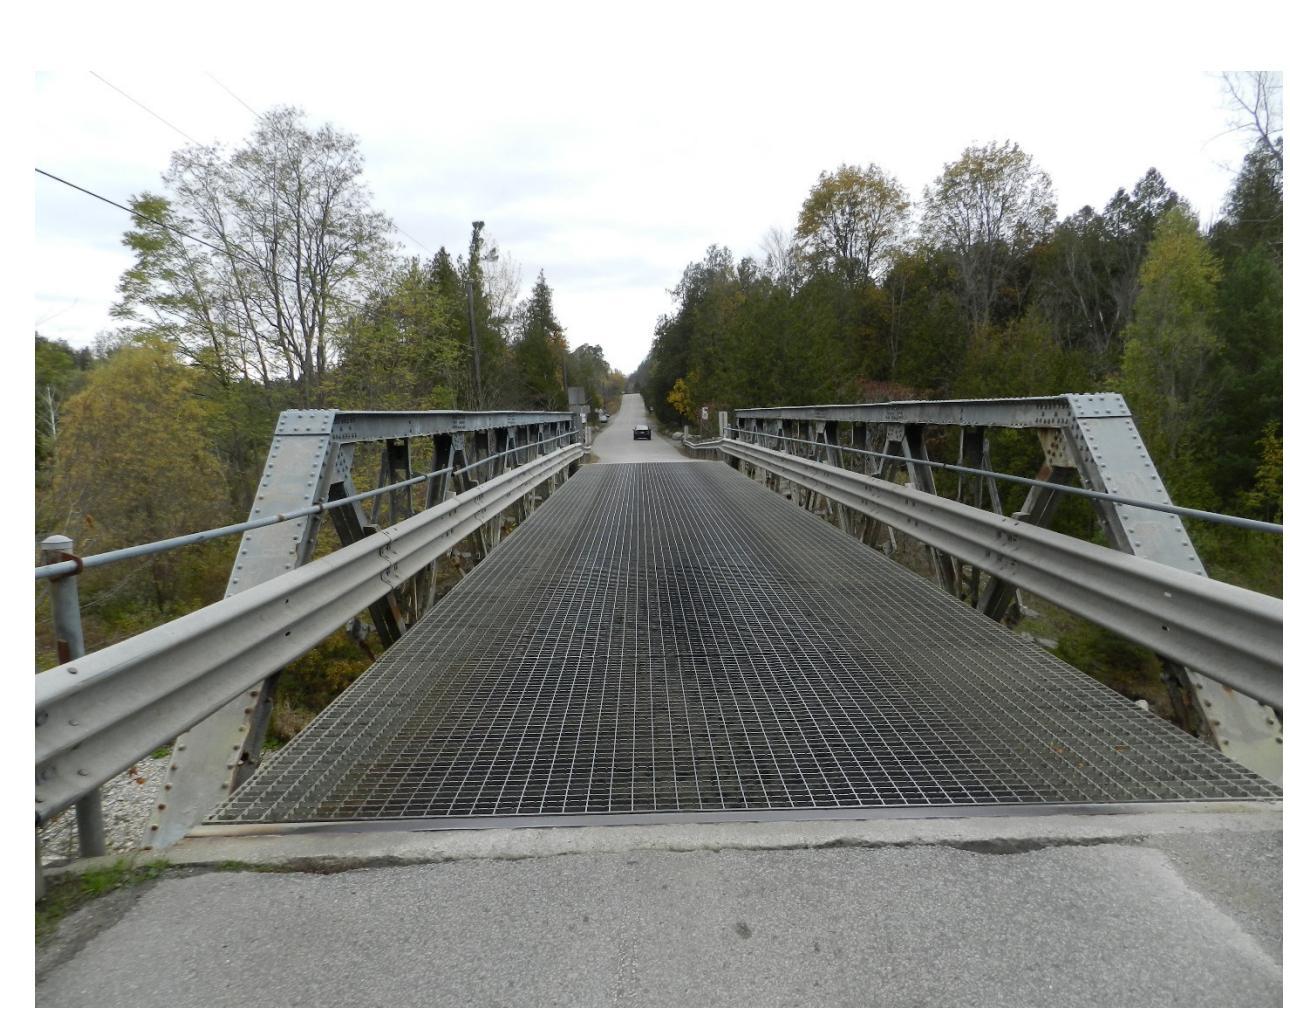
Figure 4 – Hillside Bridge (October, 2020)

The Hillside Bridge is located on Meadowvale Road Drive between Plug Hat Road and Old Finch Ave, over the Little Rouge River. The Hillside Bridge, constructed between 1905 and 1932 and rehabilitated in 1985, is a single span steel-beam pony truss bridge with a steel grated deck that carries one lane of traffic over the Little Rouge River (MMM Group, 2017). The existing structure is shown on **Figure 4**.

The 2020 Natural Heritage Existing Conditions Memo notes that the bankfull width of the Rouge River at the crossing is approximately 30 m, with a bankfull depth of approximately 5 m. In addition, erosion of both banks was observed both upstream and downstream of the existing structure.

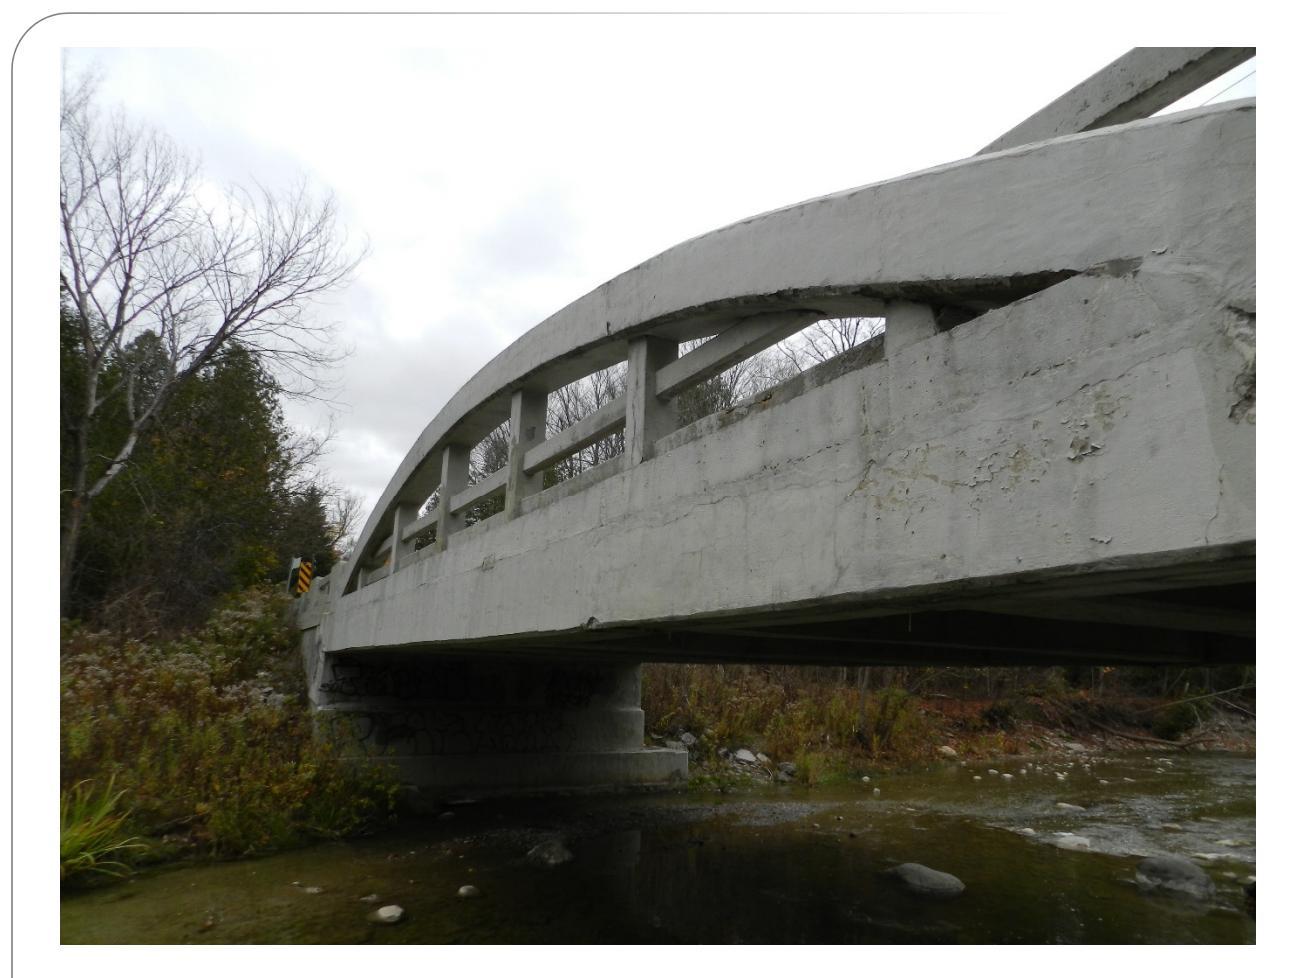
#### Figure 5 - Maxwell's Bridge (October, 2020)

Maxwell's Bridge is located on Twyn Rivers Drive northeast of Shepperd Avenue East, over the Little Rouge River. The Maxwell's Bridge, constructed in 1927, and is a single span concrete bowstring through arch bridge with a concrete deck carrying two narrow lanes of Twyn Rivers Drive over the Little Rouge River (Associates Engineering, 2013c). The existing structure is shown on **Figure 5**.

The 2020 Natural Heritage Existing Conditions Memo notes that the bankfull width of the Little Rouge River at the crossing is approximately 15 m, with a bankfull depth of approximately 1.5 m. In addition, undercutting of the south bank was observed, while sediment deposition was observed on the north bank.

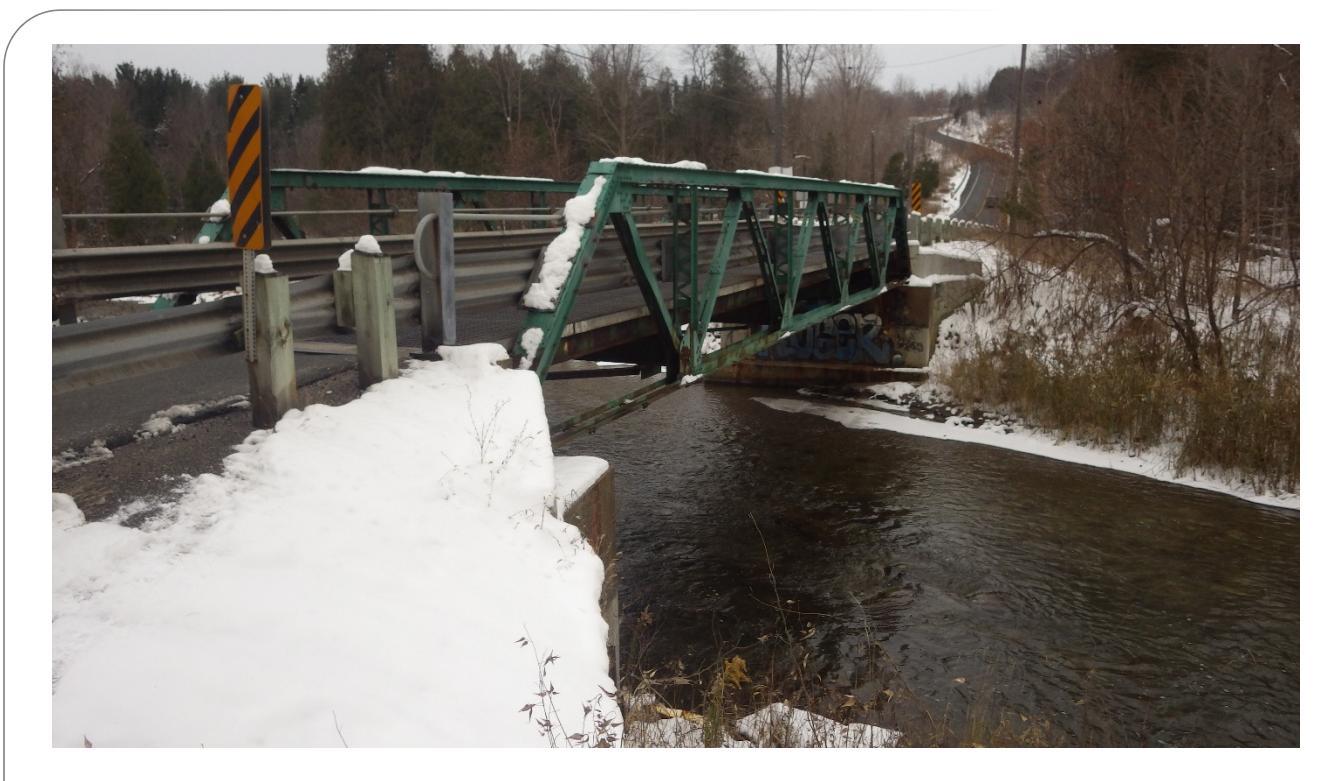
#### Figure 6 - Stott's Bridge (November, 2019)

Stott's Bridge is on Twyn Rivers Drive north-east of Sheppard Avenue East, over the Rouge River. The Stott's Bridge, constructed in 1997, is a single span steel Warren pony truss bridge with a steel grated deck that carries one lane of traffic over the Rouge River (Associates Engineering, 2013d). The existing structure is shown on **Figure 6**.

The 2020 Natural Heritage Existing Conditions Memo notes that the bankfull width of the Rouge River at the crossing is approximately 20 m, with a bankfull depth of approximately 2 m. The banks underneath the existing structure are armoured, however upstream of the crossing the eastern bank is heavily eroded with a steep exposed sandy sections.
