334 Dundas Street West: Richard Chadd House

Description:

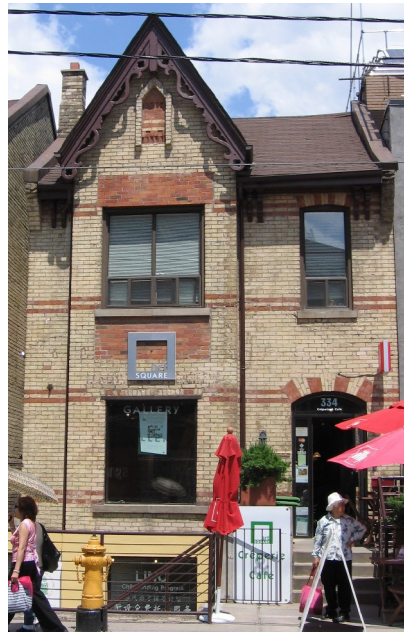
The heritage attributes of the Richard Chadd House related to its cultural heritage value as representative examples of Gothic Revival styling with a high degree of craftsmanship are found on the principal (south) façade and the south slope of the roof above this wall, consisting of:

- The 2½ storey plan above a raised base (the window opening in the base has been altered)
- The gable roof with a cross-gable on the south slope, which displays carved wood bargeboard, and the extended eaves with paired wood brackets

- The application of buff brick with buff and contrasting red brick, stone and wood detailing
- The organization of the principal (south) façade into two bays with brick firebreaks and brackets on the outer corners and red brick string courses; the main entrance, which is elevated in the right (east) bay and placed in a segmental-arched opening with brick voussoirs (the original doors and transom have been replaced); in the second storey above the entry, the segmental-arched window opening with brick voussoirs and a stone sill; the treatment of the left (west) bay as a frontispiece beneath the cross-gable; in the west bay, the large flat-headed window openings (which have been altered); and, beneath the cross-gable, the pointed-arched window opening with a brick surround
