## Glenn Shimoda - 839 Brimorton Dr at Hiscock Bl - Sight Line Complaint

**From:** Ken Scott  
**To:** Taylor, Bob  
**Date:** 12/04/2007 12:56 PM  
**Subject:** 839 Brimorton Dr at Hiscock Bl - Sight Line Complaint  
**CC:** Bozzo, Frank; Burrows, Al; Gurley, Jessica; Oinonen, Marko ; Overchuk, Andrew W.; Shimoda, Glenn

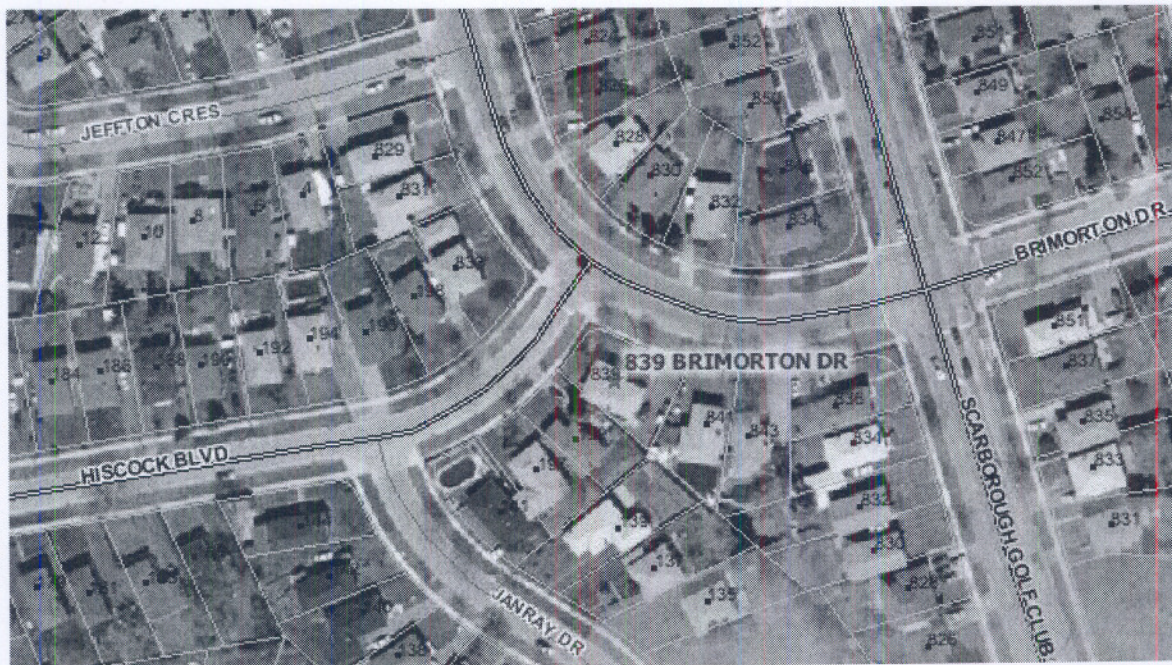
Please note that as per my August 3, 2007 e-mail, it has been determined that the encroachment in the public boulevard of the approximate 6 foot high wood fence ***does not obstruct*** the sightlines at the intersection of Hiscock Boulevard and Brimorton Drive. Our operational review indicates that a driver looking right while stopped at the stop bar for eastbound traffic on Hiscock Boulevard at Brimorton Drive can clearly see past the fence and see the Brimorton Drive roadway all the way to the traffic signals at Scarborough Golf Club Road (see attached photo).

I checked 839 Brimorton Dr at Hiscock Blvd (SE corner) regarding Jessica Gurley's sight line complaint and have determined there is no sight line problem at the above location. The new 6 foot high fence appears to be at or close to the property I sight lines are fine. From the stop bar on Hiscock Blvd I can easily see the traffic signals to the east at the intersection of Scarborough Golf & Brimorton (See attached photos).

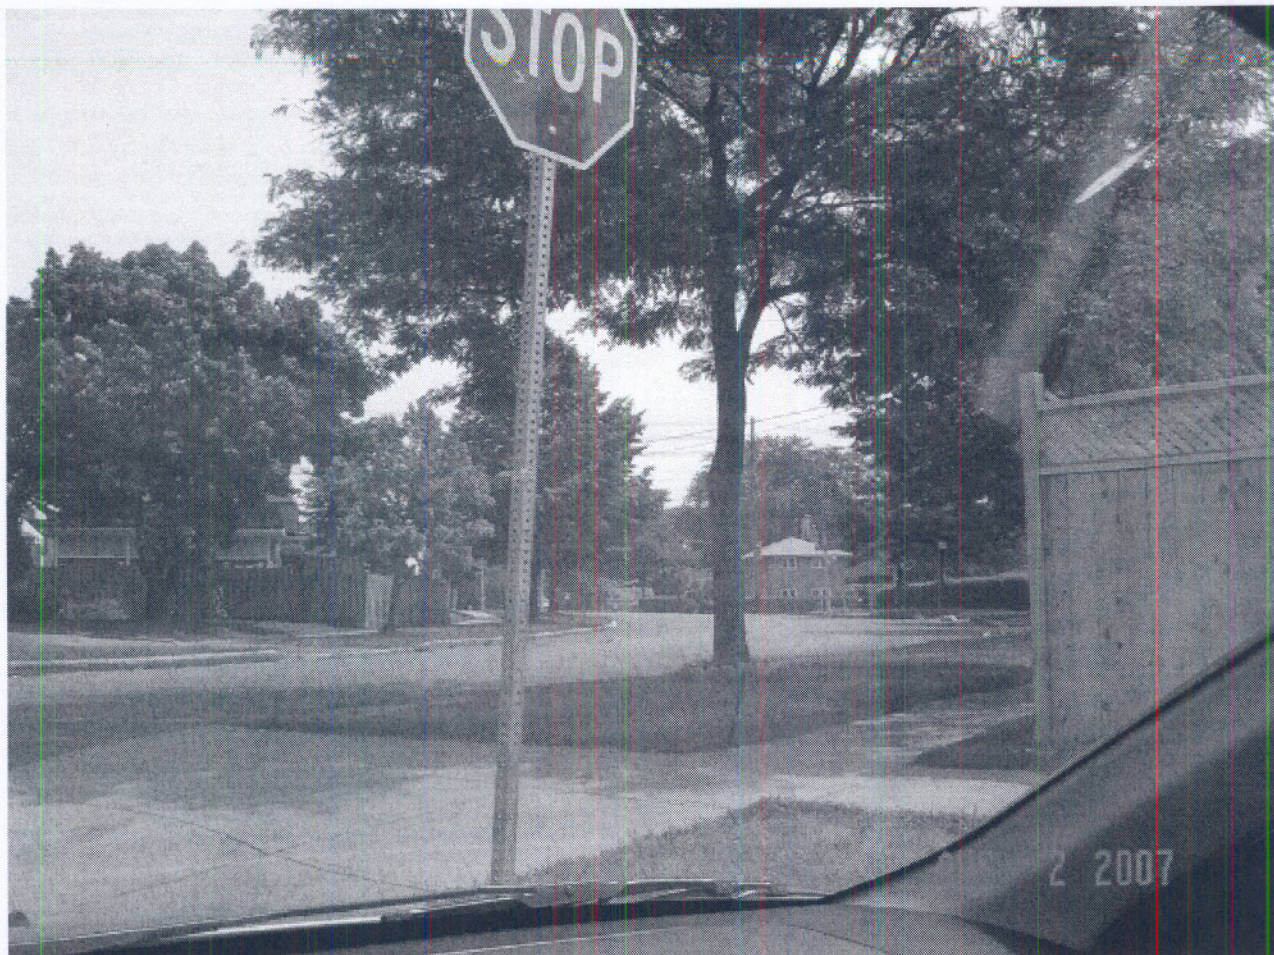
HISCOCK BL EB AT BRIMORTON DR AT #839\_LOOKING RIGHT AT CURB

The fence does partially obstruct the sight line of the sidewalk along Brimorton Drive but pedestrians have plenty of time to see a vehicle approaching the stop sign. However, a fence height of 1.0 metres for the boulevard encroachment would allow pedestrians on the sidewalks to see each other.
