STAFF REPORT ACTION REQUIRED

Application for Fence Exemption 145 Judson Street

Date:	October 30, 2013
То:	Etobicoke York Community Council
From:	Eletta Purdy, District Manager, Municipal Licensing and Standards
Wards:	Ward 6, Etobicoke - Lakeshore
Reference Number:	Municipal Licensing and Standards Folder 13-219798 and 13-228786

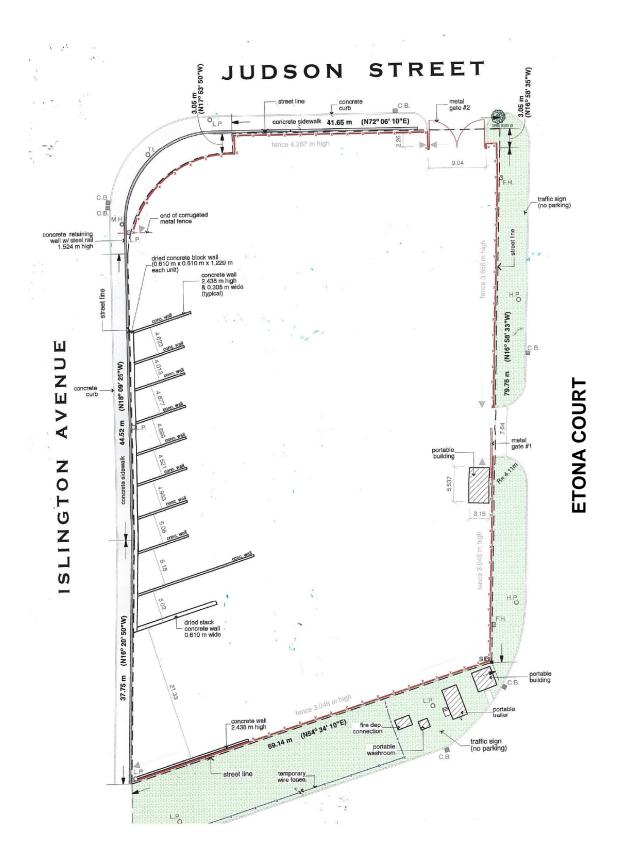
Attachment 2: Site Plan

Inspection conducted by a Municipal Standards Officer revealed that the fence in question is a corrugated metal fence erected along the perimeter of the property fronting Judson Street, flanking Etona Court to the east and backing on a private street that leads to the GO Transit depot at 171 Judson Street (Attachment 2). The fence varies in height from 3.05 metres (10 feet) at the rear as well as the southern portion of Etona Court flankage, 3.66 metres (12 feet) on the northern portion, and 4.27 metres (14 feet) at the Judson Street frontage (Attachments 3 and 4). A Notice of Violation was issued.

- 1. The side-hung metal gate on Judson Street frontage (Attachment 2) is to be reinstalled to avoid encroaching on City road allowance when it opens; and
- 2. When the fence is replaced it should be constructed in compliance with City of Toronto Municipal Code, Chapter 447 Fences, or its successor by-law.

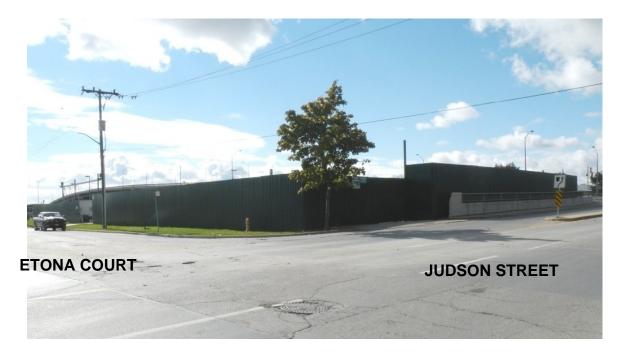
Attachment 3: Photographs of Fence (View from Judson Street and Etona Court)

Corrugated metal in not permitted to be used in any fence under section 447-2A(3) of the City of Toronto Municipal Code, Chapter 447, Fences.

Chapter 447, Fences. The fence is in excess of the permitted height by 0.55 metres (1 foot 10 inches) at the lowest point and 1.77 metres (5 feet 10 inches) at the highest point.

View from Judson Street frontage and Etona Court flankage

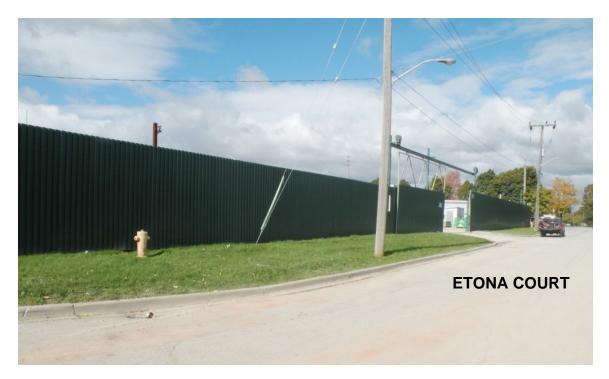
View from Etona Court flankage

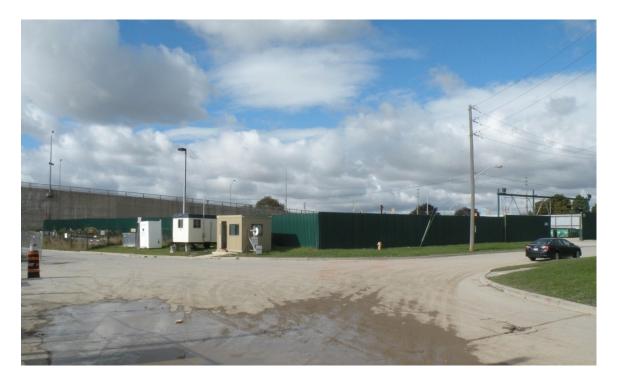
Attachment 4: Photographs of Fence (View from private street at rear & Islington)

View from private street at rear and Etona Court flankage

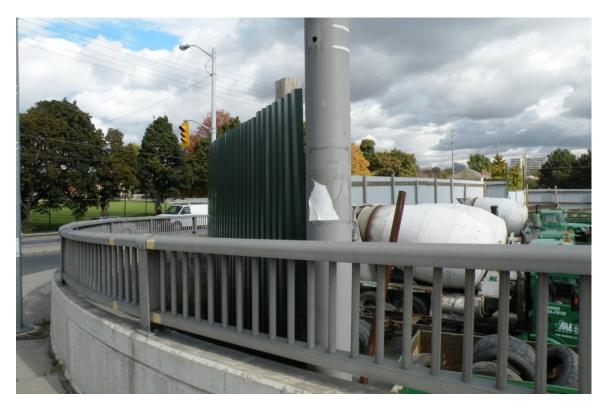
View from Islington Avenue showing the end of fence at Judson frontage

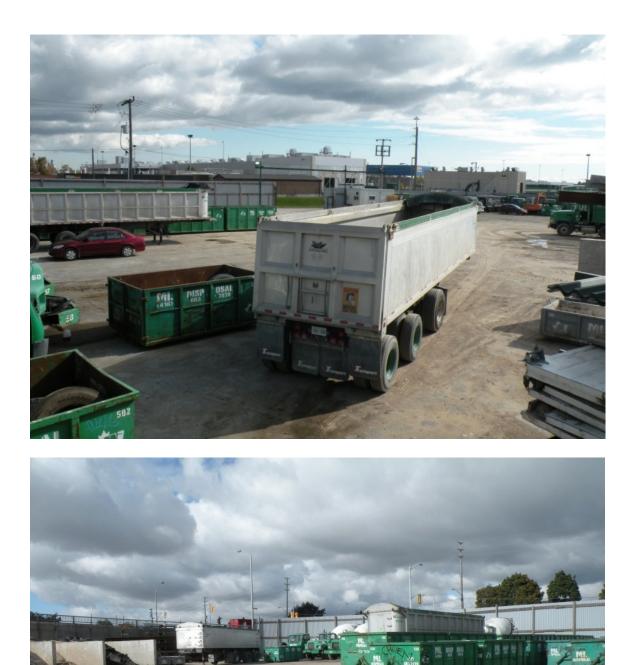
Attachment 5: Photographs showing the site condition within the fenced area

The property at 145 Judson Street is used for outside storage of raw materials. This matter is currently subject to a Zoning Notice of Violation as the use is not permitted under the Zoning By-laws. There is no permanent building on site. Corrugated metal fence is a prohibited fence under the City of Toronto Municipal Code, Chapter 447, Fences. Additionally, the fence is in excess of the permitted height of 2.5 metres (8 feet 2 inches) for fences on non-residential properties under the regulations. As a result, a Notice of Violation was issued to the property owner.

The applicant indicates the fence is for privacy, safety and aesthetics. The fence may provide some barrier to contain dust and noise, as well as act as a visual screen to hide the operations from the immediate neighbourhood (Attachment 5).
