HERITAGE PROPERTY RESEARCH AND EVALUATION REPORT

WILLIAM SEXTON HOUSES

54A, 56 AND 58 SCOLLARD STREET AND 1315 BAY STREET, TORONTO

May 2016

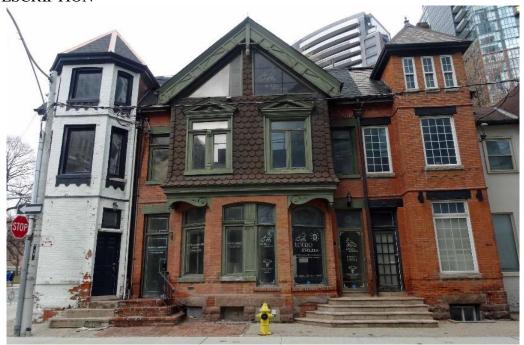
Above: showing, from right to left, the row houses at 54A, 56 and 58 Scollard, with the westernmost portion (left) identified as 1315 Bay Street; cover: the William Sexton Houses on the northeast corner of Bay and Scollard streets (Heritage Preservation Services, April 2016)

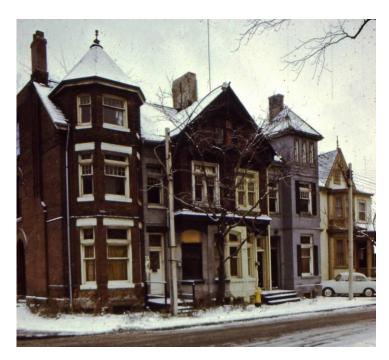
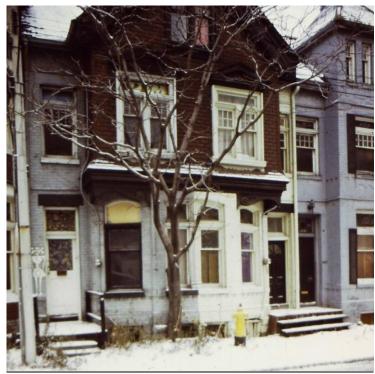
13. <u>Archival Photographs</u>, 54A, 56 and 58 Scollard Street and 1315 Bay Street, 1974: showing the subject properties on the northeast corner of Bay Street (above) and the centre units at 56 and 58 Scollard (below) (Toronto Historical Board).

On the principal (south) elevation, the east and west corners are marked by three-storey towers, with a square tower with a four-sided pyramidal roof on the east end and a multisided tower with an octagonal roof marking the west end adjoining Bay Street. Between the towers, the south elevation is highlighted by a wide three-sided bay window that is surmounted by a projecting jetty with shingled cladding and wood brackets. Above the jetty, an oversized gable displays wood bargeboard and a king post. The entrances to the two easternmost row houses (54A and 56 Scollard) are placed side-by-side in the first storey between the southeast tower and the bay window. The single entrance to 58 Scollard adjoins the southwest tower. The door and window openings on the south elevation are flat-headed with transoms, with two-part windows in the first-floor bay window and the second-storey jetty, and a trio of narrow window openings marking the third storey of the southeast tower. The original two-part opening in the apex of the gable has been replaced, but is visible in the archival photographs attached as Image 13.

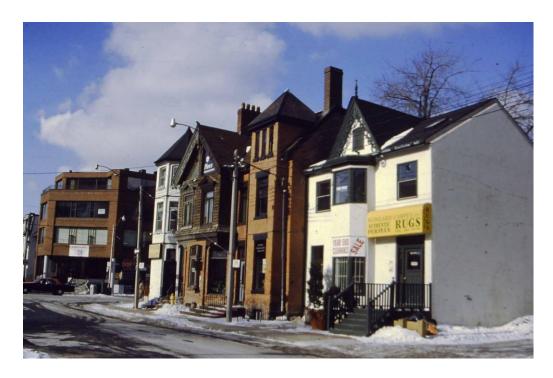
14. <u>Archival Photograph</u>, 54A, 56 and 58 Scollard Street and 1315 Bay Street, 1994: the view west along the north side of Scollard Street to Bay Street shows the subject properties in the centre of the image, with the neighbouring heritage building at 54 Scollard on the right (Toronto Historical Board).

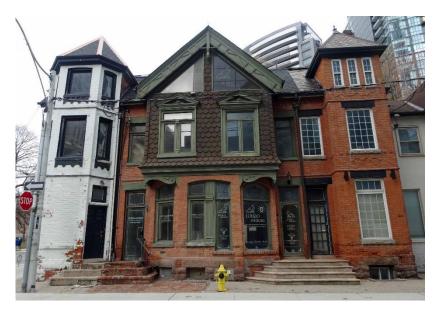
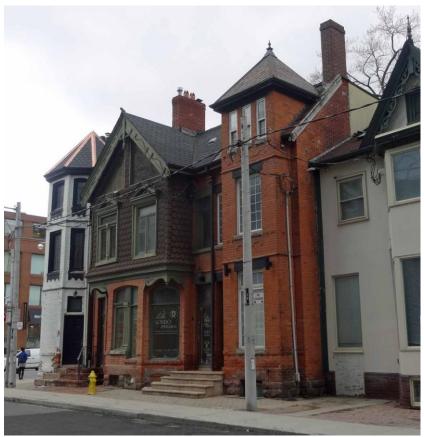
18. <u>Current Photographs</u>, 54A, 56 and 58 <u>Scollard Street and 1315 Bay Street</u>, <u>April 2016</u>: showing the principal (south) elevations of the row houses (above) and the east (side) elevation of the unit at 54A Scollard (below) (Heritage Preservation Services).

The east elevation of 54A Scollard with the firebreak wall is visible above the neighbouring house form building at 54 Scollard Street. Overlooking Bay Street, the west elevation has flat-headed and round-arched window openings, as well as the entrance to 1315 Bay in a round-arched door opening. The rear (north) elevations of the row houses and the single-storey rear north wing are not identified as heritage attributes.

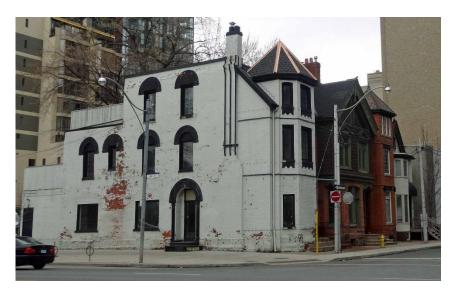
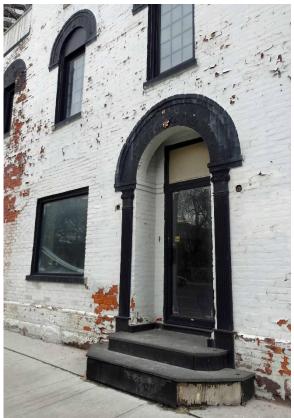
19. <u>Current Photographs</u>, 54A, 56 and 58 Scollard Street and 1315 Bay Street, April 2016: showing the west side elevation on Bay Street (above) and the west entrance to the unit at 1315 Bay Street (below) (Heritage Preservation Services).

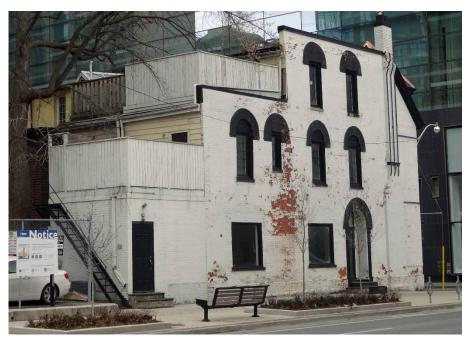
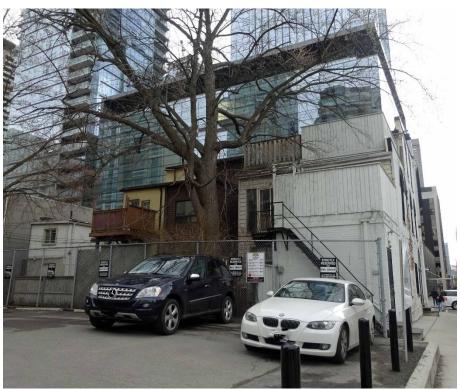
20. <u>Current Photographs</u>, 54A, 56 and 58 <u>Scollard Street and 1315 Bay Street</u>, <u>April 2016</u>: showing the rear (left) and west (right) elevations of the row houses (above) and the rear elevations and addition from Bay Street (below, right) (Heritage Preservation Services).
