# **TORONTO**

### REPORT FOR ACTION

## Traffic Control Signals Review - McLevin Avenue and Greenspire Road, McLevin Avenue and Malvern Street

**Date:** January 15, 2020

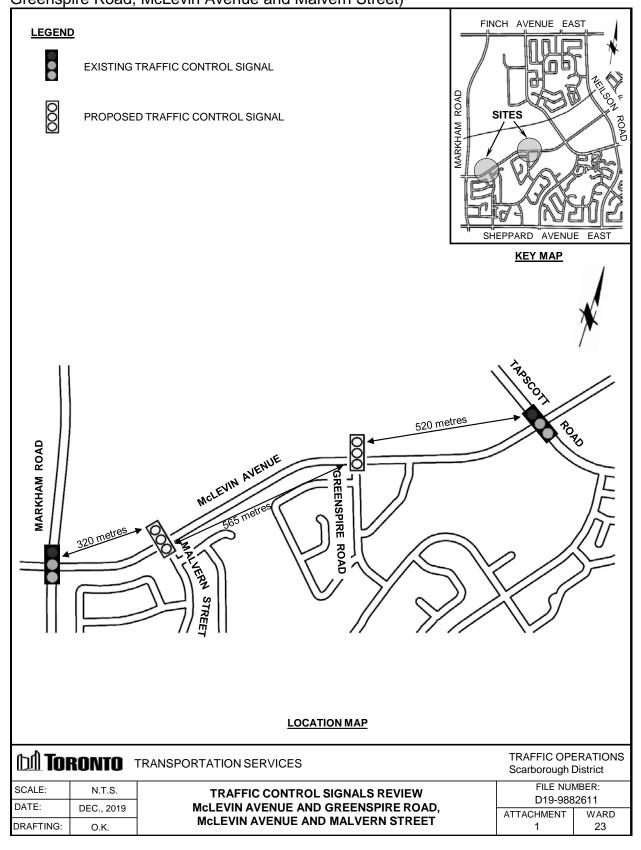
Attachment 1 - Location Plan (Traffic Control Signals Review McLevin Avenue and Greenspire Road, McLevin Avenue and Malvern Street)

- Existing traffic control signals are located to the west on McLevin Avenue at Markham Road and to the east on McLevin Avenue at Tapscott Road. The distance between the existing signalized crossings is approximately 1.4 kilometres (see attached drawing for distances between existing and proposed traffic control devices).
