All drawings prepared by MulvannyG2 Architecture.

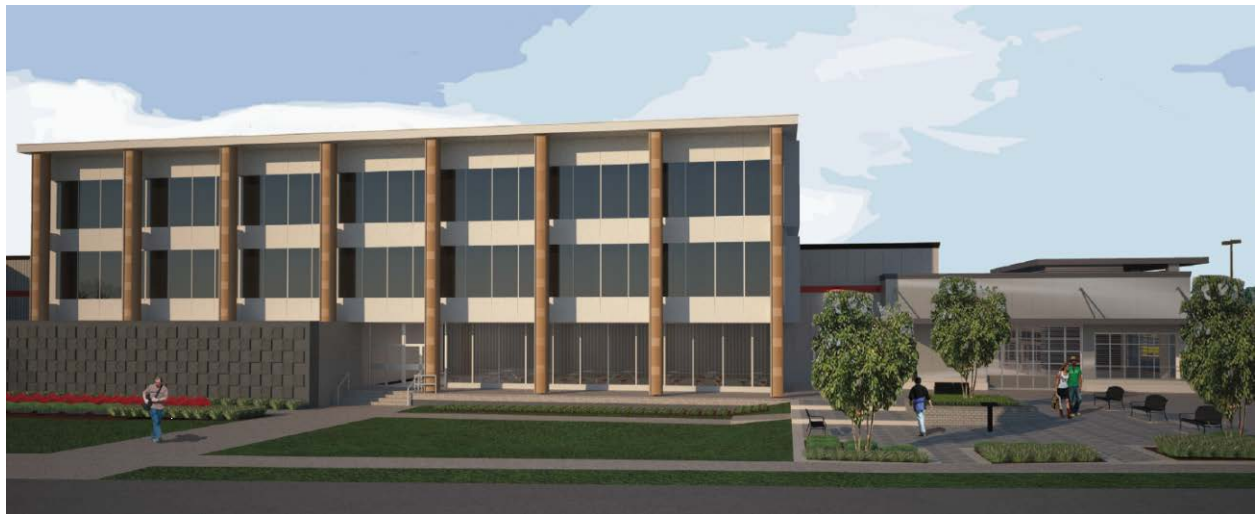
Perspective from Overlea

This view includes the retained south elevation of the existing administrative building with new east portion of the Costco Wholesale building to the right side of the drawing with landscaped court in the foreground (former location of the sunken courtyard)

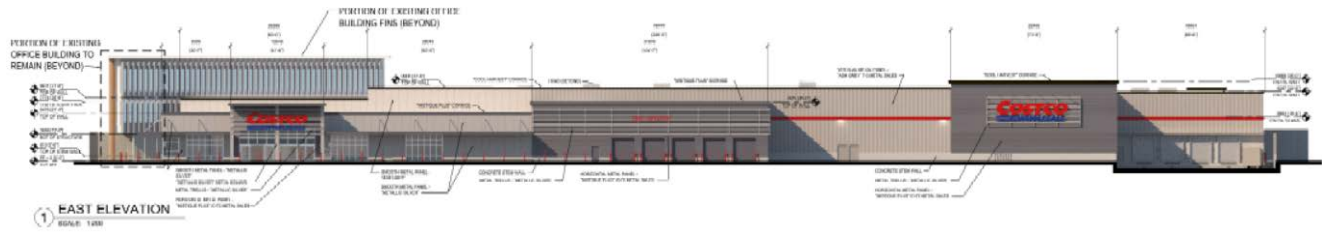
East Elevation

Heritage resource is shown on the left with new entry to the Costco Warehouse from at-grade parking area

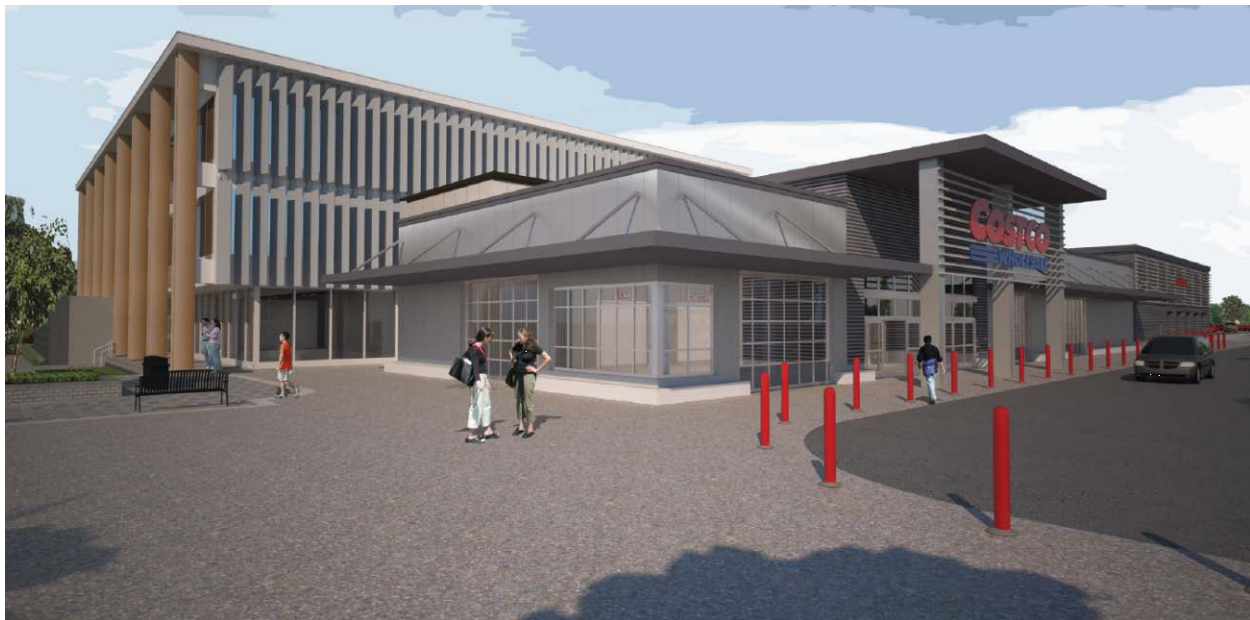
Perspective view of Costco Wholesale from south east corner

This view includes the retained bay of the administrative building on the left side with reinstated louvres (sun shades) on the second and third floors. Costco's main entry is located to the right.

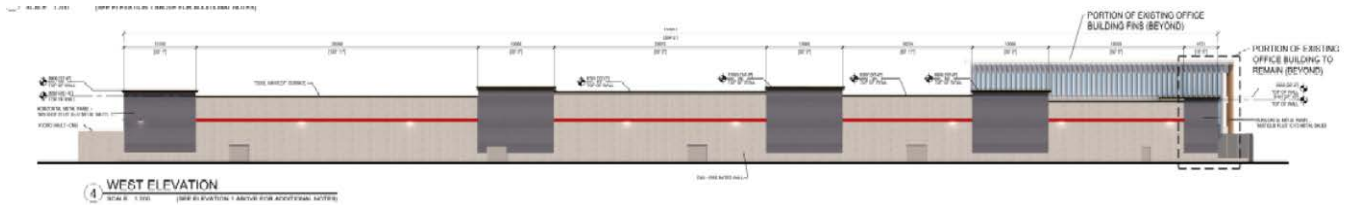
West Elevation

Retained portion of heritage building is seen on the right side of this elevation
