ATTACHMENT NO. 3 West Annex Phase II (Madison Avenue) Heritage Conservation District Part II: Plan

6.0	Heritage Conservation		
	District Plan	6.1	Objectives of Heritage Conservation District Plan
		The cł	 nief objectives of this HCD Plan are: to provide a Statement of Cultural Heritage Value and Heritage Attributes of Madison Avenue
			• to provide methods by which the residents and the City of Toronto can effectively pro- tect and restore this character and fabric;
			• to provide guidelines for conservation of the heritage fabric, and restoration of lost features in both the public and private realm;
			• to provide design guidelines which clearly define appropriate change, whether it is for altering existing buildings or for new construction, in the District;
			• to provide design guidelines for the streetscape to strengthen its heritage character; and
			• to recommend efficient implementation and management procedures.
		6.2	Statement of District Significance

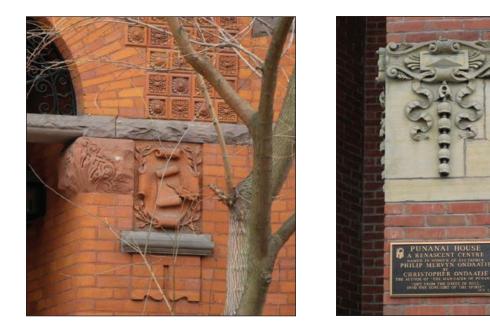
(far right) A catalogue of masonry details artistically combined, inset terra cotta, sandstone and brick arches, stringcourses, carved sandstone, corbelling and ashlar and rusticated sandstone. The entrance is inset into the main wall of the house behind a round-headed arch.

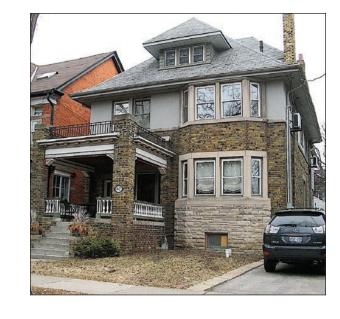
(right) Recessed entrance, rusticated and carved sandstone capitals, and stringcourses, as well as foundations

(far right) Carved limestone inset

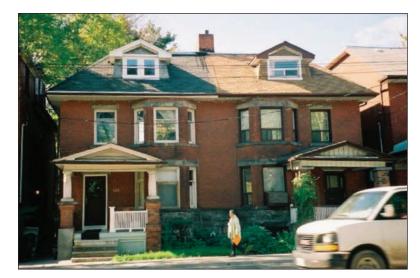
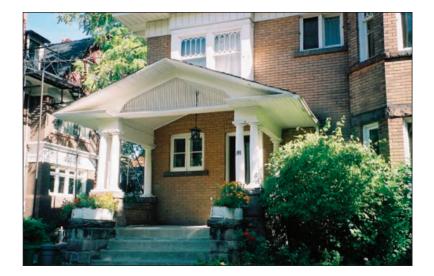
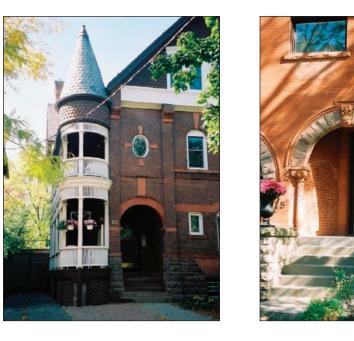
(above) Two Edwardian houses on Spadina Avenue, one in original condition with porch and original windows, one inappropriately altered by covering elements in aluminum siding, and installation of aluminum windows

(above right) Beautifully maintained Edwardian porch with gracious wood overhangs, removal of aluminum from the soffit and fascia would enhance the house
