HERITAGE PROPERTY RESEARCH AND EVALUATION REPORT
Part 2 - Background Report - Images

DE LA SALLE COLLEGE "OAKLANDS"
131 FARNHAM AVENUE, TORONTO

Heritage Preservation Services
City Planning Division
City of Toronto

July 2015

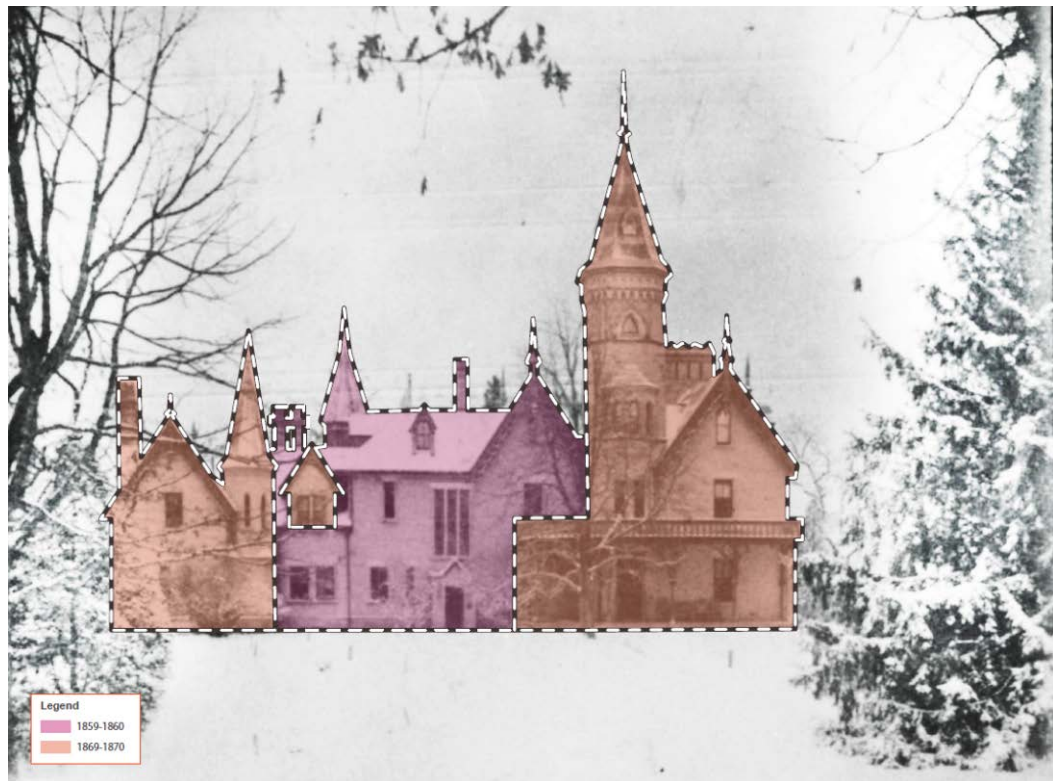
13. "Oaklands," Toronto residence of Senator John Macdonald, ca 1905: Photograph marked up to indicate the two first periods of construction (1859-60 and 1869-70) as noted. (Canadian Archives, PA no. 119997)

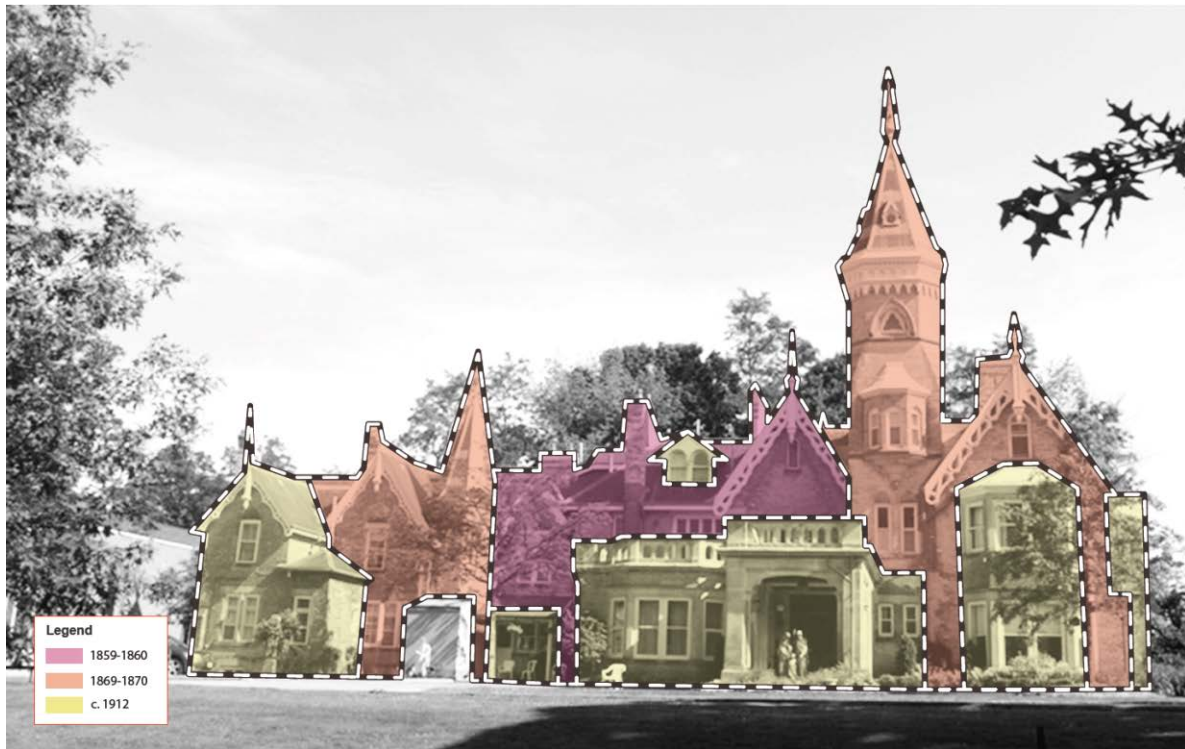
20. Oaklands, North Elevation, 1859-1912: Showing the three different periods of construction. The yellow, c 1912 shows Mary Mc Cormick's additions and alterations which largely consisted of adding large bay windows on the north, west and south facades, a stone porte-cochere. The single-storey kitchen wing, at the left was extended forward and has a second storey. (HPS, 2015)

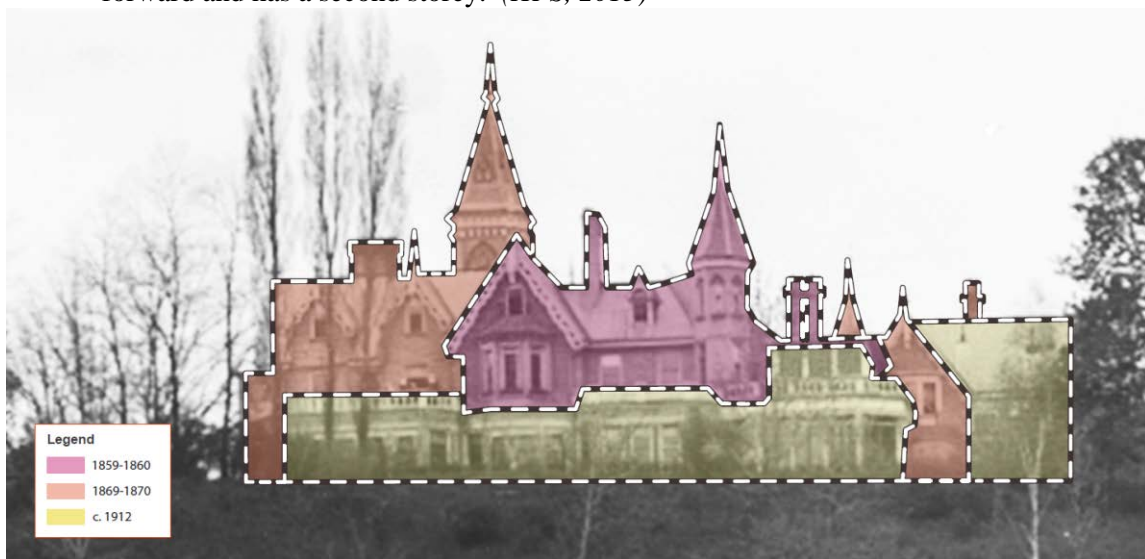
21. Oaklands, South Elevation 1859-1912 (detail from 'De La Salle Physical Training Class, "Oaklands" May 15th, 1932'): Showing the three periods of construction: the original house with gable and tower (1859-60), the 1869-70 addition of the west wings and the great tower and east kitchen wing and the post-1912 additions of bay windows to the existing house and the double storey kitchen wing at the right and the bowling alley which is not visible also at the right. (Archives of Canada with HPS overlays)

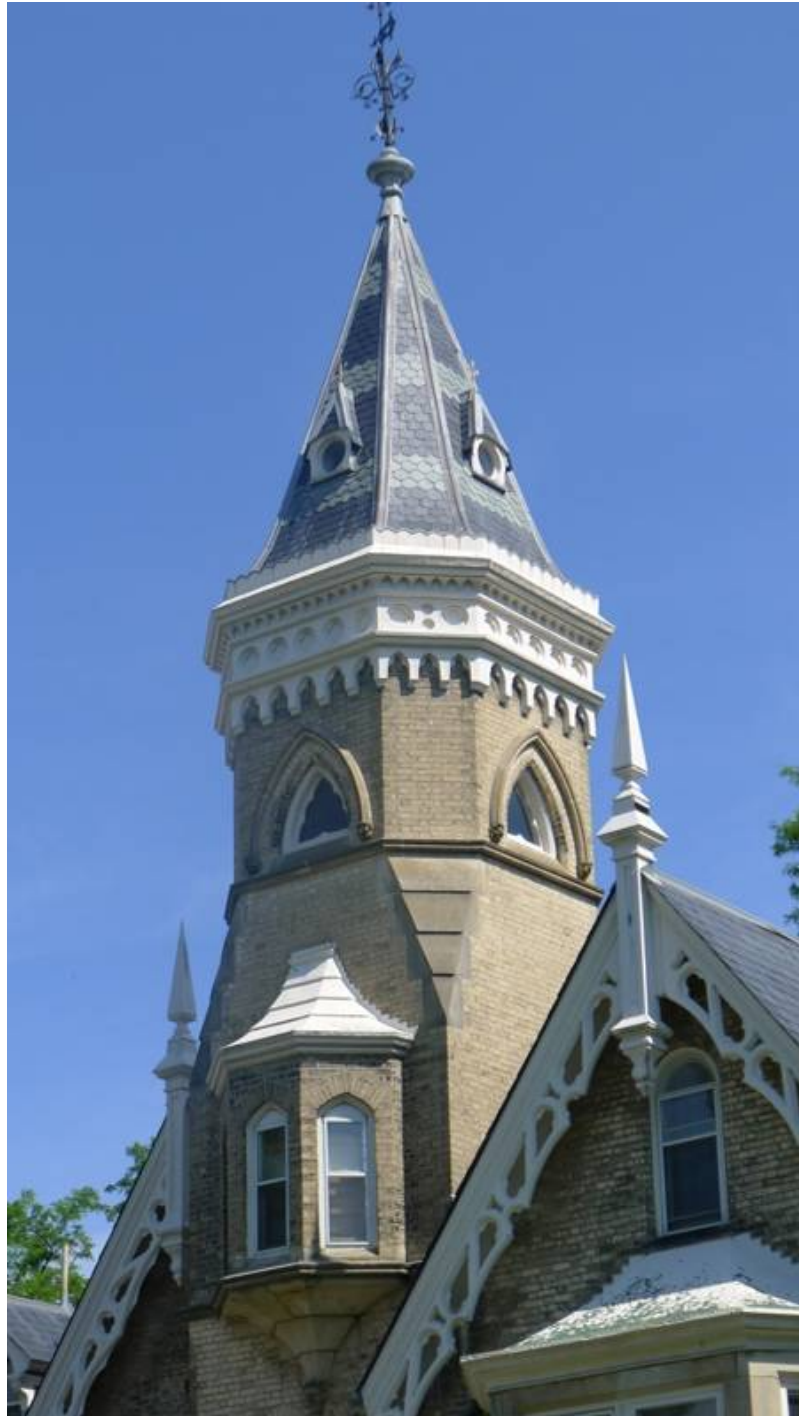
38. Oaklands, Main Tower, 1869-70: Gothic Revival details abound in the oriel window with its pointed apertures, the buttress effect of the stone in the transition to an octagonal plan, the triangular windows with their lobed edges surrounded by stone roll moulds with carved bosses, the wide cornice of the roof with its multiple bands of decorative corbelling with the trefoil and quatrefoil motifs, the striped fish scales of the tower roof with its dormer windows with decorative metal finials and finally the great metal weather vane. Note the bargeboard pattern and large wooden finials of the adjacent gable roofs. (HPS, 2015)

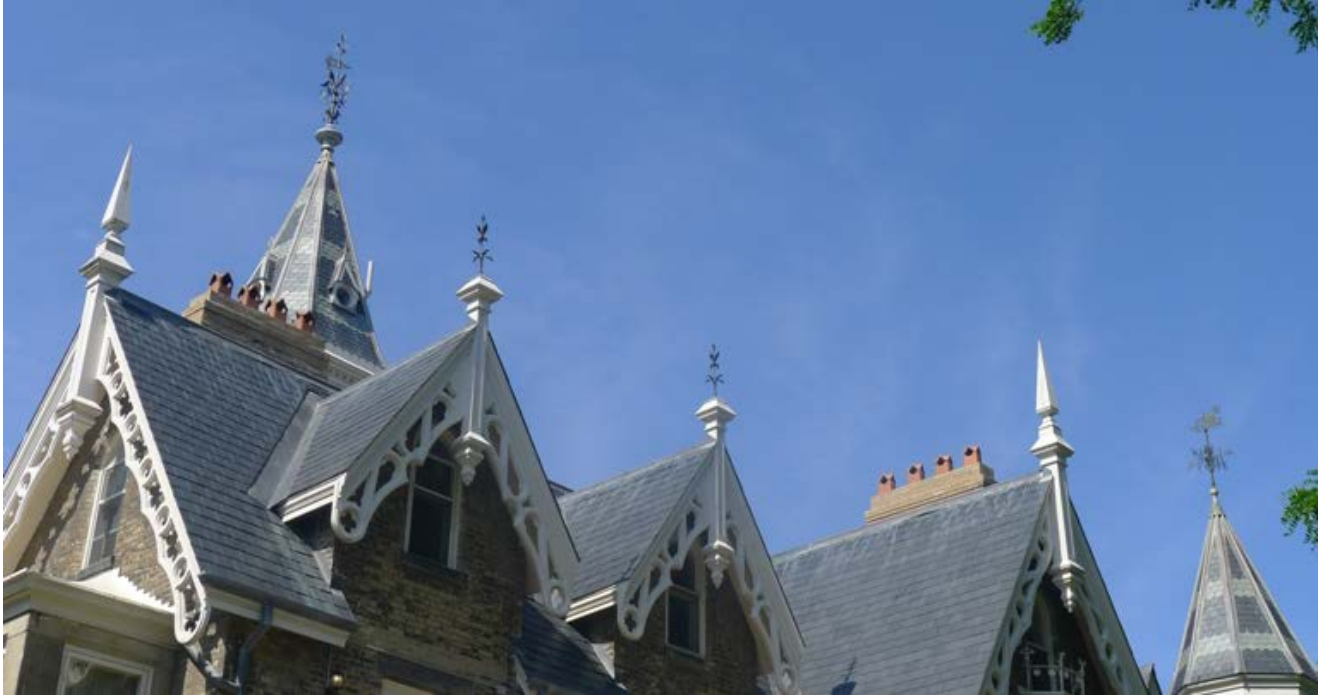
39. Oaklands, West Wing, 1869-70, Bargeboards and Finials and Weathervanes: Showing the south-west corner with the weathervane of the 1859-60 house at far-right. (HPS, 2015)

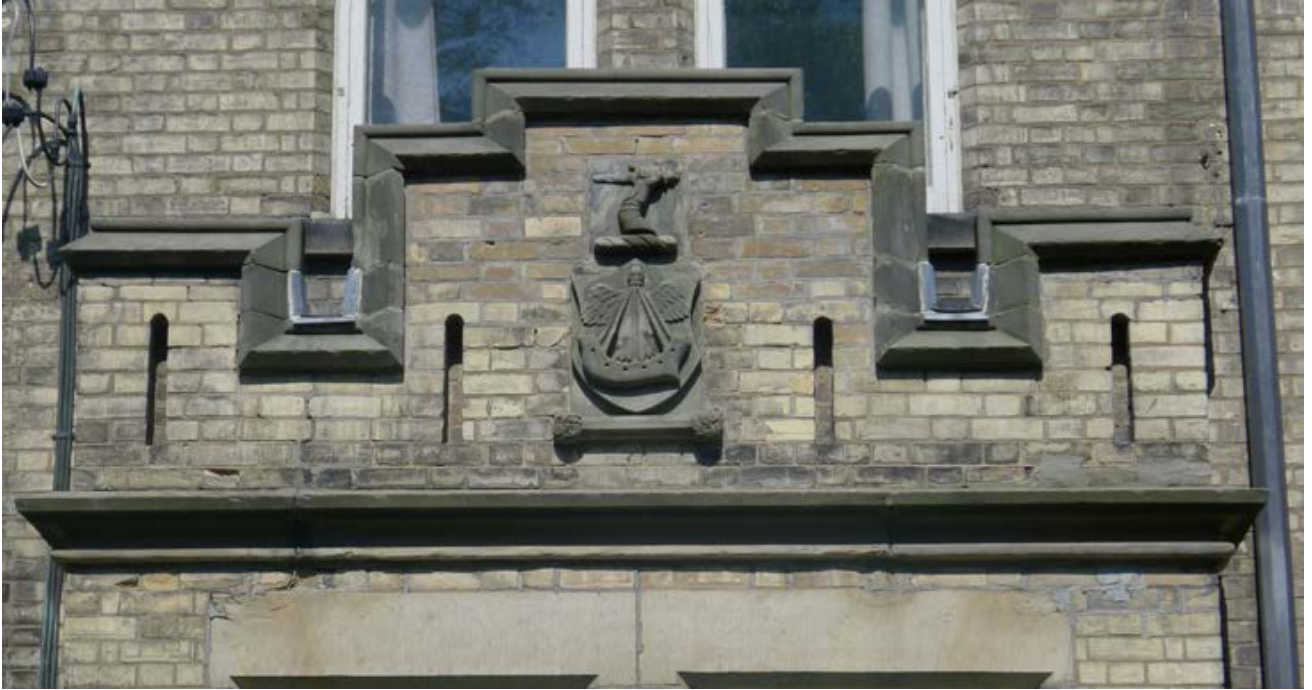
42. Oaklands, West Elevation, 1869-70, Bay Window: Showing the crenellations of the bay window parapet on the west elevation with the Macdonald family crest which features a severed arm above a galley ship. (HPS, 2015)

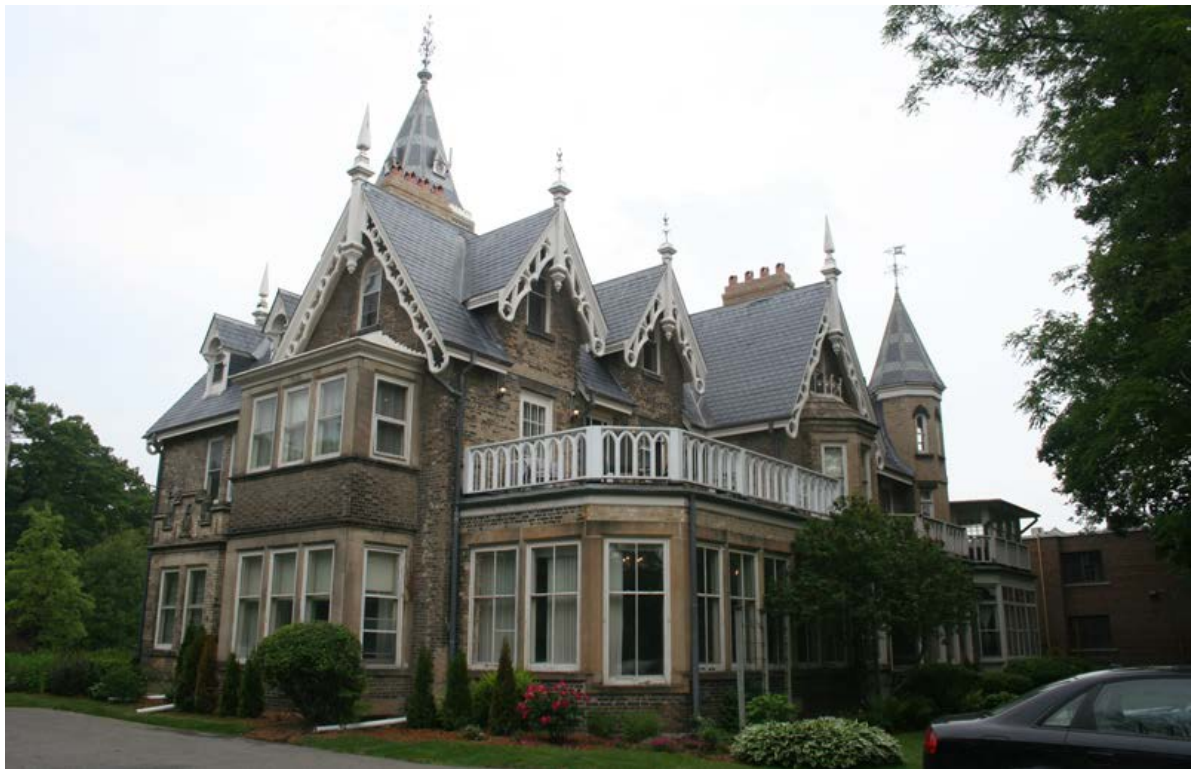
45. Oaklands, South and West Elevations: Showing the c1912 additions including the double story bay window on the west façade, the 4 bay windows on the south façade and the upper story addition on the bay window at the far right. Compare with Image 35 for the 1869-70 version. (HPS, 2015)

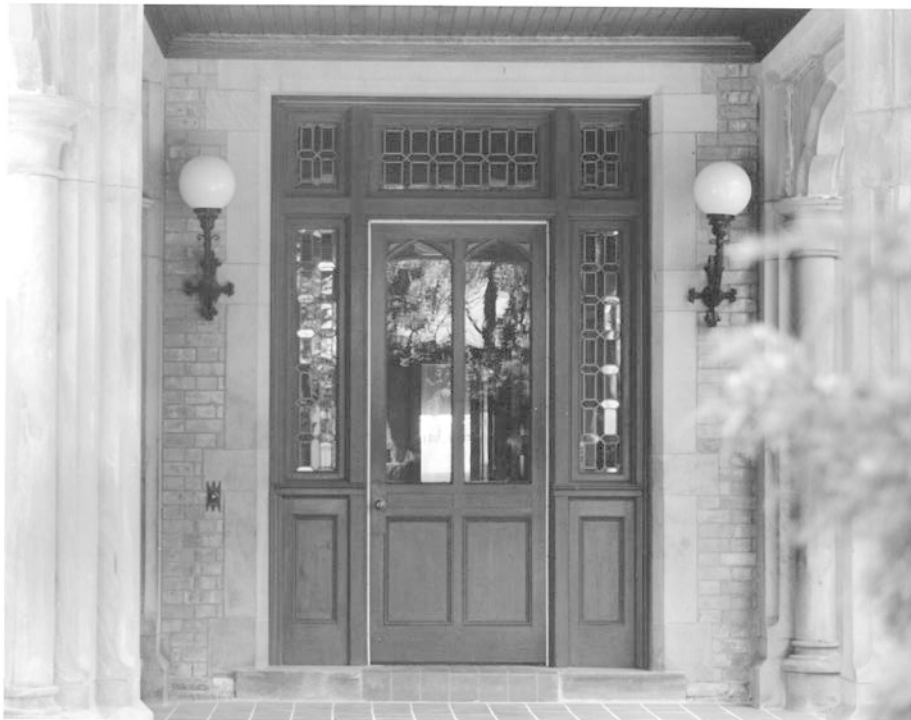
47. Main Entry: Showing the paneled door with two pointed-head lights, surrounded by a paneled door case containing multi-paned sidelights and a transom. (*Photograph 6, Heritage Easement Agreement (HEA) 1995*)

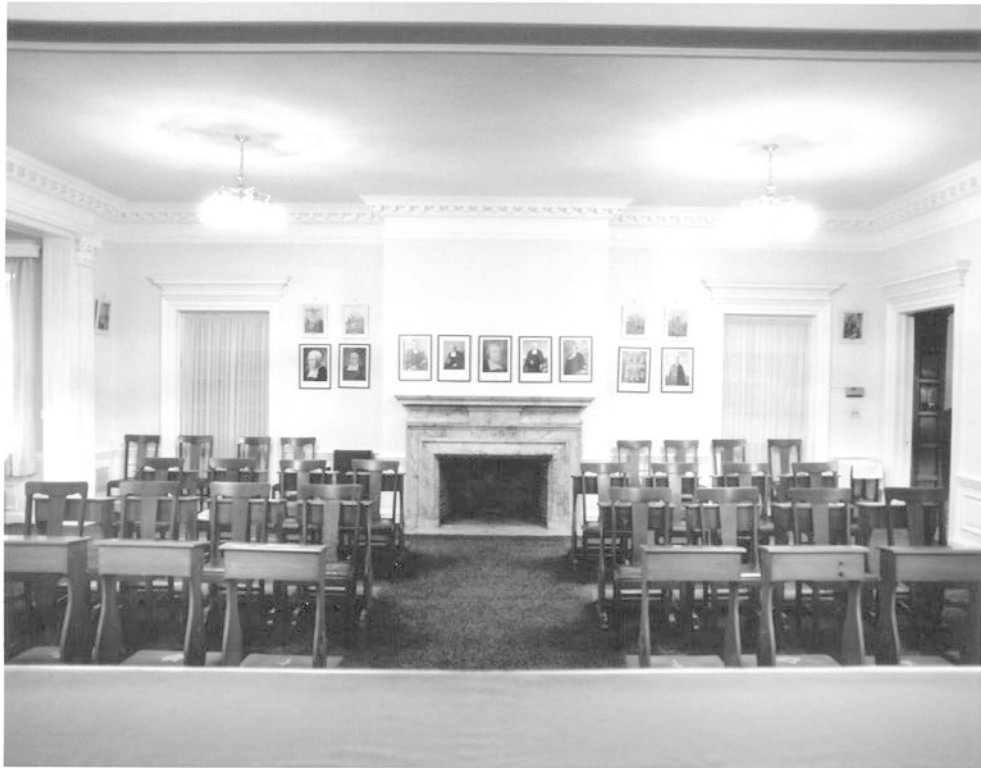
50. View of the Chapel: Showing the centrally placed marble fireplace flanked on either side by single doorway with Classical door surrounds with fluted mouldings and entablatures with projecting cornices. (*Photograph 11 ,HEA*)

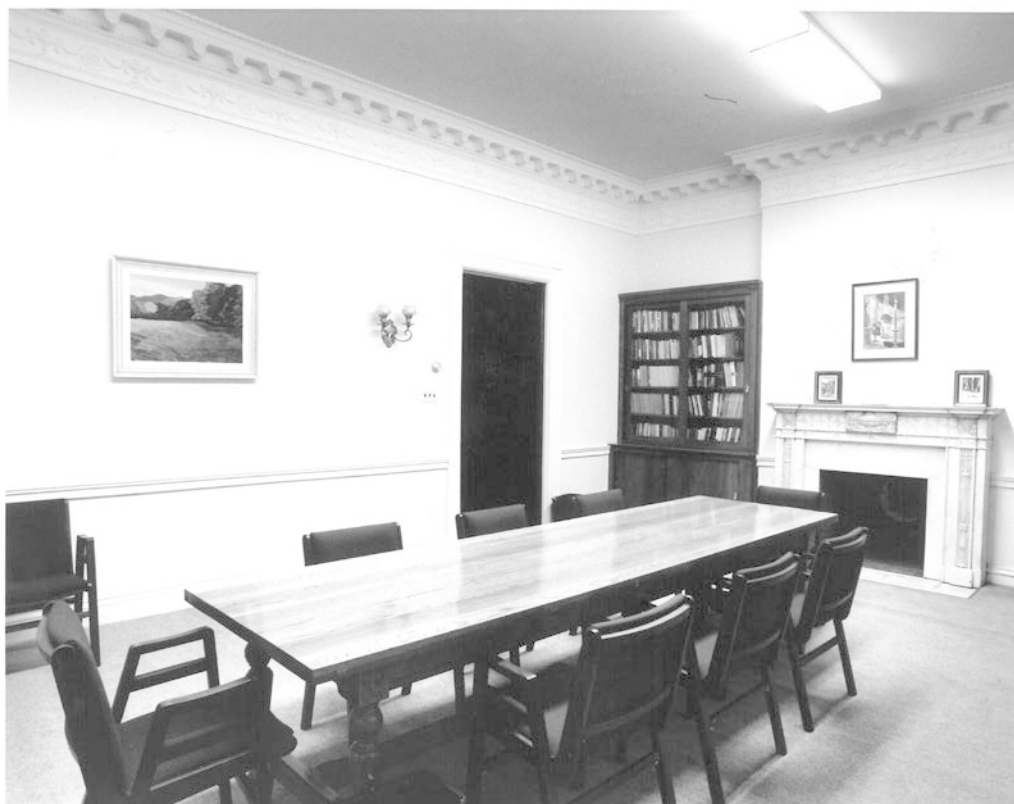
53. General view of the Board Room: Showing the neo-classical frieze, cornice and fireplace. (*Photograph 13, HEA*)

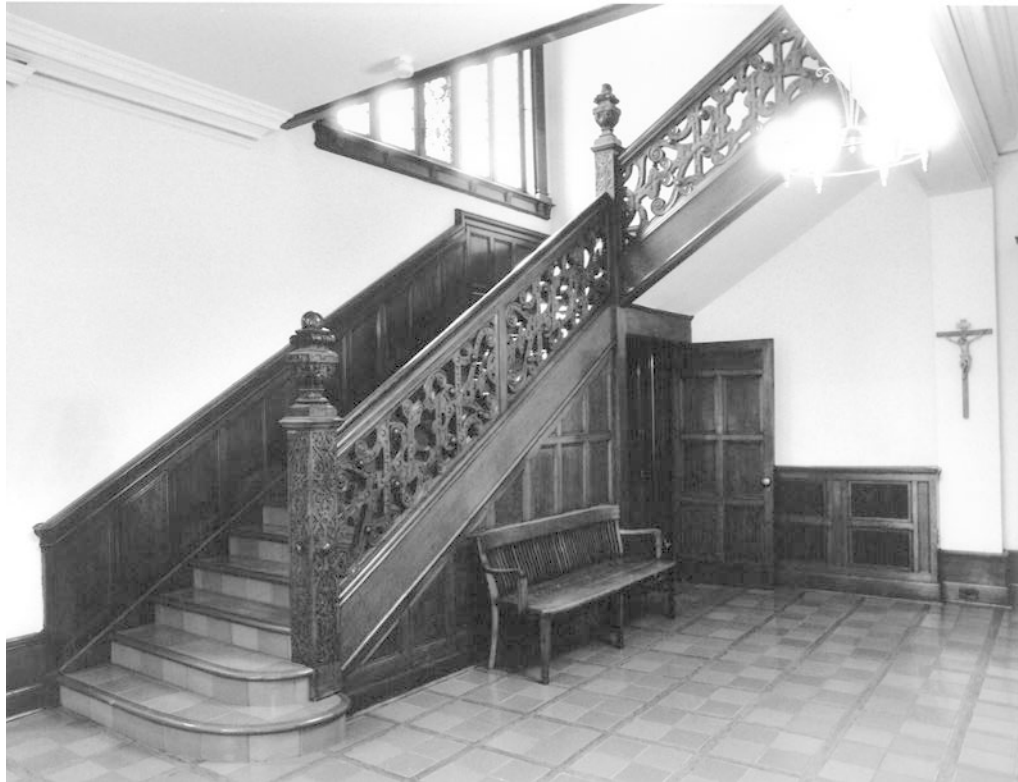
58. General view of the Entrance Hall: Showing the wood paneling, the quarter-turn staircase with a landing and the stair hall window. (*Photograph 16 , HEA*)

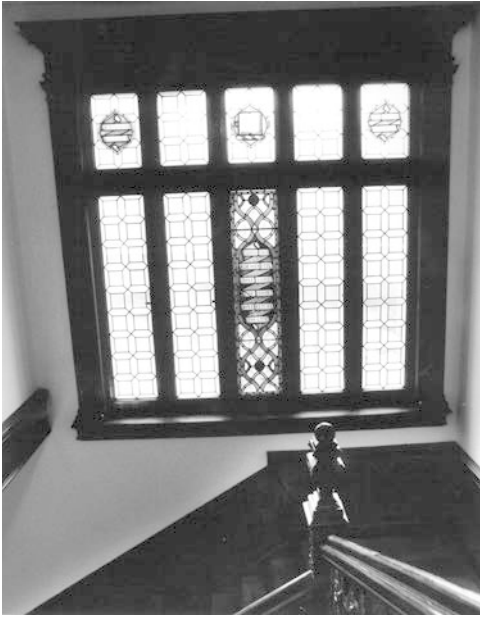
60. Detail of the stair hall window above the main staircase in the Entrance Hall (above left): Showing the five vertical lights with transom lights above, wood window surround and leaded and stained glass. The inscription in the glass reads: "Through this wide open gate none come too soon, none return too late." An open book with the words "Holy Bible" is in the transom above. Latin inscriptions are featured in the upper left and right.

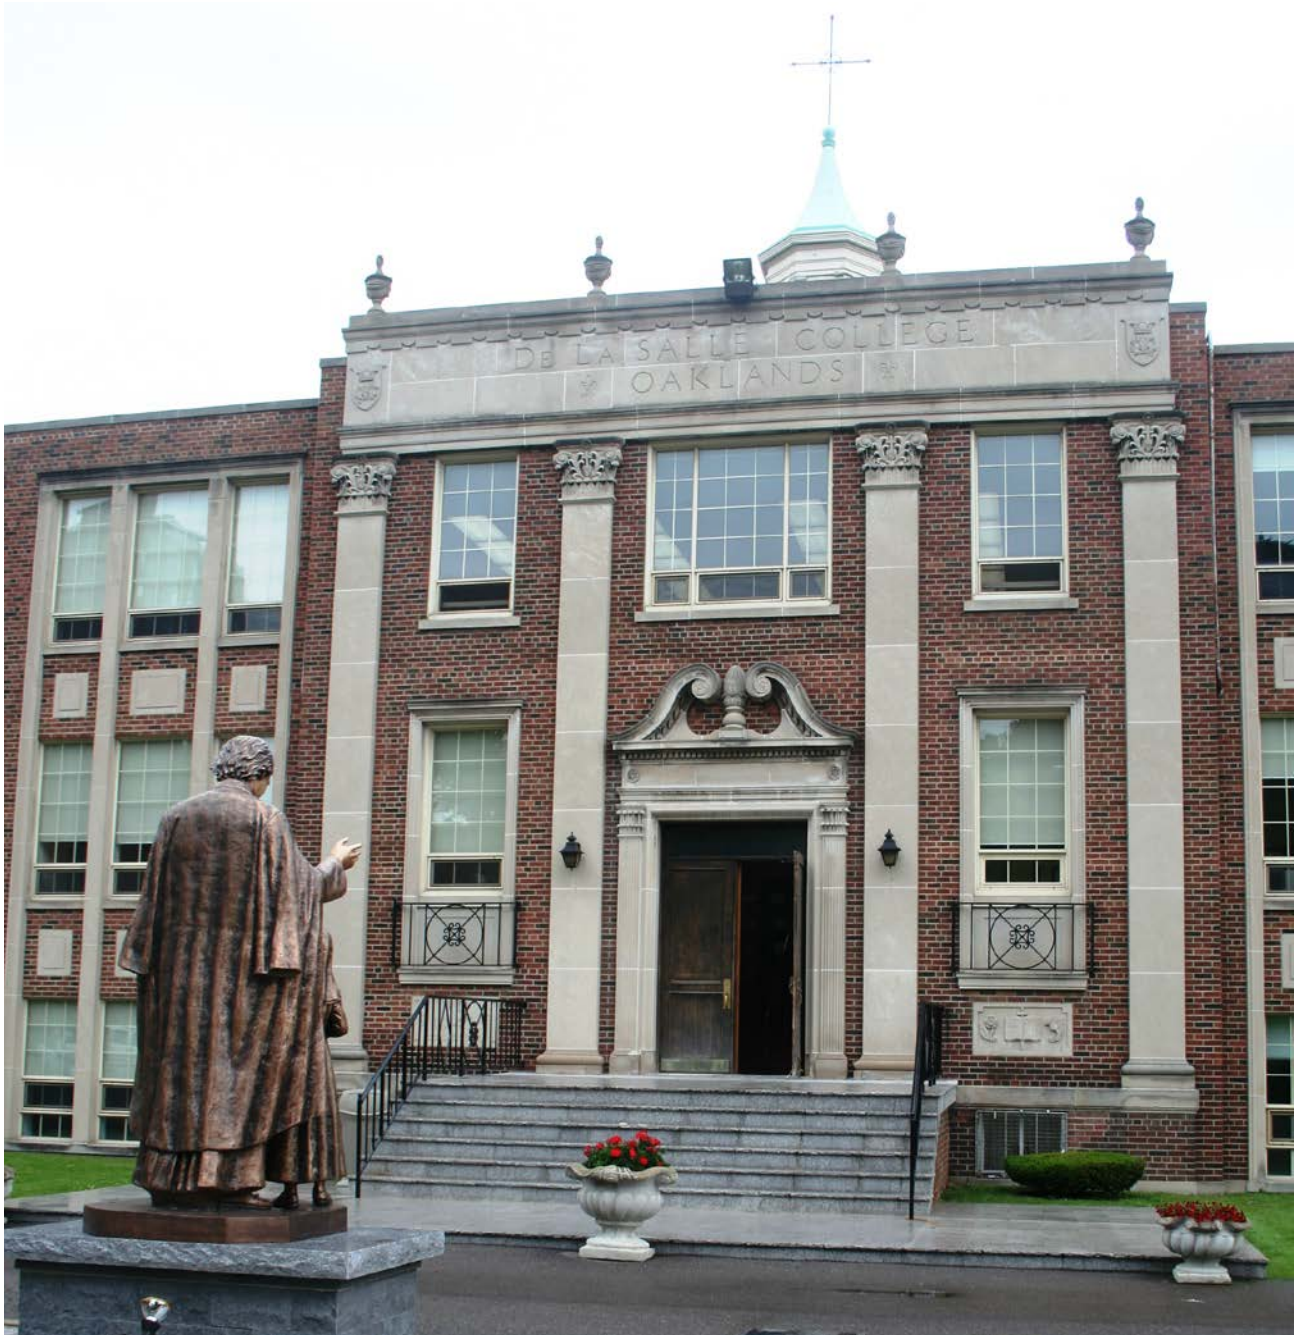
71. De La Salle College "Oaklands", west façade, central entry bay: Showing the classical details of the stone portico and the main entry. (*HPS, 2015*)

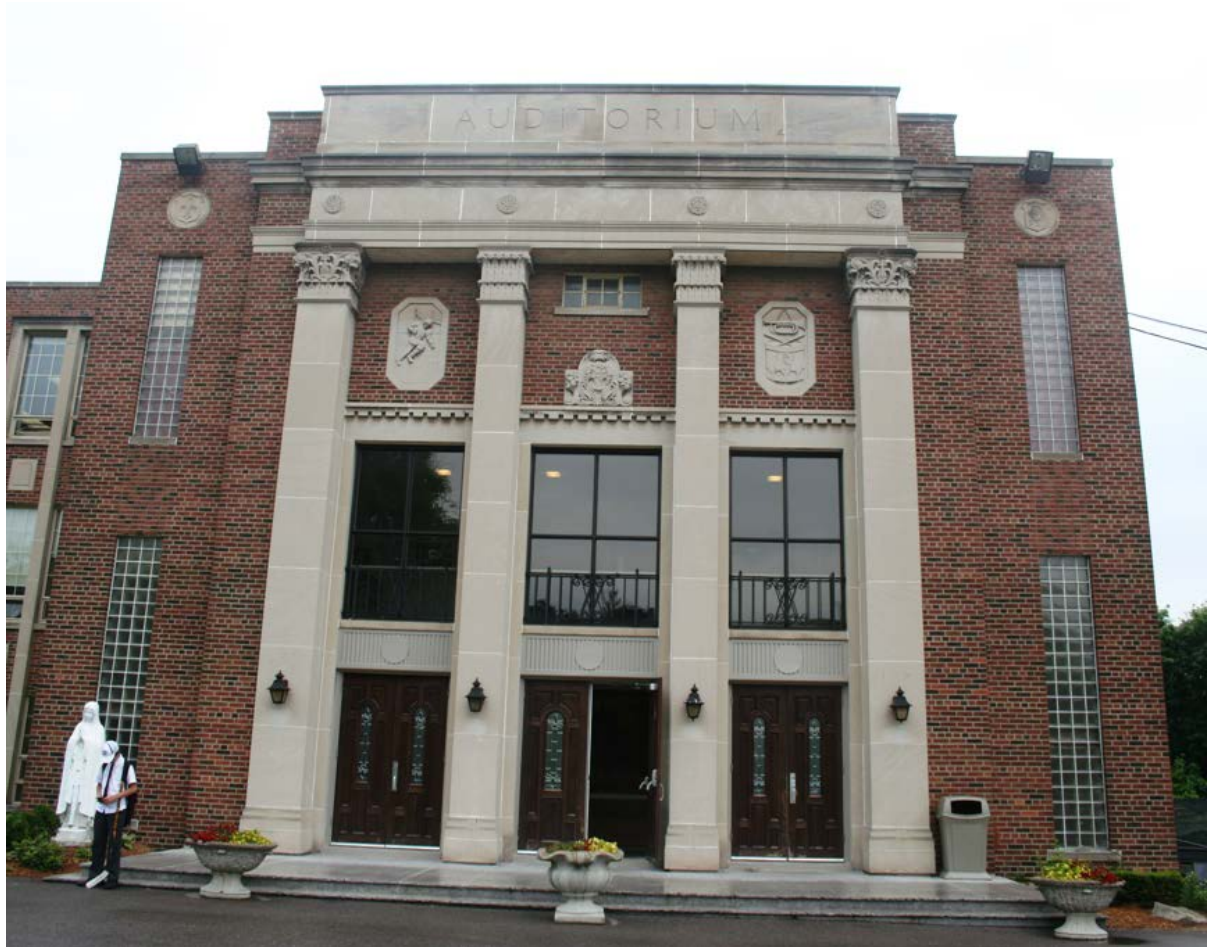
72. De La Salle College "Oaklands", west façade, south entry bay to auditorium: Showing the classical details of the stone portico and the triple doors. (HPS, 2015)

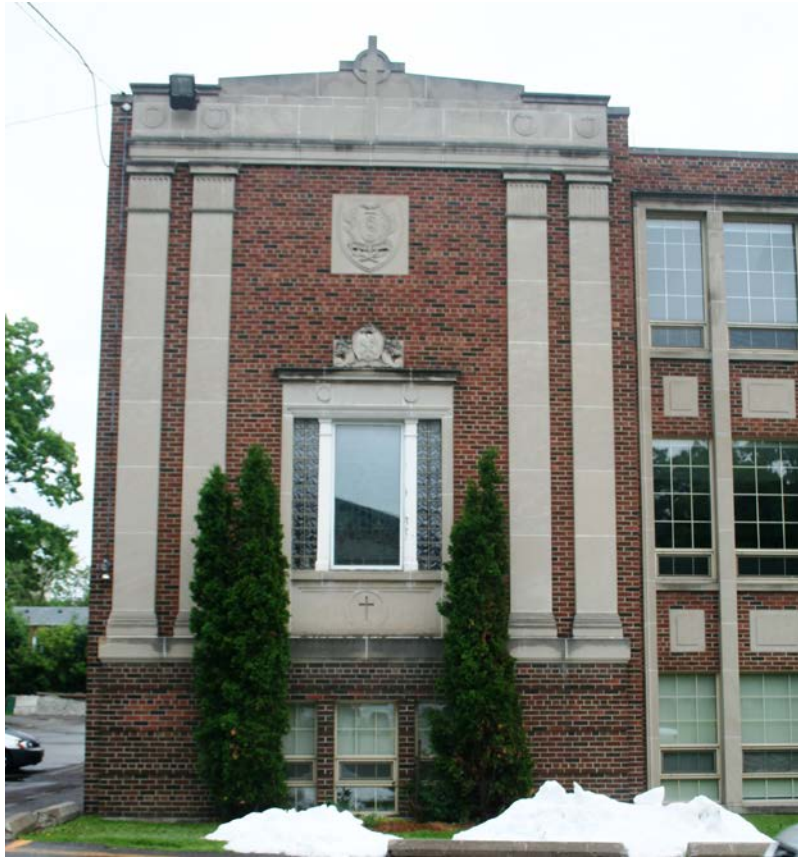
74. De La Salle College "Oaklands", west façade, north bay with chapel: Showing the classical details of the stone portico, with the Palladian window with glass blocks, the papal shield above and the De La Salle Shield at the top. The portico supports and entablature with a shallow pediment alluding to traditional church form and the chapel inside. (*HPS, 2015*)

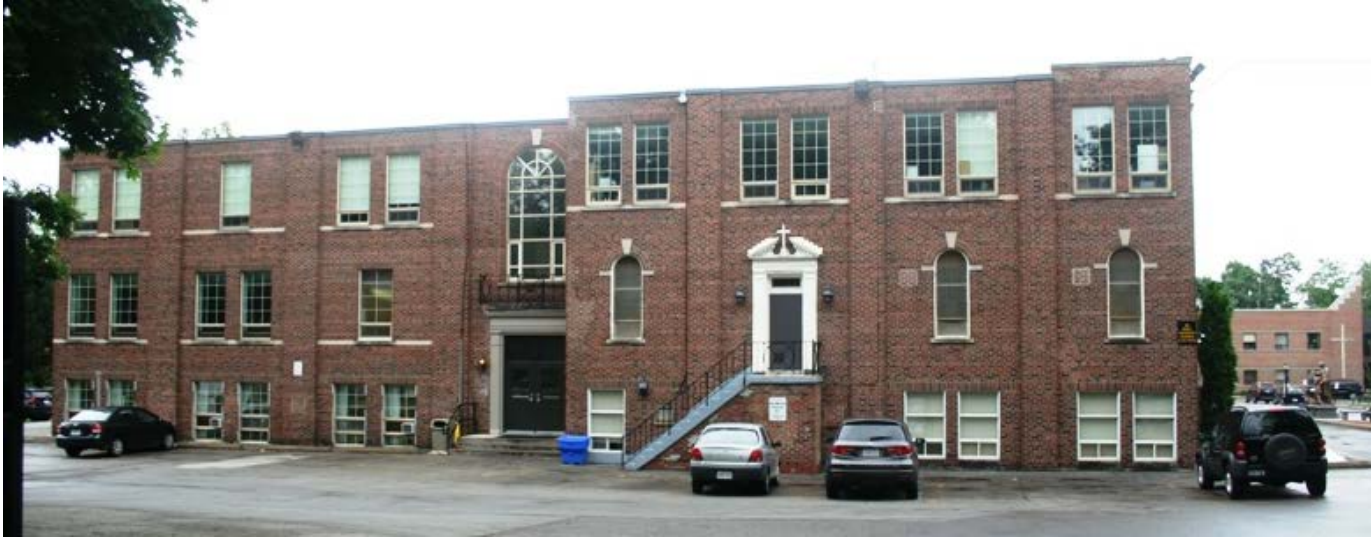
76. De La Salle College "Oaklands", north façade: Showing the façade that faces the approach from Farnham Avenue. The chapel is at right with white entry door case and three round-headed windows. Classroom wing is at the left with a stone framed entry and window with circular head and stone keystone. (*Heritage Preservation Services, 2015*)

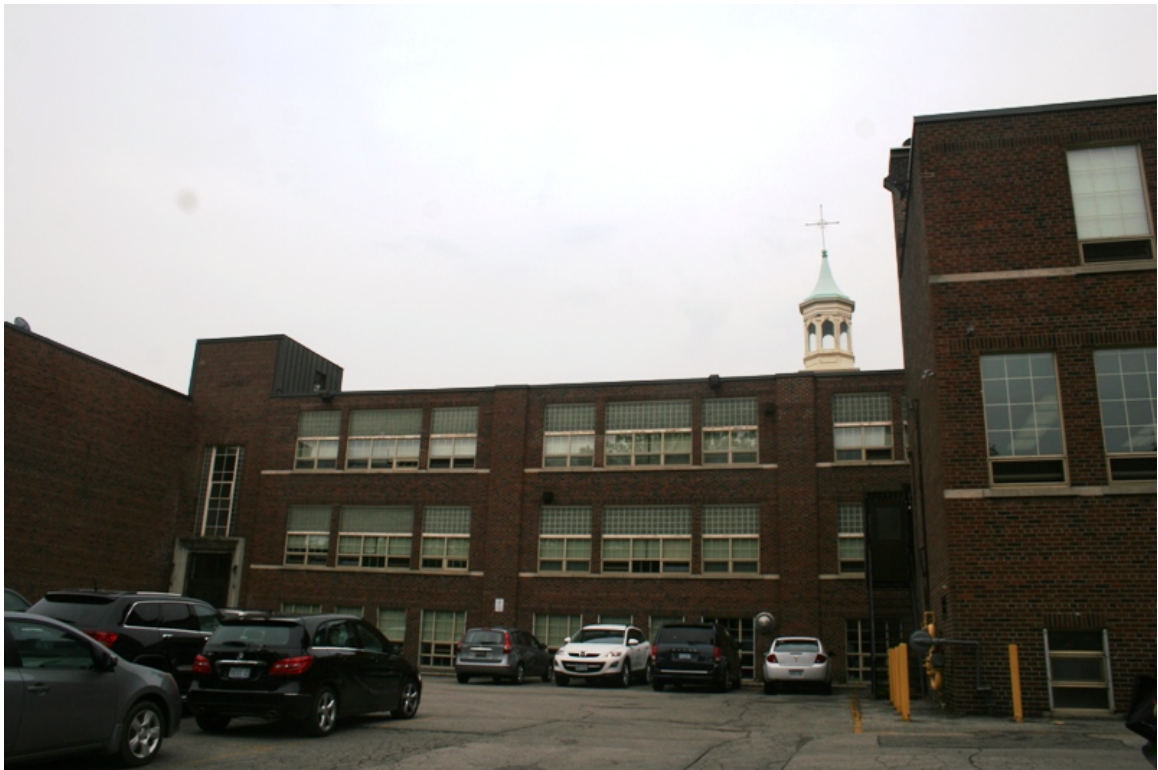
77. De La Salle College "Oaklands", rear east façade: Showing typical post-World-War II school details with glass blocks used in the upper windows and the cupola. (*Heritage Preservation Services, 2015*)

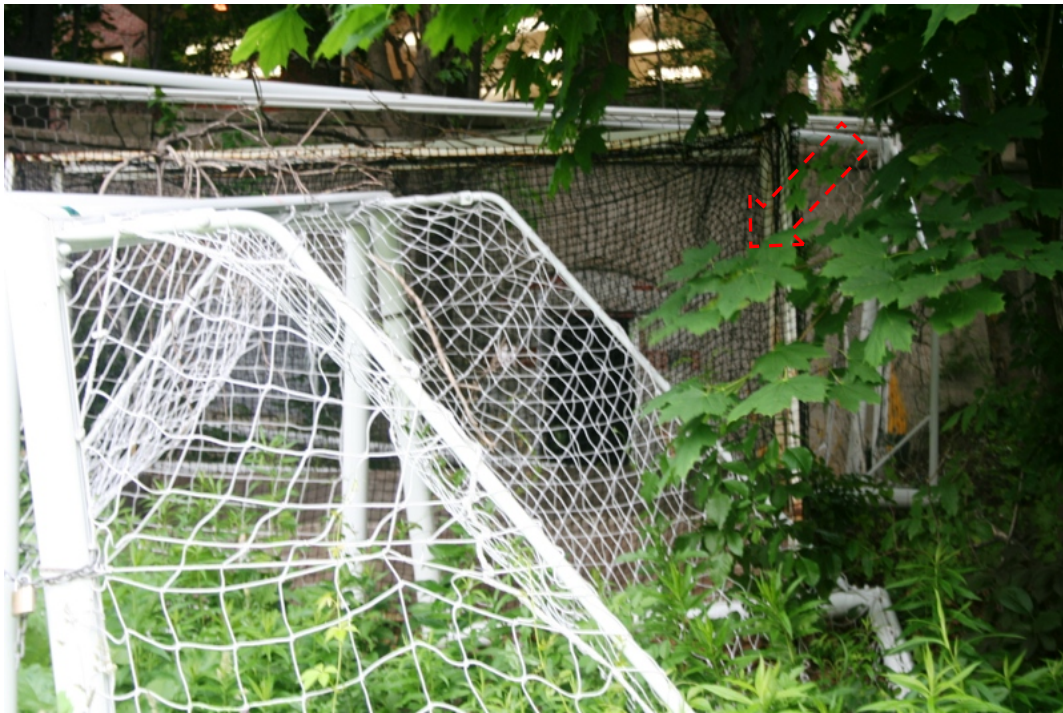
87. Bridge under carriage way: The arrow indicates the archways filled in with a doorway as viewed from the lower levels of the escarpment above the running track. (*Heritage Preservation Services, 2015*)
