Coalition of Yellow Creek Residents' Associations

RE: PE 23.3 - Vale of Avoca/Yellow Creek update

OBJECTIVES OF NEIGHBOURING RESIDENTS ASSOCIATIONS FOR NEEDED IMPROVEMENTS TO YELLOW CREEK (VALE OF AVOCA) RAVINE

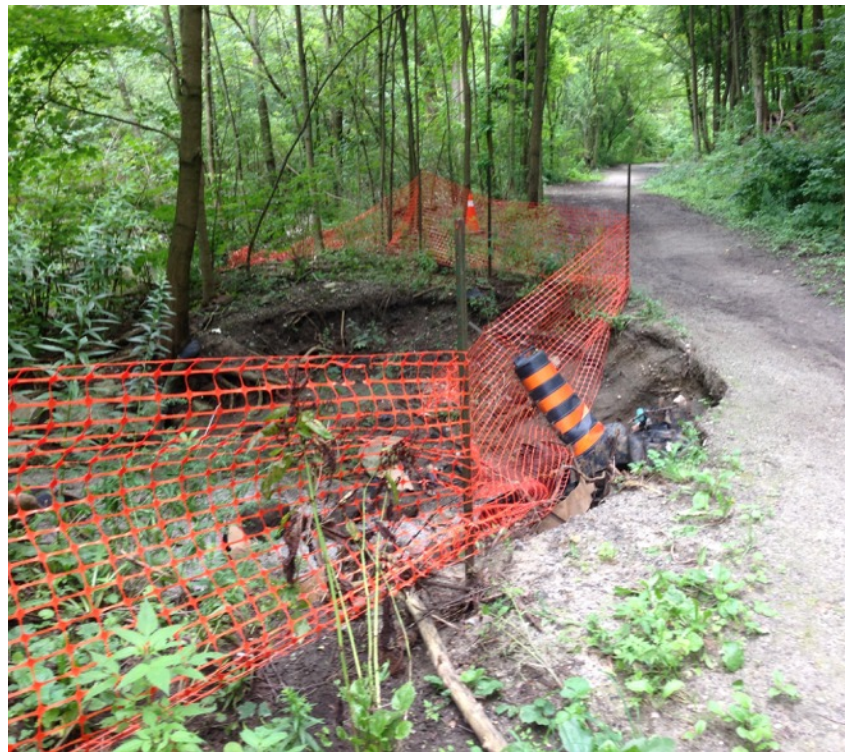
(11) Northern bridge: Repair the washout just below the footbridge and maintain the footbridge through the Toronto Water project.

As the picture to the right shows, each rain storm erodes more, extending the washout and undercutting the bridge.

Growing washout at northern footbridge

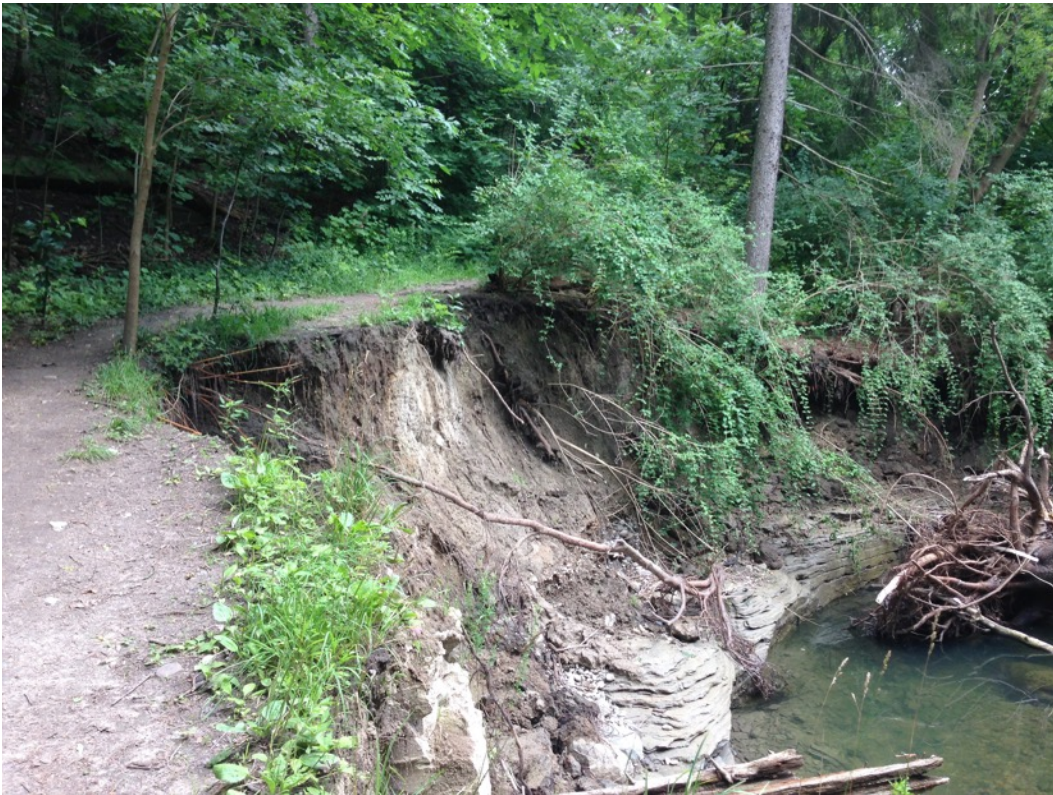
Washout on eastern footpath (as of early August)

(8) The washout (pictured above) is a safety issue.

Should post signs at entrances to trail warning of risk and also provide safety fence like around other washouts to keep footpath users away from the undercut edge. People will continue to use this footpath in spite of the dangerous condition, which will get worse with every storm.

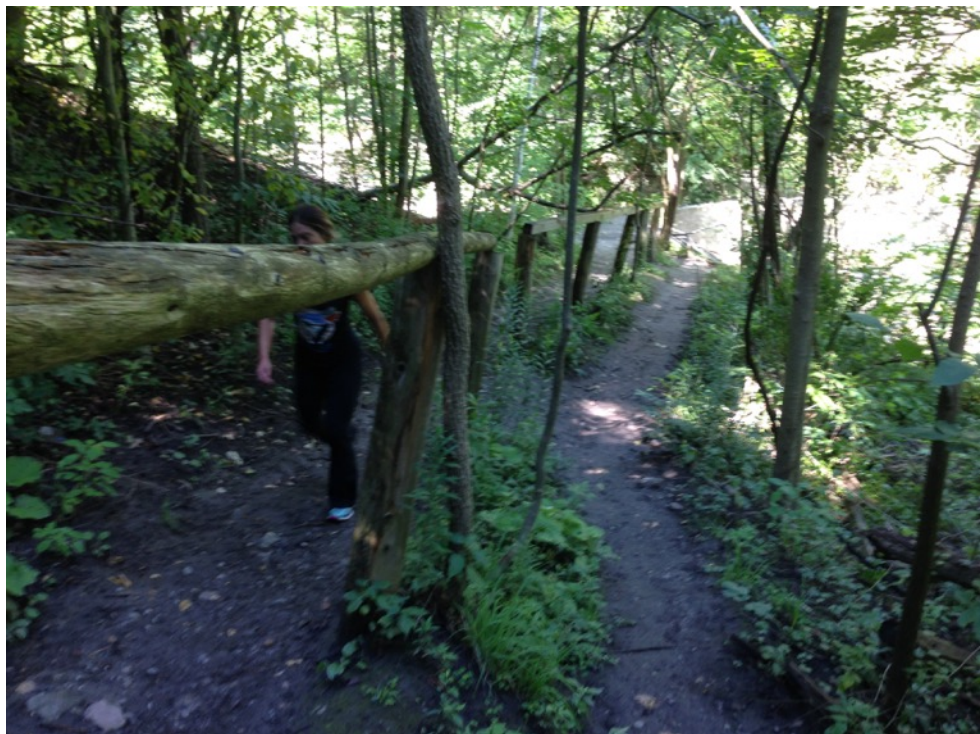
(13) Rebuild/repair the eroded foot trail from the southern (washed out) bridge up to the Shaftesbury stairs.

Footpath has deteriorated. Users have created parallel path (see photo).

Path up to Shaftesbury steps (formal path to left of partially missing railing)

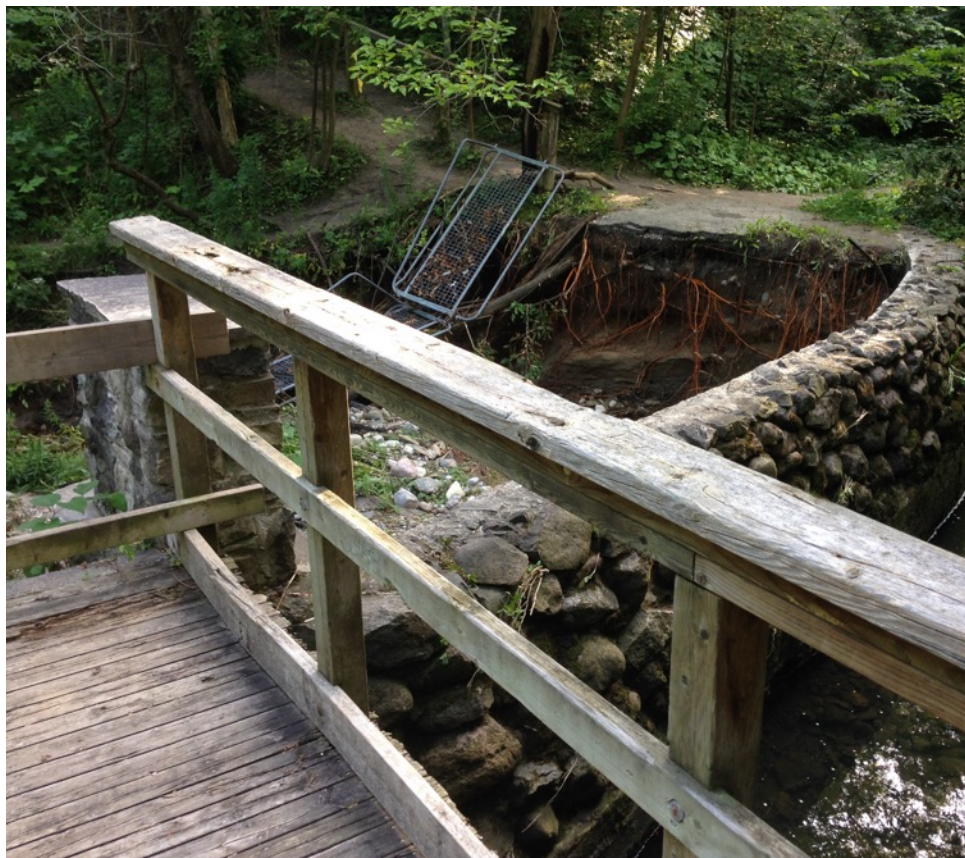
(14) Rebuild or replace washed-out southern footbridge and repair/rebuild footpath beside new “spillway” stream south of this footbridge.

The photo to right shows the remains of the former paved path to the bridge. Washouts also eliminated much of the footpath leading south, to the left of the photo. Design and location of the bridge and footpath will depend on stream remediation.

(15) Reconstruct fallen granite-block wall and washed-out west stream-side footpath north of the CPR railway bridge.

This and the footpath in (14) are widely-used, in spite of their deplorable condition. The spillway created by washouts may remain as a component of the stream redesign. The washed-out footpath, replaced by new slope-eroding informal paths in the adjacent forest, should be rebuilt.

Missing path to southern bridge (stream to right of wall, washout to left)

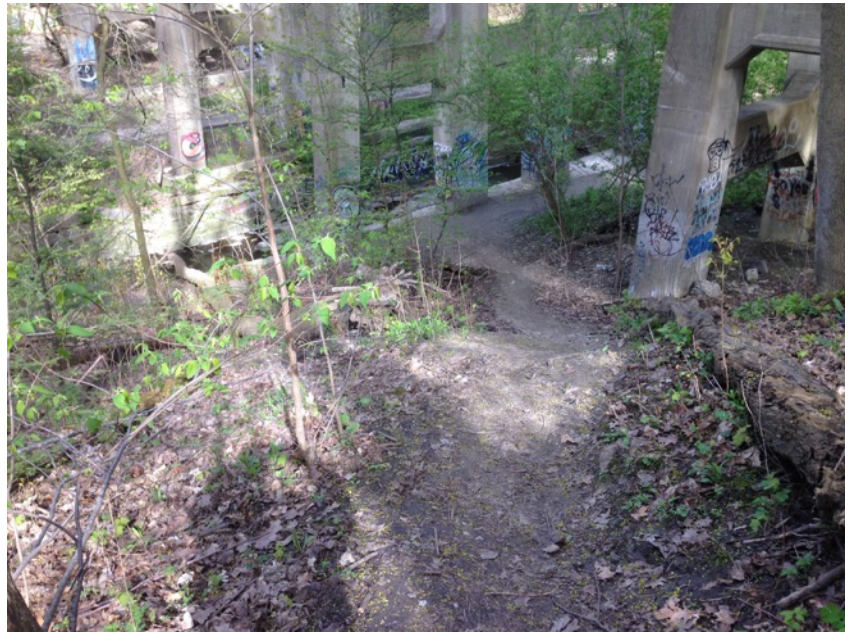
(17) If not already done, construct stairs to provide a safer connection to the west stream-side footpath down from the upper footpath under the CPR railway bridge.

The current steep informal footpath beside the railway bridge is used as a convenient access route into the ravine by people entering through the Mathersfield and Shaftesbury stairs, progressively eroding the slope as a consequence. Its steep slope makes the path a safety issue.

Foot-eroded steep footpath down to stream by railway bridge

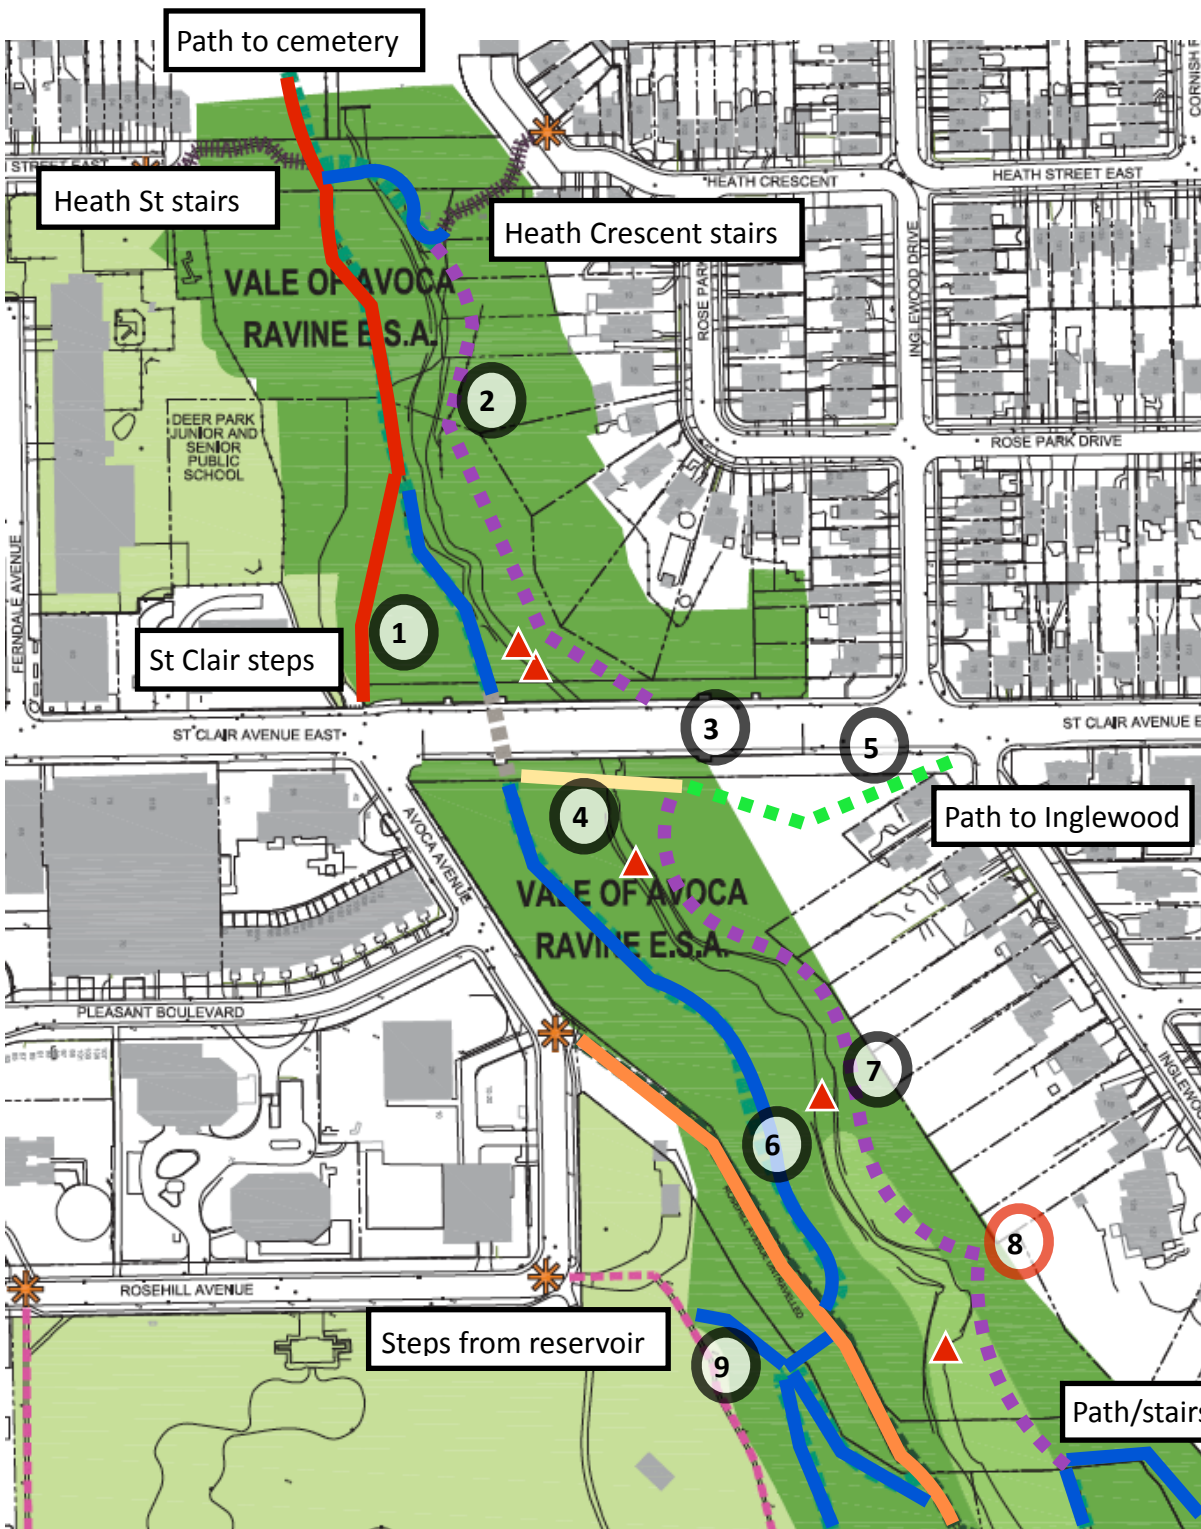
NORTH SECTION
 From
 Mt Pleasant
 Cemetery
 to
 former Rosehill Ave
 crossing of stream

- Locations shown above (see previous list for details on required work):
- (1) Path and steps down from NW end of St Clair bridge (need repair, potential upgrade to bike path)
 - (2) East-side path from St Clair bridge to cemetery (minimal safety maintenance prior to Phase 2)
 - (3) Path over unsafe flagstone slope under St Clair bridge
 - (4) Potential future footbridge or maintained low-water crossing (Phase 2)
 - (5) Steep at-risk footpath to Ingleswood at St Clair (consider upgrade to safe steps)
 - (6) Steps in need of maintenance
 - (7) East-side path to St Clair bridge (minimal safety maintenance prior to Phase 2)
 - (8) Path washout (current safety issue)
 - (9) Heritage stone steps from Rosehill reservoir to bike road (need repair)

▲ Trees fallen across stream
