M TORONTO

REPORT FOR ACTION

Proposed Traffic Control Signals - Bathurst Street approximately 15 metres South of Danby Avenue

Date: March 19, 2020
To: North York Community Council
From: Acting Director, Traffic Management, Transportation Services
Wards: Ward 6 - York Centre

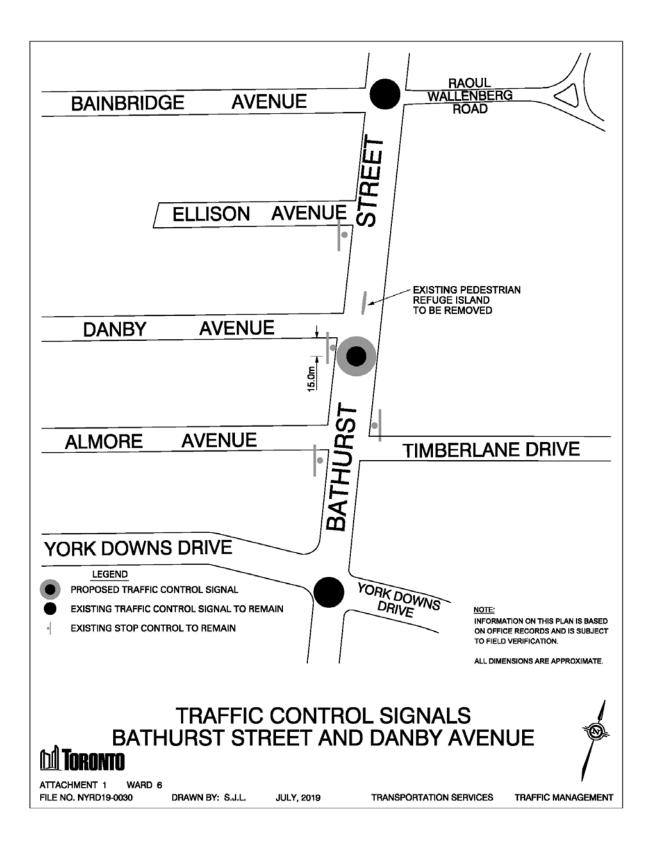
Attachment 1: Map - Traffic Control Signals - Bathurst Street and Danby Avenue

1. City Council authorize the installation of traffic control signals on Bathurst Street at a point approximately 15 metres south of the intersection of Bathurst Street and Danby Avenue.

2. City Council authorize removal of the pedestrian refuge island on Bathurst Street at a point approximately 20 metres north of the intersection of Bathurst Street and Danby Avenue, in conjunction with the installation of traffic control signals at a point approximately 15 metres south of the intersection, as set out in Recommendation 1 above.

The area is comprised of mixed residential on the west side of Bathurst Street. Earl Bales Park is on the east of Bathurst Street. The pedestrian refuge island is located approximately 20 metres north of the intersection of Bathurst Street and Danby Avenue.
