City of Toronto

**SAFETY IMPACTS AND REGULATIONS OF ELECTRONIC  
STATIC ROADSIDE ADVERTISING SIGNS  
TECHNICAL MEMORANDUM #2B –  
BEFORE/AFTER COLLISION ANALYSIS AT MID-BLOCK  
LOCATIONS**

# **FINAL REPORT**

Project No: B000203-3

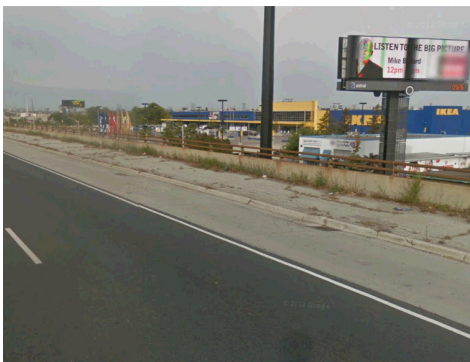
Figure 1: Electronic static roadside advertising sign – Gardiner Expressway

Figure 1 and Figure 2 show example signs located along the F.G. Gardiner Expressway and Highway 27, respectively.

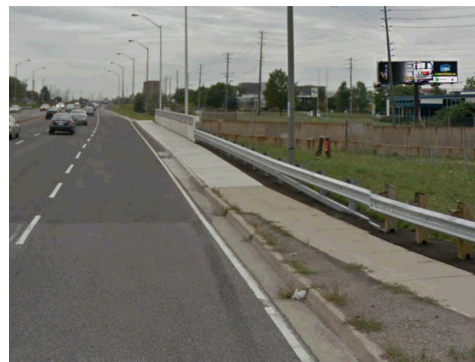
Figure 2: Electronic static roadside advertising sign – Highway 27

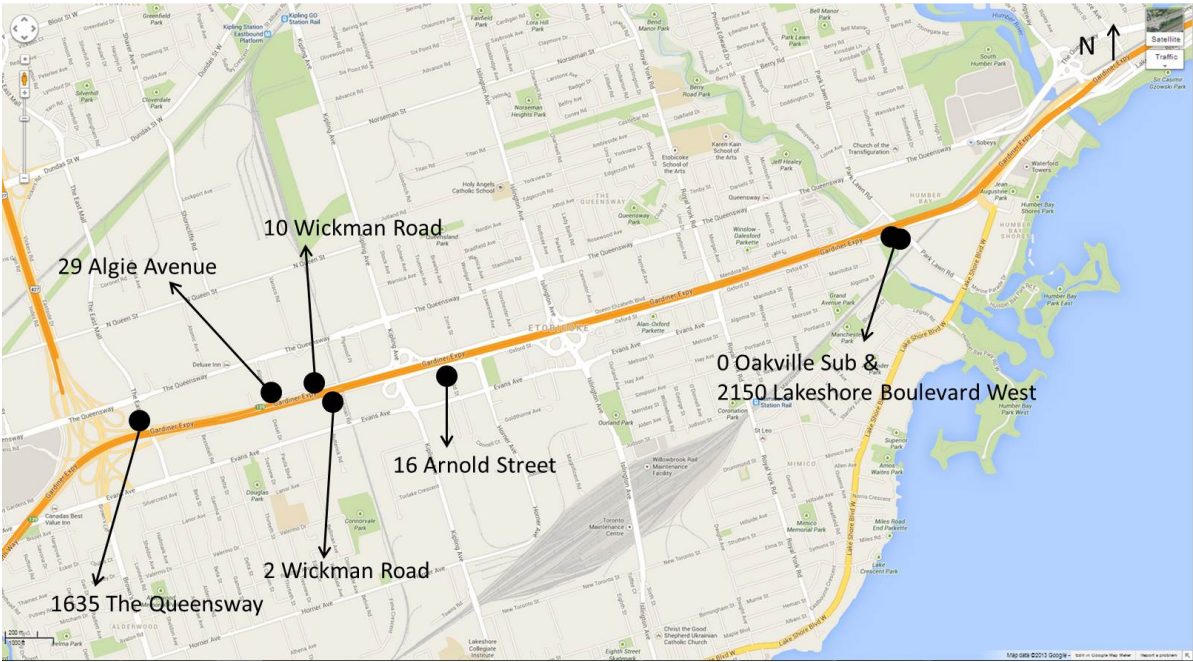
Figure 3: Location of Signs along the F.G. Gardiner Expressway

Figure 3 shows the location of the studied signs along the F.G. Gardiner Expressway, and Figure 4 shows the location of the studied signs along Highway 27.

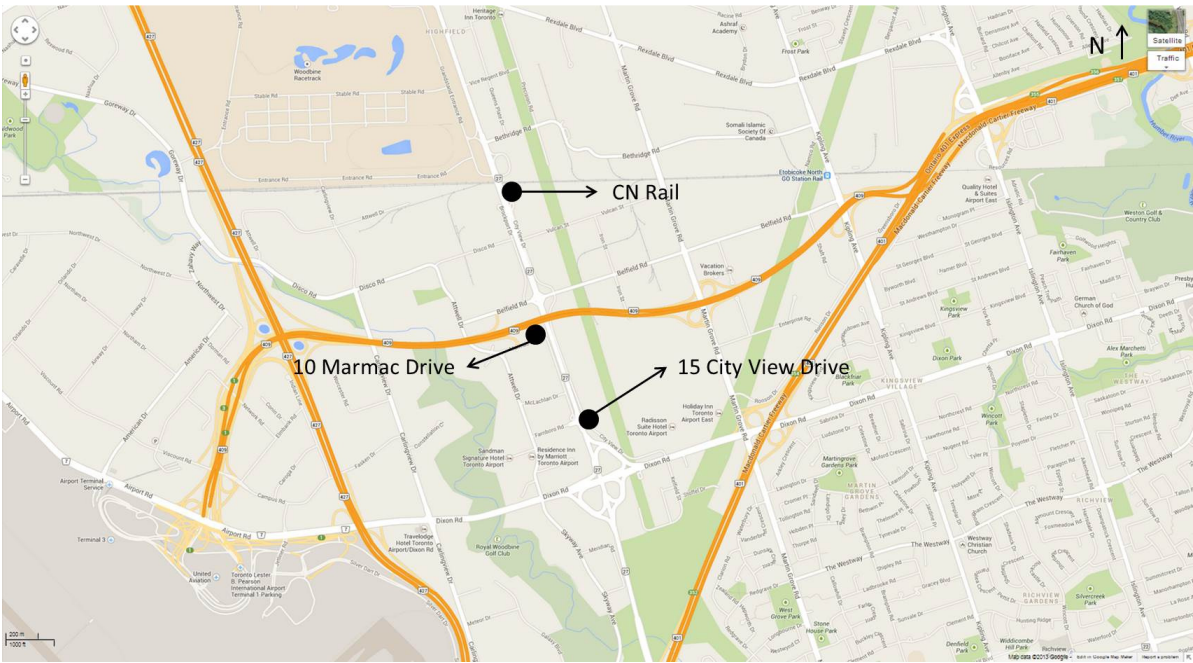
Figure 4: Location of Signs along Highway 27

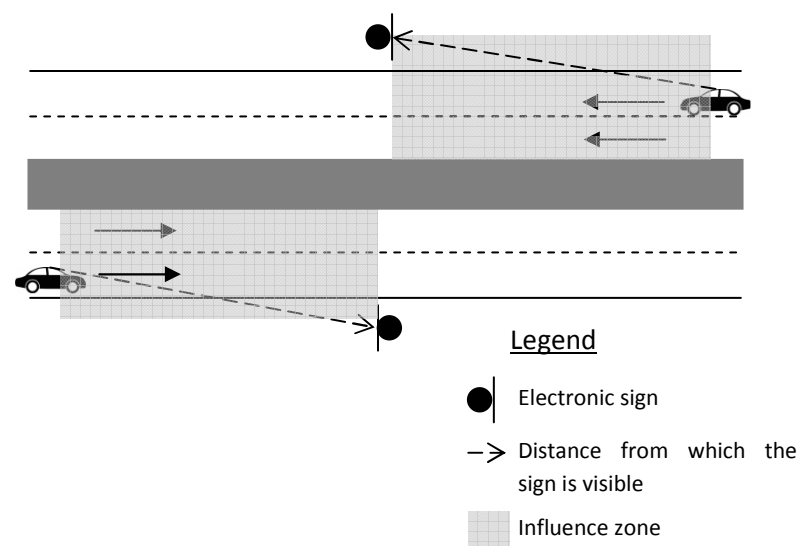
Each of the above electronic signs has a specific influence zone that can be defined as the area in which drivers heading towards the sign face can potentially see the sign and consequently be distracted by it (Figure 5). To determine the influence zone, the furthest distance from the sign at which the sign face is visible to oncoming drivers, was assessed through field visits conducted on June 14 and 15, 2013. Therefore, for this analysis, the influence zone for each sign was considered the treatment site.

Figure 5: Influence Zone

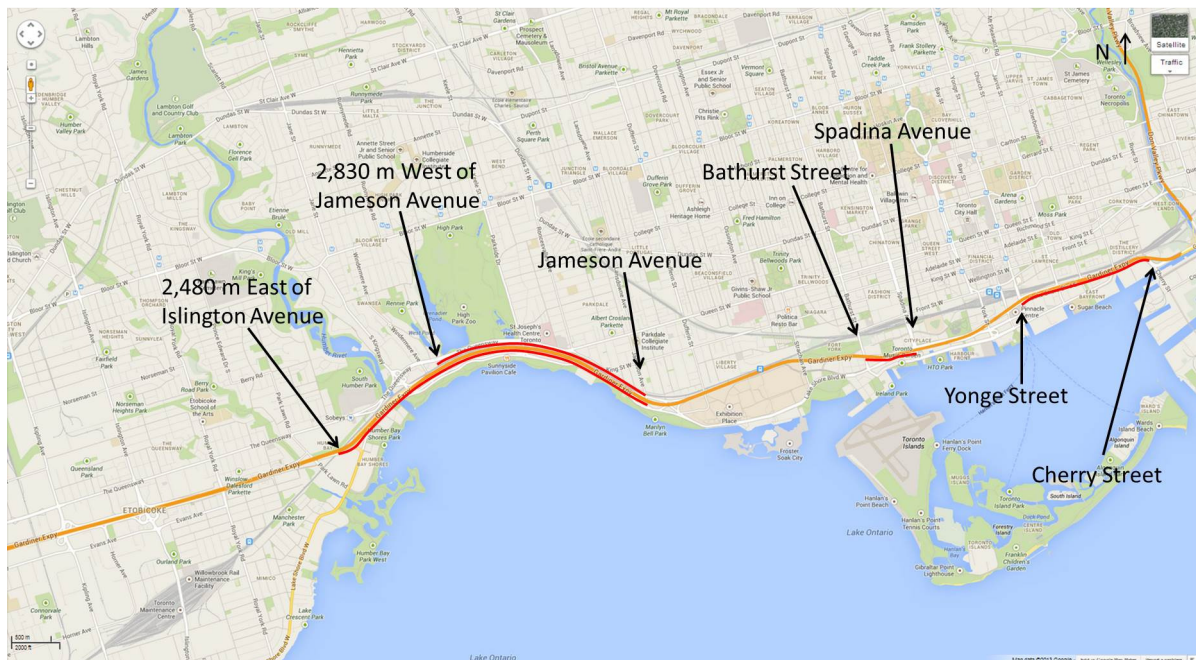
Figure 6: Comparison Sites on the F.G. Gardiner Expressway

Figure 6 shows the comparison sites on the F.G. Gardiner Expressway, and Figure 7 shows the comparison sites on Highway 27.

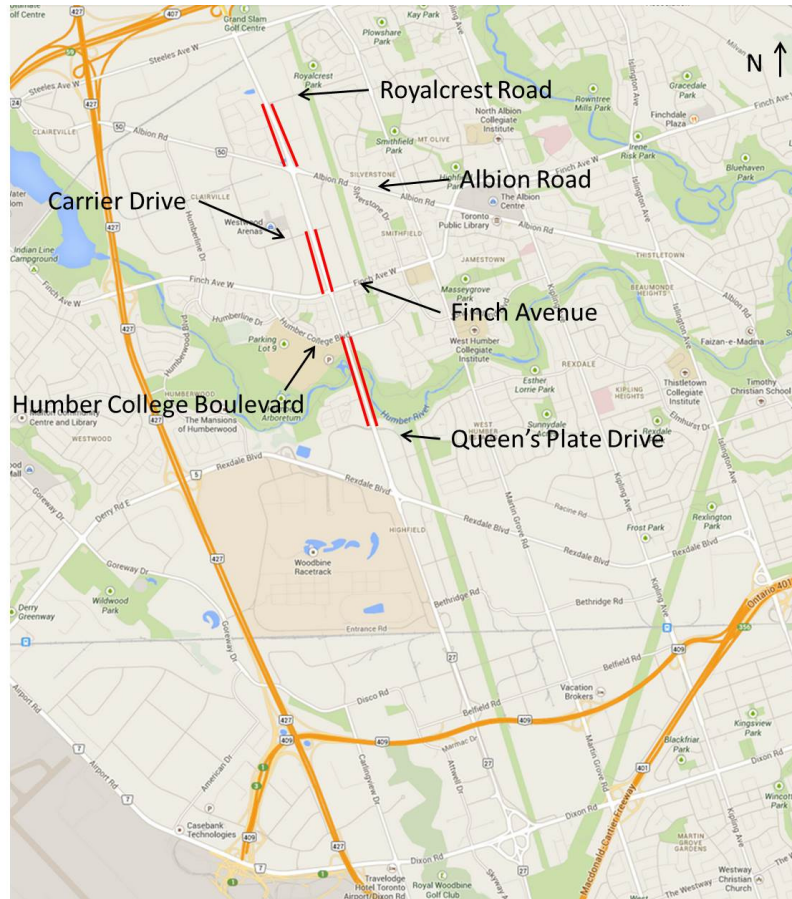
Figure 7: Comparison Sites on Highway 27
