Left-Turn Prohibitions - Middlefield Road at a point approximately 92 Metres South of Steeles Avenue East

Date: December 6, 2019
To: Scarborough Community Council
From: Acting Director, Traffic Management, Transportation Services
Wards: Ward 23, Scarborough North

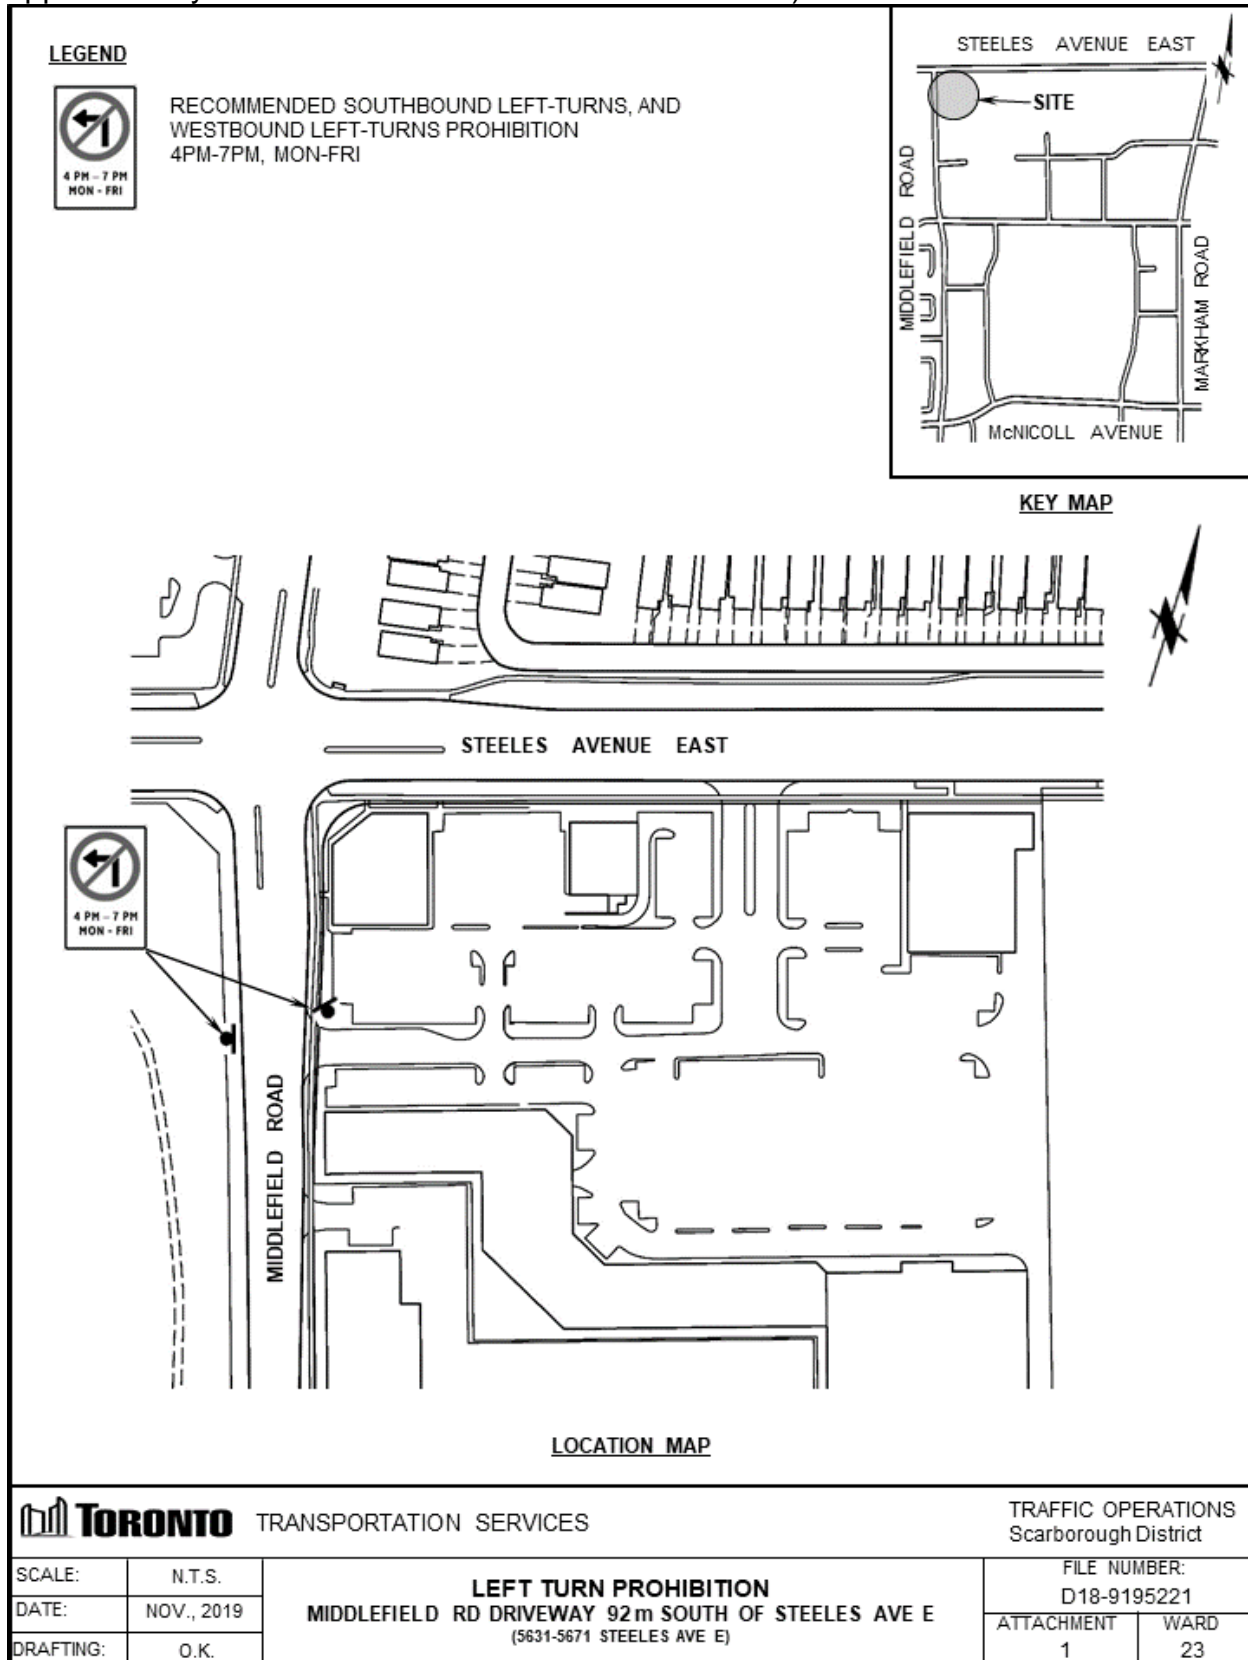
Attachment 1 - Location Plan (Left-turn prohibitions on Middlefield Road at a point approximately 92 metres South of Steeles Avenue East)

This report recommends that southbound and westbound left turns be prohibited from 4:00 p.m. to 7:00 p.m., Monday to Friday at the driveway to Milliken Crossing shopping centre (5631-5671 Steeles Avenue East), located on the east side of Middlefield Road at a point approximately 92 metres south of Steeles Avenue East.
