## Additional Photos

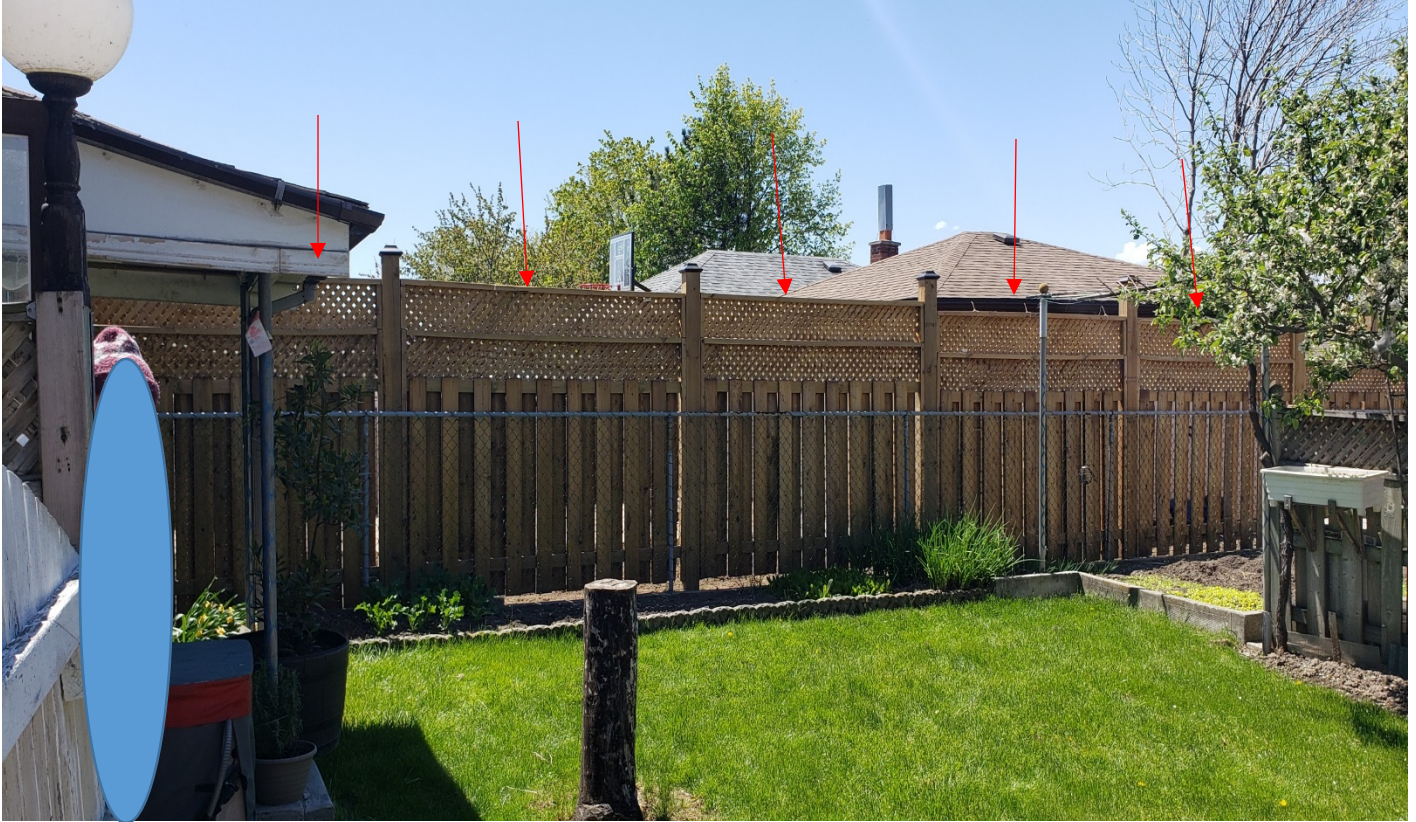
Photo #1:

Photo taken from 104 Lomar Drive.

-5 panels measuring 6ft in width, top layer of lattice is not in compliance, adding 16inch in height to the 2m height.

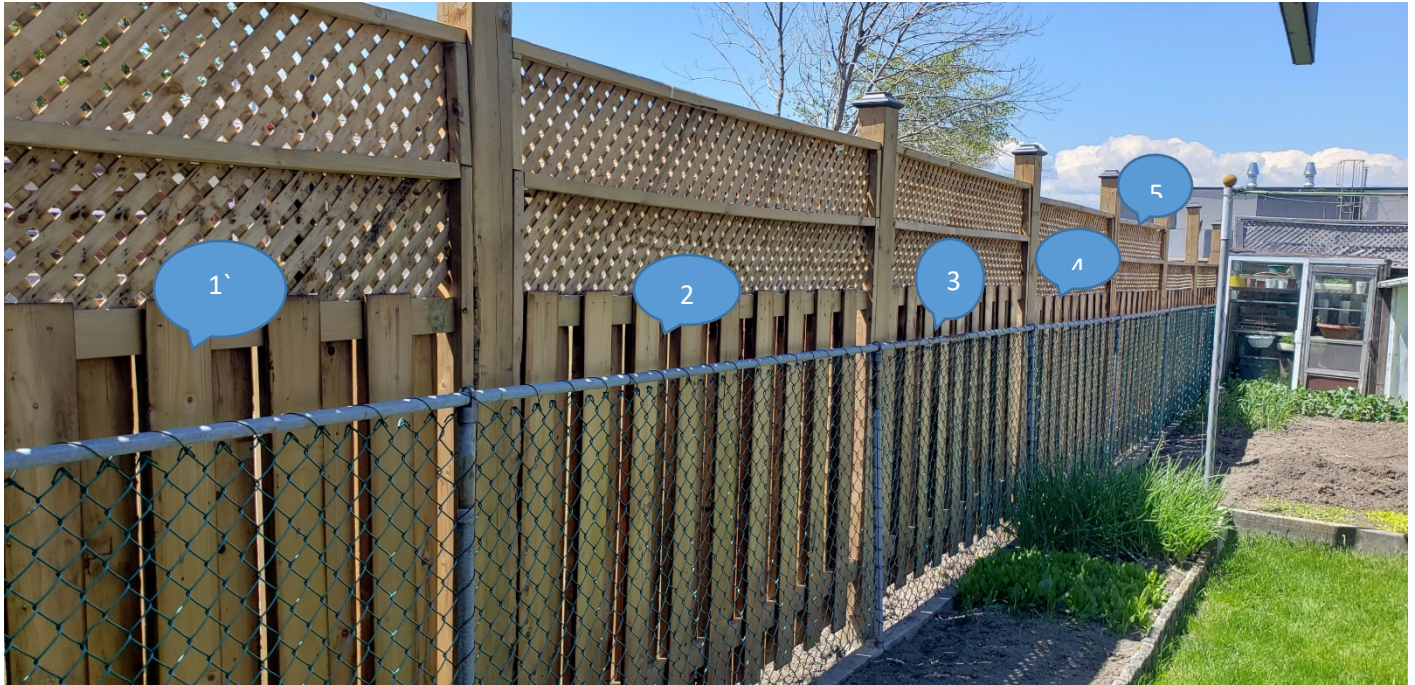
Photo #1:

Photo taken from 104 Lomar Drive.

-5 panels measuring 6ft in width, top layer of lattice is not in compliance, adding 16inch in height to the 2m height.
