RE: IE31.12 Cycling Network Plan - 2022 Cycling Infrastructure Installation - Second Quarter Project Updates

State of Bicycle Parking in Pleasant View

Report by Brad Fonseca, as of 2022-05-12

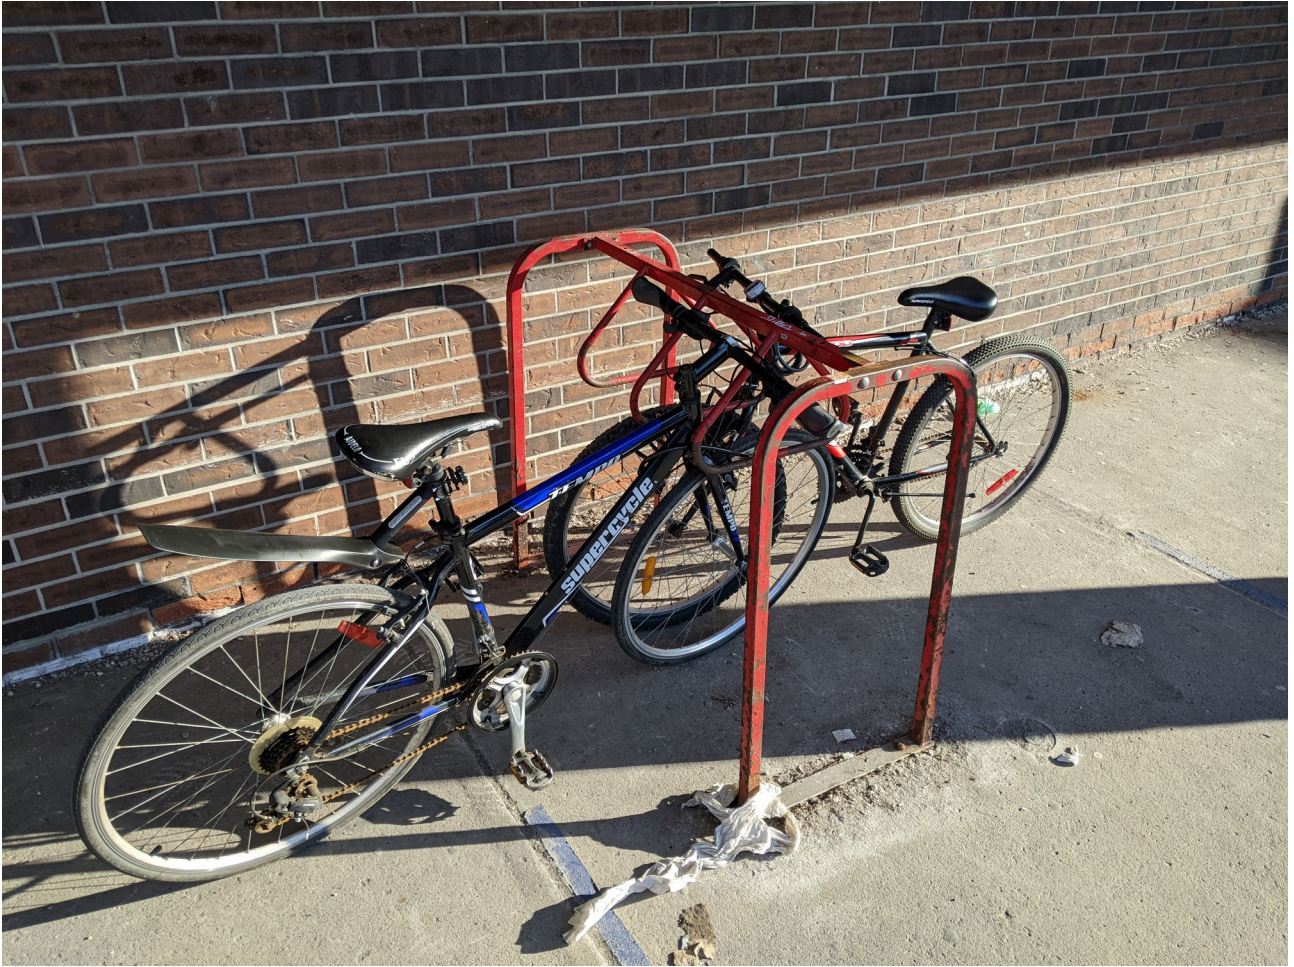
This represents the “best” example of bicycle parking at a shopping plaza in our neighbourhood. It is covered by the building overhang and the rack is tall enough to properly lock up both adult and youth bicycles (both the frame and the wheel).

However, the bicycle rack appears to be made of an untreated metal that rusts, as seen where the paint has flaked away. At minimum, it would benefit from a new paint job. The other issue is this bicycle rack represents the entirety of the available bicycle parking in this plaza. There is a capacity for four or five bicycles, at most. It is also located on one end of this large plaza, in front of the Value Village. If you have errands to run at the other end of the plaza you will have to walk from the opposite end as this is the only bicycle parking available.

Figure 1: Victoria Van Horne Plaza Bicycle Parking (in front of Value Village). Note the visible rusting on the rack.

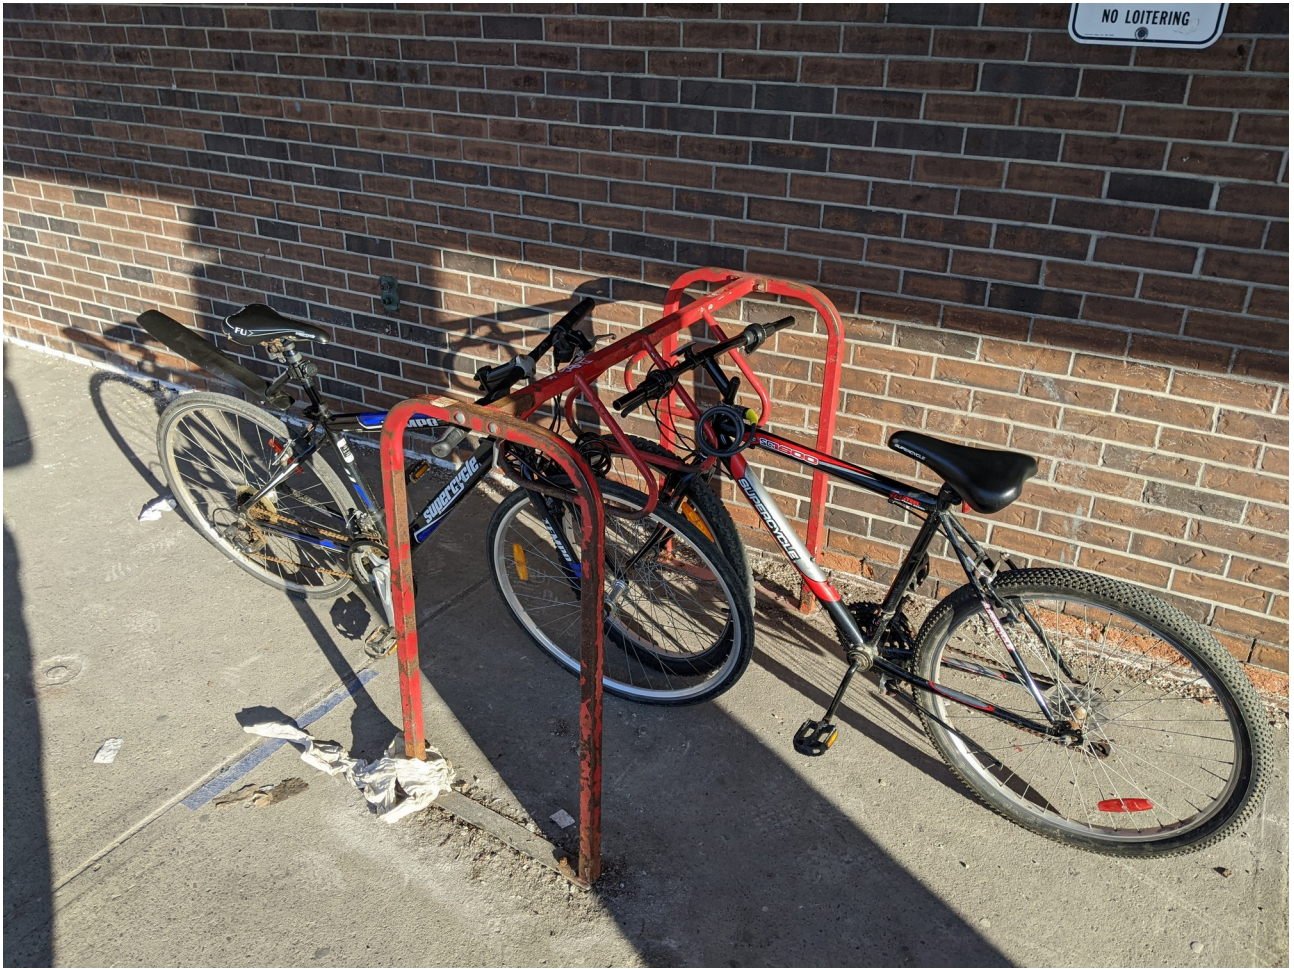
Figure 2: Victoria Van Horne Plaza Bicycle Parking (in front of Value Village – reverse angle)

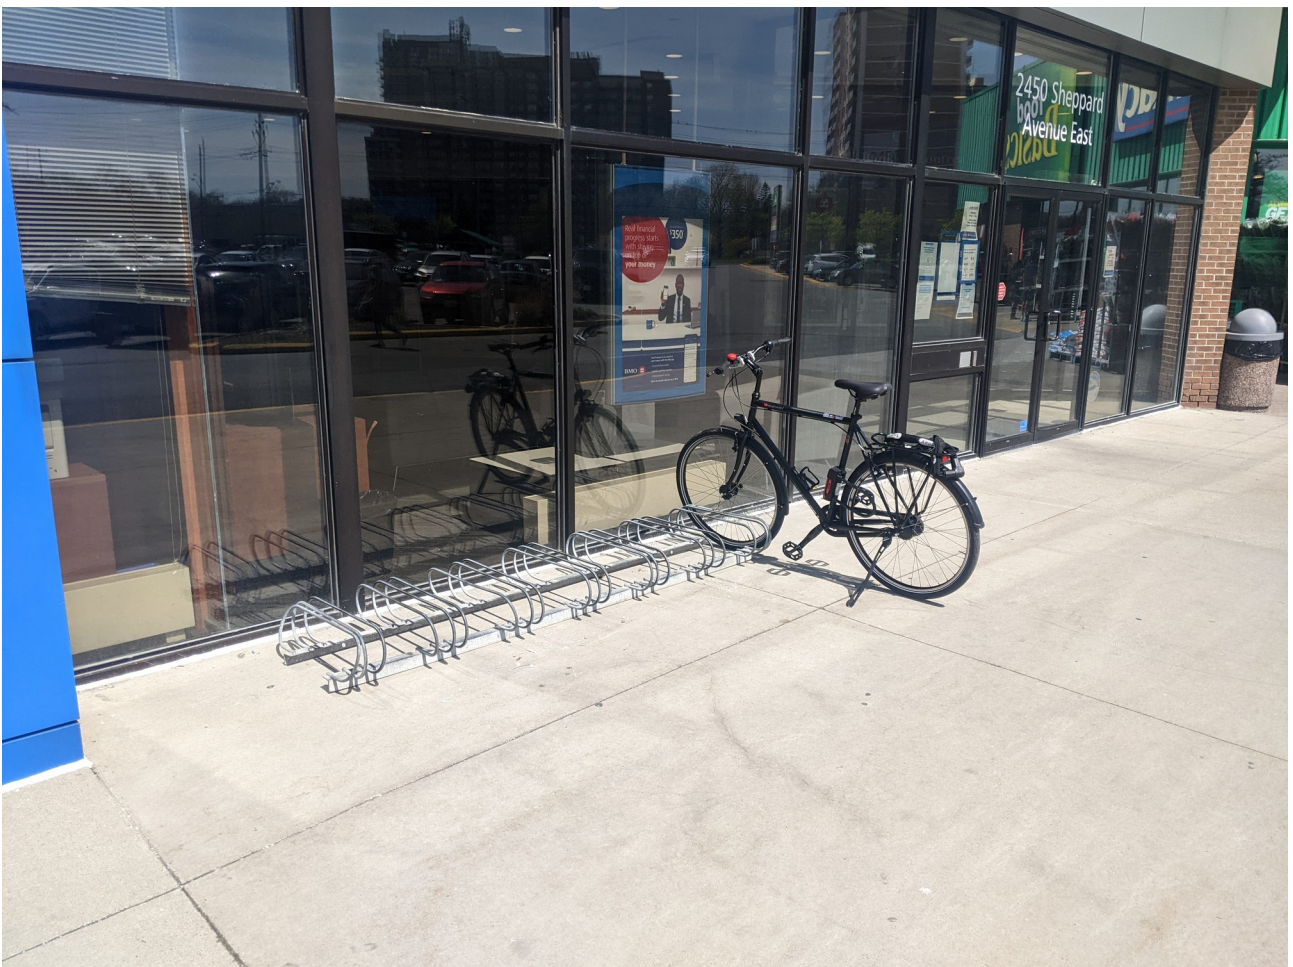
This example suffers from some of the same issues noted above. The one rack is still located towards one end of the plaza, in front of the Bank of Montreal, requiring the cyclist to walk all the way back to visit the Winners (for example). It is also what the reference document refers to as a “wheel bender” rack. If one wants to properly lock up their bike, then they will need to bring multiple locks to at least lock the frame to the front wheel. However, it is only possible to lock the wheel to the rack, leaving the bicycle vulnerable to theft by simply removing the wheel from the frame and stealing most of the bicycle. The bicycle is also more vulnerable to vandalism (the “wheel bending”).

Figure 3: The “Wheel Bender” bicycle rack in Victoria Park Square (in front of Bank of Montreal)

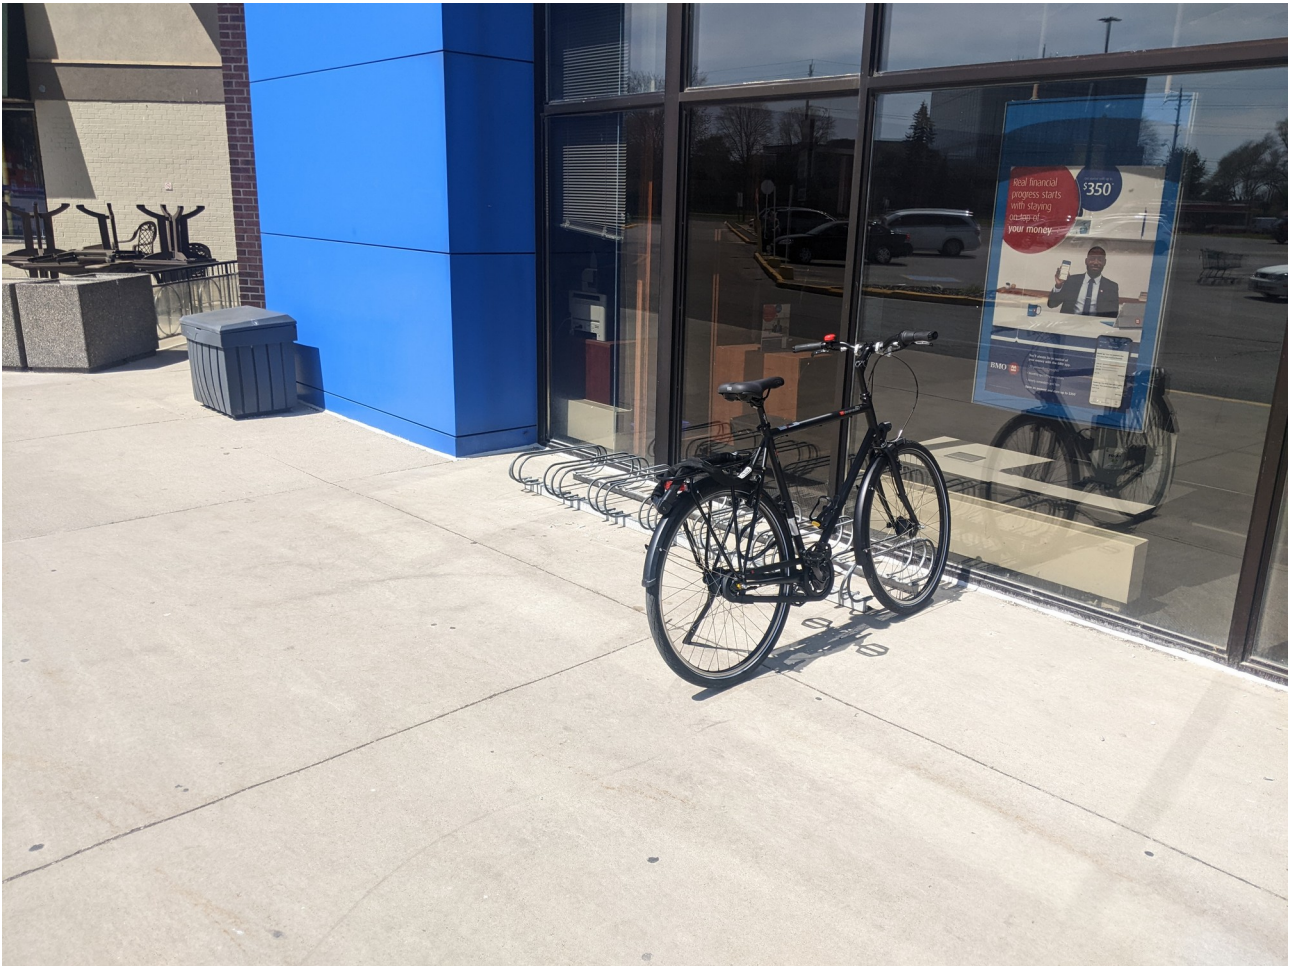
Figure 4: The “Wheel Bender” bicycle rack in Victoria Park Square (in front of Bank of Montreal – reverse angle)

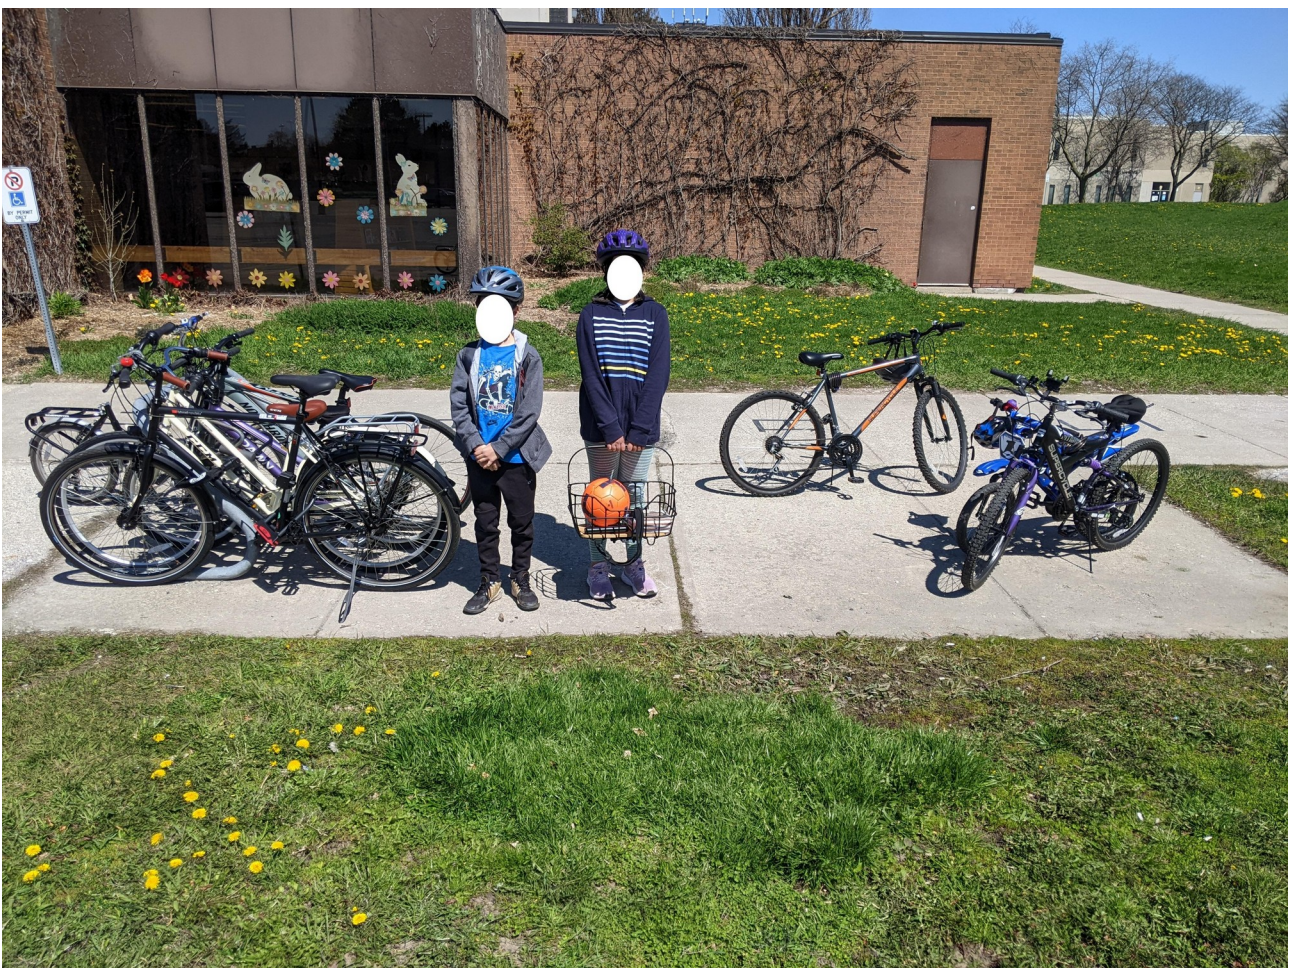
The local library branch has a reasonably good bicycle rack that allows one to lock up both the bicycle's wheel and frame. However, it gets easily overwhelmed by patrons (mostly local children) who bicycle to the library on the weekend or during other peak times.

Figure 5: Bicycle rack in front of Pleasant View Public Library. Note that the number of bicycles exceed available capacity. Some are not even locked up at all!

As can be seen, some patrons are forced to just park their bicycles where they can, without being able to securely lock them up. It is a testament to the safety felt by the residents of Pleasant View that one can observe bicycles left unattended and unlocked by library patrons.

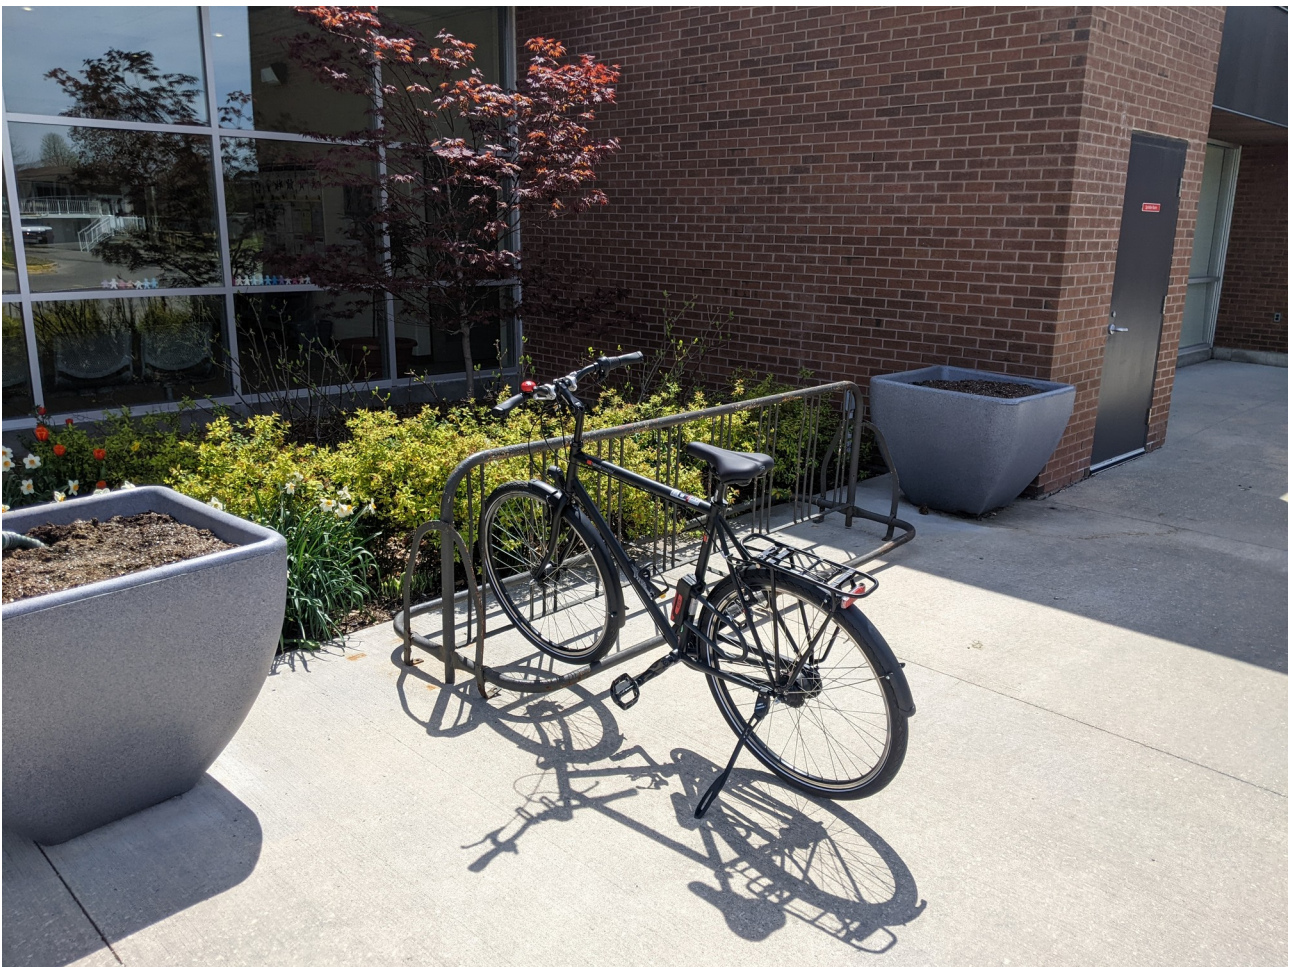
The community centre, located in the same “plaza” as the public library, also has its own bicycle rack. The rack need to be modernized though, as this is another example of the “wheel bender” bike rack. One cannot get their bicycle far enough into the rack to allow for at least two points of contact to secure the wheel and frame to the rack (though at least one could theoretically lock their bicycle to one of the outside edges).

Figure 6: The “Wheel Bender” bike rack in front of Pleasant View Community Centre. Note that one cannot lock a bicycle’s wheel and frame with this style of bicycle rack.

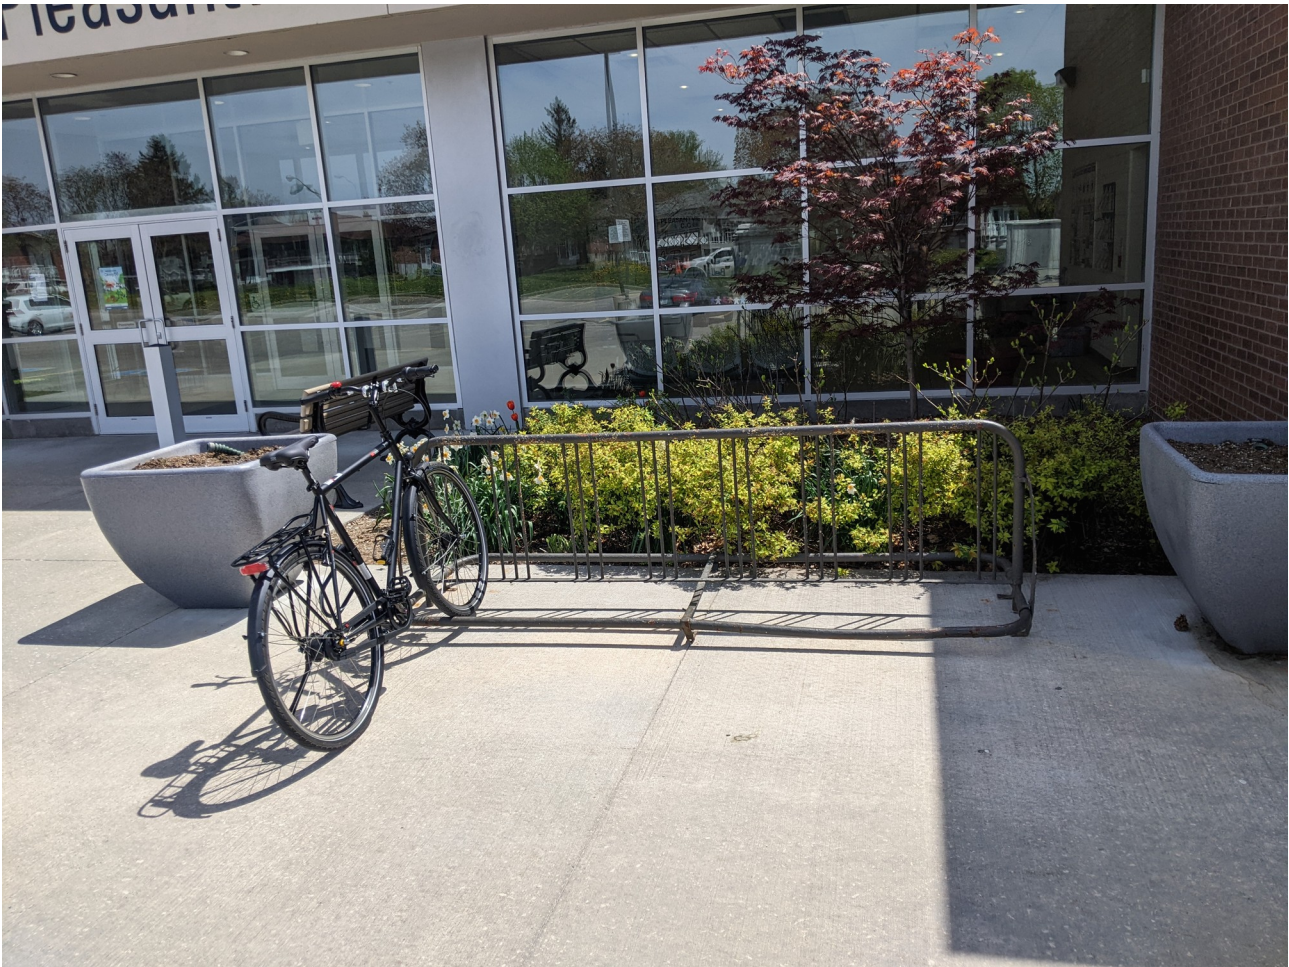
Figure 7: The “Wheel Bender” bike rack in front of Pleasant View Community Centre (reverse angle)
