## **Traffic Control Signals - Shuter Street at Sackville Street and Shuter Street at Sumach Street**

**Date:** June 13, 2022

**To:** Toronto and East York Community Council

**From:** Director, Traffic Management, Transportation Services

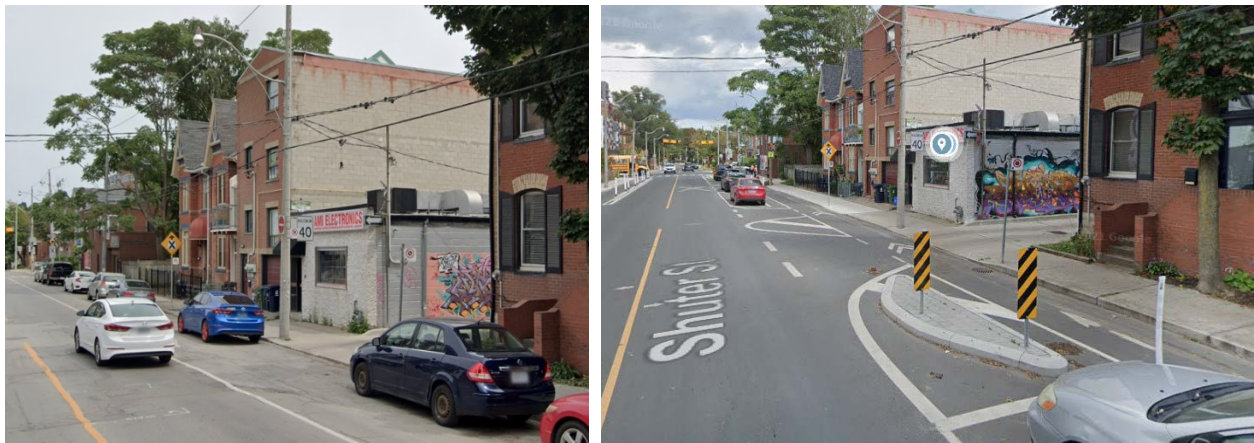
Figure 1: On the left is a photo of the before condition at Tracy Street and on the right is a photo the after condition at Tracy Street

Before the installation in 2020, motorists could park adjacent to all the streets and laneways mentioned without any setbacks. As part of the cycle track and road reconstruction, sightline setbacks have been reinforced by utilizing pre-cast parking islands and pavement markings. The pre-cast concrete islands and pavement markings follow Transportation Services and Ontario's standards to ensure proper sightlines for motorists in motor vehicles exiting side streets and laneways.

Transportation Services has also completed several site visits along the corridor to observe major obstructions of sightlines. No major obstructions were found on site. Transportation Services also reviewed the 2021 collision data and did not find a trend of collisions at driveways or side streets.
