Cabbagetown Southwest  
Heritage Conservation  
District (HCD) Plan

CABBAGETOWN SOUTHWEST  
HERITAGE CONSERVATION DISTRICT

HCD PLAN

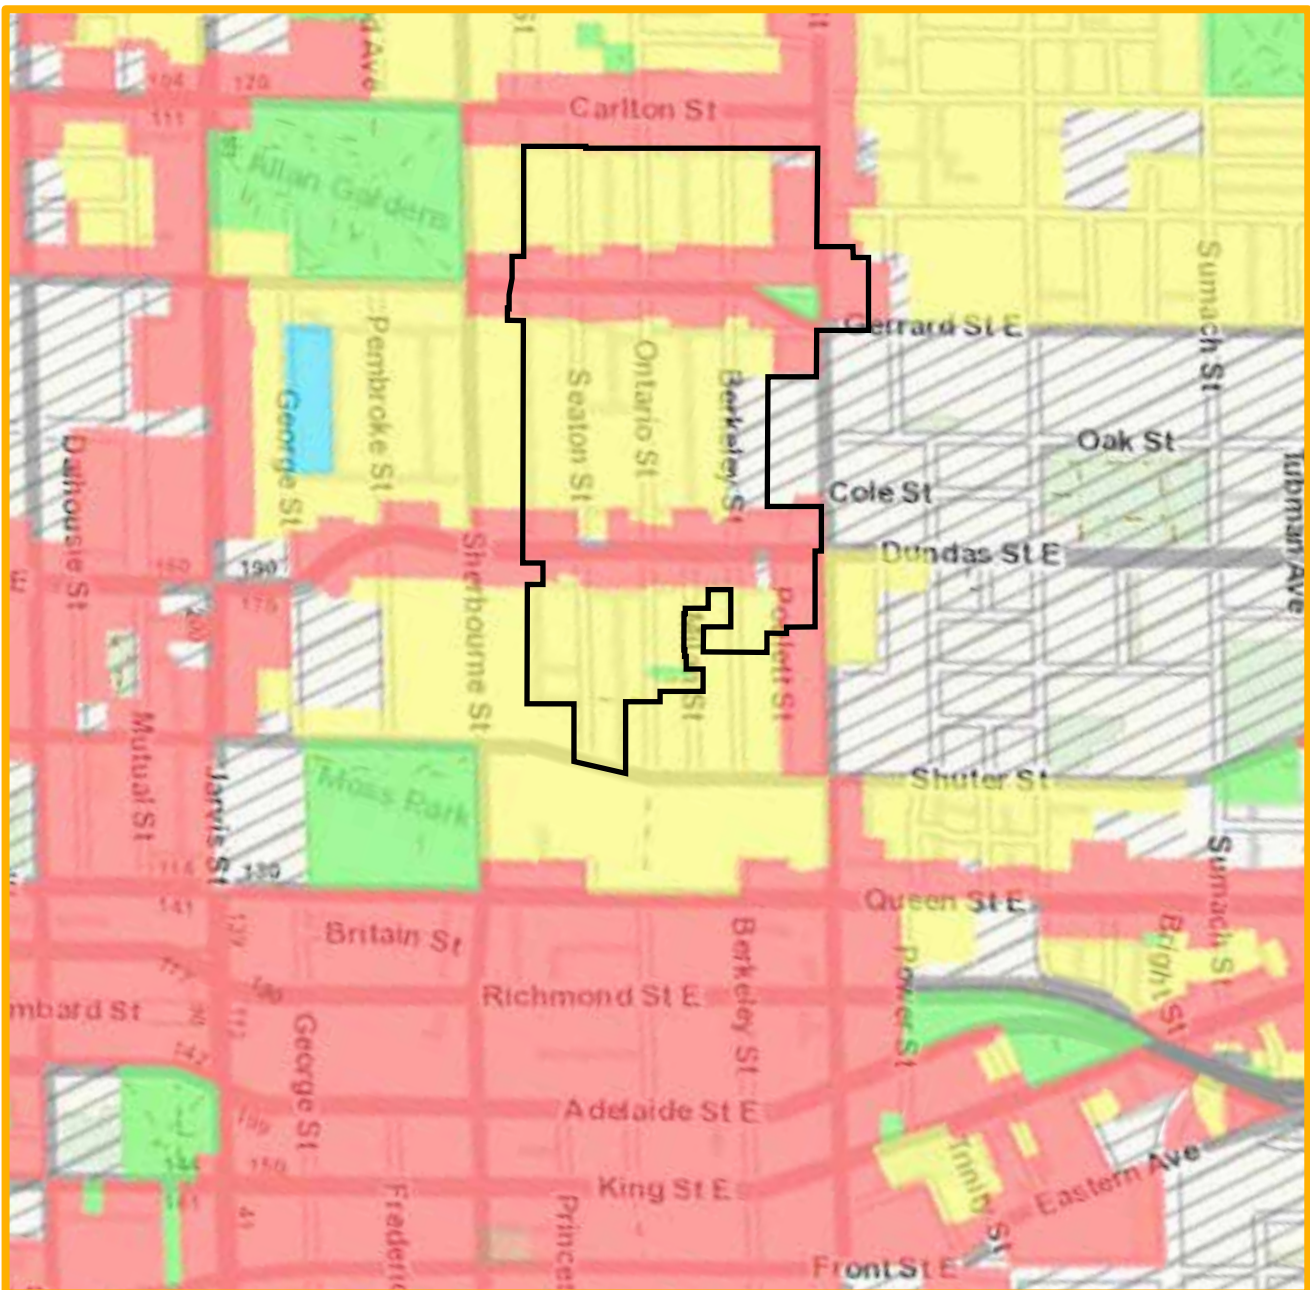
Figure 12 (Above): The HCD Plan area overlaid on the zoning map; red-shading is Commercial-Residential zoning and yellow shading is Residential zoning.

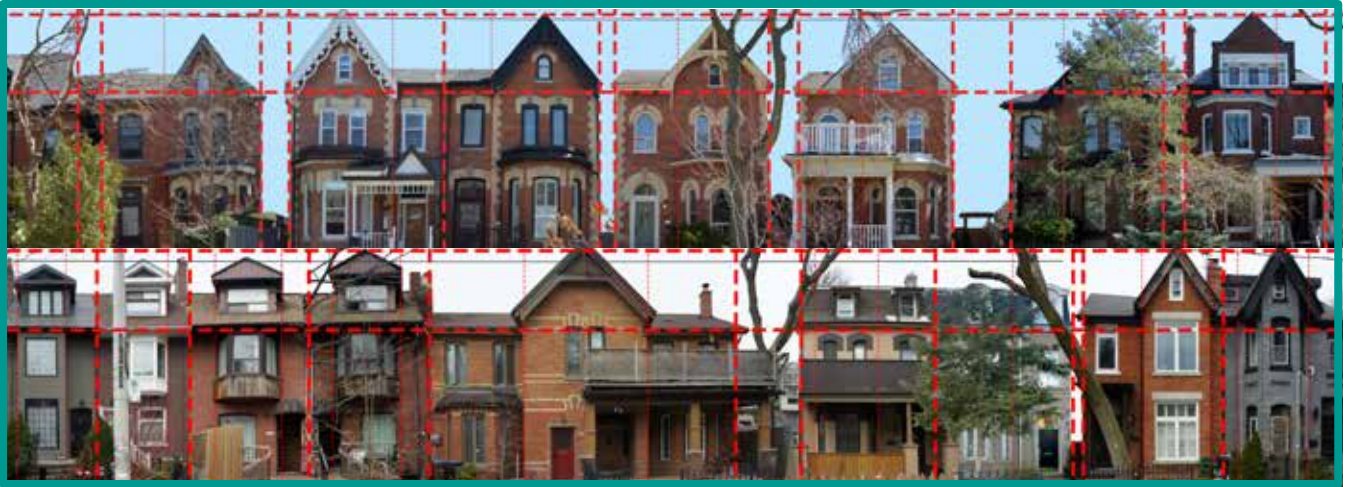
Figure 18: Vertical and horizontal articulation (datum lines) heritage attributes outlined.

The neighbourhood's contextual values are based on the streetscapes with dense fine grain historic residential buildings that create a sense of time and place. The streetwalls are defined by low-rise buildings with narrow frontages, a datum line of pitched roofs with intersecting gables, an articulated rhythm of bays and gables, a predominance of brick cladding, and mixture of late 19th and early 20th-century architectural styles. Although the architecture is extremely cohesive throughout the district given the narrow period of development, each building maintains a level of uniqueness through its ornamentation and detailing. The area's distinct identity is further accentuated by its juxtaposition to the Moss Park and Regent Park areas of urban renewal immediately adjacent to the south and east where the original fine grain neighbourhoods were replaced with large-scale developments.

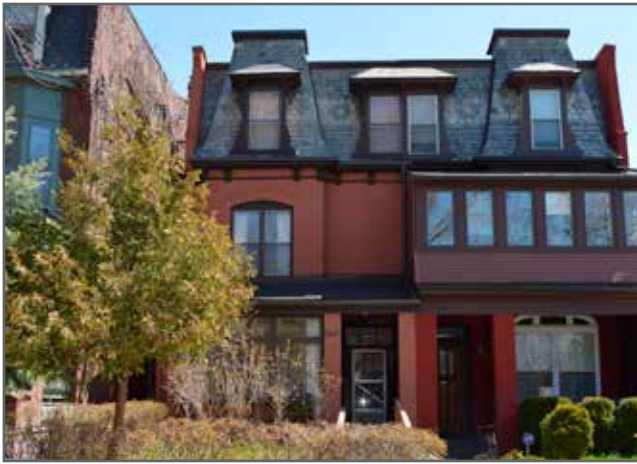
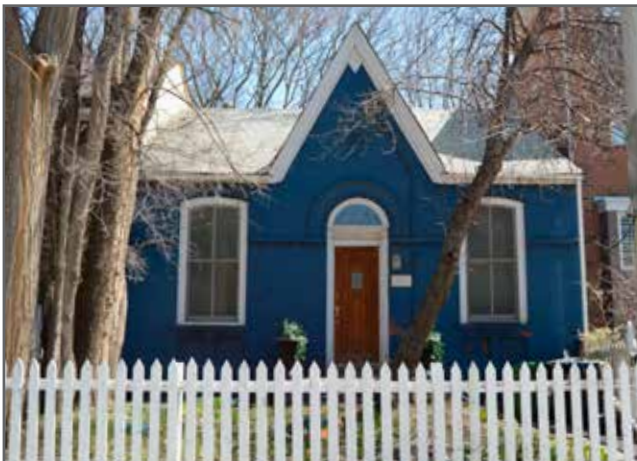
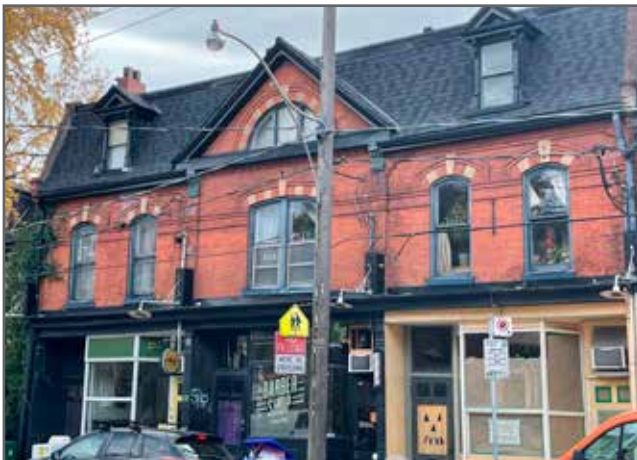
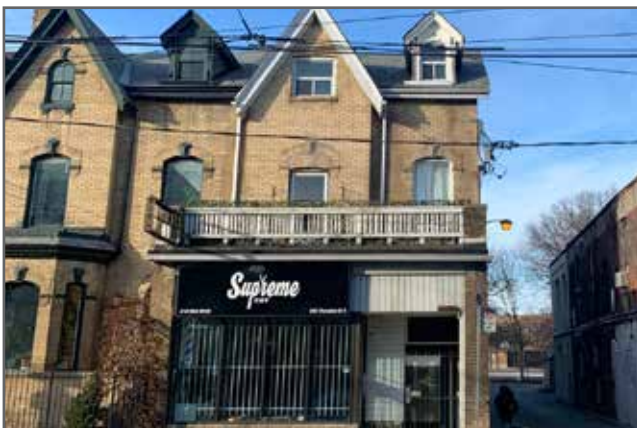
The side gable typology has a side-gabled roof structure often with a projecting bay. The side gables are generally 2.5 storeys tall, and the projecting bays range from the first storey to the full height. The side gables can have two to three bays and are often asymmetrical in composition with an off-centre entrance.

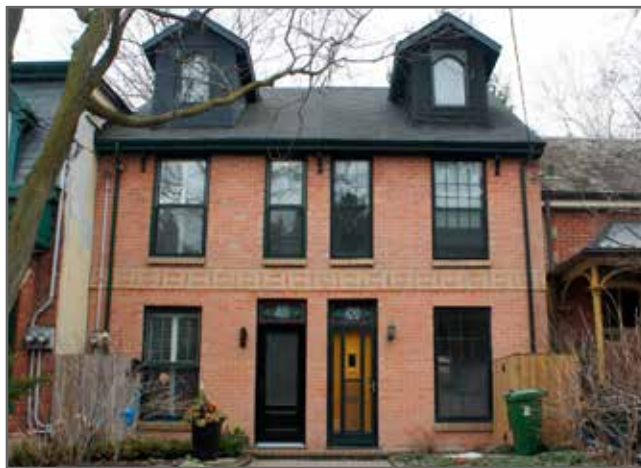
Figure 35: 418-420 Ontario St.

The Georgian Revival style is simple and understated with minimal ornamentation. Buildings are often constructed of brick, stone or clapboard, range between 1 and 2.5 storeys, have a simple rectangular plan, and may incorporate a hip or gable roof structure.

Cabbagetown Southwest includes many examples of working and middle class Georgian Revival houses with several groupings located on Seaton Street, south of Dundas Street East.

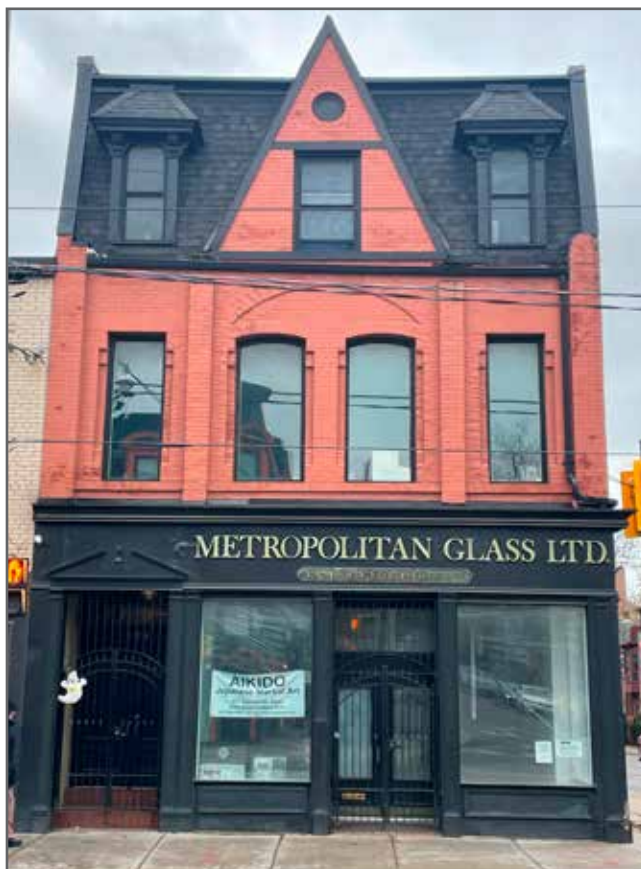
Figure 36: 377 Dundas St. E.

Residential Italianate loosely draws inspiration from Italian palazzos using classical detailing such as wooded arcade porches, segmental arched windows with extravagant hood mouldings, quoins, and ornamental bracketing under the eaves.

The majority of properties in this style are located on Gerrard and Dundas streets; however, the residential sub-style is prominently used, with only two buildings along Dundas Street that fit the commercial Italianate mould.

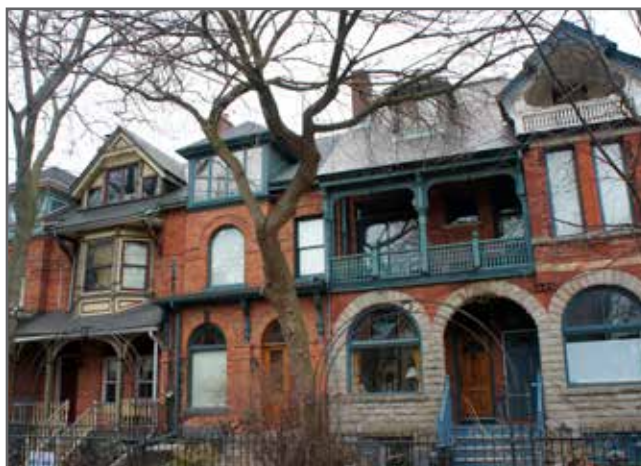
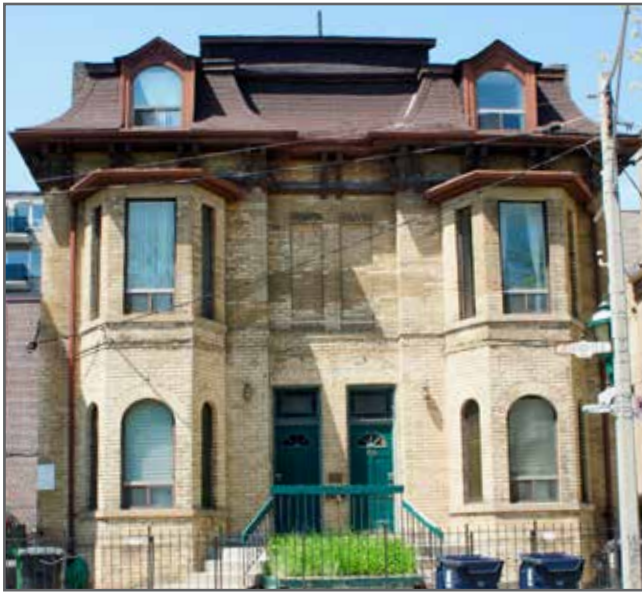
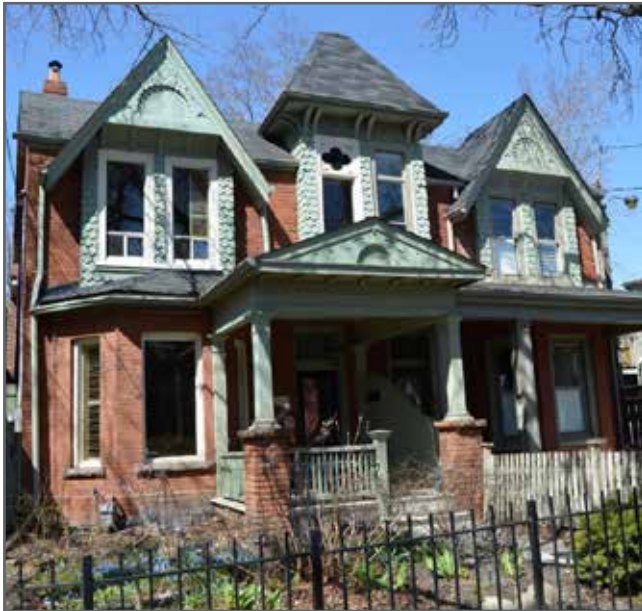
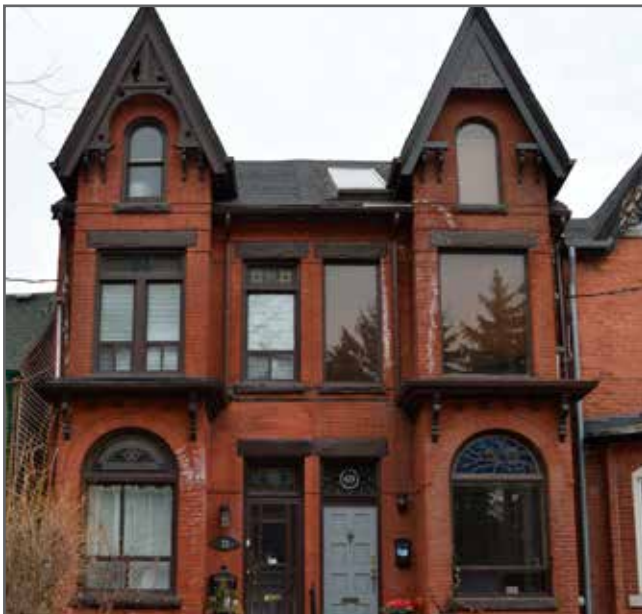
Romanesque Revival drew from early medieval architecture, particularly monastic architecture that incorporated classical elements. It uses early medieval motifs in a highly ornamental form; arched windows, arched and segmental openings, drip moulds, and stone courses incorporated into brick façades are common features. These buildings are often asymmetrical with a grounded expression of the masonry structure and brick corbelling. There are only a few examples within Cabbagetown Southwest along Seaton, Berkeley, and Ontario Streets.

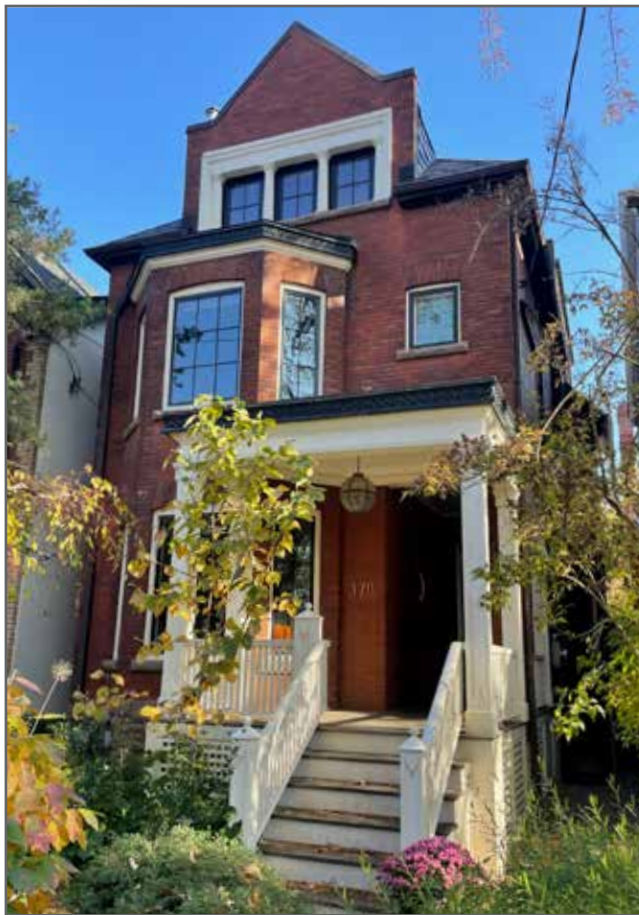
Figure 41: 379 Berkeley St.

The Victorian style draws from multiple influences and is characteristic of buildings built between 1840 and 1900. Cabbagetown Southwest is predominantly composed of Victorian housing that blends Gothic Revival, Italianate, Romanesque Revival, and Queen Anne Revival elements (40% of the existing building stock); and can be found on all streets within the district.

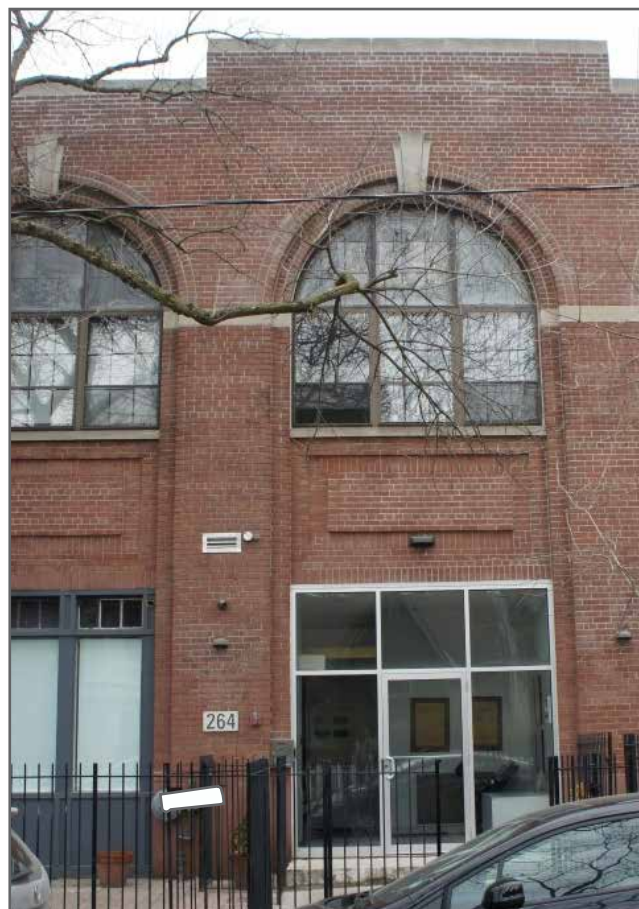
Figure 42: 264 Seaton St.

The Edwardian style is noted for its simplified and restrained classical detailing including its regular window rhythm, pediments, columned entrances or porticos, simple rooflines, bay windows, dormers, and brick cladding. All the Edwardian-style buildings within Cabbagetown Southwest are on the residential streets except for 331–335 Dundas Street. The highest concentration of this style can be found along Seaton Street.

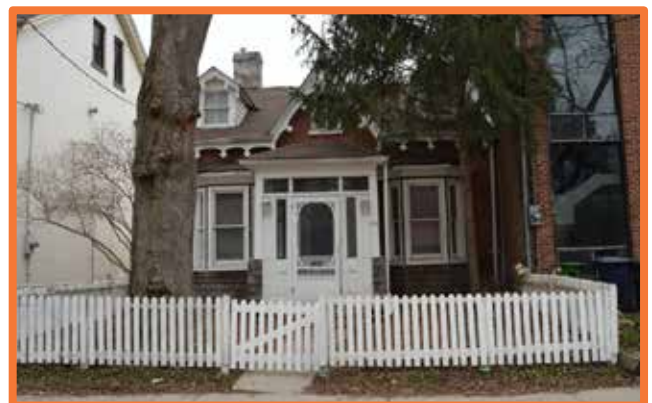
Front yard fencing is prevalent in the Cabbagetown Southwest. It was noted by residents in the Community Advisory Group meetings that these fences are a more recent addition to the neighbourhood, and that historically they would not have existed. It was also noted that many of the fences are a security feature for the residences. Most of them are composed of iron pickets that allow a view of the front yard and house; however, some solid wood fences block off these views. While most of the fences are at waist height, a few residences have erected higher fencing. Most properties with fencing have some type of front yard green space except for the mixed-use properties that face Dundas and Gerrard Streets. The fences on Berkeley Street are mostly in metal (cast or wrought iron, steel pickets), whereas Seaton and Ontario Streets have a mix of both wood and metal fencing.

Figure 48: An example of wood fencing used in the area.

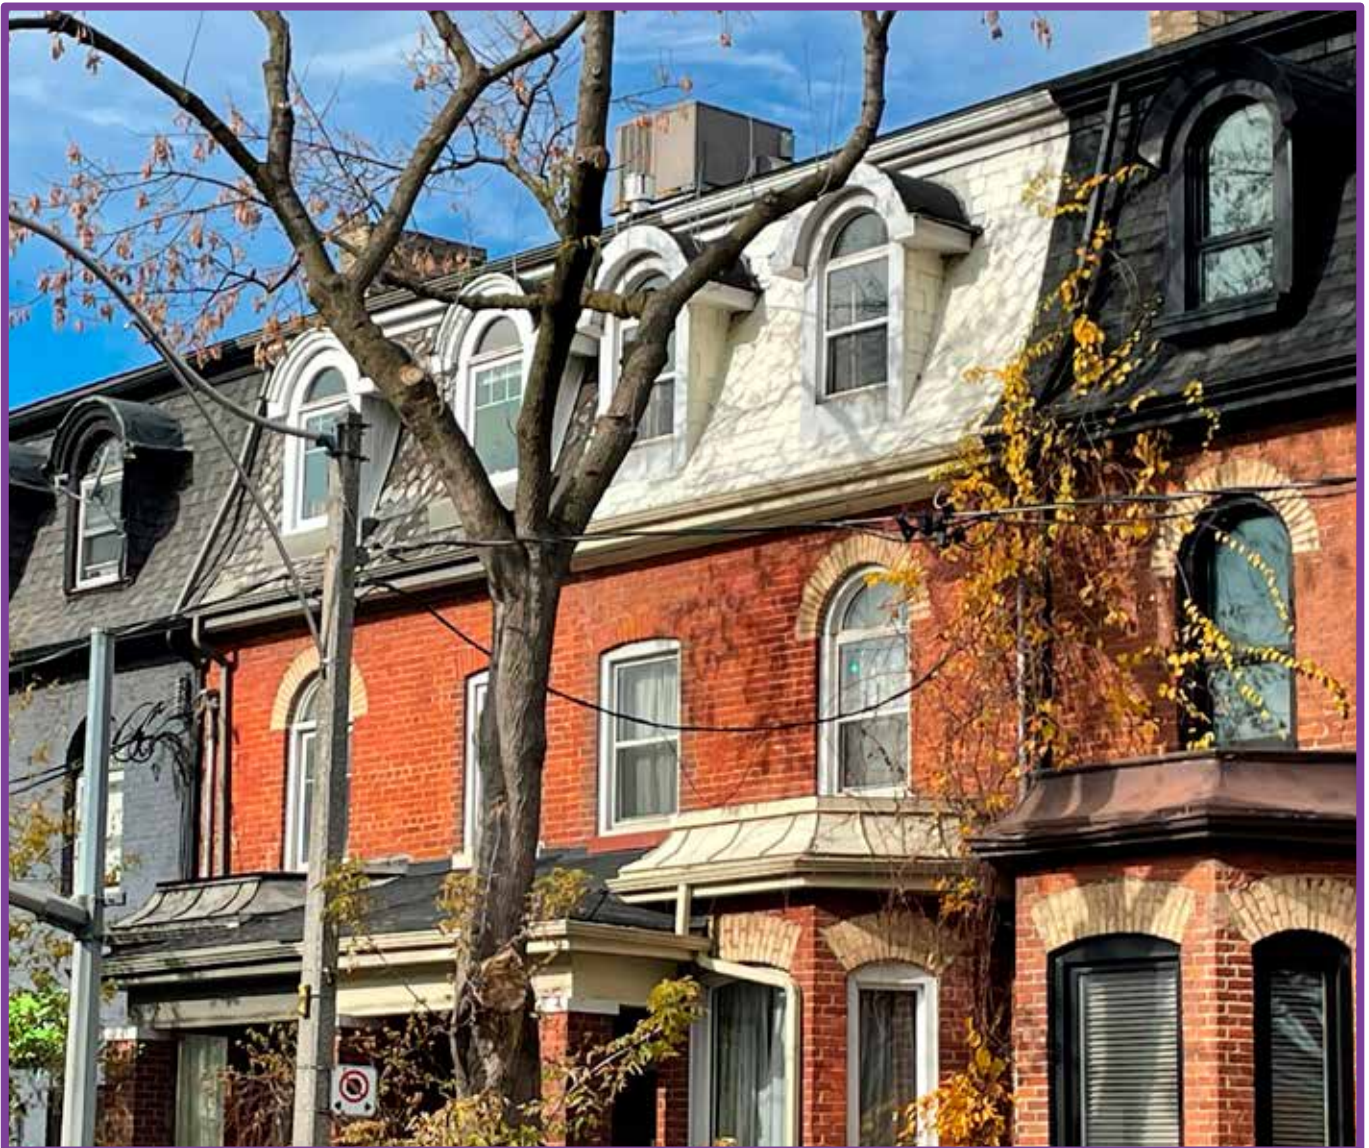
Figure 65: Consistent roofline of 242-252 Gerrard St. E

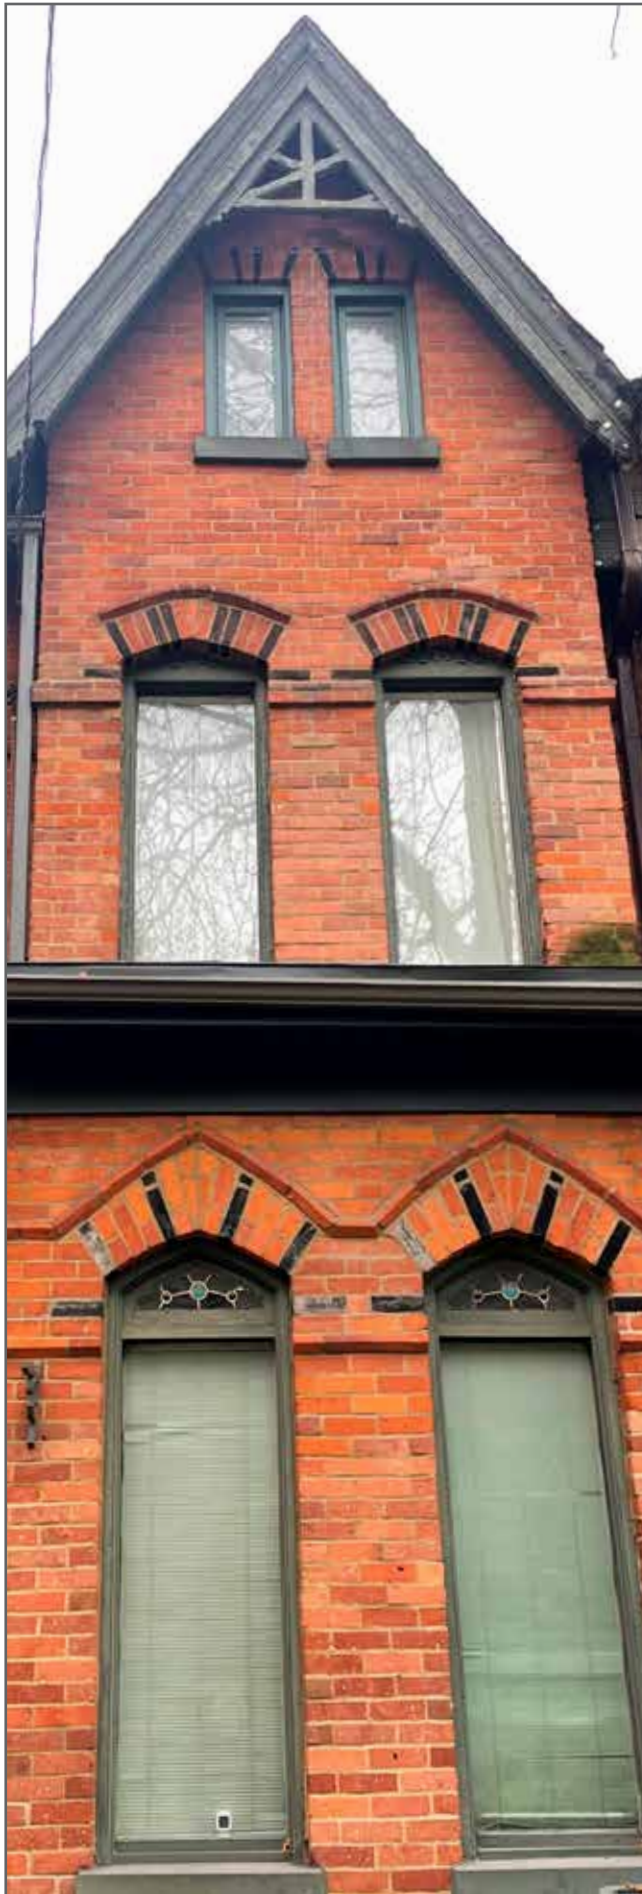
Figure 68: Retention of ground floor transom lights at 175 Seaton St.

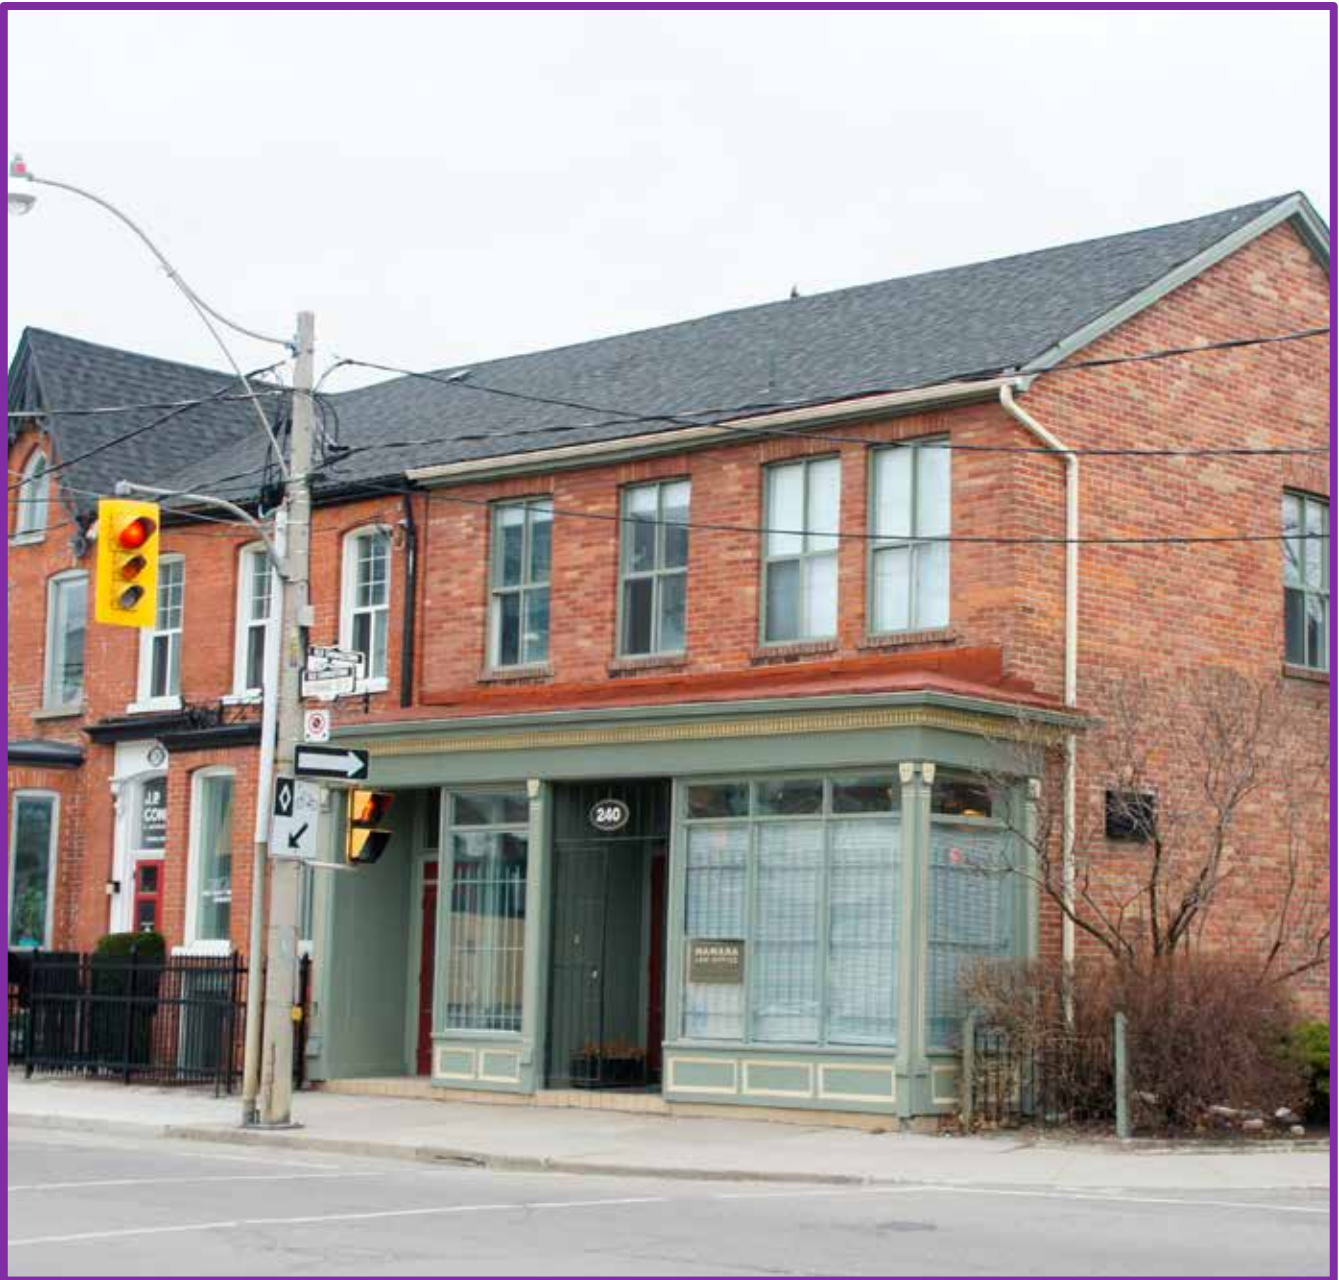
Figure 70: Historic storefront at 240 Gerrard St. E.

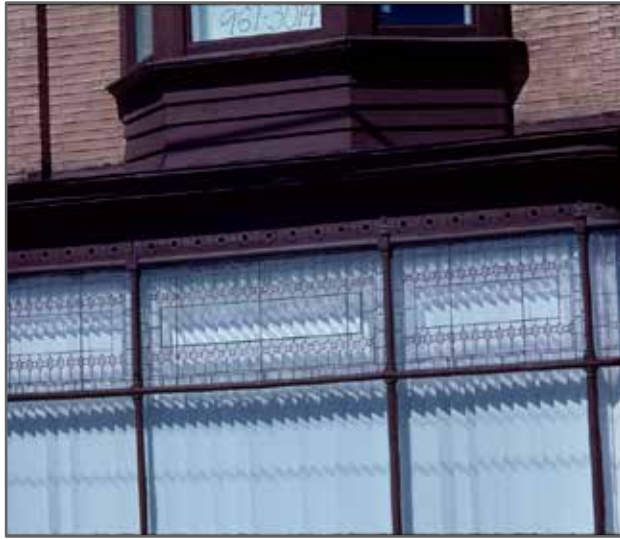
Figure 71: Historic storefront details at 412 Dundas St. E., 1984, City of Toronto Archives.

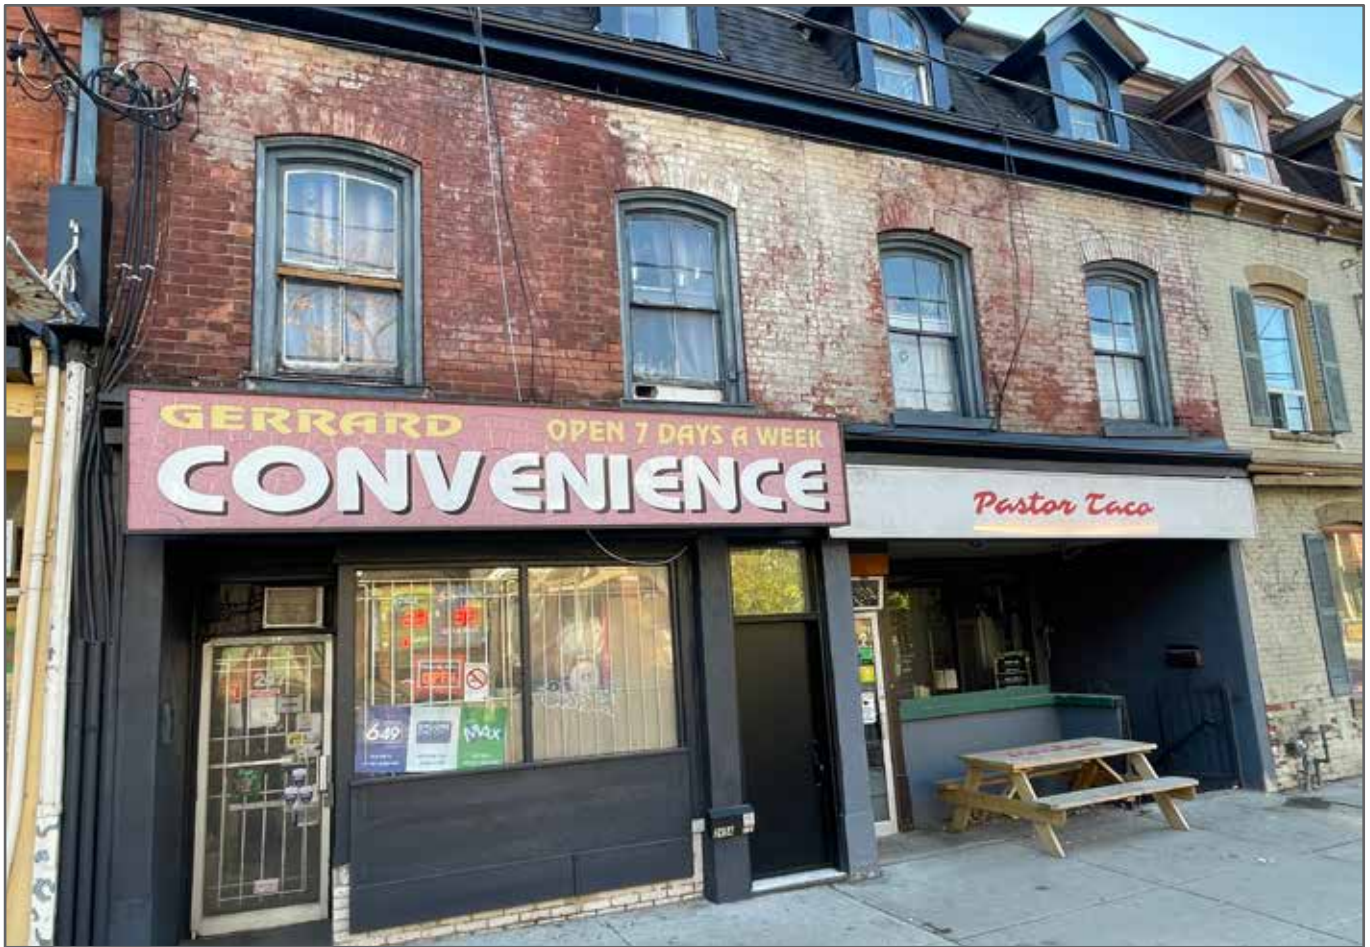
Figure 72: Gerrard St. E. storefront with non-historic finishes.

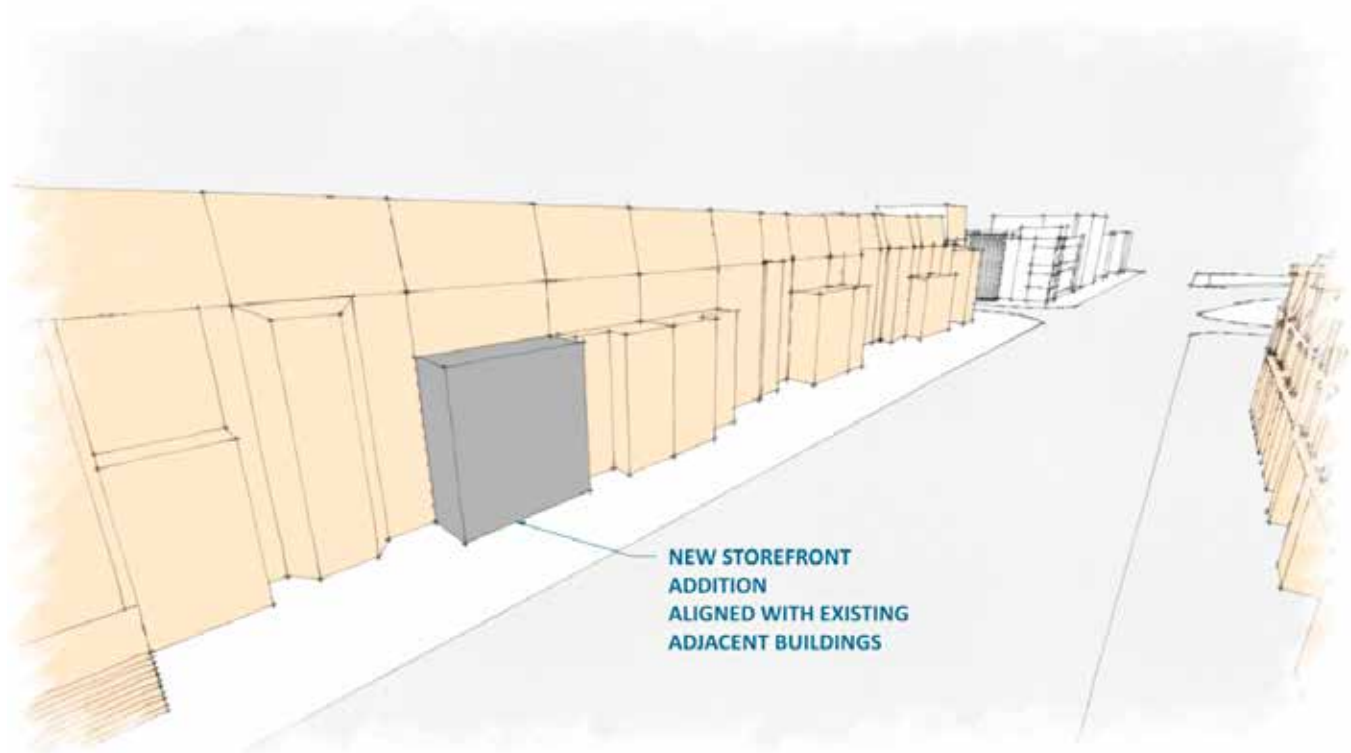
**Figure 73:** Diagram illustrating a new storefront addition on a *contributing property* in the Dundas and Gerrard *character sub-area*.

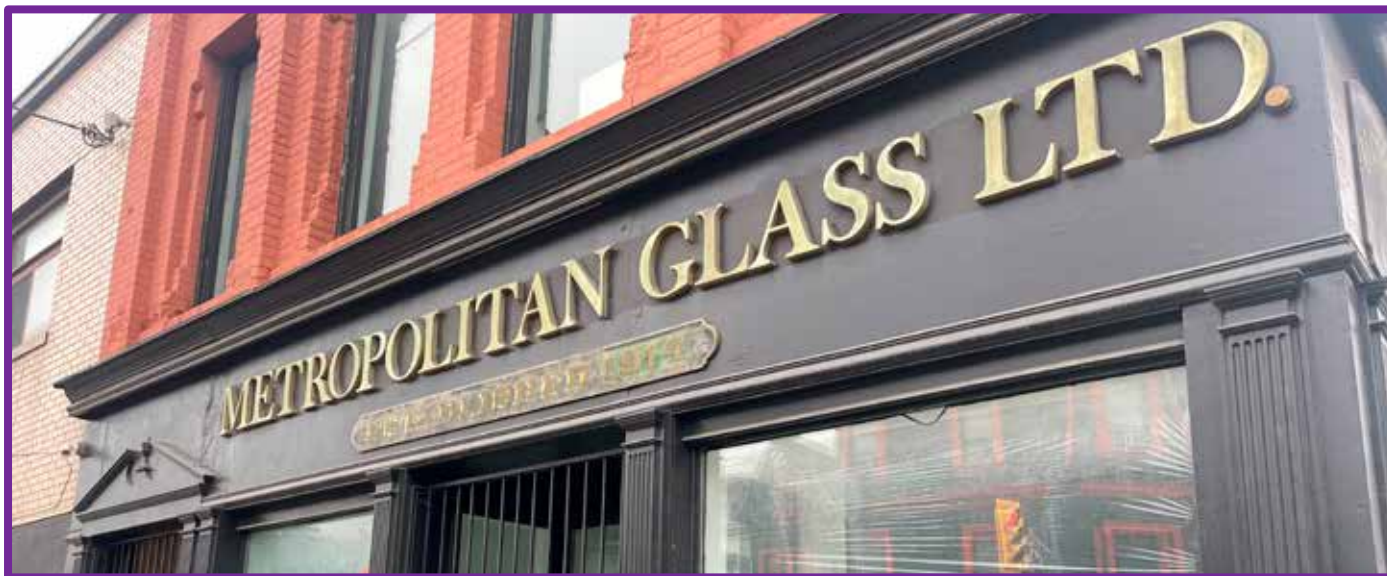
Figure 74: Signage of a contributing property at 377 Dundas St E. utilizing the historic signage area of the facade.

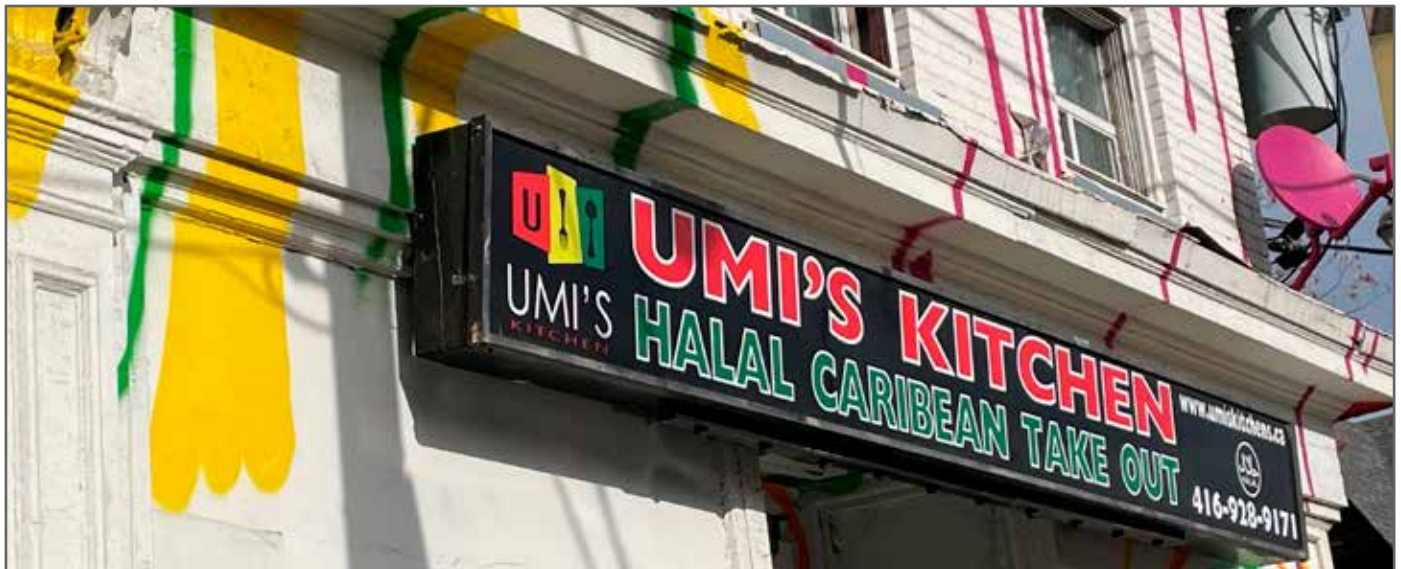
Figure 75: Existing signage on historic storefront at 346 Dundas St. E.; existing fascia boards (sign bands) should be utilized for contemporary signage.

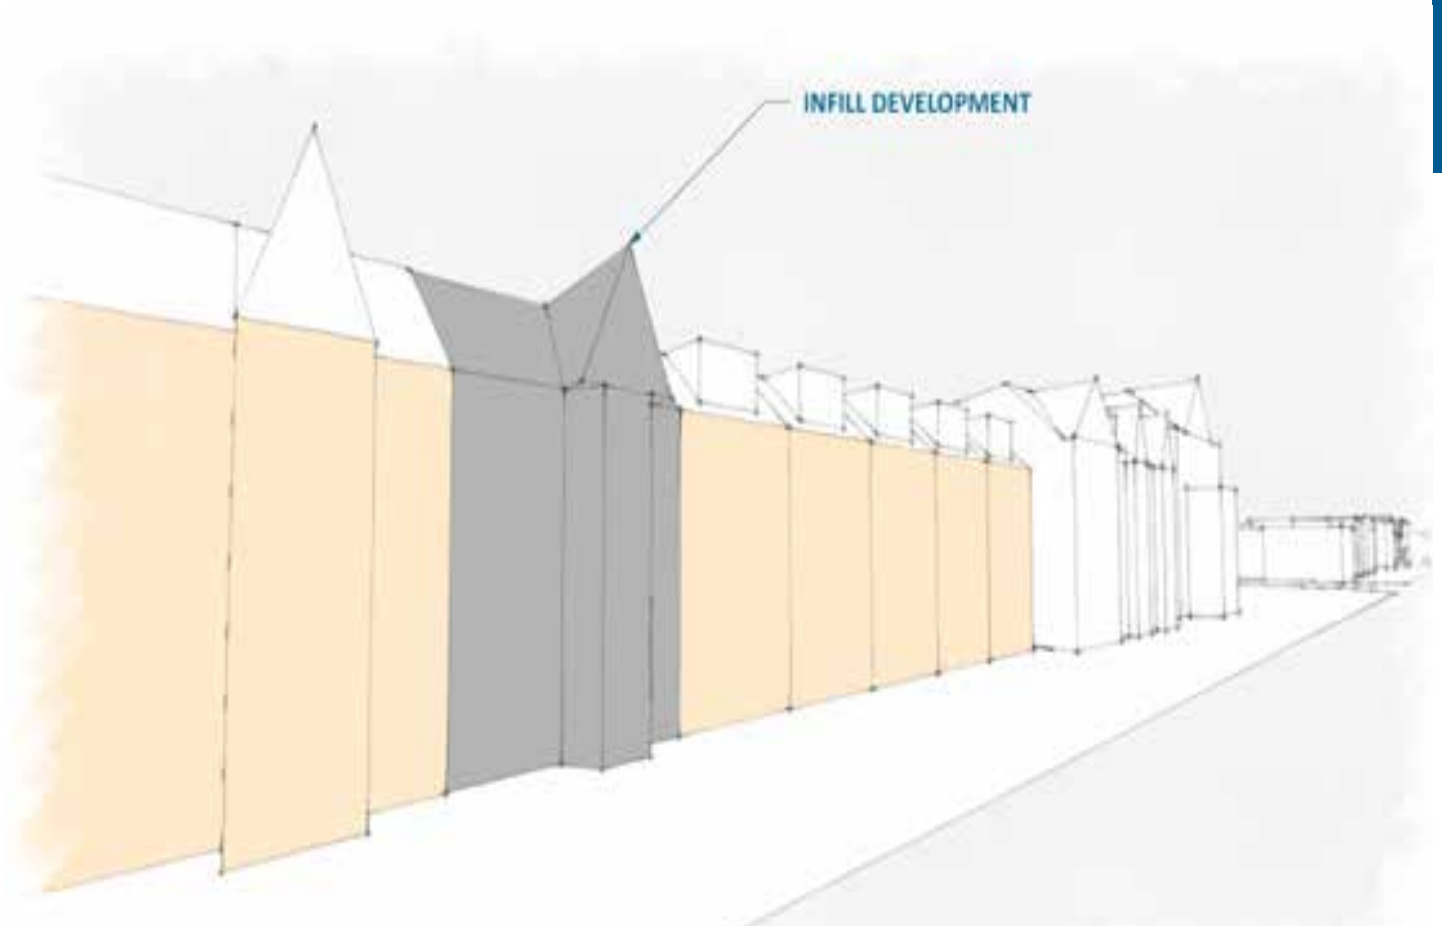
**Figure 81:** Diagram illustrating *infill* development with a projecting gable bay that reflects the *pattern of building*, *streetwall* height and *street proportions* of neighbouring *contributing properties*.

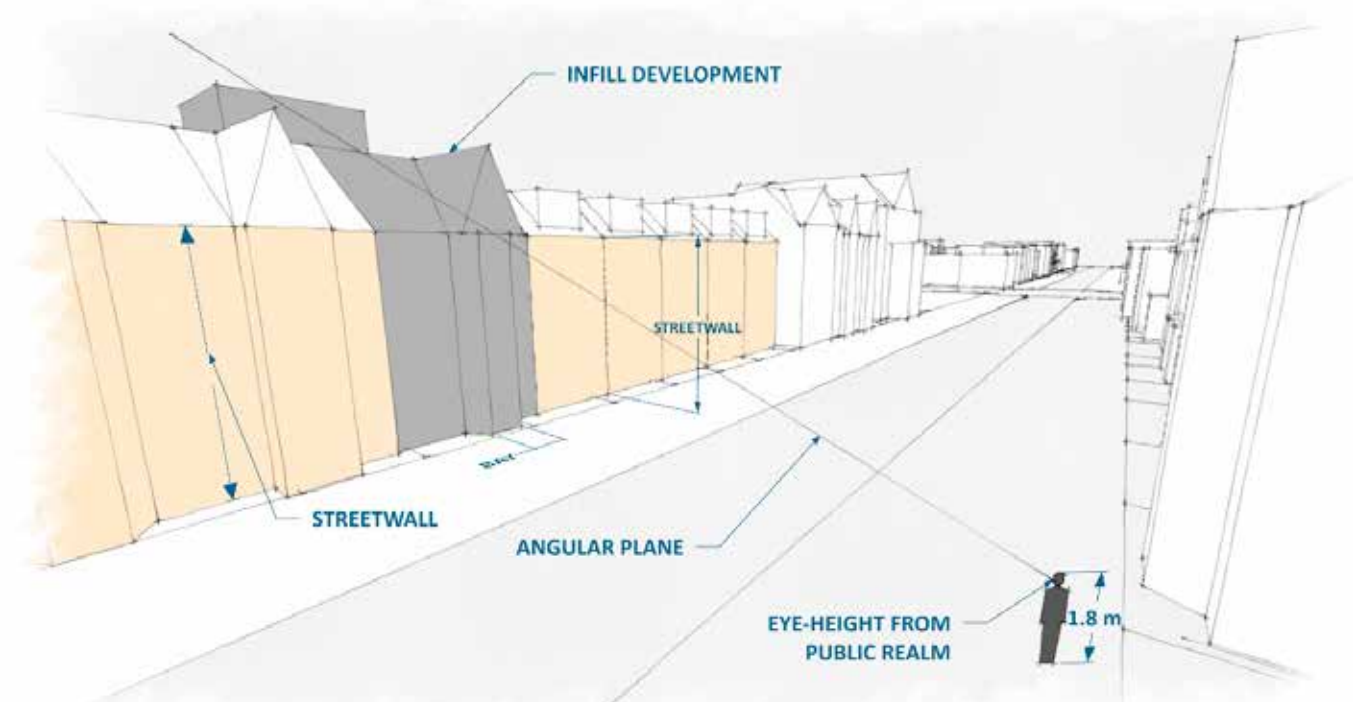
**Figure 83:** Diagram illustrating *infill* development in a residential *character sub-area* with a projecting gable bay that reflects the *pattern of building, streetwall height and street proportions* of neighbouring contributing properties.

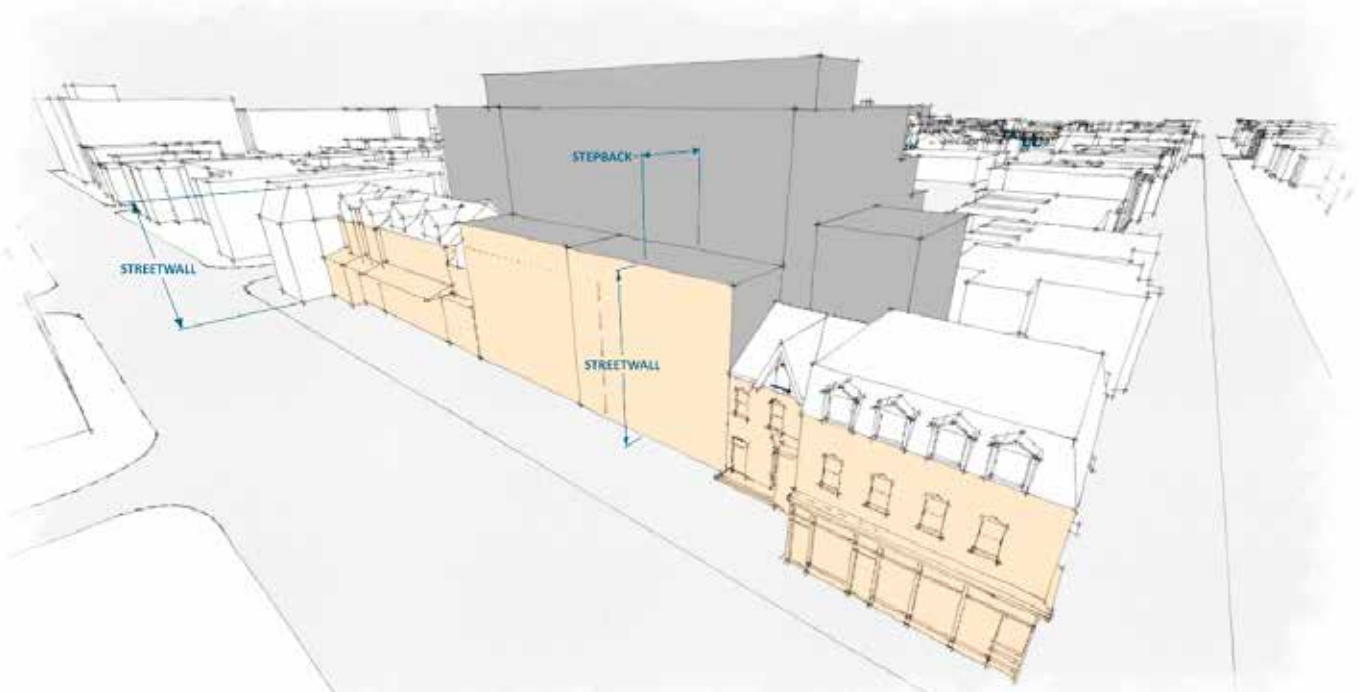
**Figure 84:** Diagram illustrating *new development* in the Dundas and Gerrard residential *character sub-area* that maintains the *streetwall* height. Its rear portions are higher than the *primary structures* of neighbouring *contributing properties* and it has a *stepback* aligning with the *primary structures* of neighbouring *contributing properties*.

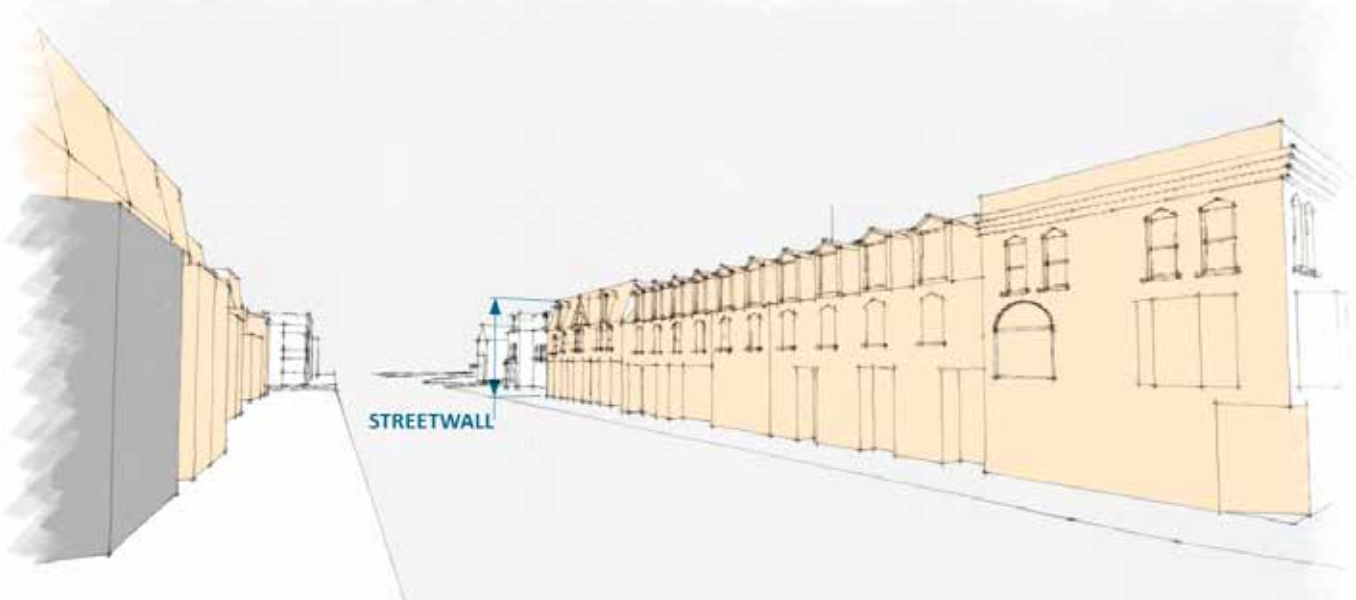
**Figure 85:** Diagram illustrating the *streetwall* height composed of a series of façades. The architectural features of the façades including bays, windows, dormers, and decorative features that express the articulation of the *streetwall*.
