Cabbagetown Southwest  
Heritage Conservation  
District (HCD) Plan

CABBAGETOWN SOUTHWEST  
HERITAGE CONSERVATION DISTRICT

HCD PLAN

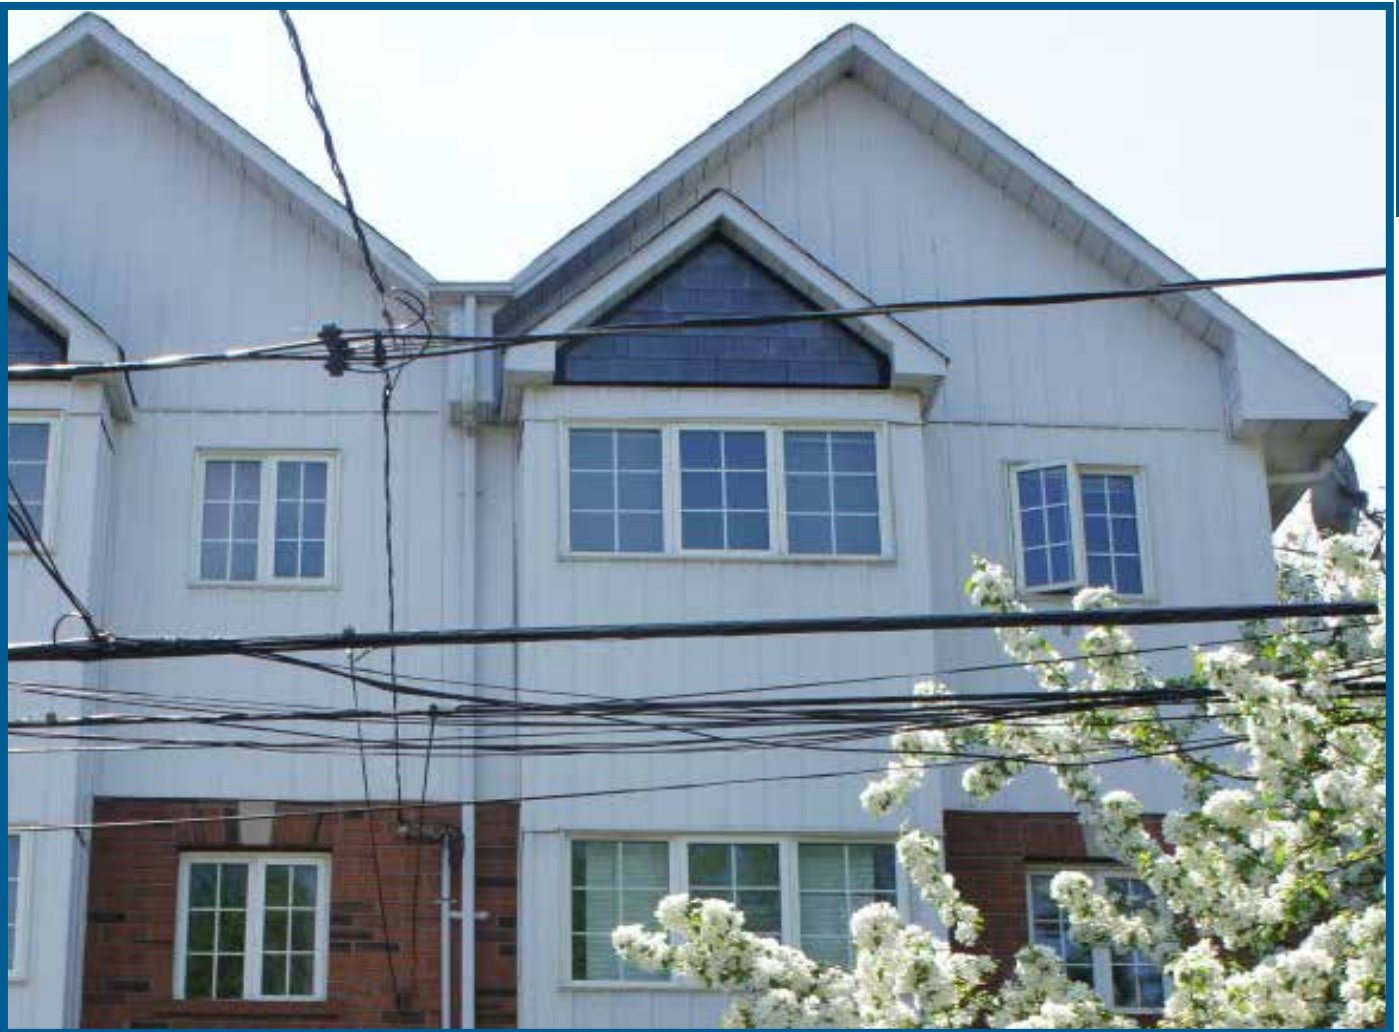
Figure 86: An example of a compatible roof profile for a non-contributing property.

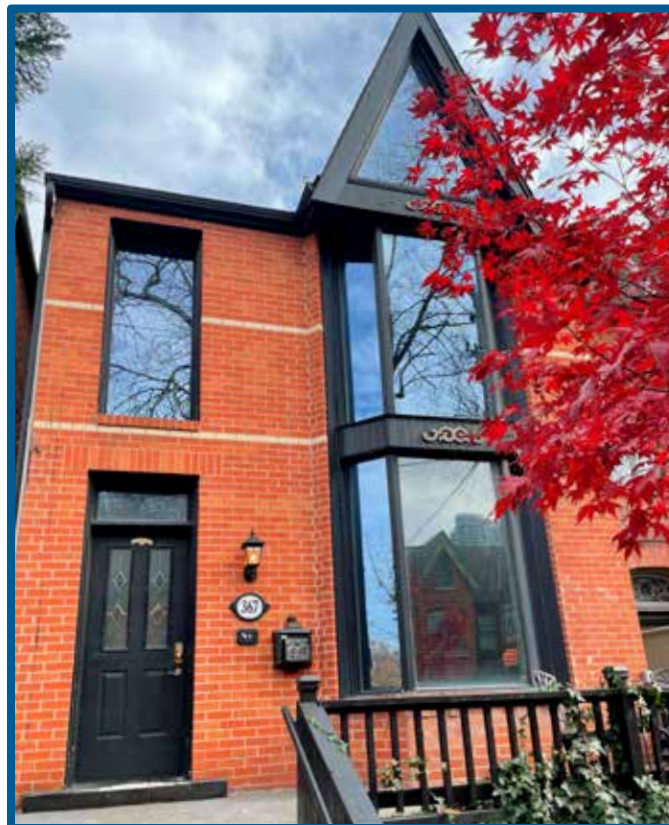
Figure 87: An example of compatible brick cladding materials.

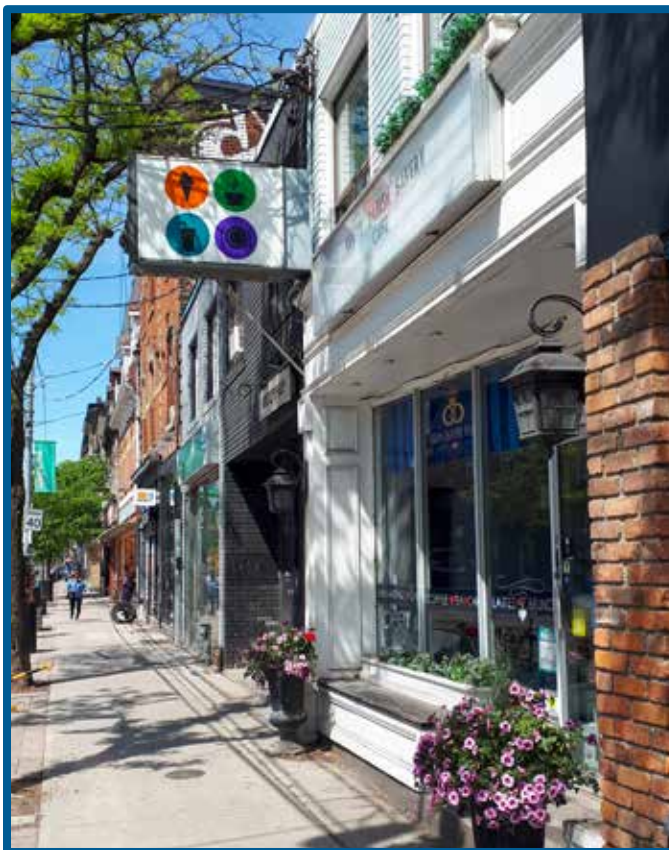
Figure 88: An example of a non-contributing property in another Toronto HCD with a storefront incorporating traditional composition principles and elements.
