## Traffic Control Signals - Main Street

**Date:** June 6, 2023

**To:** Toronto and East York Community Council

**From:** Director, Traffic Management, Transportation Services

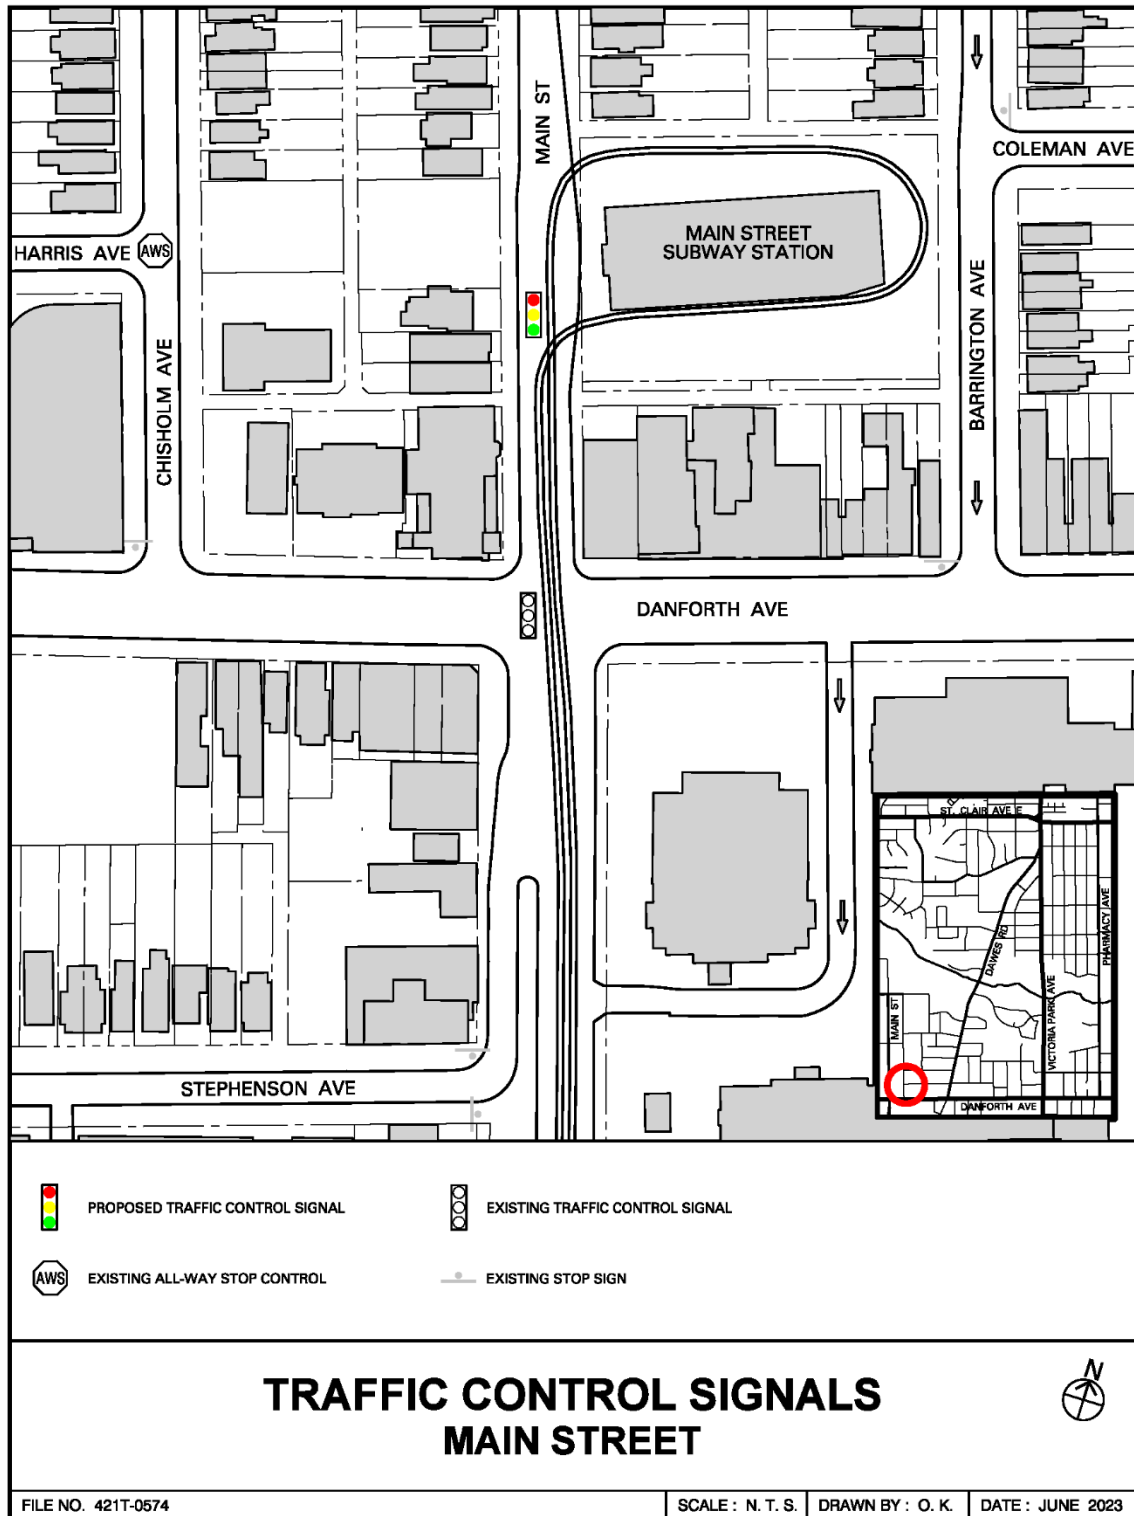
Attachment 1: Map - Traffic Control Signals - Main Street

The Main Street transit station is located on the east side of Main Street, approximately 75 metres north of Danforth Avenue. Transit streetcars and buses access the station via a one-way clockwise circular driveway, inbound from the north limit of the station and outbound from the southern limit of the main entrance to the station. Adjacent traffic control signals are located at the intersection of Main Street and Danforth Avenue, about 75 metres to the south of the main entrance to the transit station.

The area is comprised of mixed-uses, with restaurants on the east side of Main Street, south of the station. On the west side of Main Street, there is a daycare facility, Stanley G. Grizzle Park and churches. A walkway through the park connects the west side of Main Street with the adjacent residential neighbourhood via Chisholm Avenue. North of the transit station are single-family residential dwellings on both sides of Main Street.

A map of the area is included in Attachment 2.
