10 DESCRIPTION OF SURROUNDING NEIGHBOURHOOD

12 CONDITION ASSESSMENT

13 DESCRIPTION OF PROPOSED DEVELOPMENT

15 IMPACT ASSESSMENT

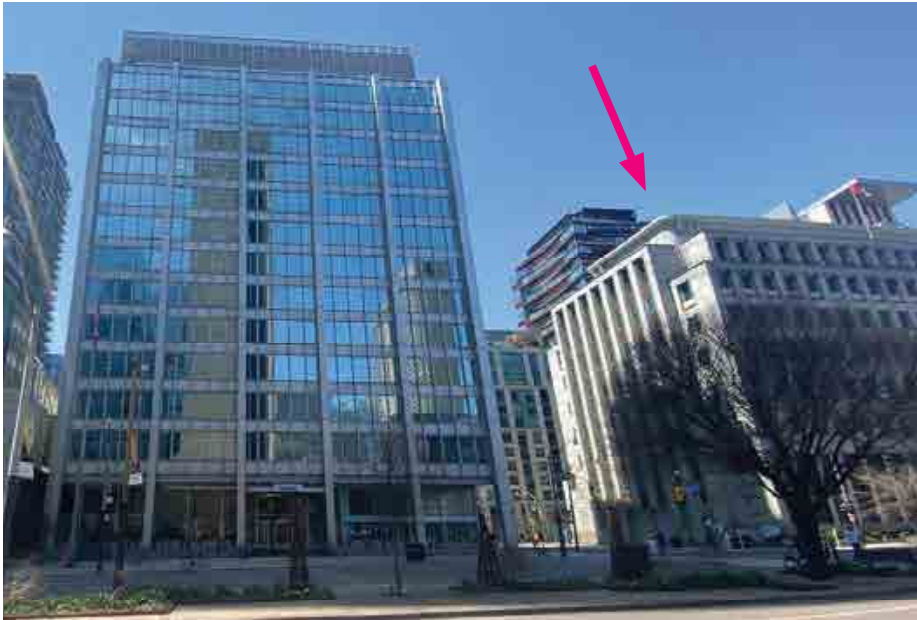
Looking west at east elevation of Site and adjacent heritage property at 250 University, shown by arrow (ERA, annotated by ERA, 2022).

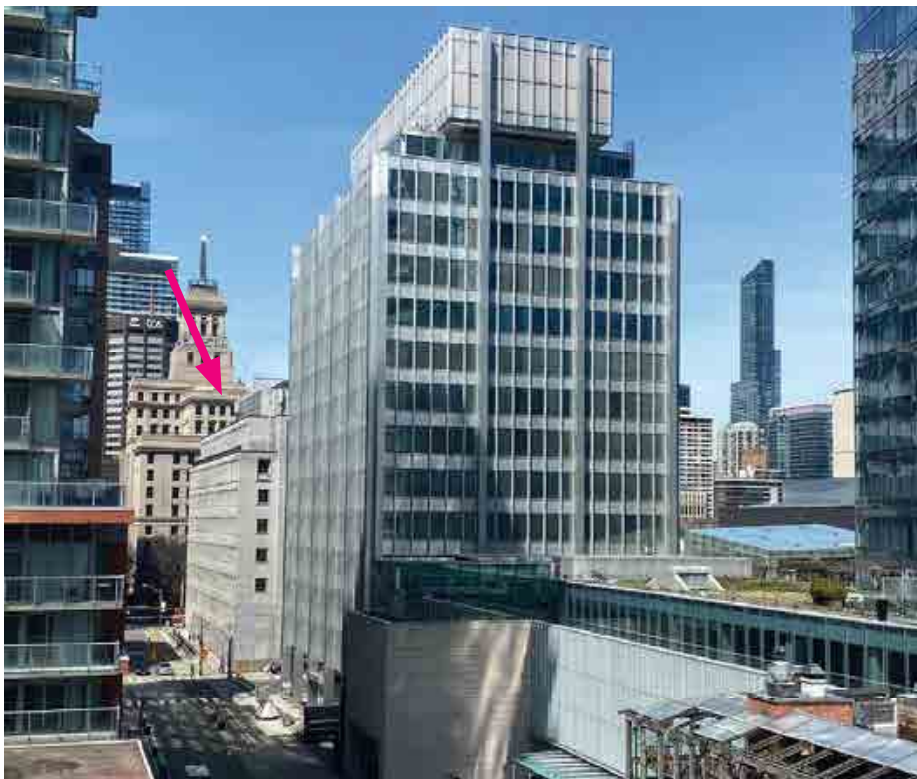
Looking north at south elevation of Site and adjacent heritage property at 250 University, shown by arrow (ERA, annotated by ERA, 2022).

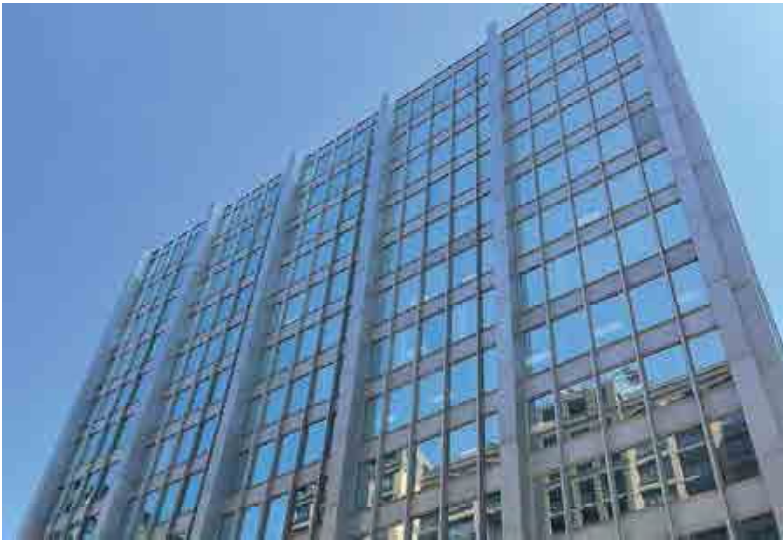
Existing curtain wall and cladding above grade (ERA, 2022).

The exterior of 200 University Ave. is composed of aluminum clad columns, aluminum clad curtain wall, aluminum vertical mullions. Generally, the building appears to be in fair to good condition. The general observable condition include:

- The existing aluminum clad columns appear to be in good condition with minor staining at the seams and the cladding appears to have been replaced at the upper sections of the 14th floor
- The existing aluminum clad curtain wall above grade appears to be in fair condition
- The existing aluminum clad curtain wall at grade appears to be in good condition
- The existing aluminum vertical mullions appear to be in good condition
- The existing aluminum clad glazed doors appears to be in good condition
- The existing 14th floor parapet flashing and roof appears to be in good condition
- The existing 16th floor parapet flashing appears to be in fair condition with some areas of rusting, flaking paint and carbon staining. The existing roof in this area appears to be in good condition

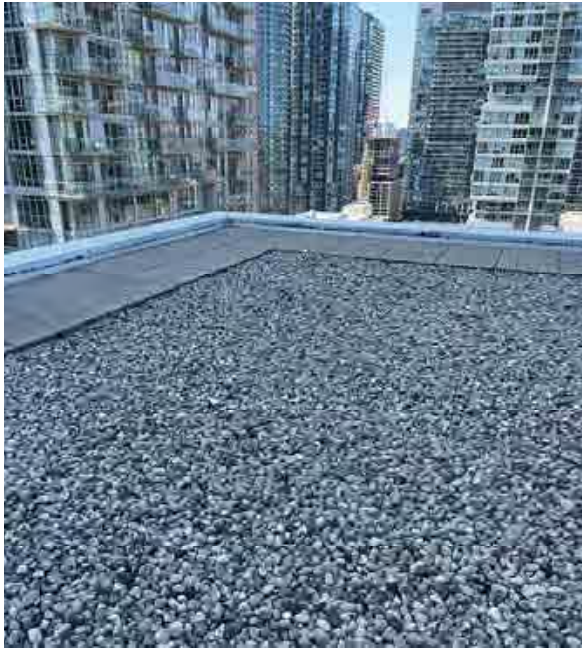
Existing 16th floor parapet and roof (ERA, 2022).

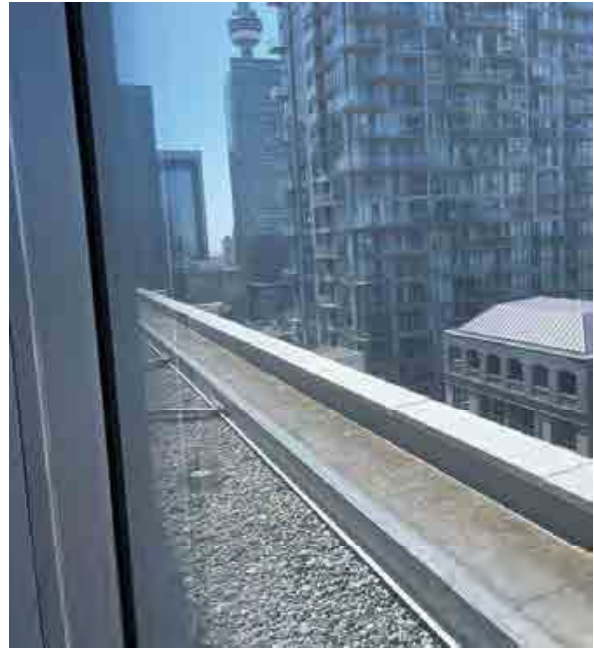
Existing 14th floor parapet and roof (ERA, 2022).

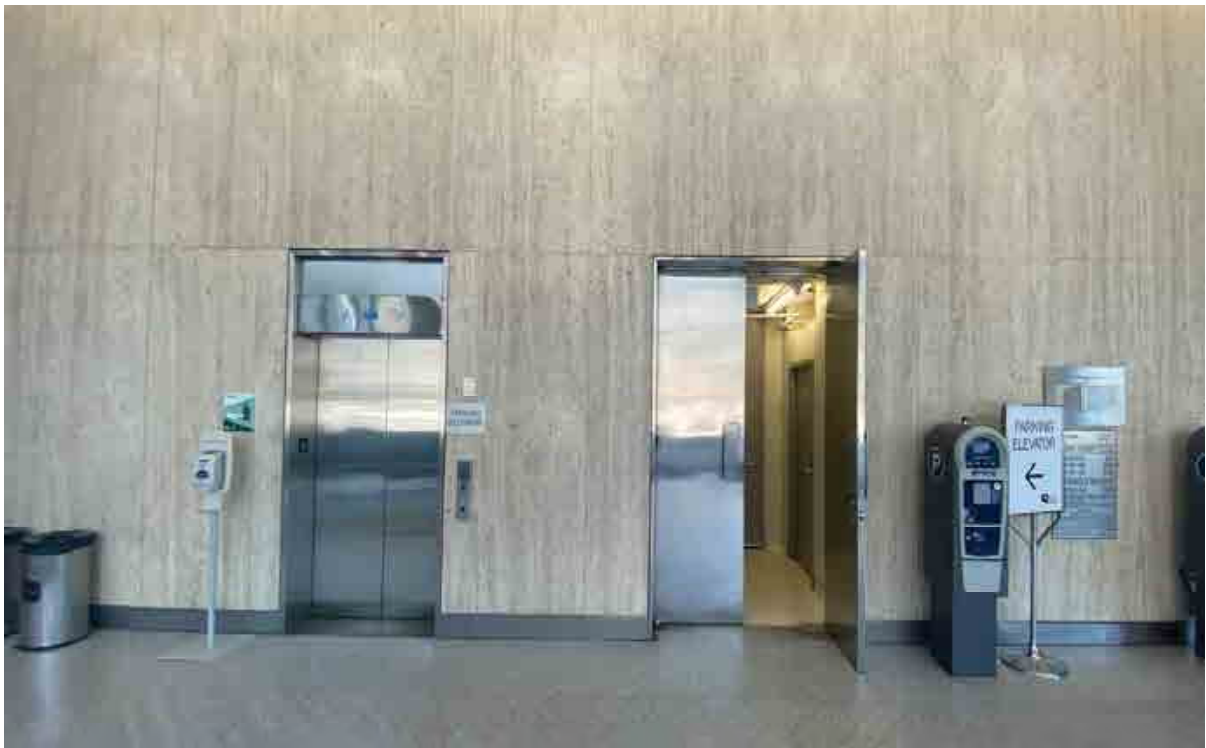
Interior details, including granite floors, travertine walls, and stainless steel elevator doors and surrounds (ERA 2022).

- The existing granite floors in the lobby appear to be in fair to good condition
- The existing travertine walls in the lobby appear to be in good condition
- The stainless steel elevator doors and surround appear to be in good condition

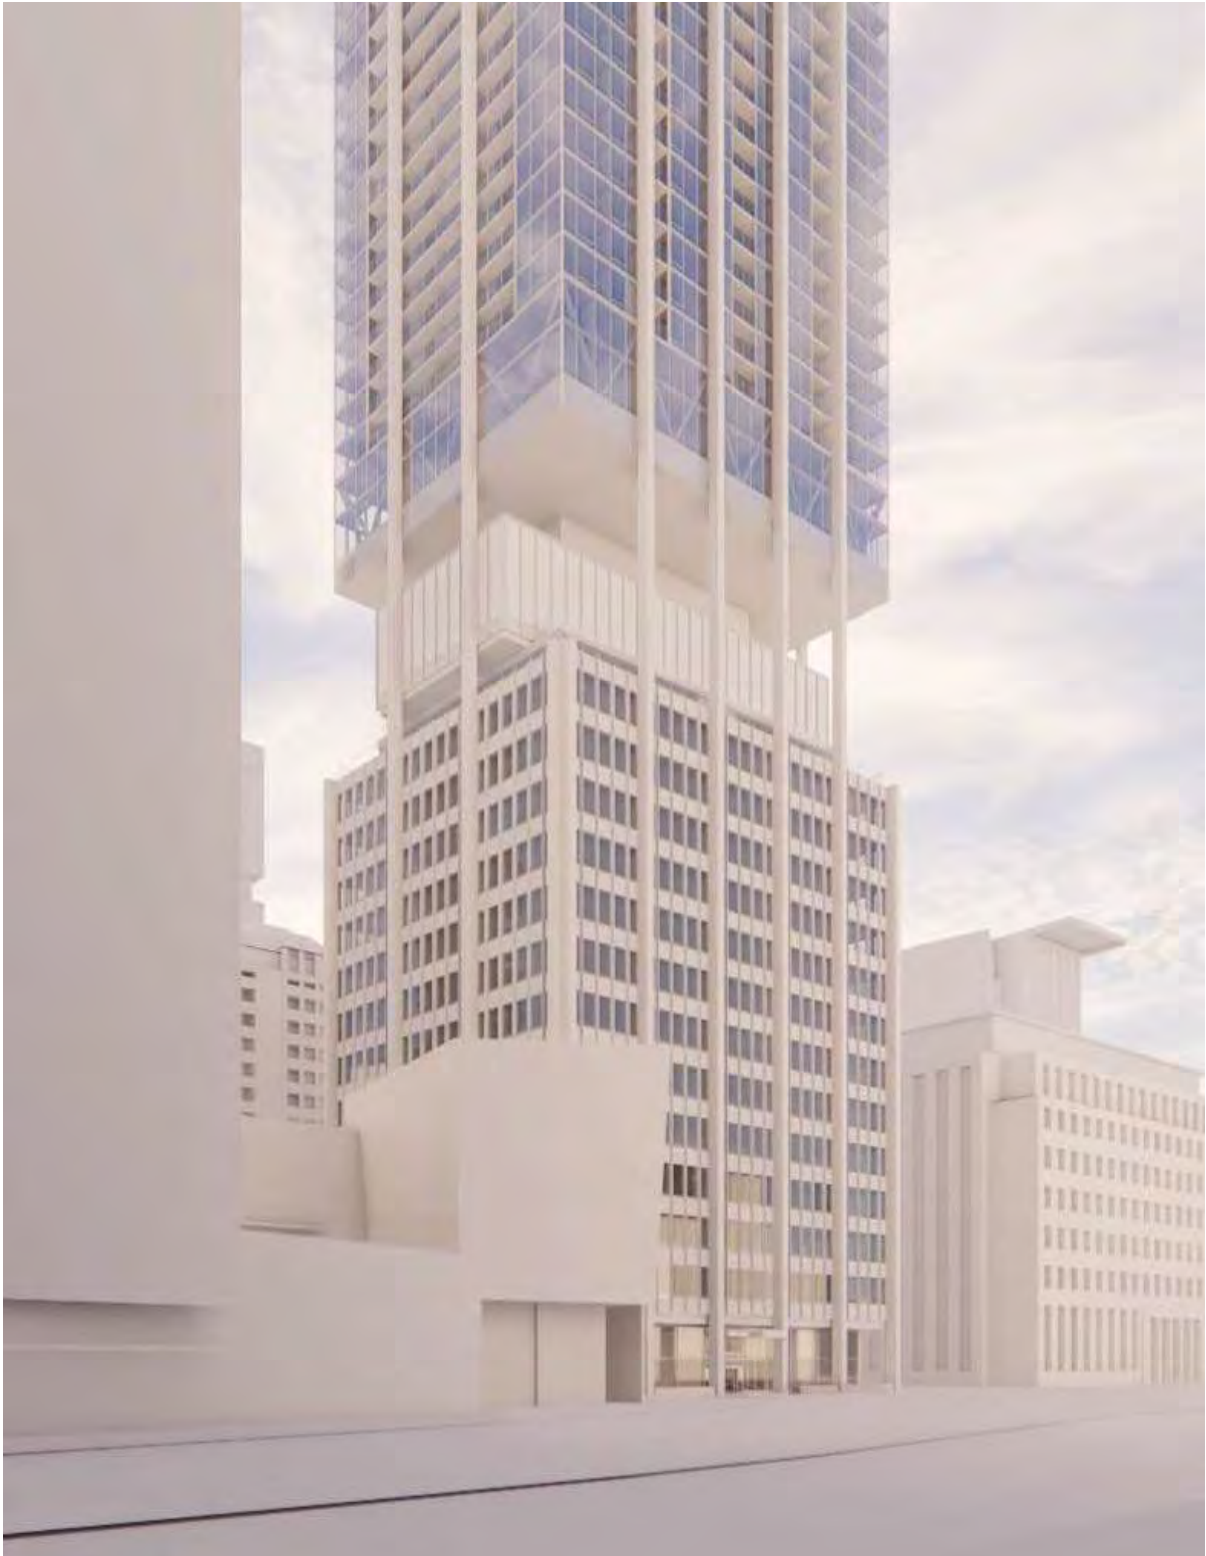
Building rendering showing south and east elevations (KPMB Architects, 2024).

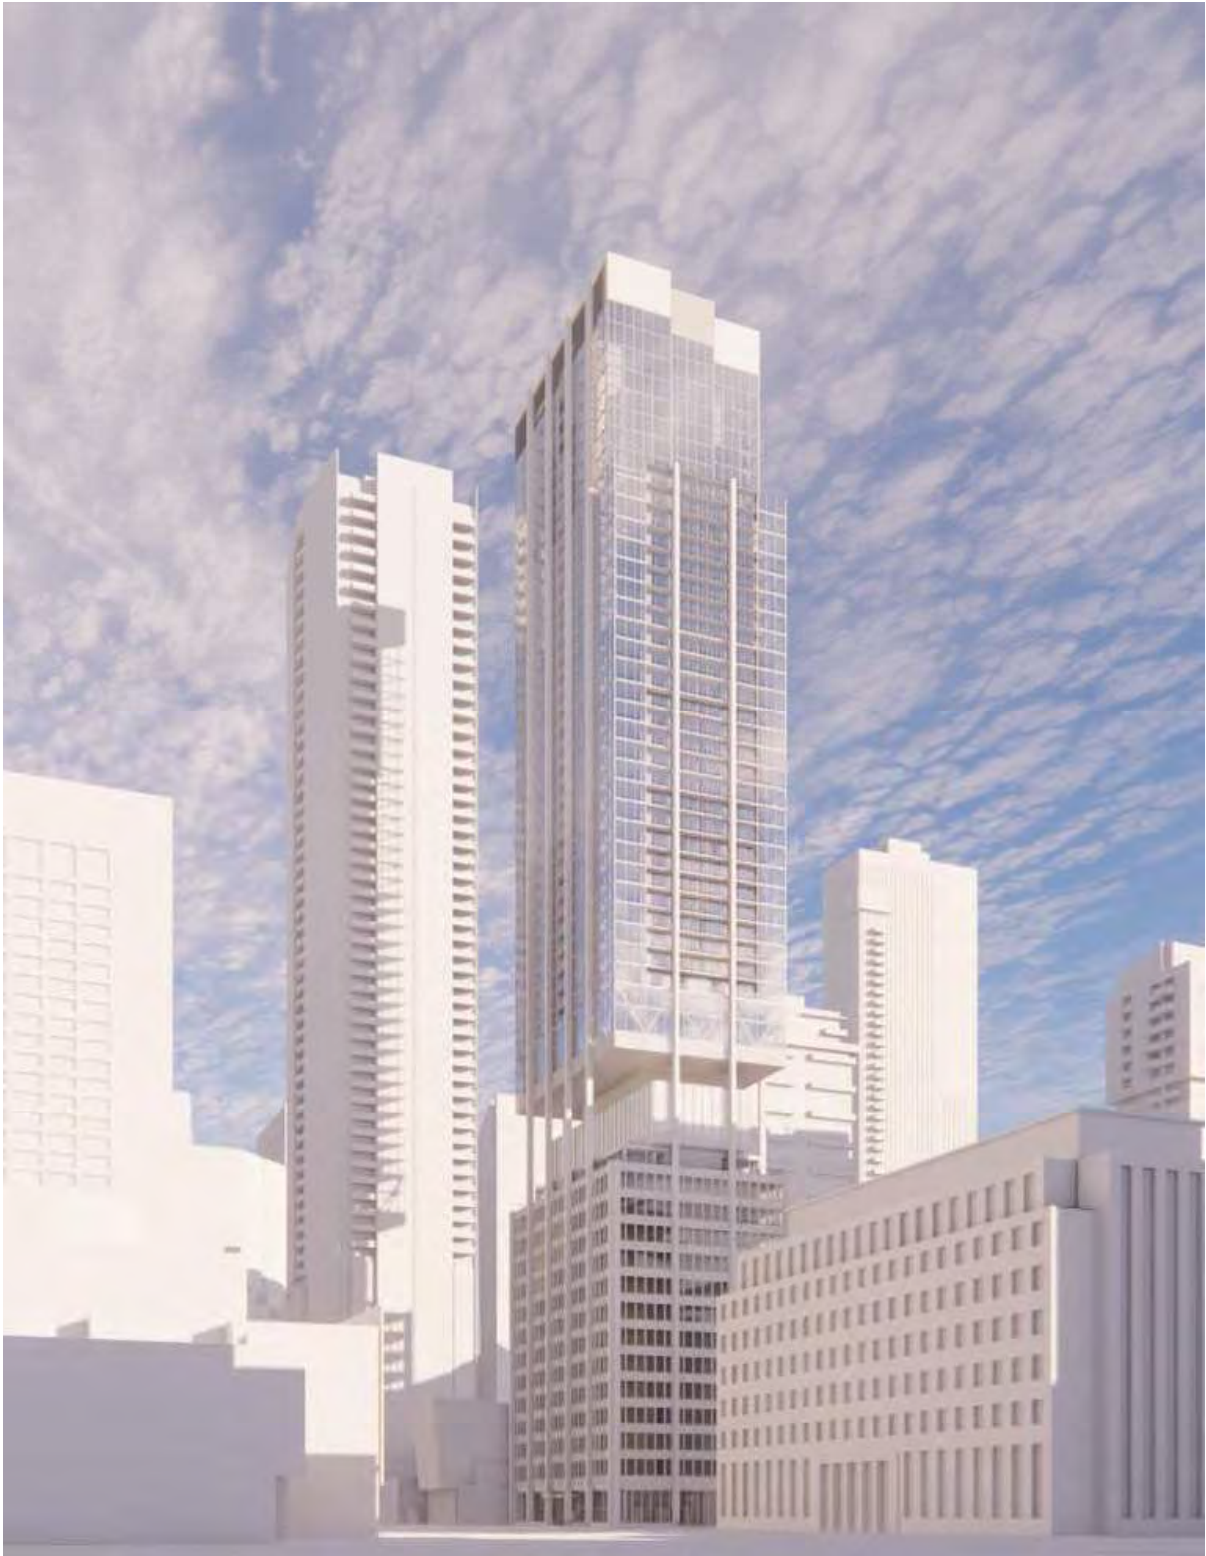
Building rendering showing principle (east) and north elevations (KPMB Architects, 2024).

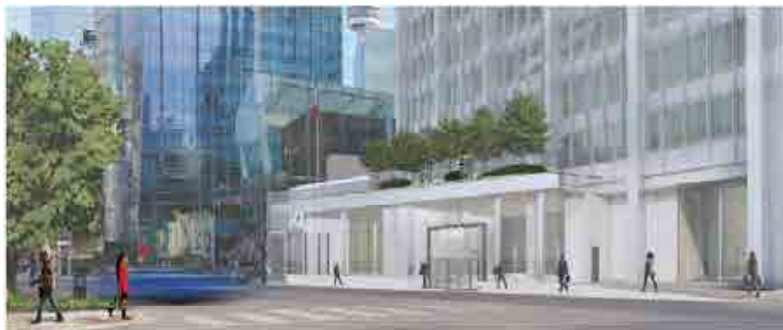
Proposed Scheme

Current Pavilion

Retail GCA = 206 m² / 2,215 sqft

The initial design proposal contemplated a Pavilion built at-grade within the bounds of the east plaza. In response to initial feedback, two design alternatives were considered to minimize the visual impact of the Pavilion. The Pavilion was ultimately removed, and is not included in the current design proposal.

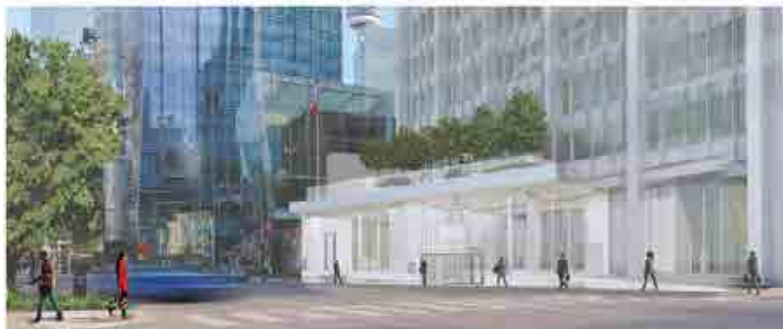
Setback

Setting back 1.5m from University Ave

Retail GCA = 184 m² / 1,980 sqft

Total GCA Loss From Current Scheme
(Lobby & Retail)
= 48 m² / 510 sqft

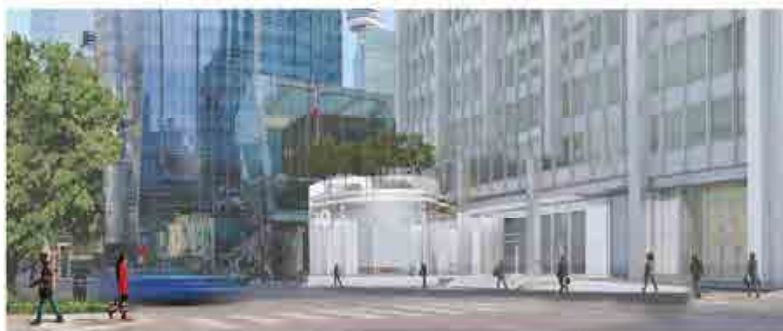
Ellipse

Change to an ellipse form and retain
existing Lobby/Entrance

Retail GCA = 180 m² / 1,940 sqft

Total GCA Loss From Current Scheme
(Lobby & Retail)
= 142 m² / 1,540 sqft

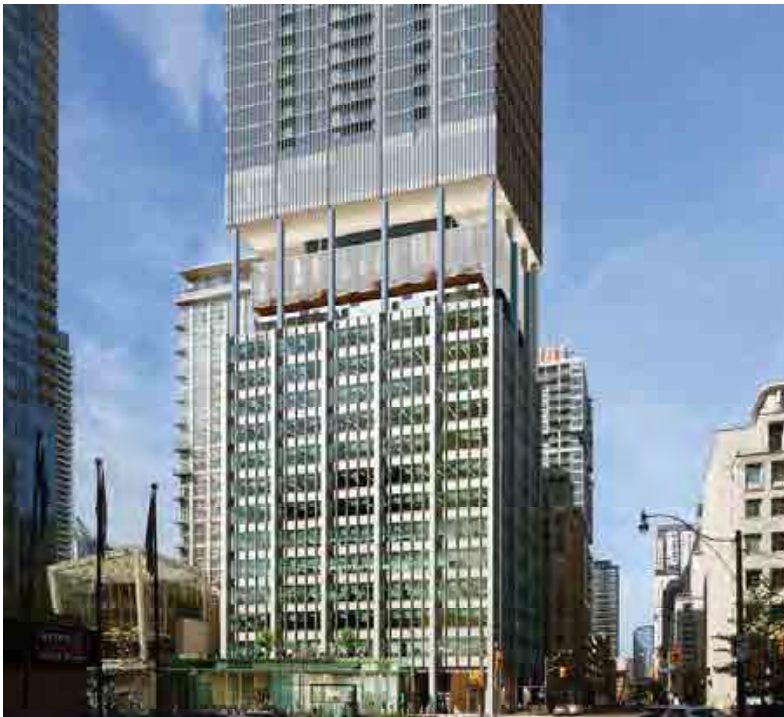
Setback columns (KPMB, 2024).

- **Setback:** Pilasters setback from existing pilasters below.
- **Squeeze:** Shifting table-top height up 1 meter, resulting in a 3 meter separation from the underside of tabletop to existing lantern.
- **Lift:** Shifting table-top height up 2.925 meters, resulting in a 5 meter separation from the underside of tabletop to existing lantern.
- **Stepback (“Pinch”):** Tower pinched 3m on the east and west sides.

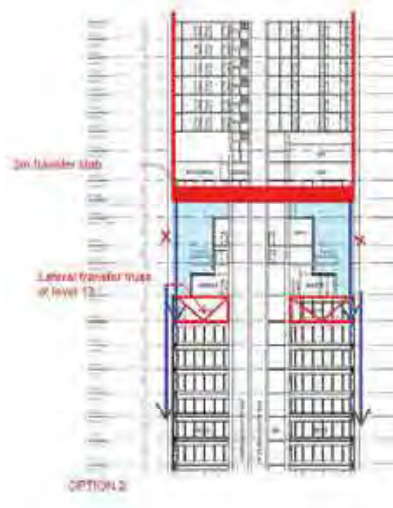
Structural Considerations (KPMB, 2024).

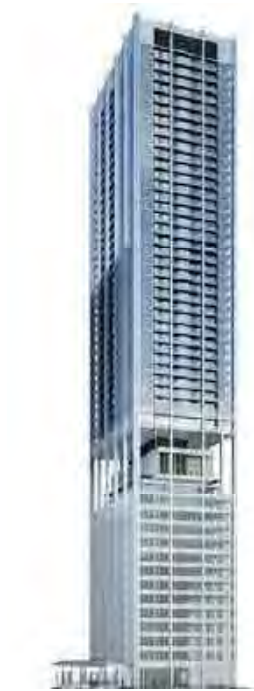
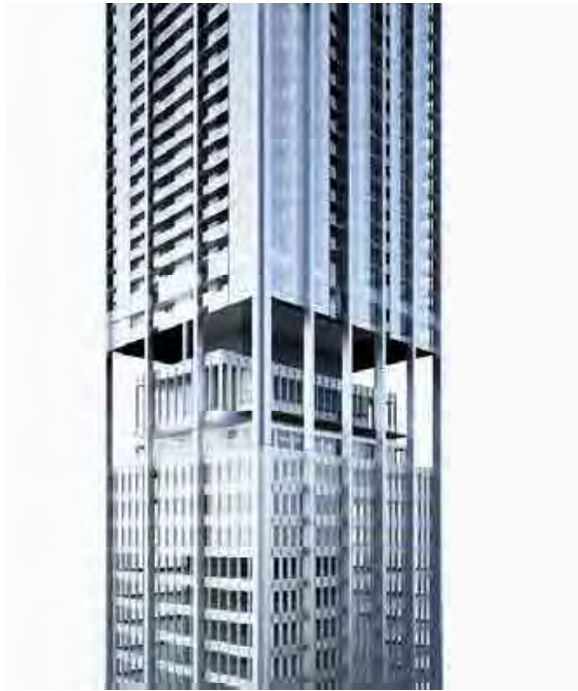
“Lift” (KPMB, 2024).

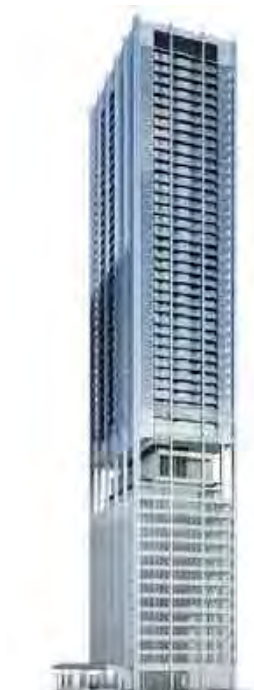
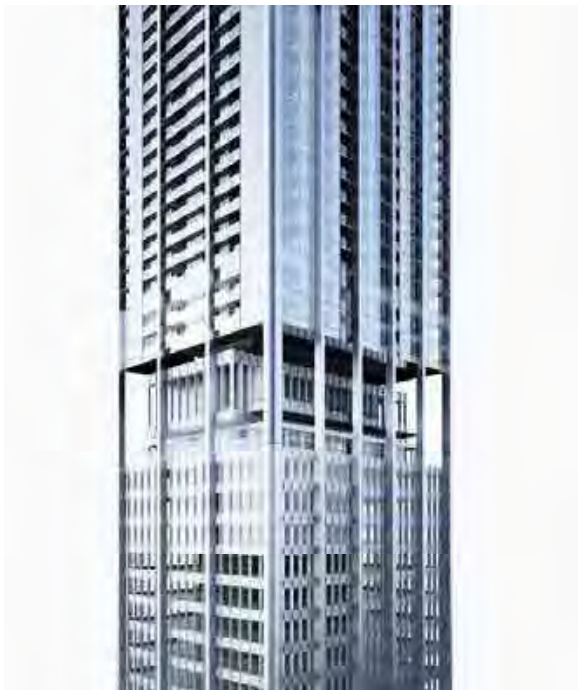
“Squeeze” (KPMB, 2024).

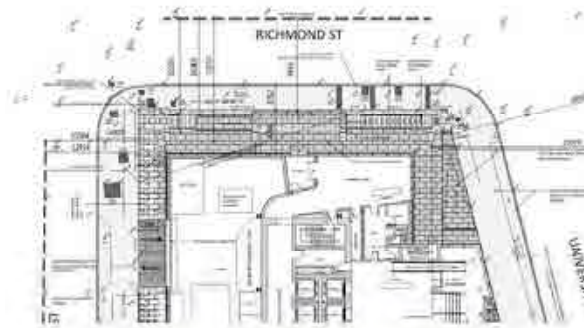
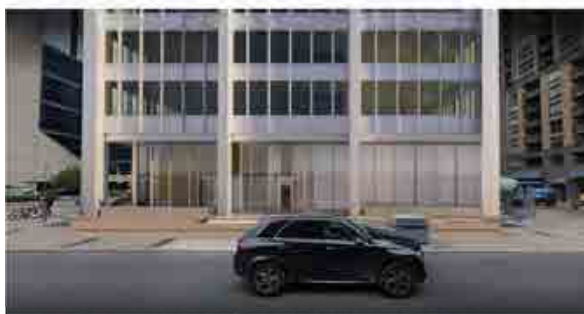
West elevation setback reduced to accommodate interior loading requirements (KPMB, 2024).

In an effort to accommodate municipal requirements for garbage collection, the initial design reduced the recessed setback of the west elevation to ensure vehicle loading requirements were satisfied.

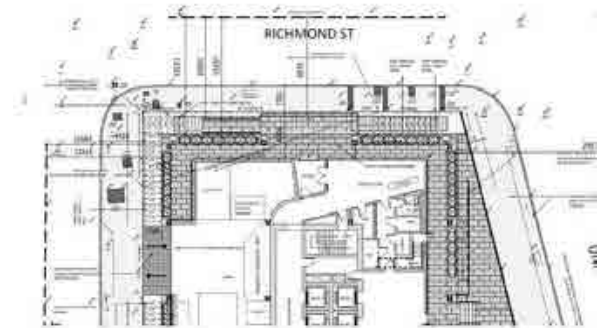
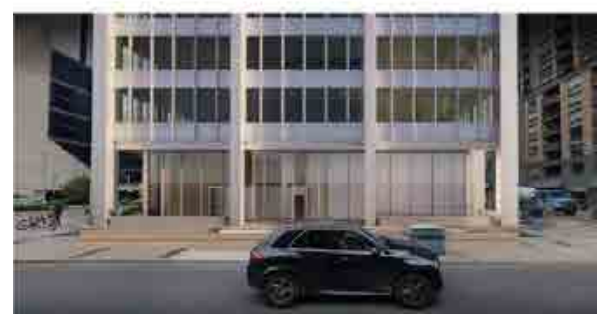
North-west corner “notch” maintains setback at corner to maintain appearance of setback when viewed from the north (KPMB, 2024).

In response to feedback from City staff, an alternative was considered that “notched” the northwest corner at grade, maintaining the existing setback at corner to maintain appearance of setback when viewed from the north.
