## **53 Yorkminster Road- Application for Fence Exemption**

**Date:** December 7, 2023.

**From:** District Manager, Municipal Licensing and Standards, East District

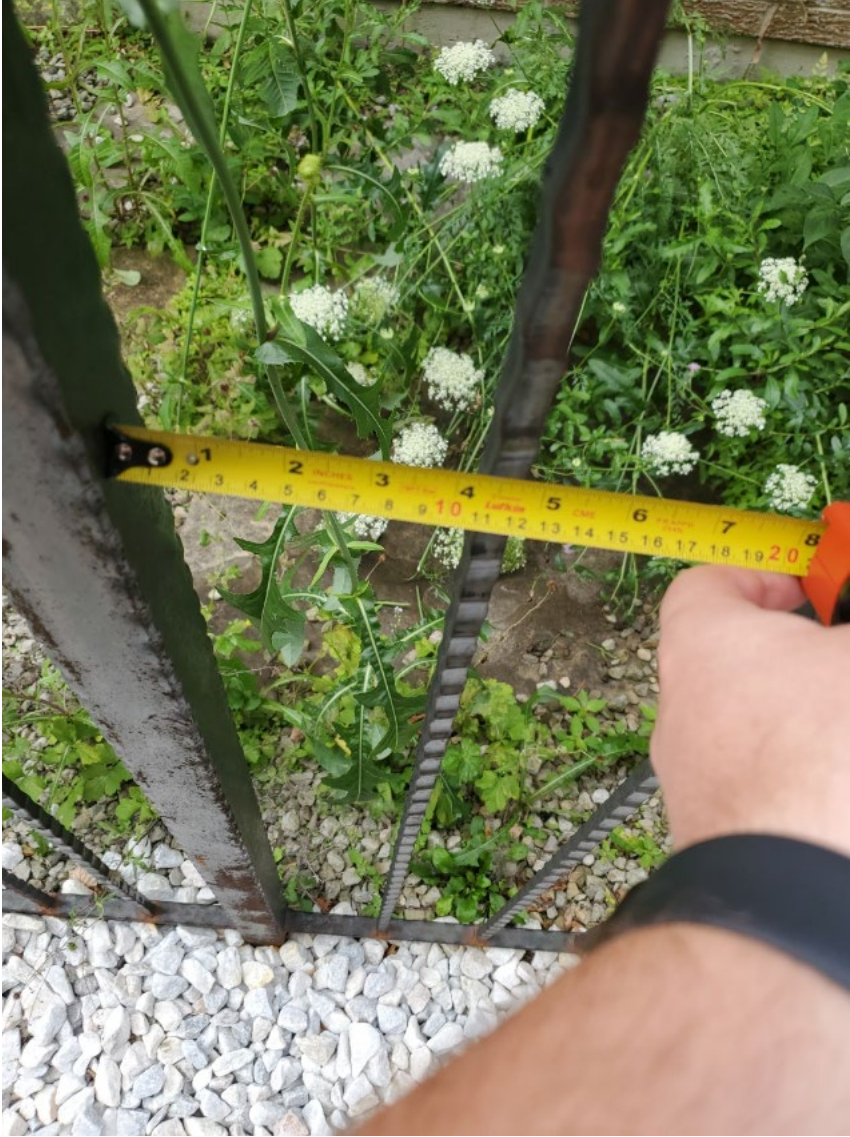
The purpose of this report is to consider an application by the owner(s) of 53 Yorkminster Road to maintain an existing pool enclosure in the rear yard. The west side of the enclosure has opening greater than the permitted spacing and the staircase from the deck forming part of the pool enclosure has external conditions that may facilitate climbing.

**Attachment 2: Municipal Standards Officer's Photo 53 Yorkminster Road - West side of the existing pool enclosure.**

1. North York Community Council refuse to grant the application for an exemption permit, by the owner(s) of 53 Yorkminster Road to maintain a swimming pool enclosure in the rear yard of the property for an enclosure that fails to comply with the provisions of Toronto Municipal Code, Chapter 447, Fences and to direct staff to issue a second notice to the property owner to bring the swimming pool enclosure into compliance.

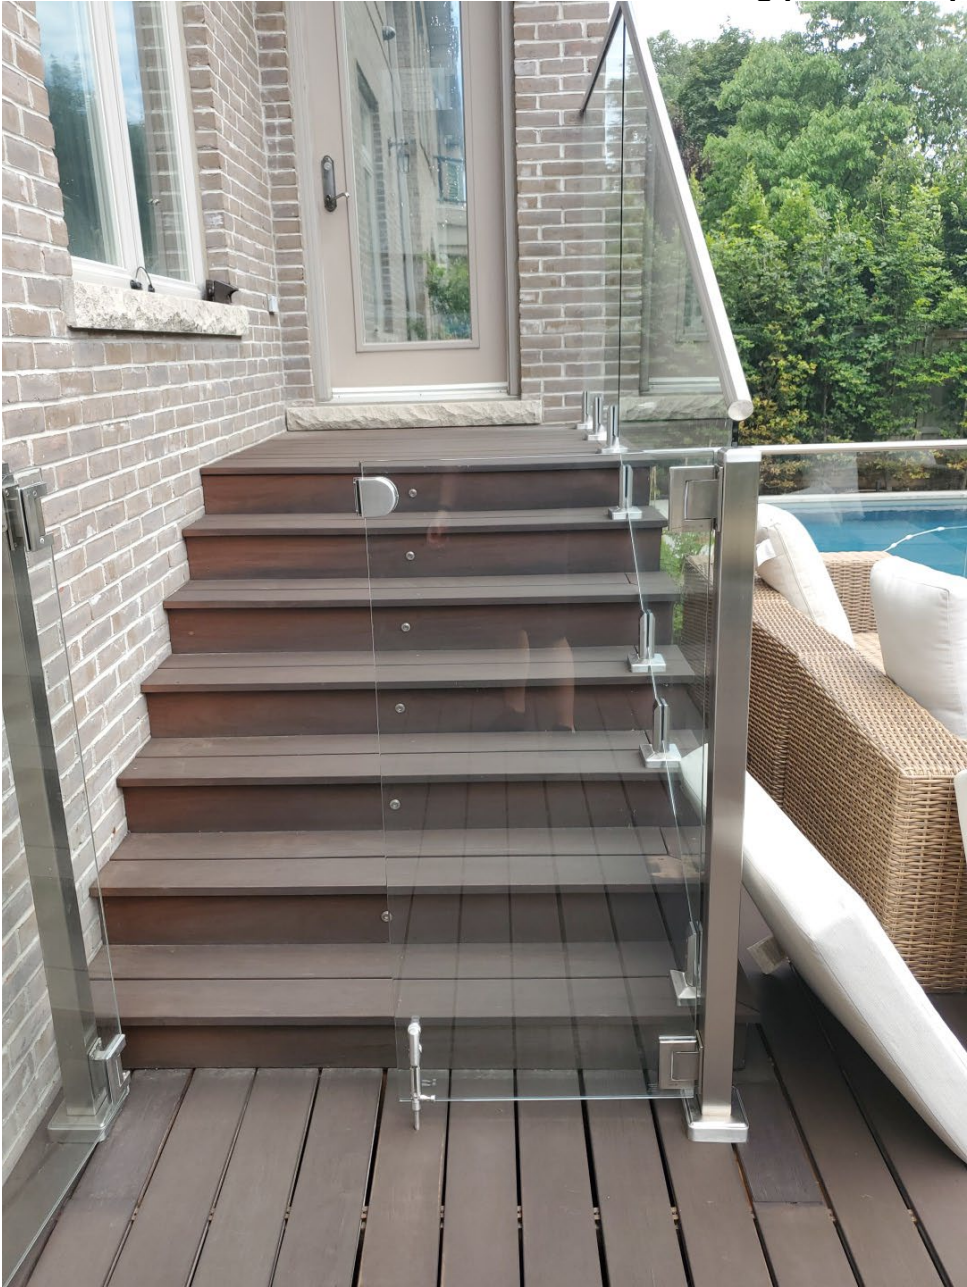
GENERAL LOCATION	SPECIFIC LOCATION	CONSTRUCTION & DEFICIENCY	BY-LAW SECTION & REQUIREMENT*
Rear yard	The staircase from the deck forming part of the pool enclosure.	Existing pool enclosure has climbable objects. Namely; the stairs raisers as the guard is less than 1.8 meters high.	Chapter 447 Section 1.3 E.(1).(b)  Be no closer than one meter to any external condition that may facilitate climbing the outside of the enclosure unless the height of the enclosure is at least 1.8 meters for a distance of at least one meter on each side of the condition
Rear yard	West side of the existing pool enclosure.	Existing metal pool enclosure has openings greater than 100 millimeters.	Chapter 447 Section 1.3 E(2)(c)1. A metal picket fence used in a swimming pool enclosure shall be not more than 100 millimeters apart where horizontal rails are spaced at least 1.2 meters apart.

**Attachment 3: The staircase from the deck forming part of the pool enclosure.**

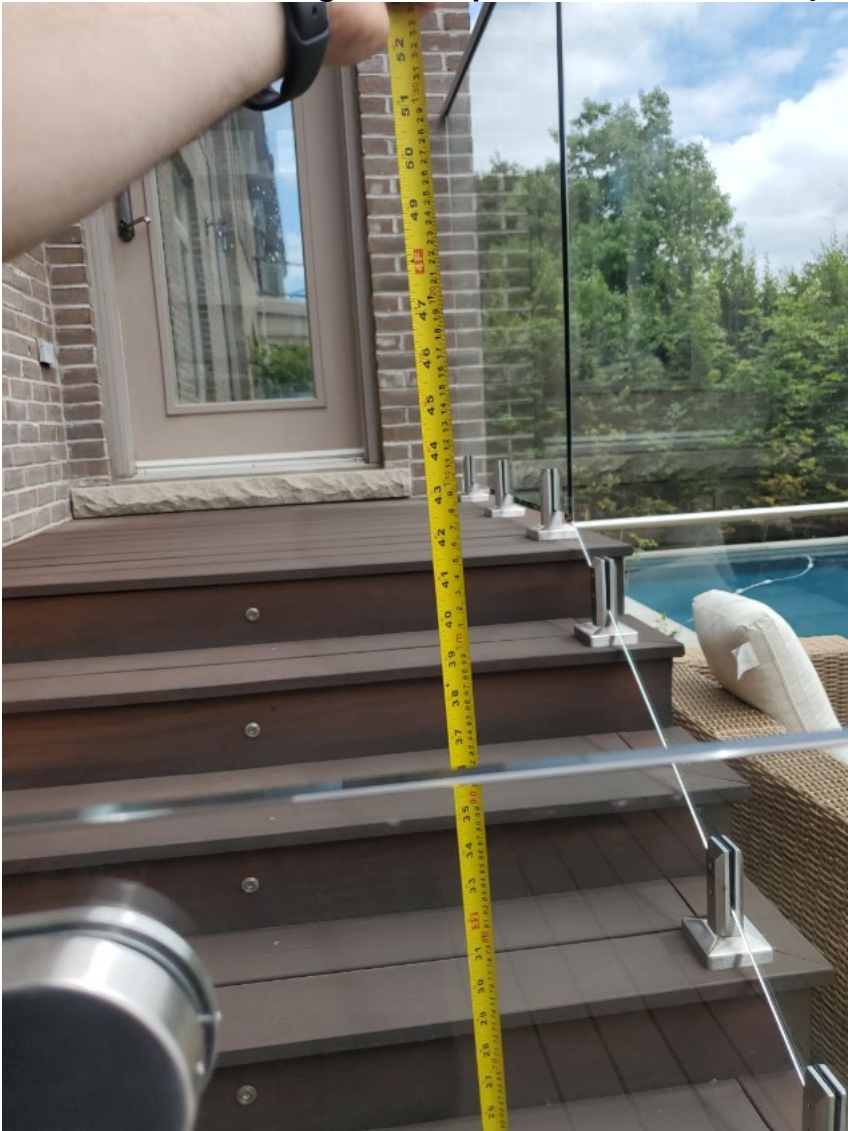
**Attachment 4: The height of the pool enclosure from top of stair raiser.**
