322 La Rose Avenue - Notice of Intention to Designate a Property under Part IV, Section 29 of the Ontario Heritage Act

Date: March 11, 2024

To: Toronto Preservation Board

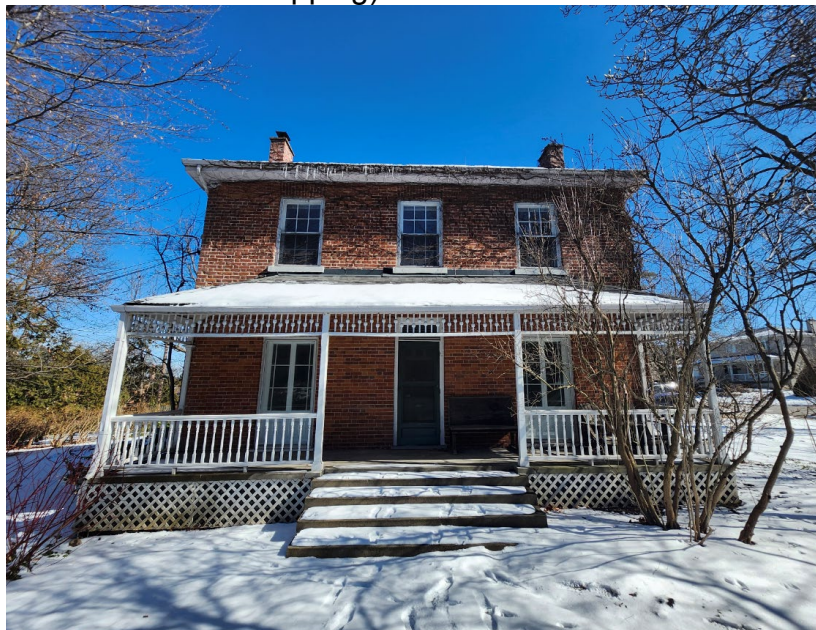
Detail of what was historically the primary elevation of the property at 322 La Rose Avenue (now the side or west elevation) (Heritage Planning, 2024)

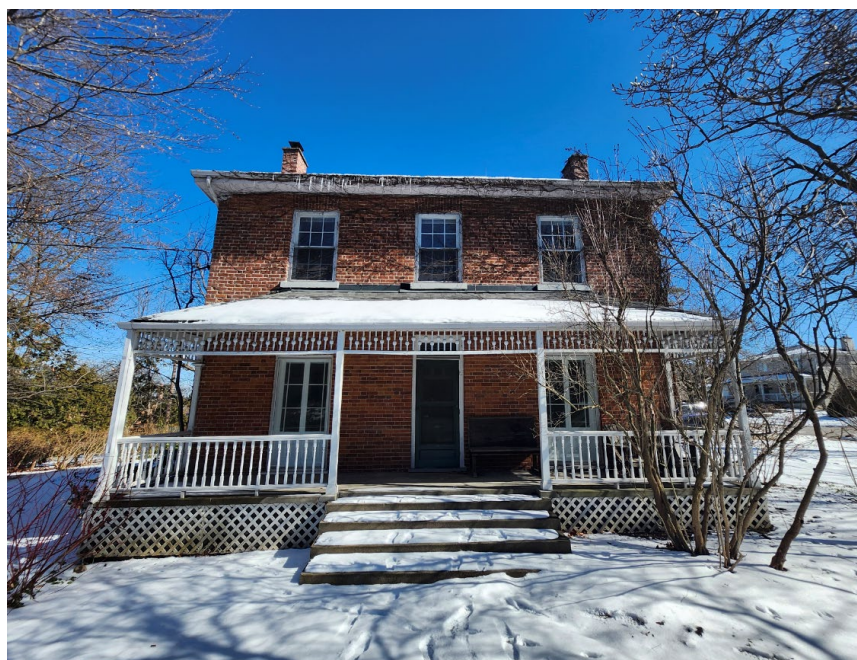
Detail of what was historically the primary elevation of the property at 322 La Rose Avenue (now the side or west elevation) (Heritage Planning, 2024)

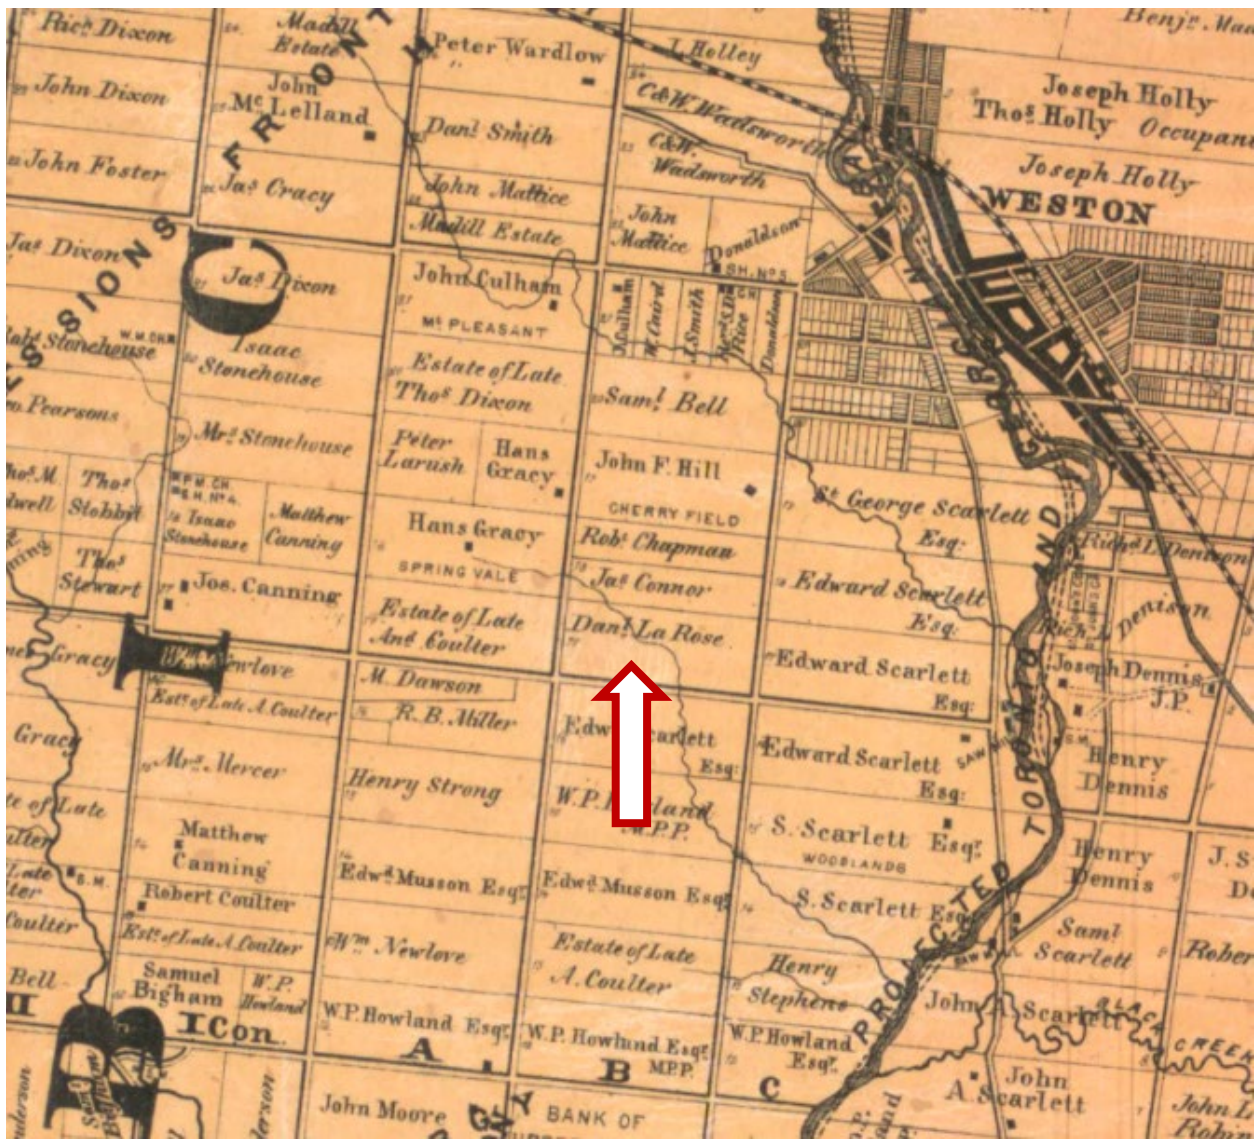
Figure 2. Tremaine's Map of the County of York, Canada West (1860), showing the location of lot 17, which was owned by Daniel La Rose

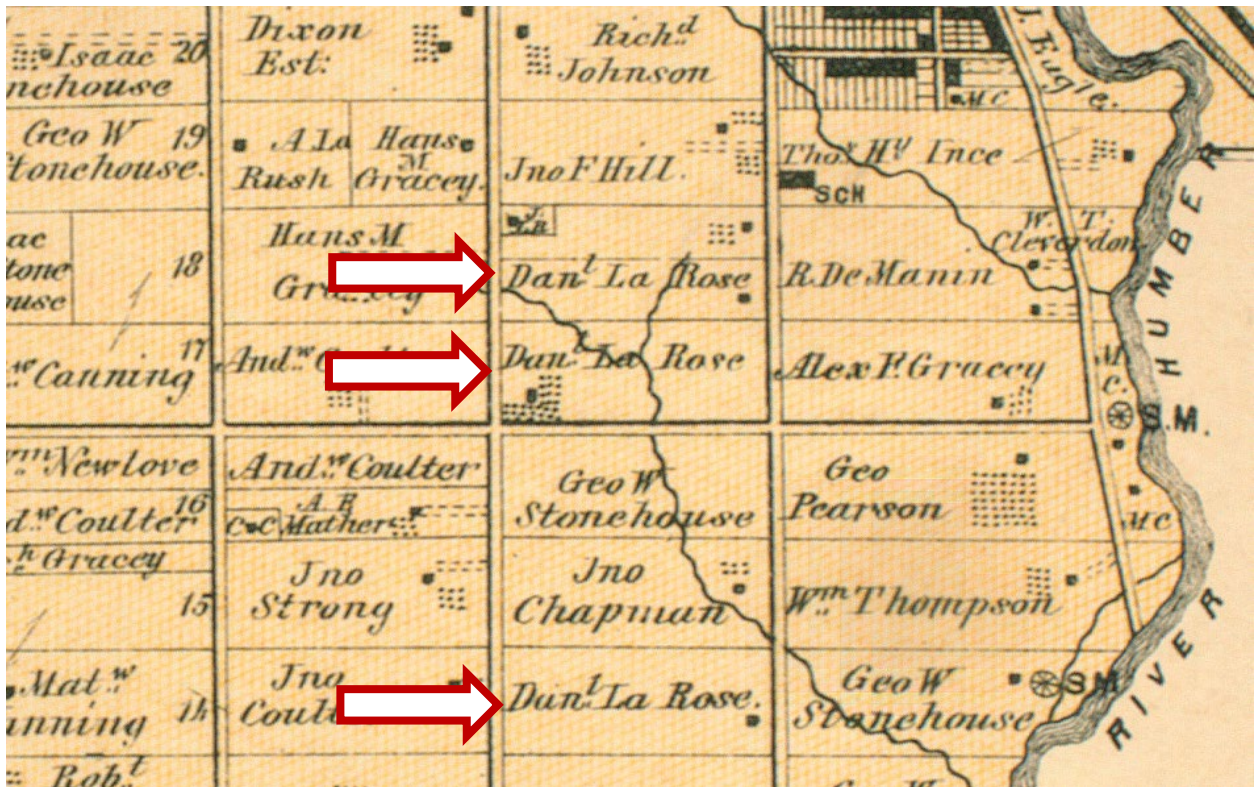
Figure 3. Miles & Co.'s Illustrated Historical Atlas of the County of York, showing Etobicoke (1878), with lots 14, 17 & 18 owned by La Rose

After his father’s death in 1820, Daniel inherited his father’s Chinguacousy property where he and his wife, Caroline, lived. In 1845 he sold the land and purchased the 100-acre Lot 17, Concession. B from Solomon Mattice. Tremaine’s 1860 *Map of the County of York* shows the development of Richview to date and illustrates the farm lots adjoining it, including La Rose’s land (Lot 17) (Figure 2). Between 1869-75 he also purchased the adjoining 100-acres of Lot 18. In 1875, he purchased another 100-acre lot (lot 14), which was sold in 1888 (Figure 3).

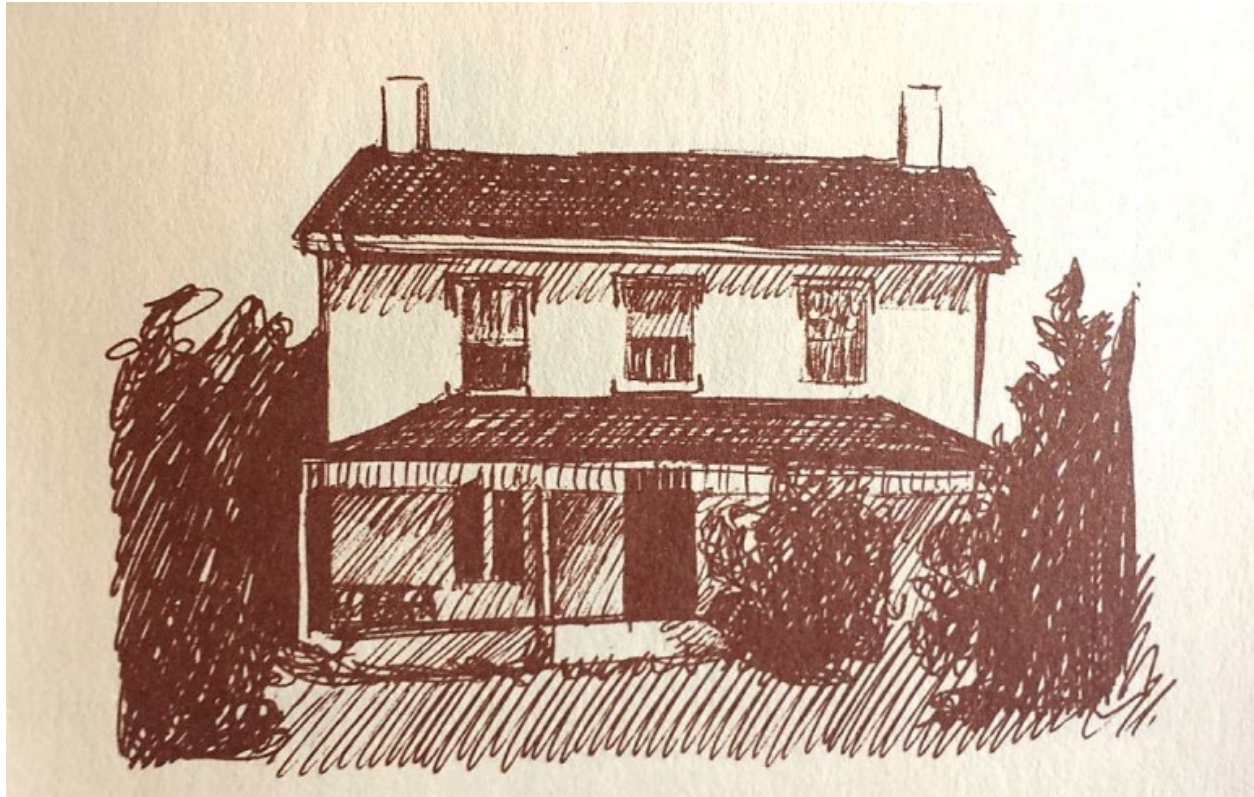
Figure 4. Sketch of La Rose House, c.1861 (Sidelights of History, 1975)

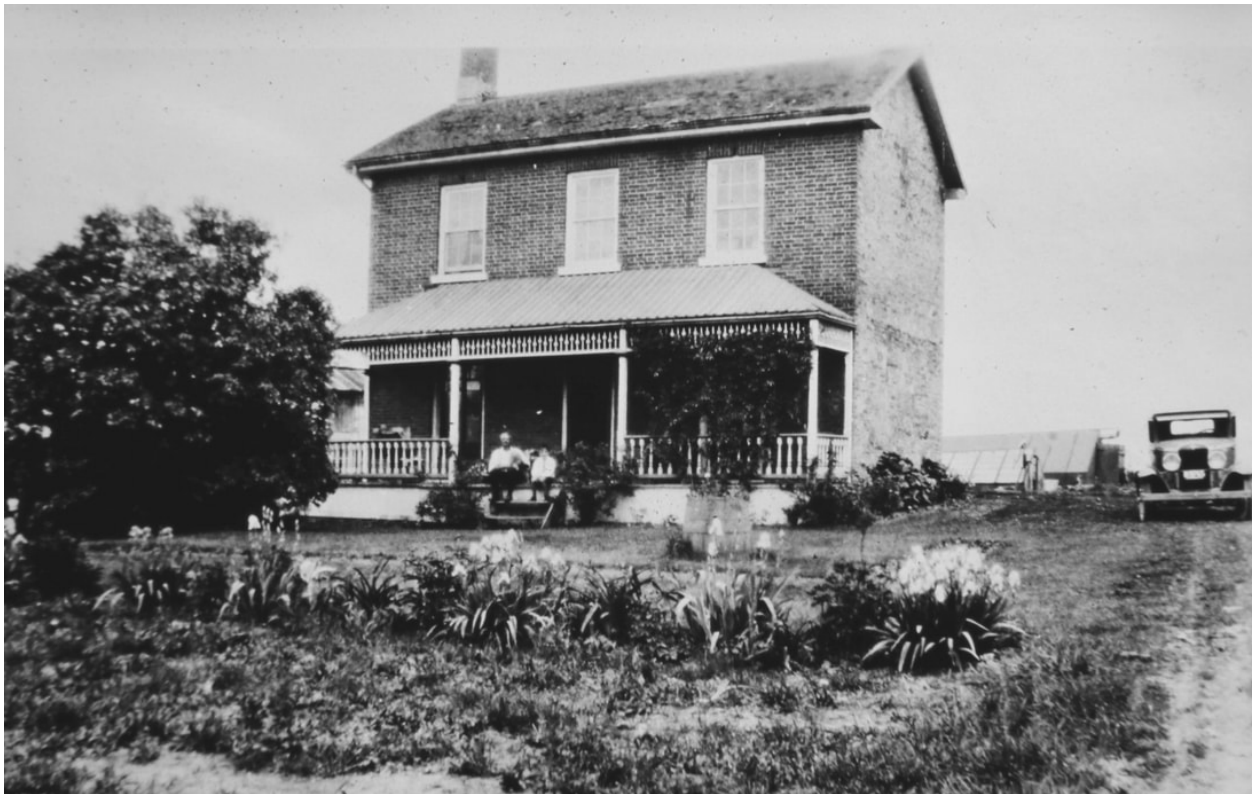
Figure 5. Historic photograph of the original primary elevation fronting Islington Avenue with the original corrugated porch roof and a barn at the rear of the house (Etobicoke Historical Society)

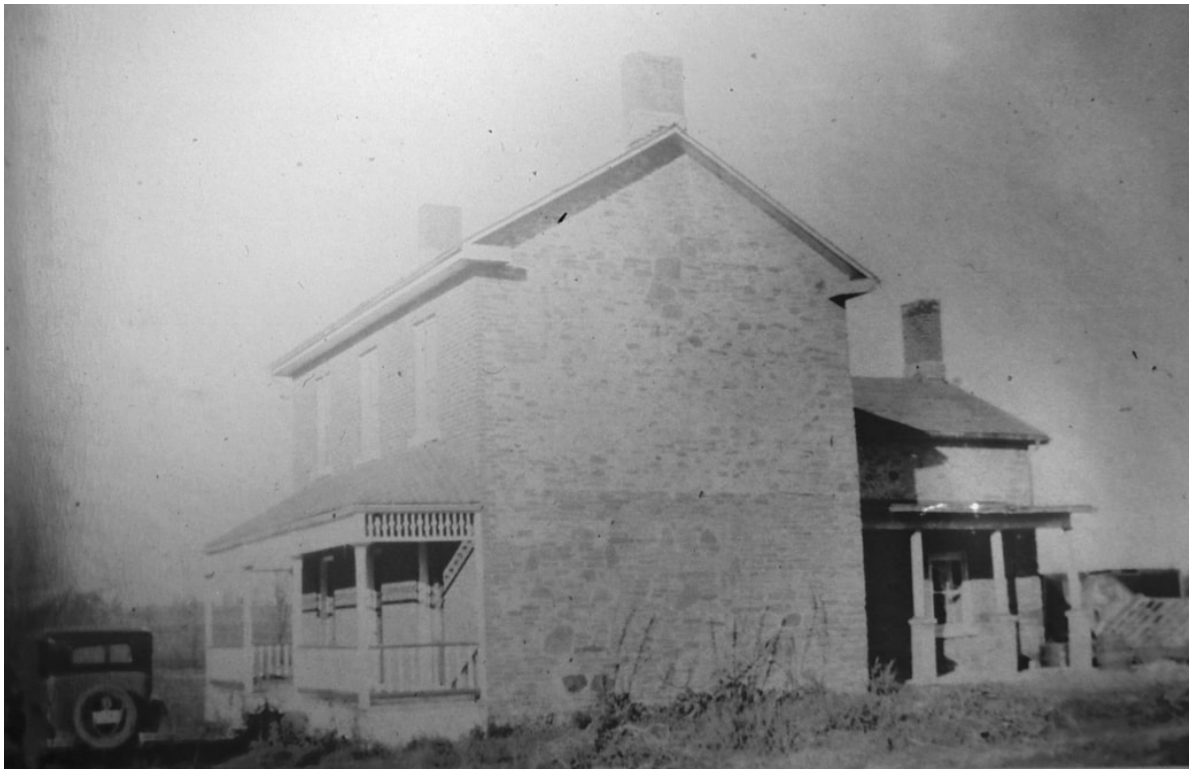
Figure 6. Historic photograph looking north at the main house (left) and rear kitchen wing (right) and 322 La Rose Avenue (Etobicoke Historical Society)

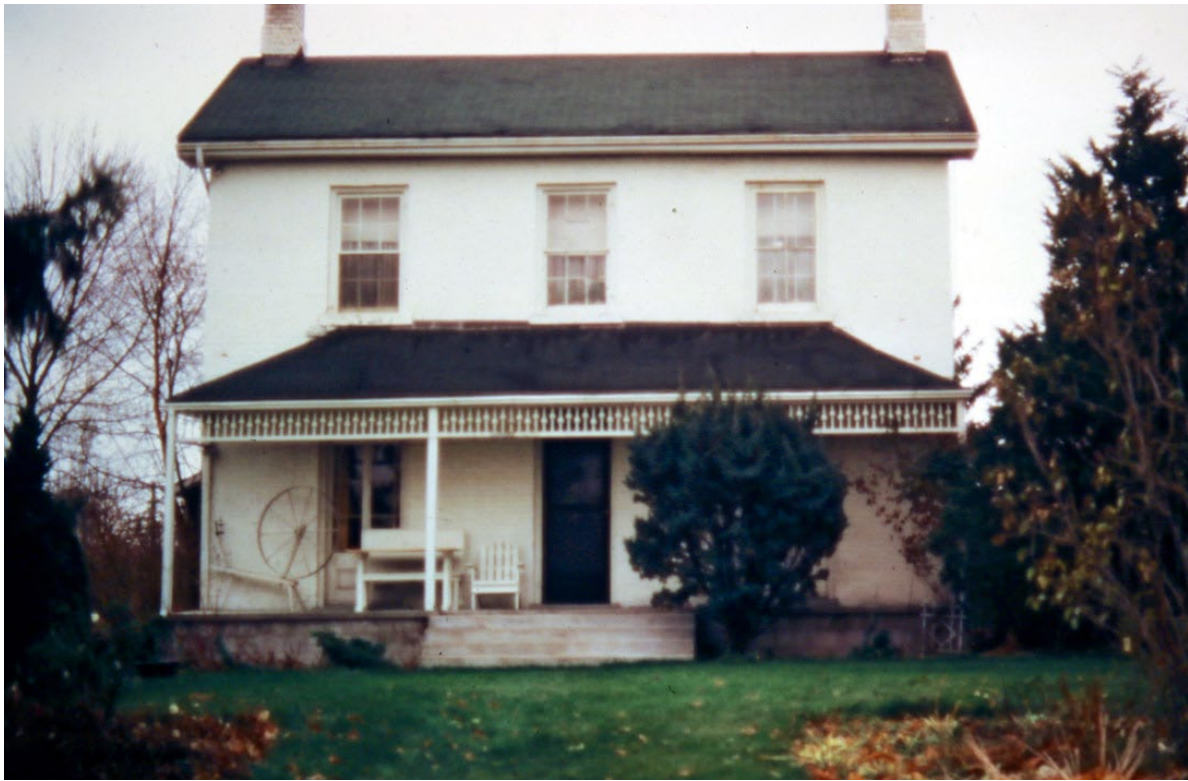
Figure 7. Historic photograph showing the property at 322 La Rose with painted brick (Etobicoke Historical Society)

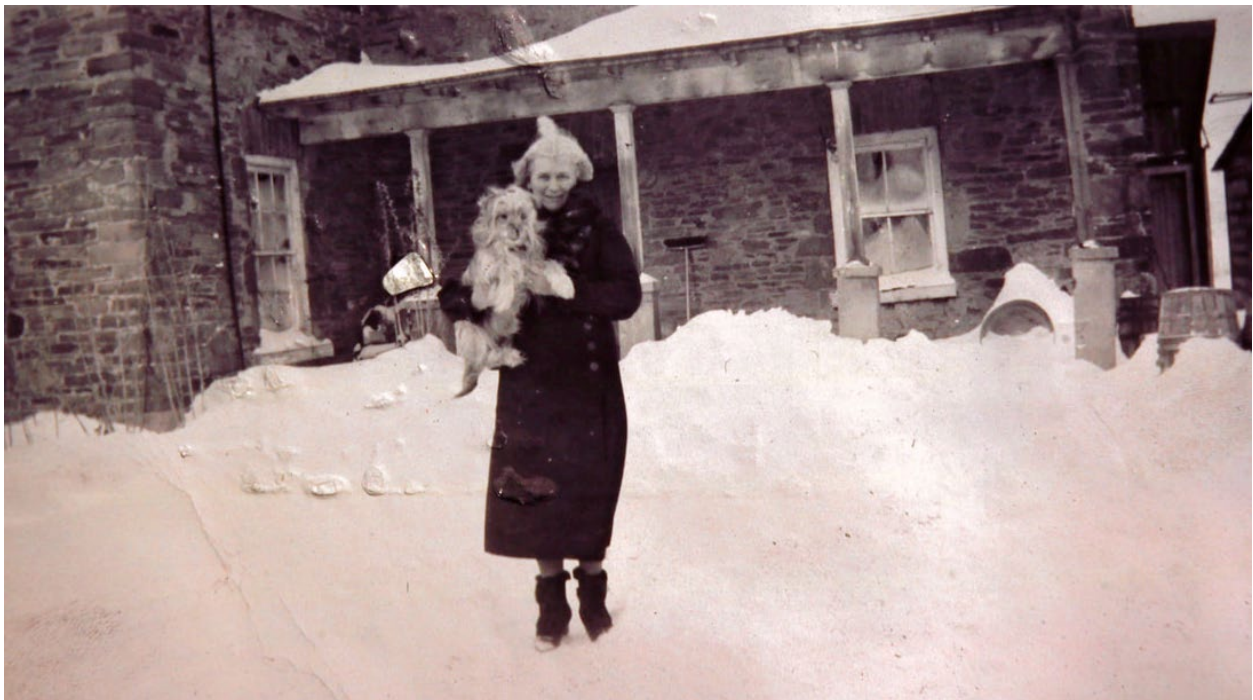
Figure 8. Historic photograph showing the rear kitchen wing and entrance (Etobicoke Historical Society)

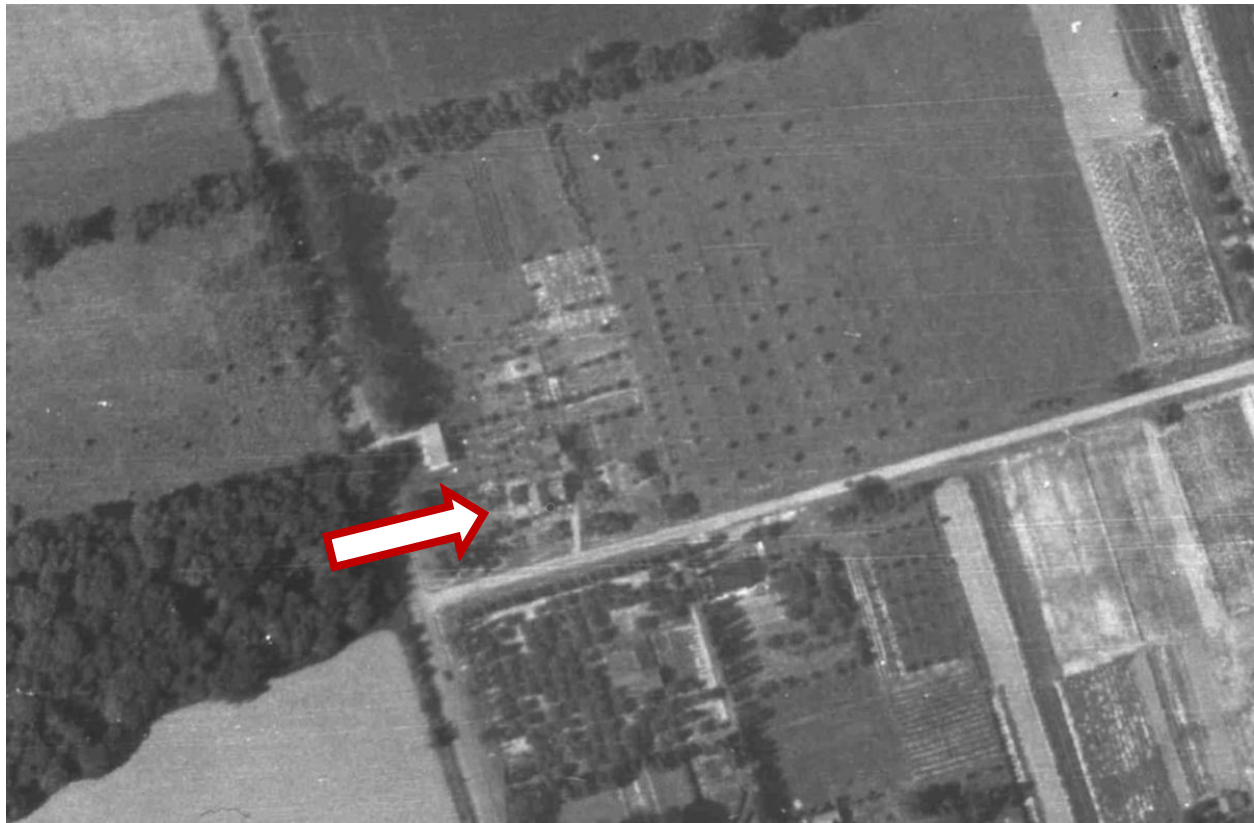
Figure 10. 1954 City of Toronto aerial map showing the location of the property at 322 La Rose Avenue and the surrounding rural land (iView, City of Toronto)

Aerial photographs illustrate that the area surrounding the subject property continued to remain largely rural until the early-1960s, when clearing for suburban development began and was completed by the end of the decade (Figure 10, Figure 11). The barn is believed to have been removed by 1963. At some point, the orientation of the primary elevation shifted to the south of the rear kitchen wing, as evidenced today (Figure 12). Both 322 and 324 La Rose Avenue are under the same ownership.

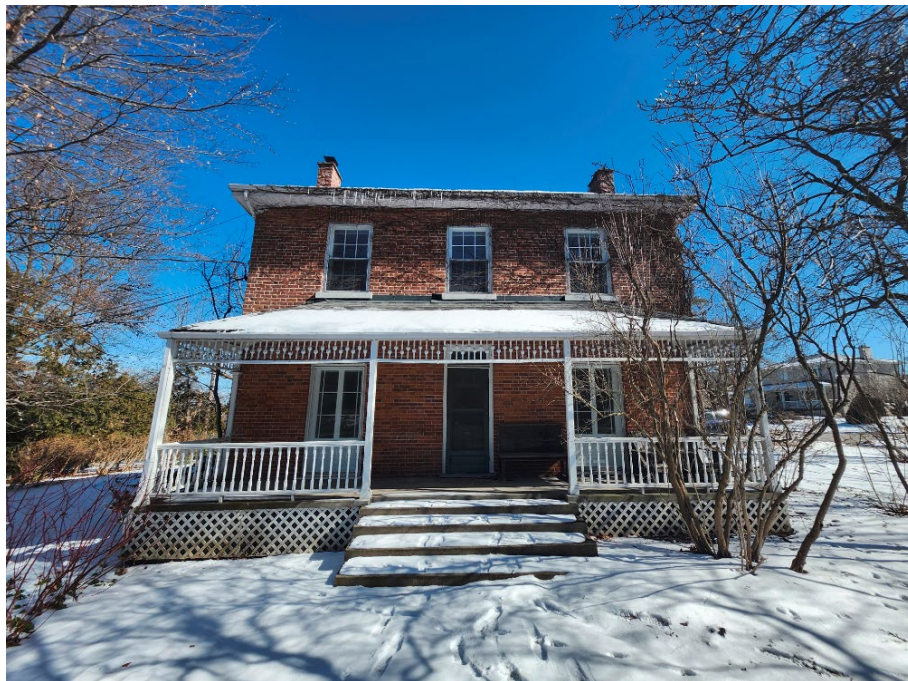
Figure 13. Detail of what was originally the primary elevation of the main house at 322 La Rose Avenue. This is now the side (west) elevation (Heritage Planning, 2024)

The property at 322 La Rose Avenue has design and physical value as a representative example of a mid-19th century, Pre-Confederation Ontario farmhouse. While modern additions have been made to the property during the 20th-century, the original section of the building remains evident in the L-shaped plan of the original 2-storey main house and 1½- storey rear kitchen wing, in the materials, including the red brick with a Flemish

bond in the original primary (west) elevation of the main house and the Humberstone in the remaining walls of the main house and rear kitchen wing, and in the side-gabled roofs. The window casings and deep sills at the interior in the first and second storeys of the main house and rear kitchen wing are also reminiscent of this typology.

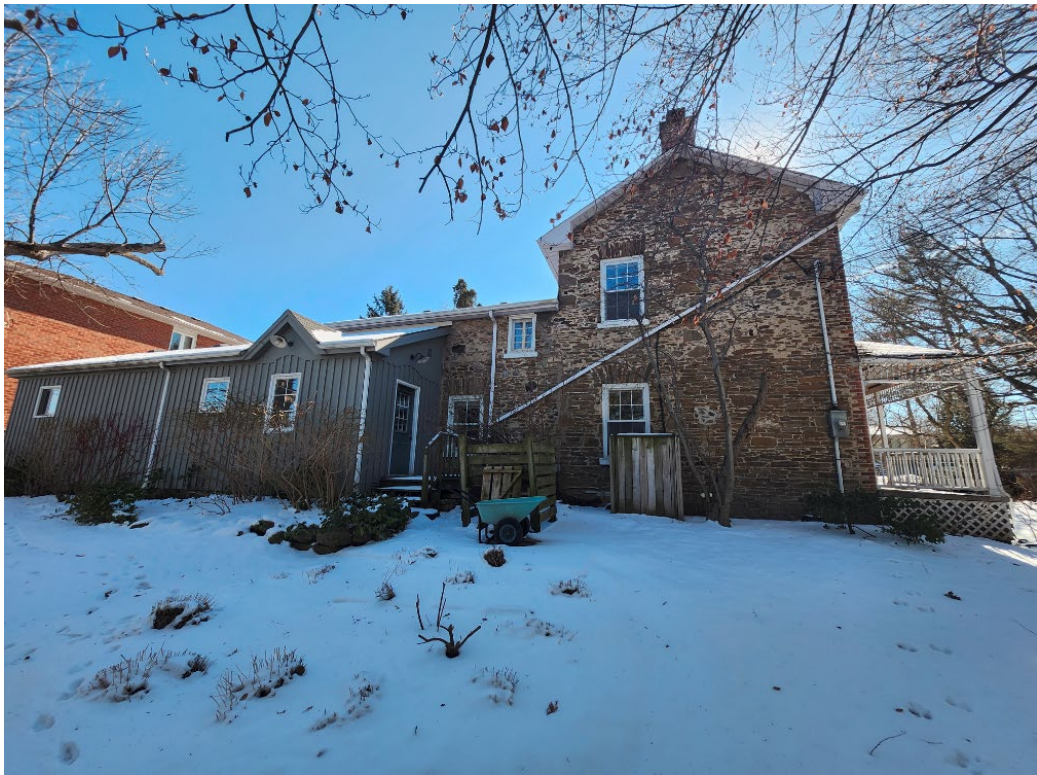
Figure 14. Detail of the rear (north) elevation of the property at 322 La Rose Avenue with the modern addition in grey on the left (Heritage Planning, 2024)

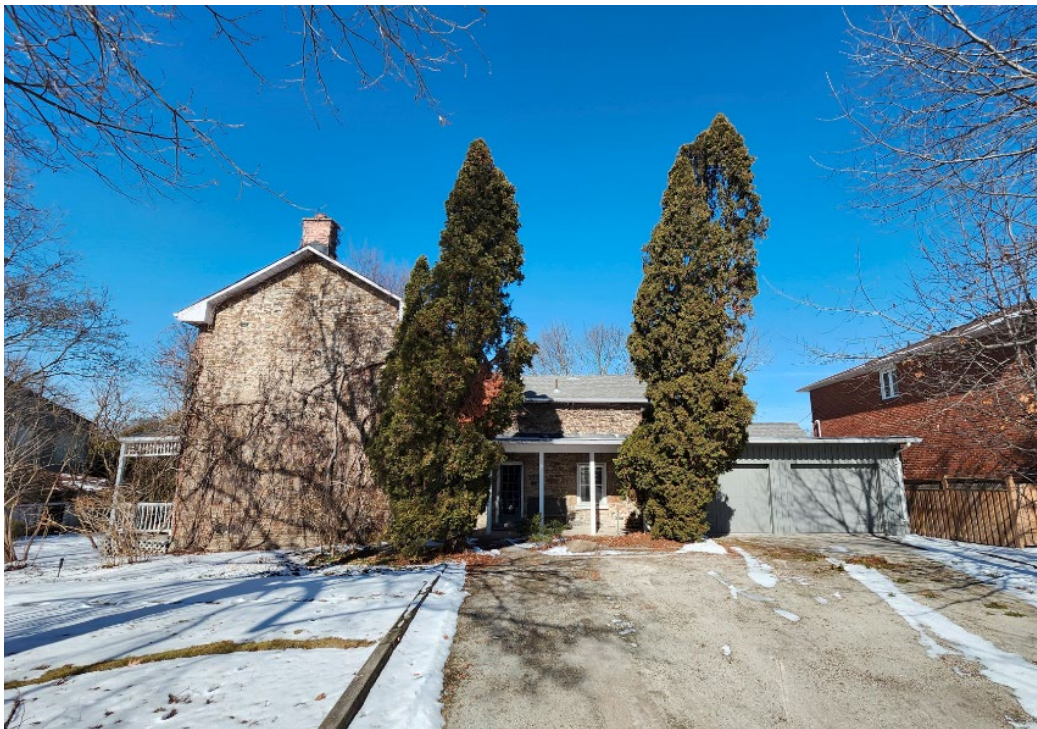
Figure 15. Detail of the current primary (south) elevation fronting La Rose Avenue with the main entrance in the centre and the modern 2-bay garage on the right (Heritage Planning, 2024)

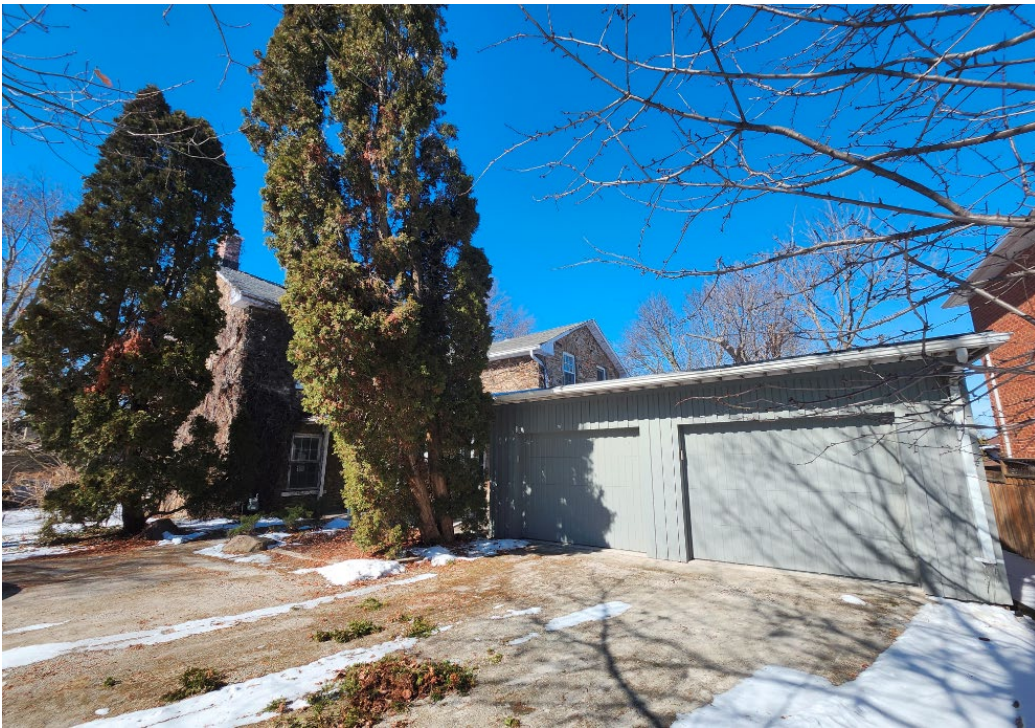
Figure 16. Partial view of the side (east) elevation with its gable peaking above the roof of the garage (Heritage Planning, 2024)

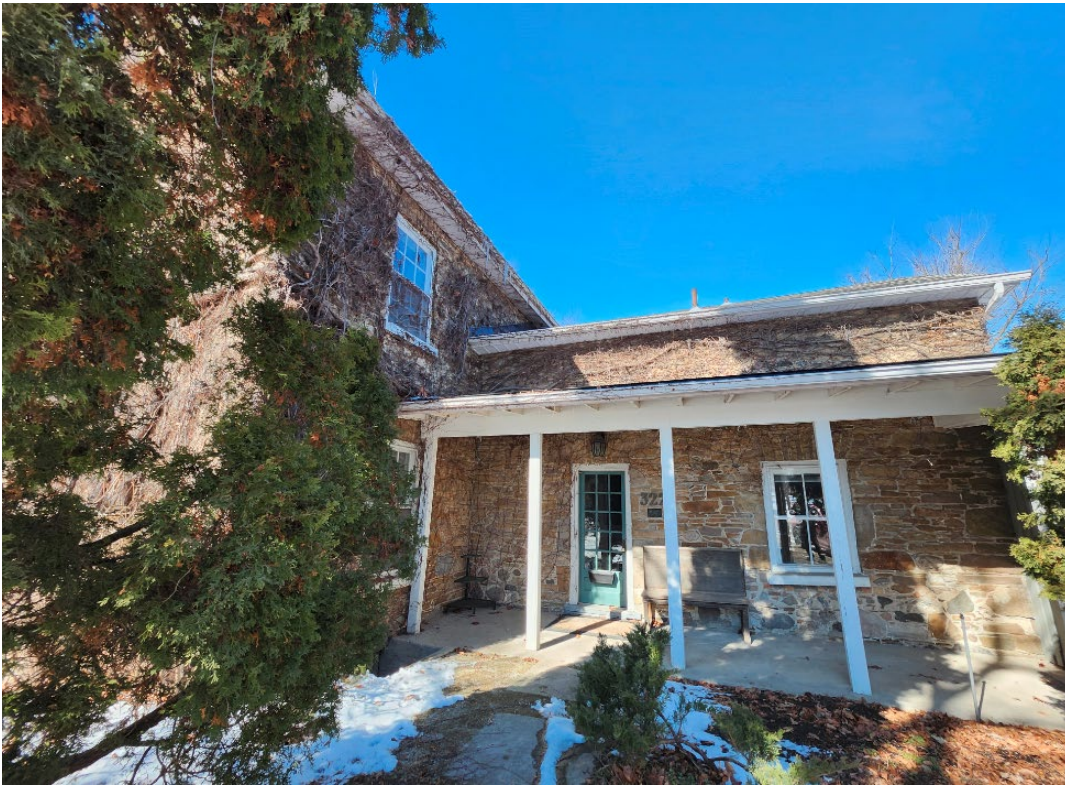
Figure 17. Detail of the current primary (south) elevation and main entryway to the property at 322 La Rose Avenue (Heritage Planning, 2024)

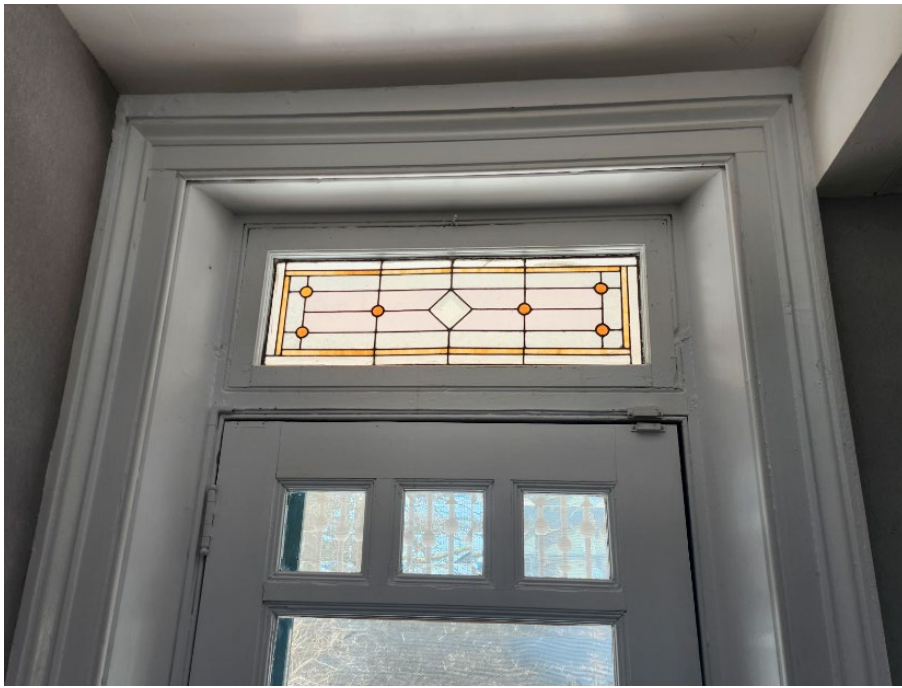
Figure 18. Detail of the transom above the door in the original primary (west) elevation of the main house (Heritage Planning, 2024)

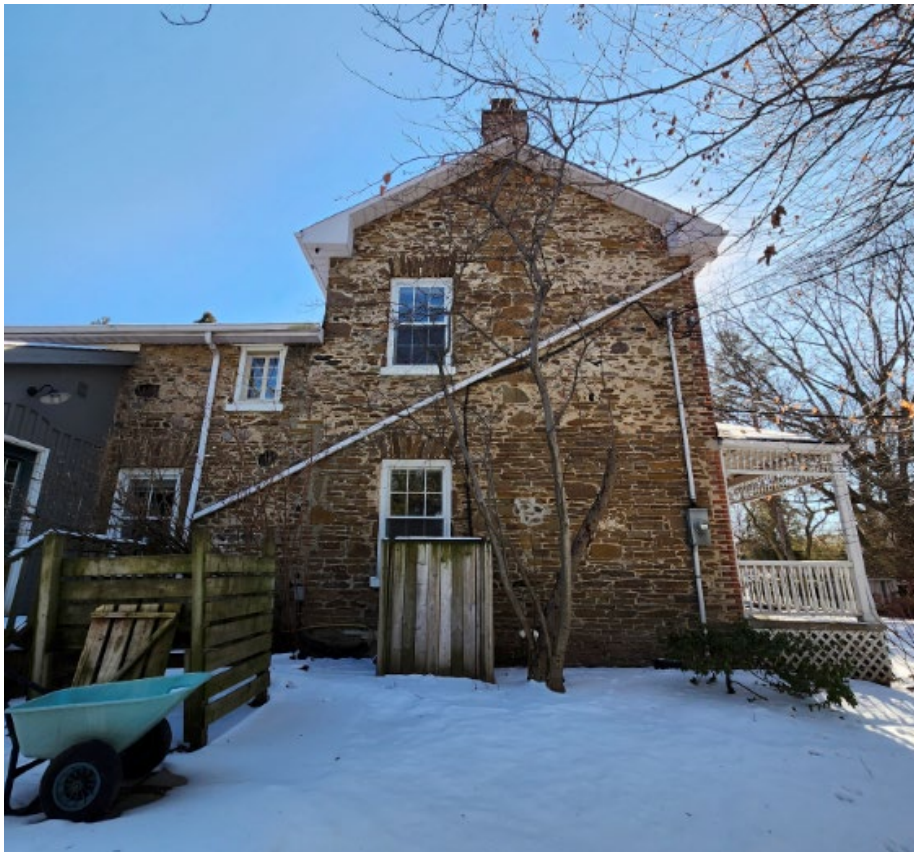
Figure 19. Detail of the side (north) elevation of the main house illustrating the windows and Humberstone (Heritage Planning, 2024)

- In the side (north) and rear (east) elevation of the main house: two six-over-six, double-hung sash windows with arch voussoirs above and wooden lug sills below in each elevation

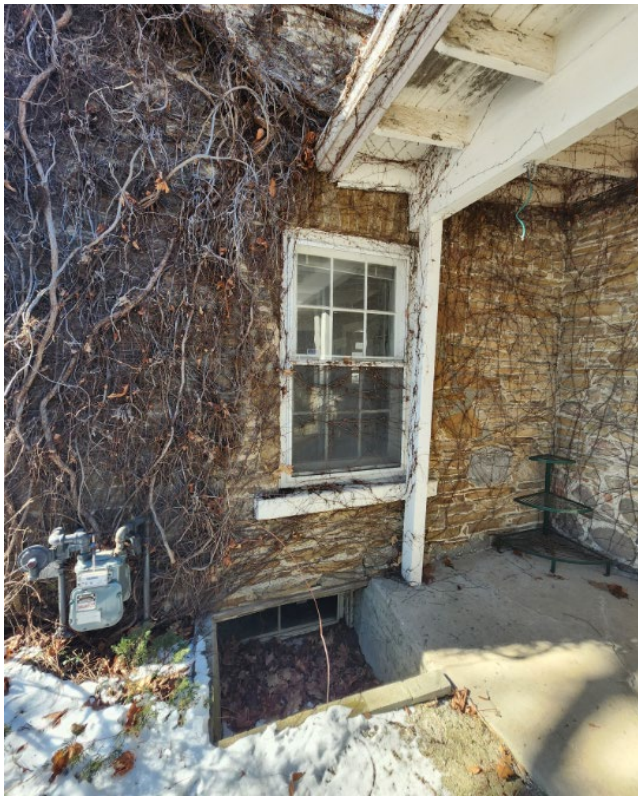
Figure 20. Detail of the rear (east) elevation of the main house illustrating the first storey window and Humberstone (Heritage Planning, 2024)

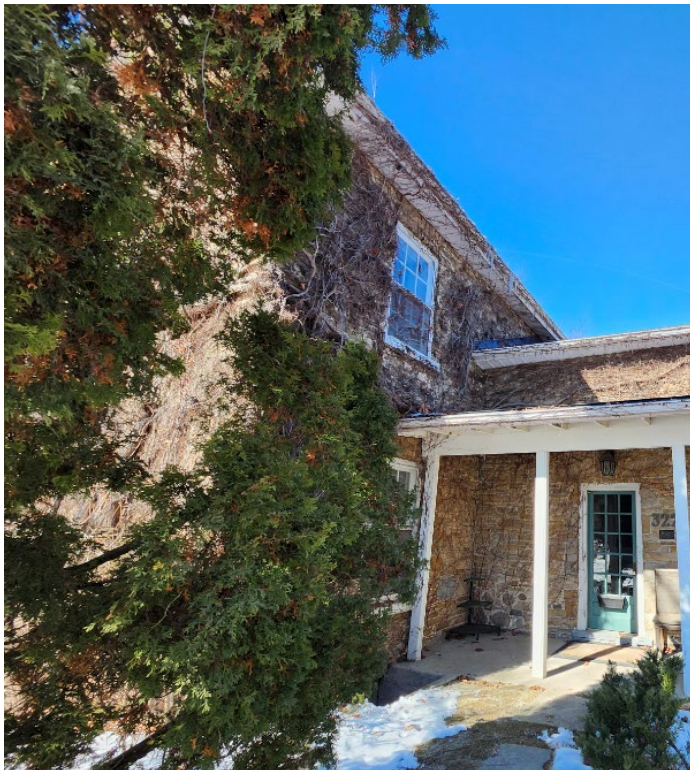
Figure 21. Detail of the rear (east) elevation of the main house illustrating the second storey window and Humberstone (Heritage Planning, 2024)

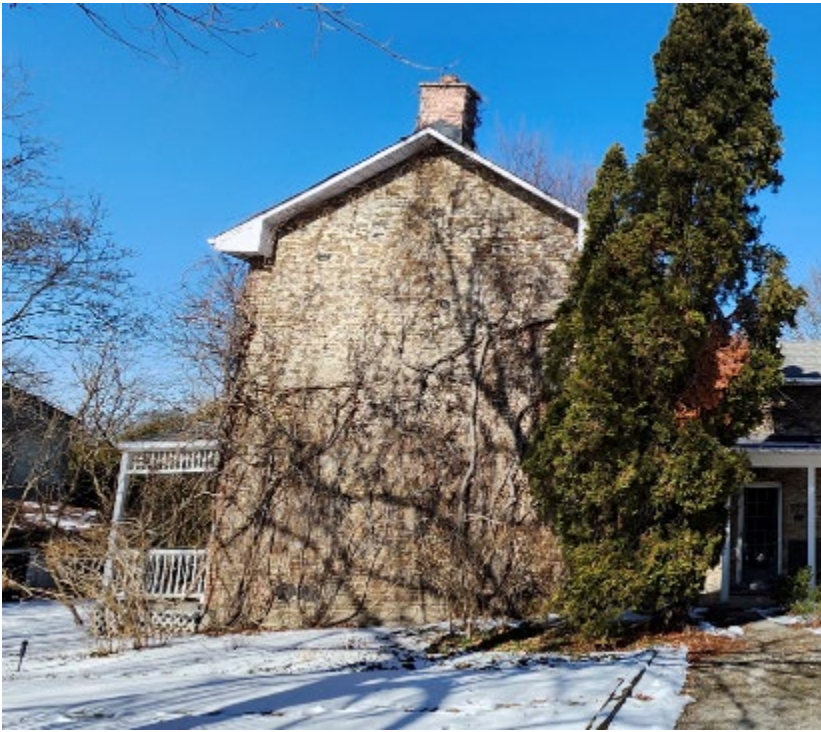
Figure 22. Detail of the side (south) elevation of the main house illustrating the vegetation (Heritage Planning, 2024)

side (south) wall of the main house has no windows and is covered in vegetation (Figure 22)

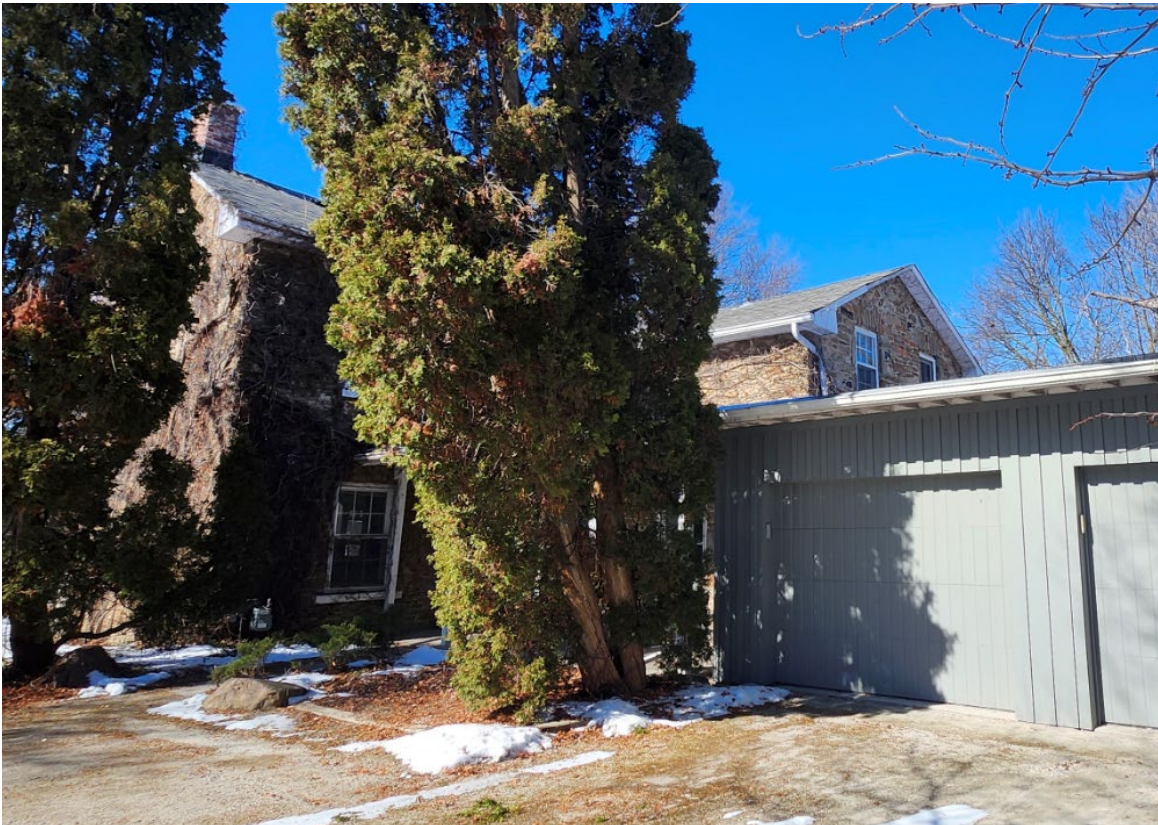
Figure 23. Detail of the side (east) wall of the rear kitchen wing illustrating a portion of the second storey windows. The side of the property is inaccessible to obtain a head-on photograph (Heritage Planning, 2024)

- In the rear kitchen wing in the side (east) elevation: the six-over-six, double-hung sash window and the opening for the one-over-one sash window with arch voussoirs above and wooden lug sills below

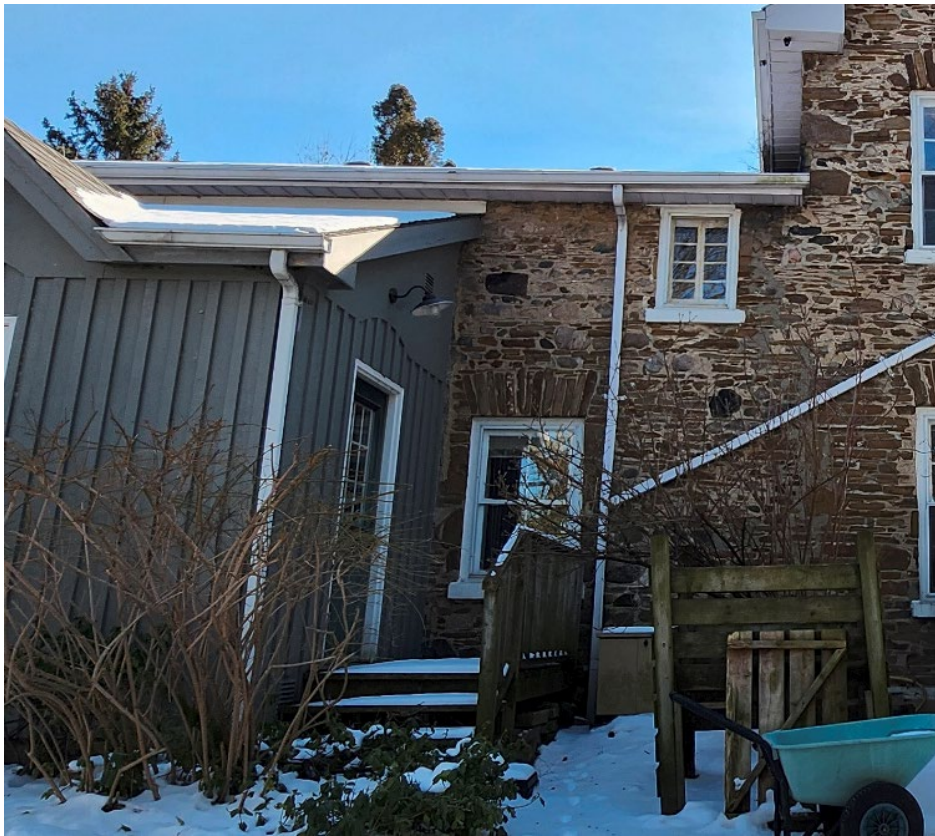
Figure 24. Detail of the two windows in the rear (north) wall of the rear kitchen wing (Heritage Planning, 2024)

- In the rear kitchen wing in the rear (north) elevation, the two-over-two, double-hung sash window with an arched voussoirs above and a wooden lug sill below and the eight-pane casement window with a wooden lug sill

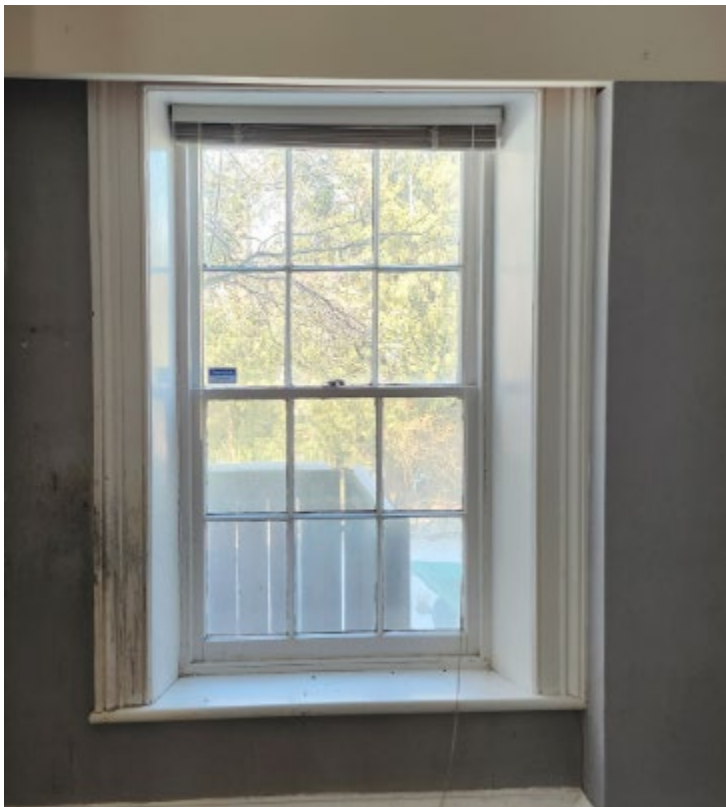
Figure 25. Detail of the casement of the window in the first storey of the side (north) wall of the main house (Heritage Planning, 2024)

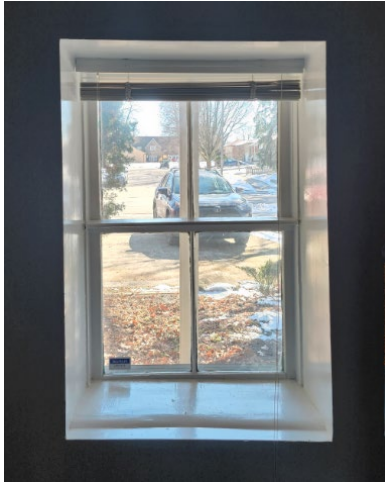
Figure 26. Detail of the casement of the window in the first storey of the current primary (south) elevation of the rear kitchen wing (Heritage Planning, 2024)

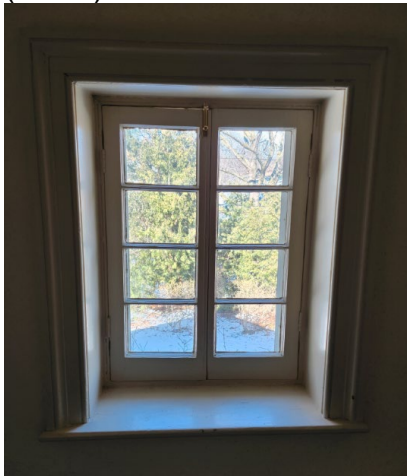
Figure 27. Detail of the casement of the window in the second storey of the side (north) wall of the rear kitchen wing (Heritage Planning, 2024)

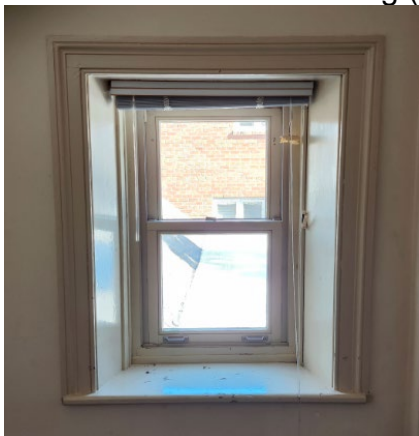
Figure 28. Detail of the casement of the window in the second storey of the side (east) wall of the rear kitchen wing (Heritage Planning, 2024)
