Cabbagetown Southwest
Heritage Conservation
District (HCD) Plan

CABBAGETOWN SOUTHWEST
HERITAGE CONSERVATION DISTRICT

HCD PLAN

This HCD Plan was prepared for City of Toronto Heritage Planning by EVOQ Architecture Inc. with LURA Consulting assisting with community engagement .

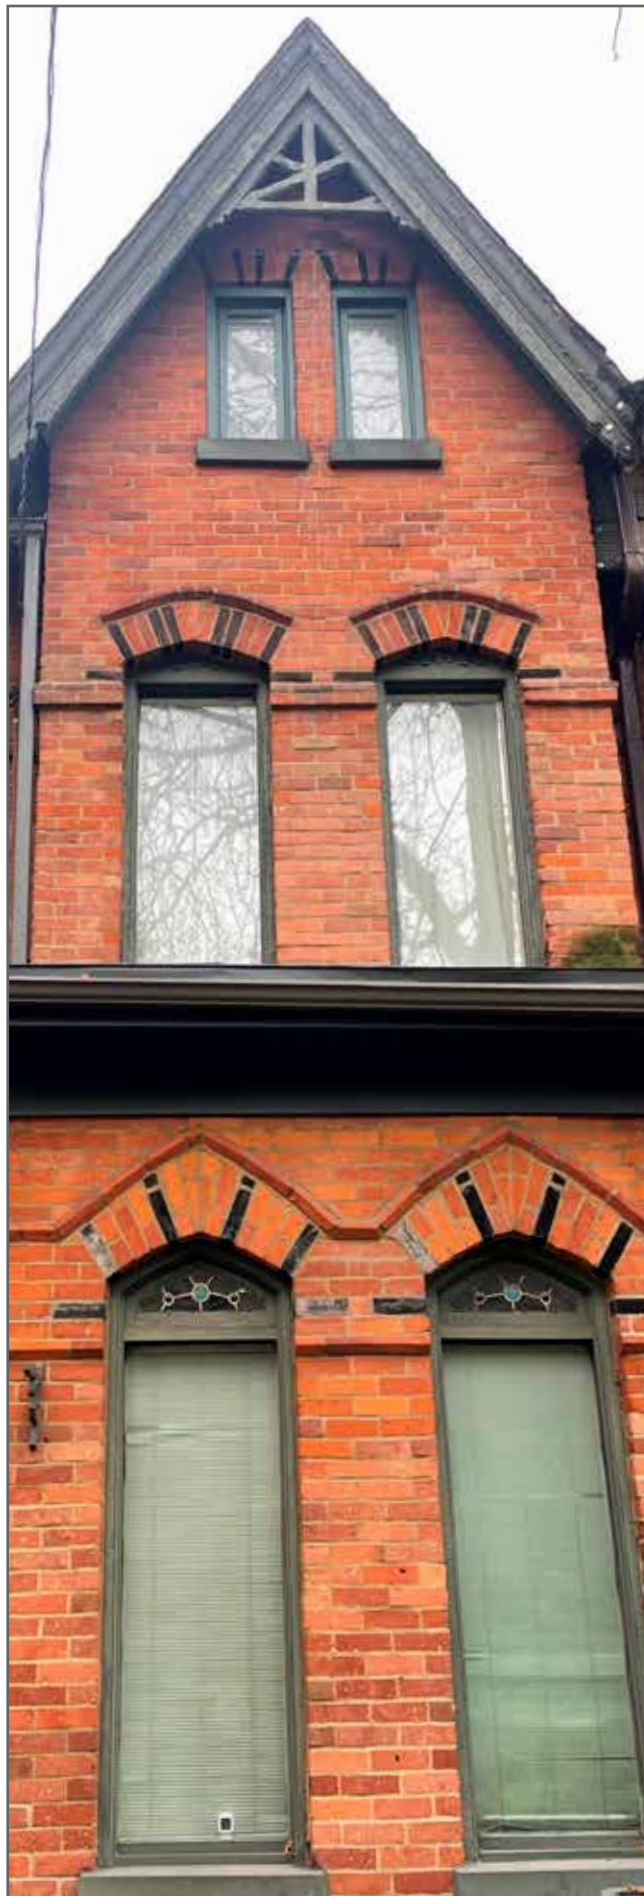
Figure 68: Retention of ground floor transom lights at 175 Seaton St.
