Traffic Control Signals - Queen Street West and Fuller Avenue

Date: September 9, 2024

To: Toronto and East York Community Council

Attachment 2: Map - Traffic Control Signals - Queen Street West and Fuller Avenue

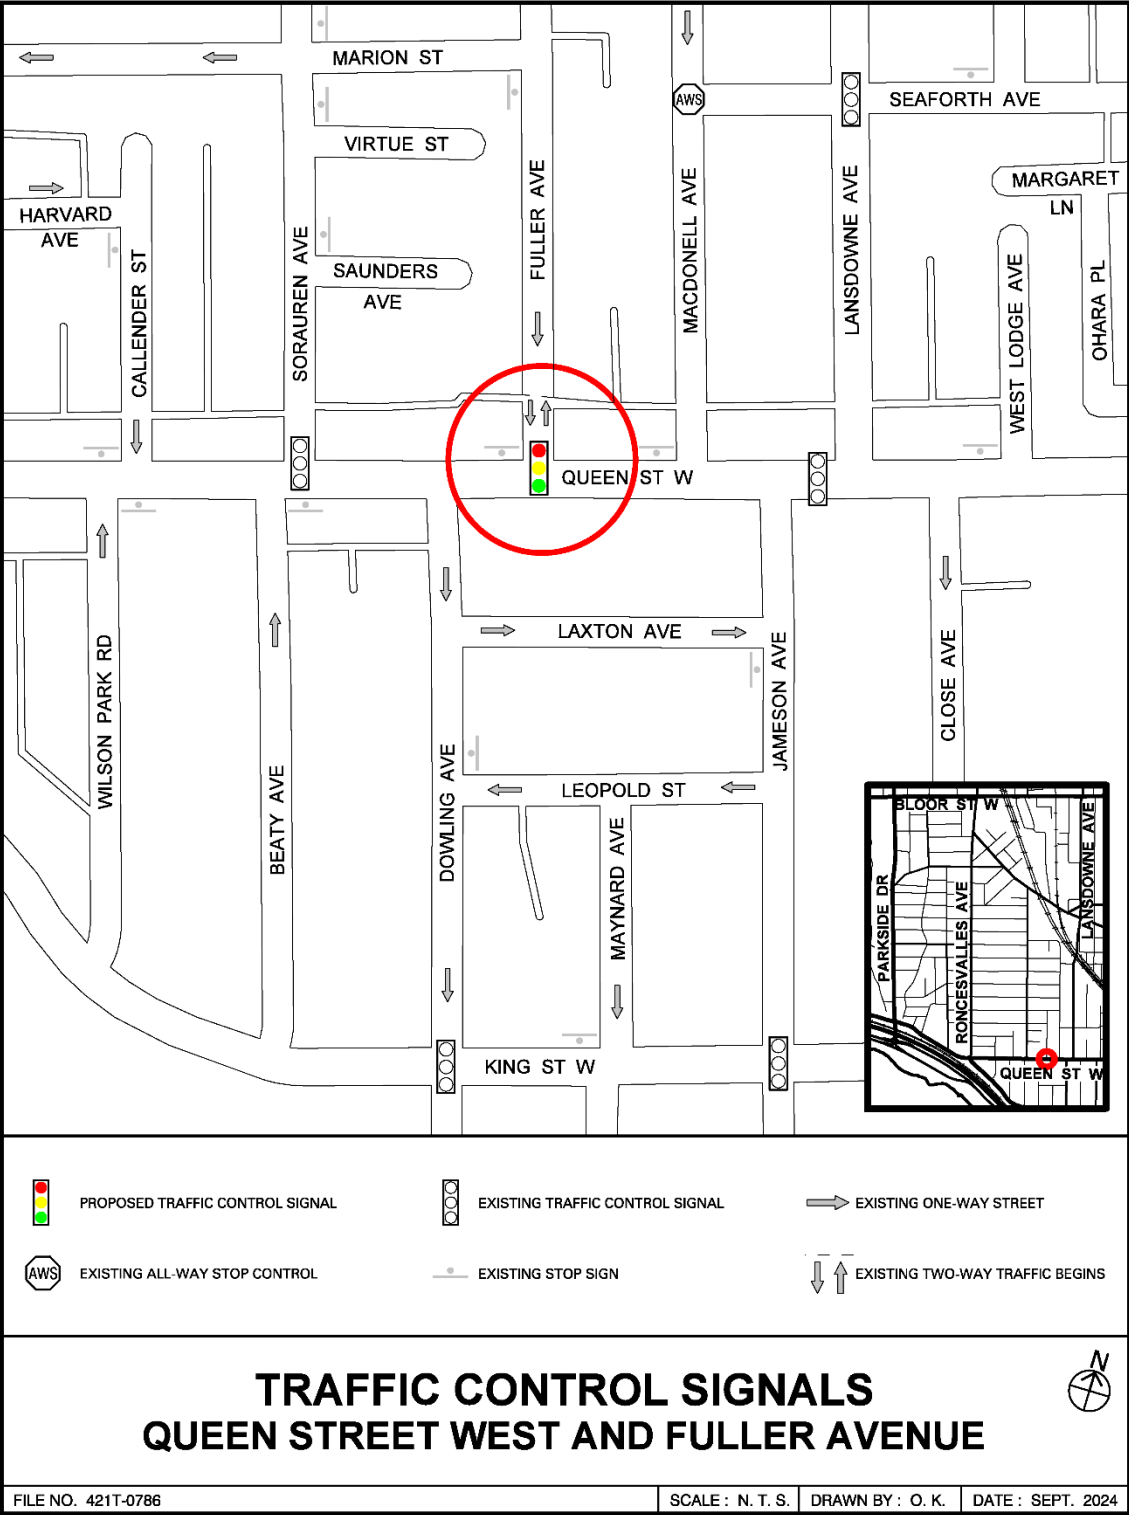
Attachment 2: Map - Traffic Control Signals - Queen Street West and Fuller Avenue

A map of the area is included in Attachment 2
