USER - FRIENDLY GUIDE TO THE RULES FOR TEMPORARY RAMPS ON CITY'S SIDEWALKS

Rules for Temporary Ramps on City's Sidewalks

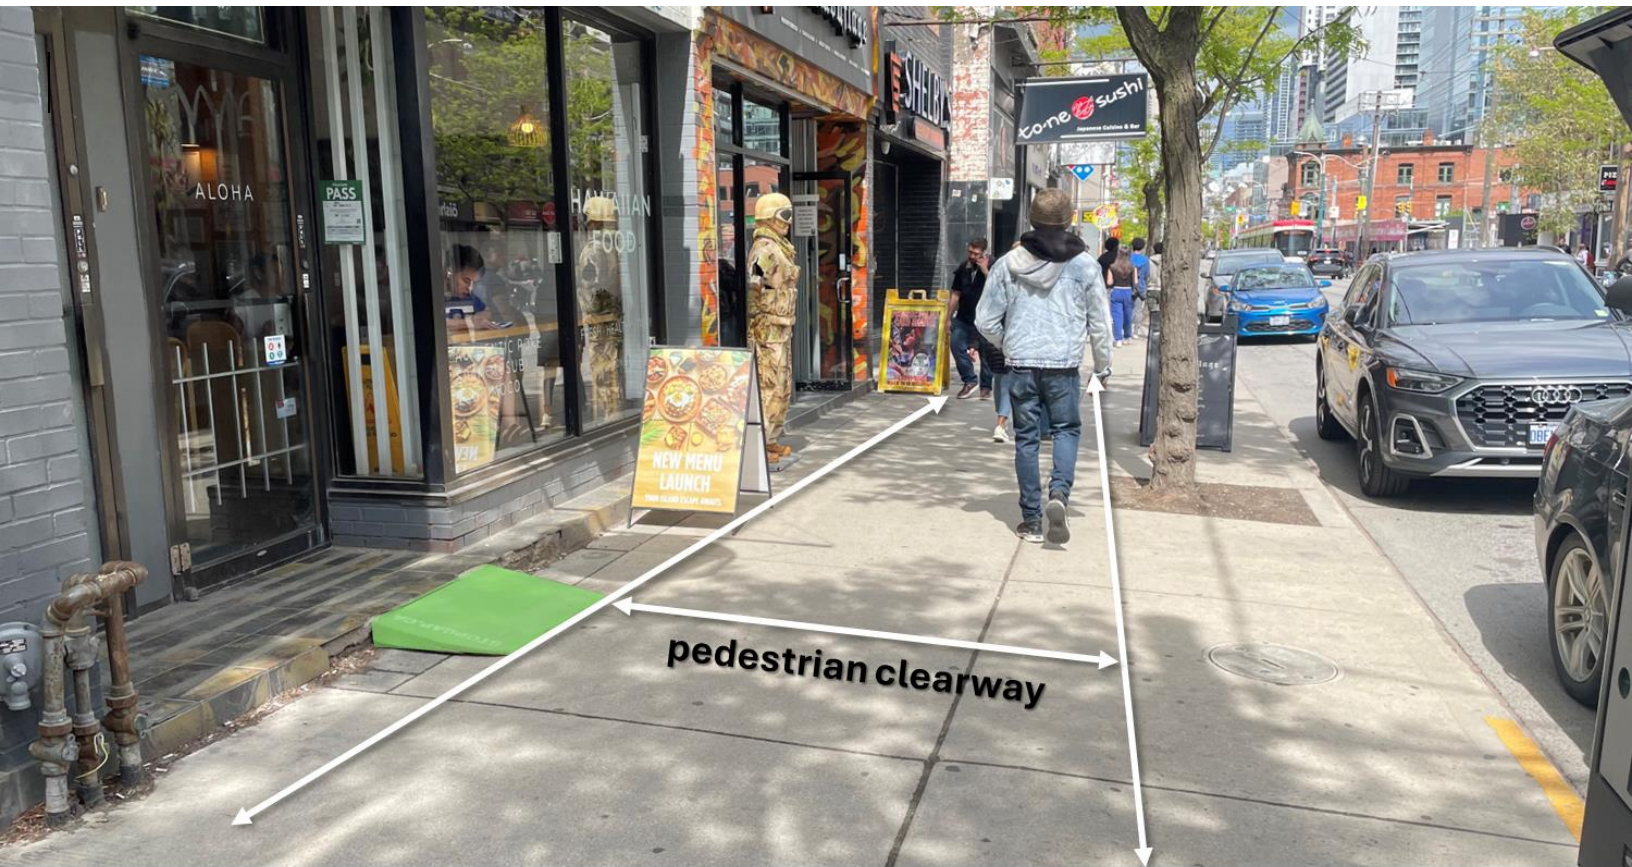
- The placement of the ramp must maintain the required pedestrian clearway of 2.1 meters on arterial roads or a collector road, 1.8 meters on a local road and 2.5 meters on streets identified in Toronto Municipal Code Chapter 742, Appendix A.
- The ramp must have a solid, enclosed base with a continuous surface along the sides of the ramp for a white cane to tap or slide along for wayfinding.
- The ramp is stable, movable, and has a slip resistant surface with a high color contrast against the surrounding sidewalk and entrance.
- The ramp does not extend in front of neighboring storefronts and entryways.
- Must always be brought inside after business hours.

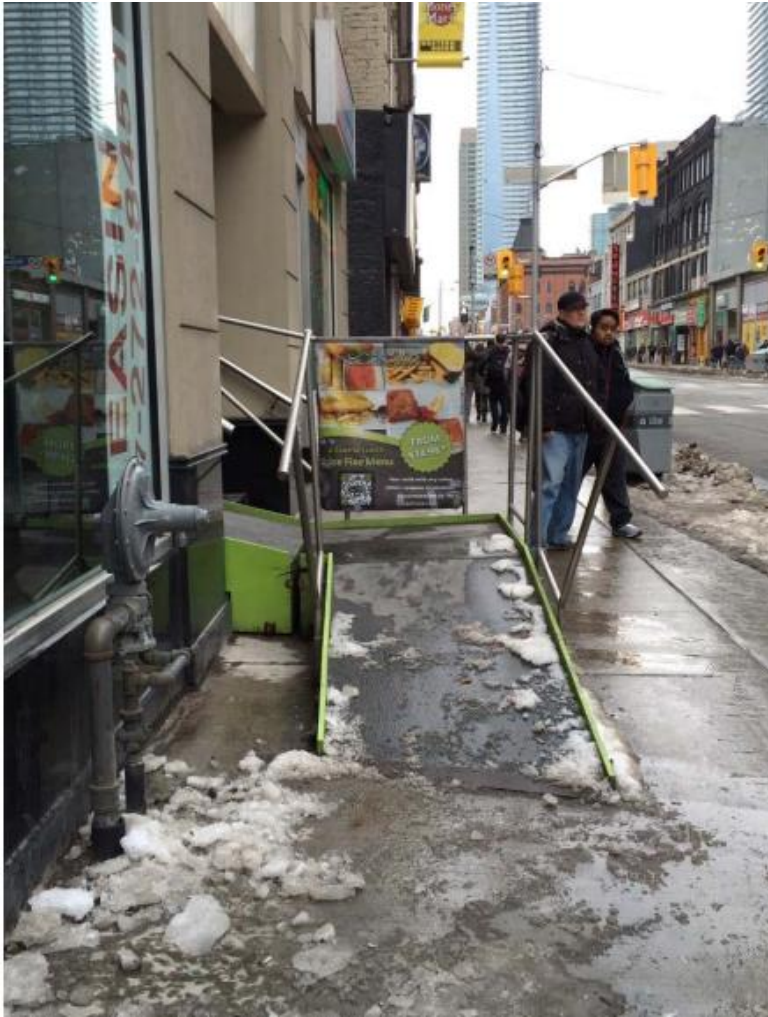
- Not well maintained and has snow and ice buildup
- The placement does not meet the 2.1m clear, unobstructed path as required
- Appears to be permanently affixed
- Ramp's slope is not oriented perpendicular to the step or building entrance
- Can not be brought inside after business hours
- Interferes with snow-clearing and other sidewalk maintenance and sightlines.
- The railing protrudes outward, creating a hazard for pedestrians especially persons with visual impairments

Examples of Non-Compliant Temporary Ramps on City's Sidewalks

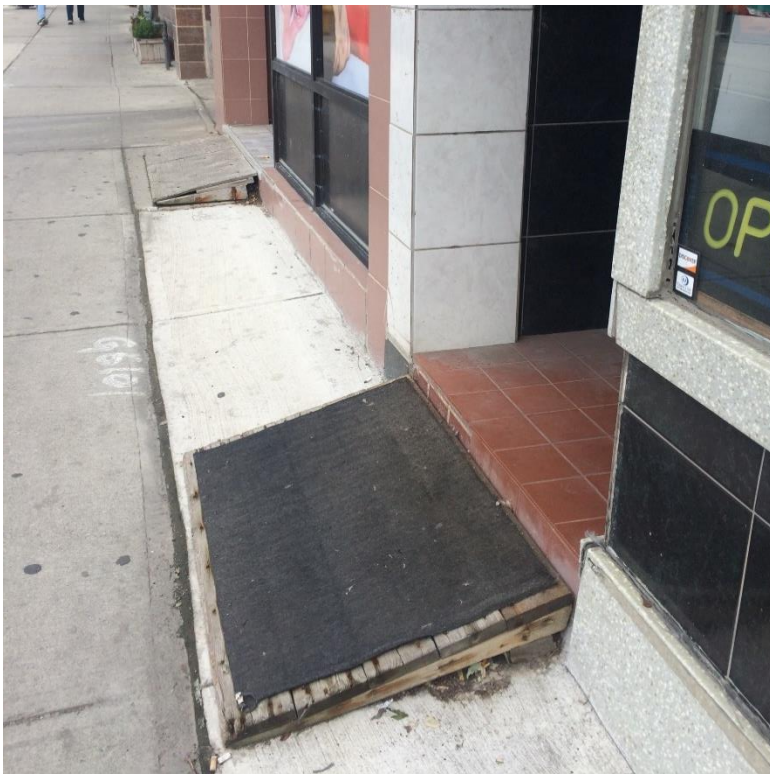
- The base of the ramp is damaged, making it unstable
- The top of the ramp is not level with the step landing
- The base of the ramp is not solid and fully enclosed. The sides have a gap/opening in which the tip of a long, white cane used by a visually-impaired person could be lodged or caught which causes challenges for their wayfinding/navigation along the sidewalk.
- The ramp in the photo's background has a solid and enclosed base but does not have a high contrast colour against the sidewalk.
