**HERITAGE RETENTION STUDY FOR  
505 UNIVERSITY AVENUE, REDEVELOPMENT  
CONFIDENTIAL & WITHOUT PREJUDICE**

**PREPARED FOR  
CARTAREAL CORPORATION N.V.**

**PREPARED BY  
JABLONSKY, AST, AND PARTNERS  
CONSULTING ENGINEERS  
400-3 CONCORDE GATE  
TORONTO, ON M3C 3N7**

**November 25, 2024**

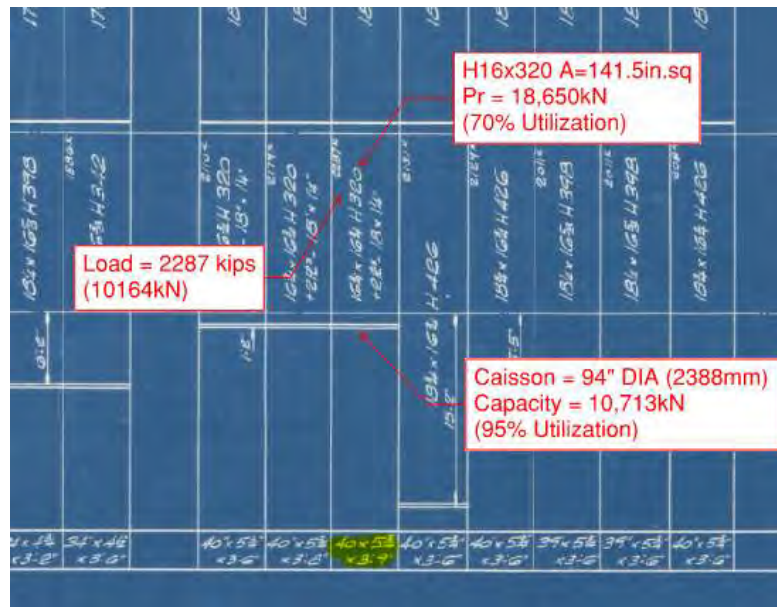
Image 3: Foundation Utilization

Based on our review, we concluded that the original building was designed for the additional stories but not for loading beyond that with the foundations at 95% utilization (Image 3). We also found that the lateral load resisting system, the steel moment frames, were not effective in resisting loads in accordance with current codes. Based on these findings we concluded that the existing building, as it stands, could not support additional vertical loads or additional lateral loads.

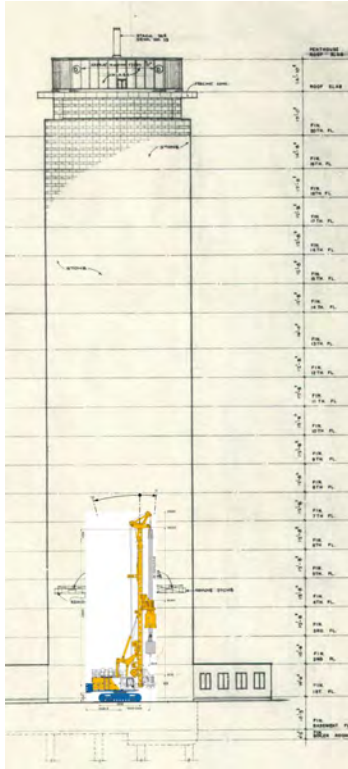
Image 4: Scaled Overlay of Drill Rig on Existing Building

If a vertical addition were to be added with the introduction of a new vertical structure within the existing floor plate, the practical installation of columns would not increase the lateral load resistance of the existing building. Also, given the soil condition at the site, and in the nearby vicinity, the foundations would need to extend to shale similar to the existing caissons. It was also readily apparent that the equipment required to install the caissons could not be mobilized due to the presence of the existing structure (Image 4). Appendix A contains the options that were explored with respect to a vertical addition to the existing building with additional structure.

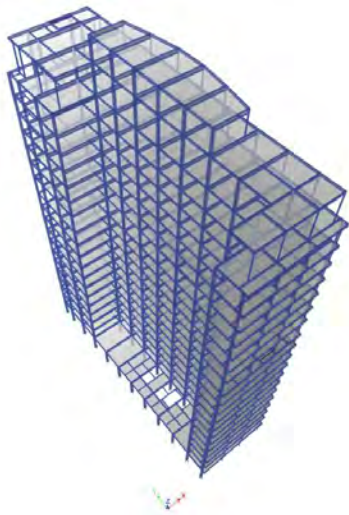
Image 5: Model of Full Building Retention

Our analysis for retention strategy started with maintaining the façade on the East, South, and West elevations with returns on the North elevation (Image 5). We determined that the existing steel frame did not have sufficient strength to resist the applied loads and that the deflections were excessive (Image 6). Combined with strengthening of the existing framing and adding stiffness to reduce movement, the deflections were still excessive. Appendix C contains a report on the Analysis of retention of the 20-storey Building.

Image 6: Summary of Deflection Exceedances For Full Height Retention

This led us to review the entire building and its original framing. Based on our analysis, the existing steel framing does not have sufficient stiffness to adequately support the building or resist deflections given the stiffness of the exterior cladding. It has become readily apparent that the stiffness and robustness of the exterior wall assembly has contributed to the performance of the building to date. The cracks in the corners of the building are indicative of the overstress in the wall assembly during wind and seismic events. Appendix D contains the analysis of the existing structure and clearly demonstrates that the exterior wall assembly is supporting the existing building from a lateral perspective. We would not criticize the original designers of the building as they were working with the knowledge and technology that was available to them at the time, however, the building in its current form and design would not meet modern-day Building Code Requirements for strength and serviceability. The building has performed to date in a satisfactory manner, however, over time the exterior wall assembly will continue to provide resistance for lateral loading and continue to show evidence of this via cracking.

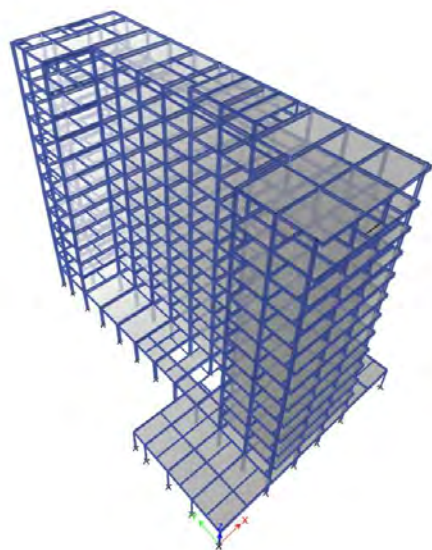
Image 7: Retention of 12 Storey Building

We then reviewed the partial retention of the original 12-storey building (Image 7). The results of the analysis were similar in that even with the strengthening of the existing structure and added stiffness, the deflections were excessive to the extent that the façade would incur significant damage resulting from movement (Image 8). This added to the conclusion we had initially, that the existing façade was carrying much of the lateral capacity of the buildings. Appendix E contains a Report on the results of the Retention of the 12-story building.

Image 8: Summary of Deflection Exceedneces of 12-Storey Retention

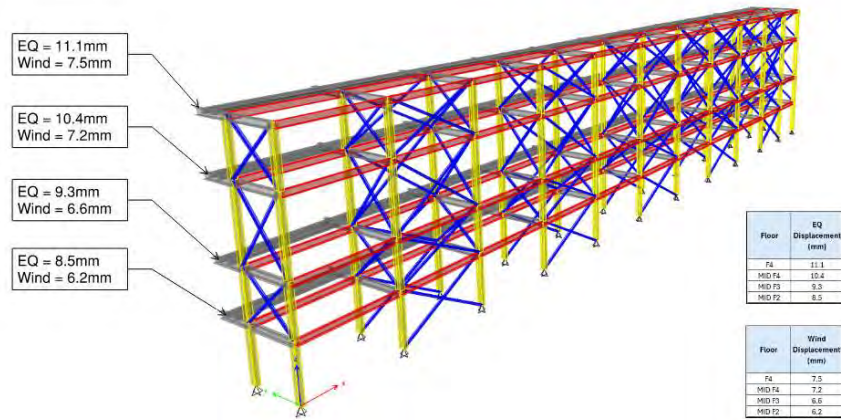
### SCENARIO 1: 4 FLOOR RETENTION

The retention strategy then turned to façade only with supplemental framing on the exterior of the building. We reviewed several options for the height of the façade to be retained and the associated deflection for each option. The review settled on 6-storey and 4-storey façade retention schemes, and we determined that the deflection at the top of the wall would be twice as large for 6-stories as for 4-stories (Image 9). Given the stiffness of the exterior façade, the deflection sensitivity is crucial as is evidenced in the existing cracks in the corners of the building. Appendix F contains the analysis of the façade retention for 4 and 6-storey.

Image 9: Comparison of 4 and 6 Storey Facade Retention Deflections

With façade only retention, a 6-storey façade will sustain twice the amount of deflection as a 4-storey façade. Given the robust exterior wall construction, the façade is highly susceptible to deflection and will crack if the retention system is not sufficiently robust. Based on past experience, we have observed that the façade retention systems expand and contract with temperature fluctuations which cause the heritage wall to move with the retention frame. This induces cracking in a typical brick façade which will be more pronounced in the large stone, interlocked façade. The temperature fluctuations are not controllable and must be considered in any retention system design.

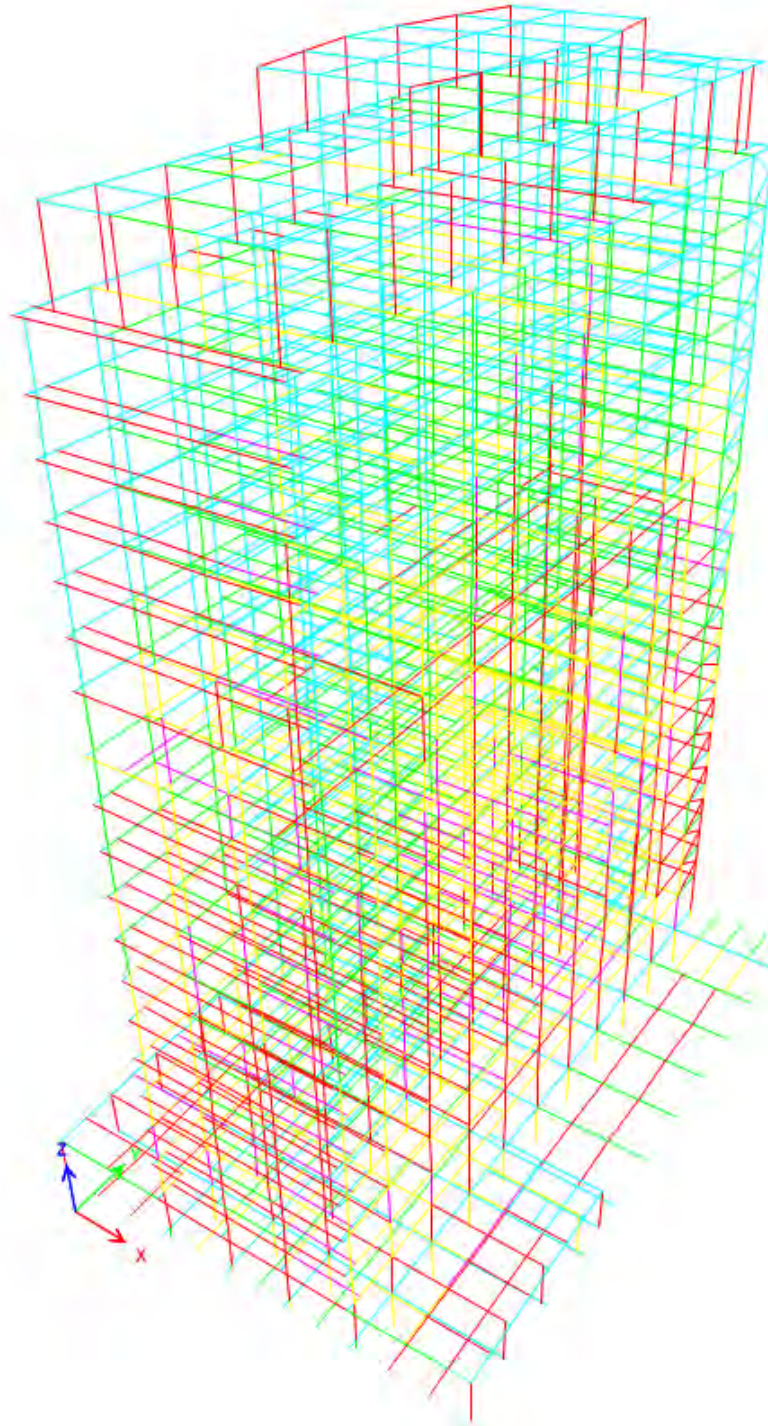
**Stress Contour Diagram for Wind Load Combination**

Columns, beams and braces are designed in ETABS for the design load combinations by setting the design code as **CSA S16-14** and framing type as **Conventional Moment Frame**

3D view of the overall building is shown below and some the braces, beams and columns which are not satisfying for wind load design combinations are **red** in color.

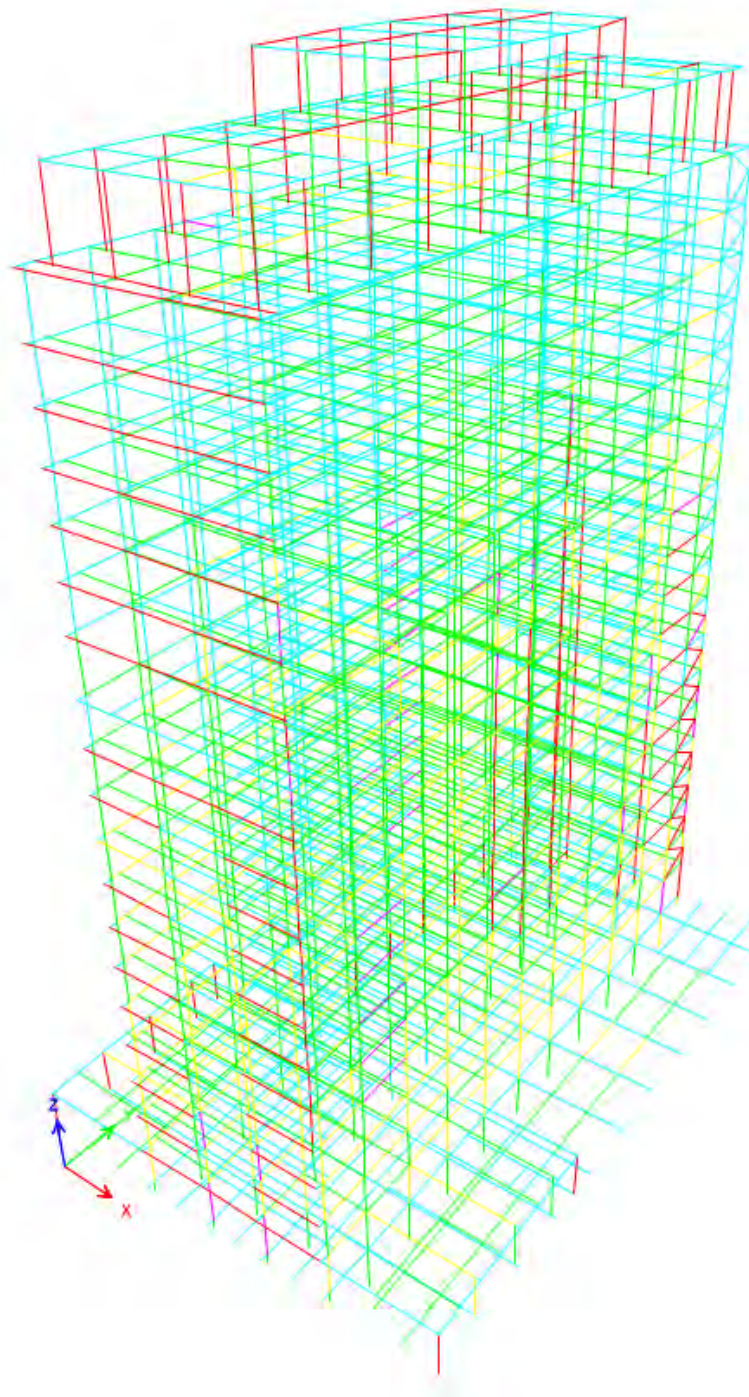
**Stress Contour Diagram for Seismic Load Combination**

Columns, beams and braces are designed in ETABS for the design load combinations by setting the design code as **CSA S16-14** and framing type as **Conventional Moment Frame**

3D view of the overall building is shown below and some the braces, beams and columns which are not satisfying for seismic load design combinations are **red** in color.

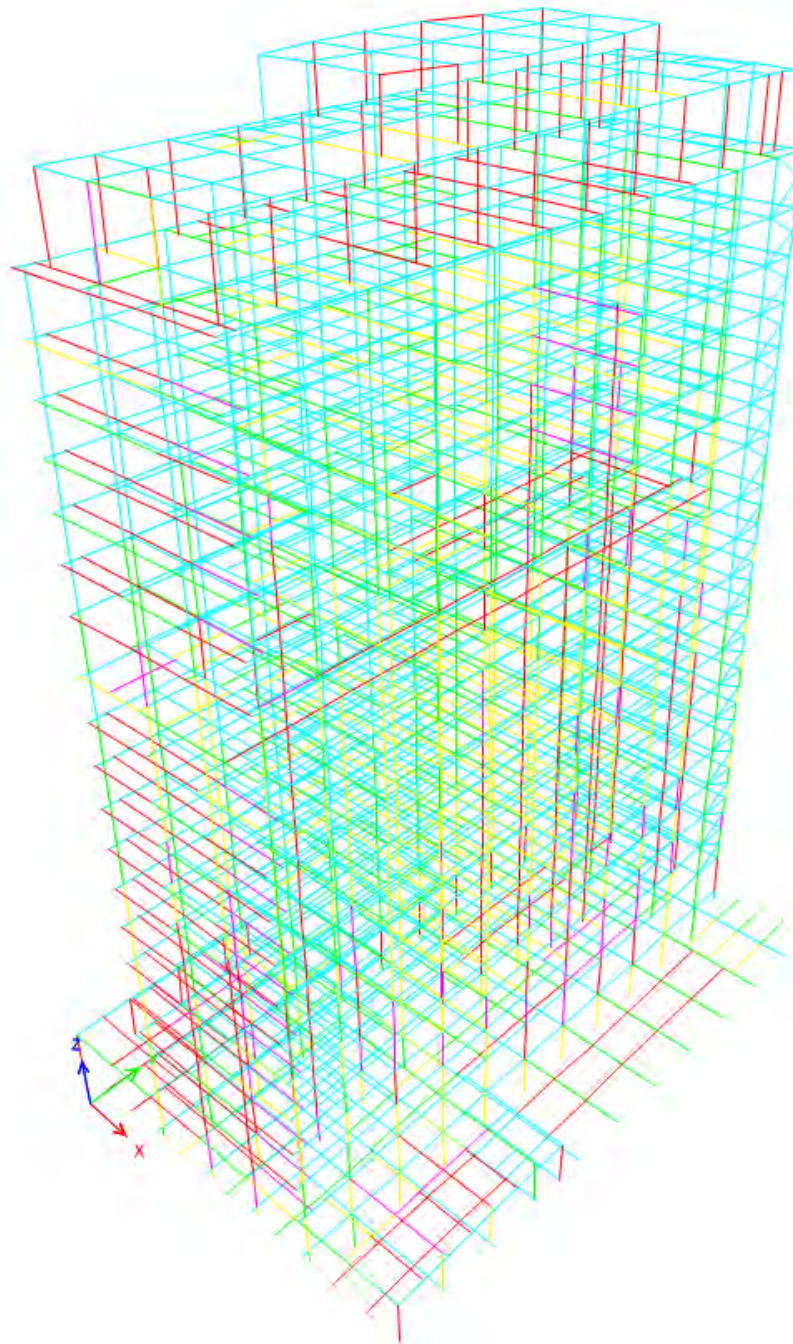
**Stress Contour Diagram for Gravity Load Combination**

Columns, beams and braces are designed in ETABS for the design load combinations by setting the design code as **CSA S16-14** and framing type as **Conventional Moment Frame**

3D view of the overall building is shown below and some the braces, beams and columns which are not satisfying for gravity load design combinations are **red** in color.

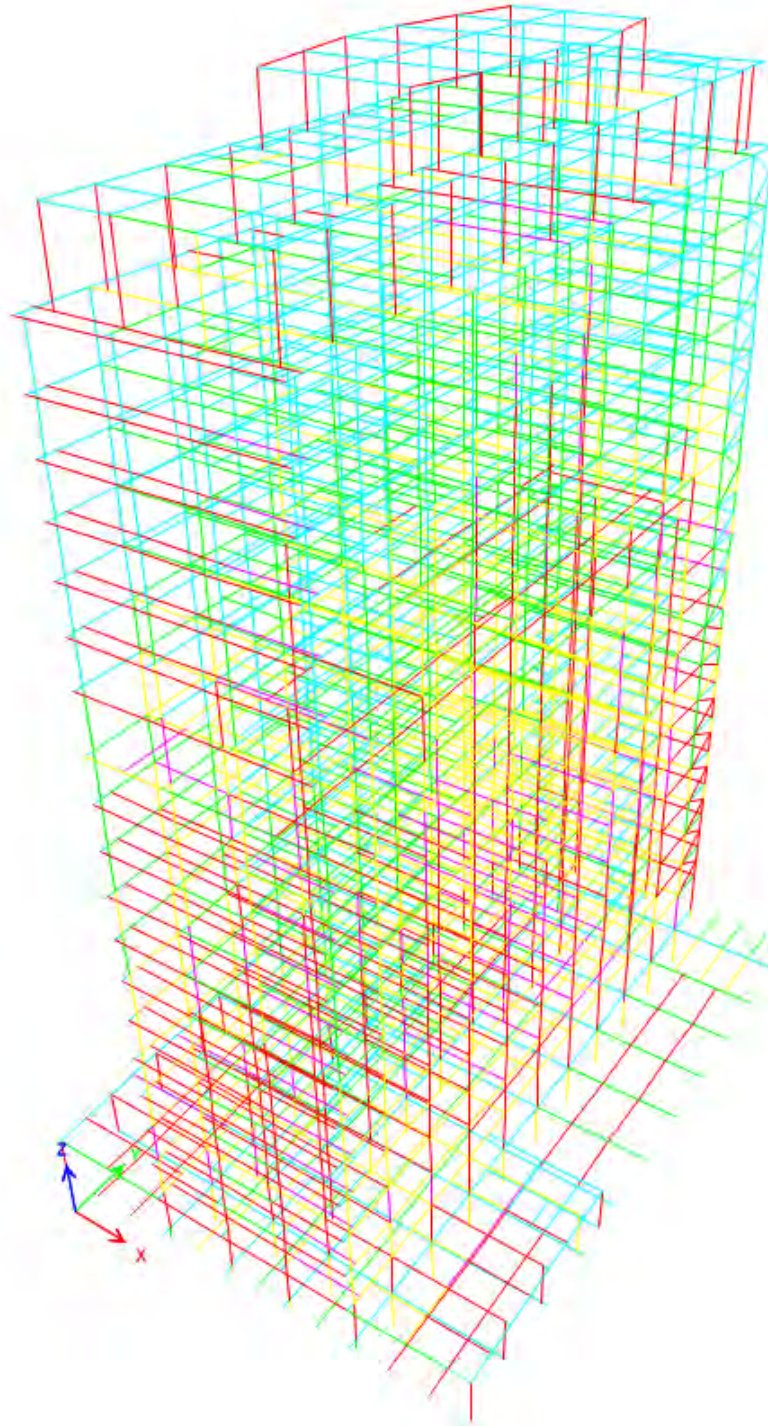
**Stress Contour Diagram for Wind Load Combination**

Columns, beams and braces are designed in ETABS for the design load combinations by setting the design code as **CSA S16-14** and framing type as **Conventional Moment Frame**

3D view of the overall building is shown below and some the braces, beams and columns which are not satisfying for wind load design combinations are **red** in color.

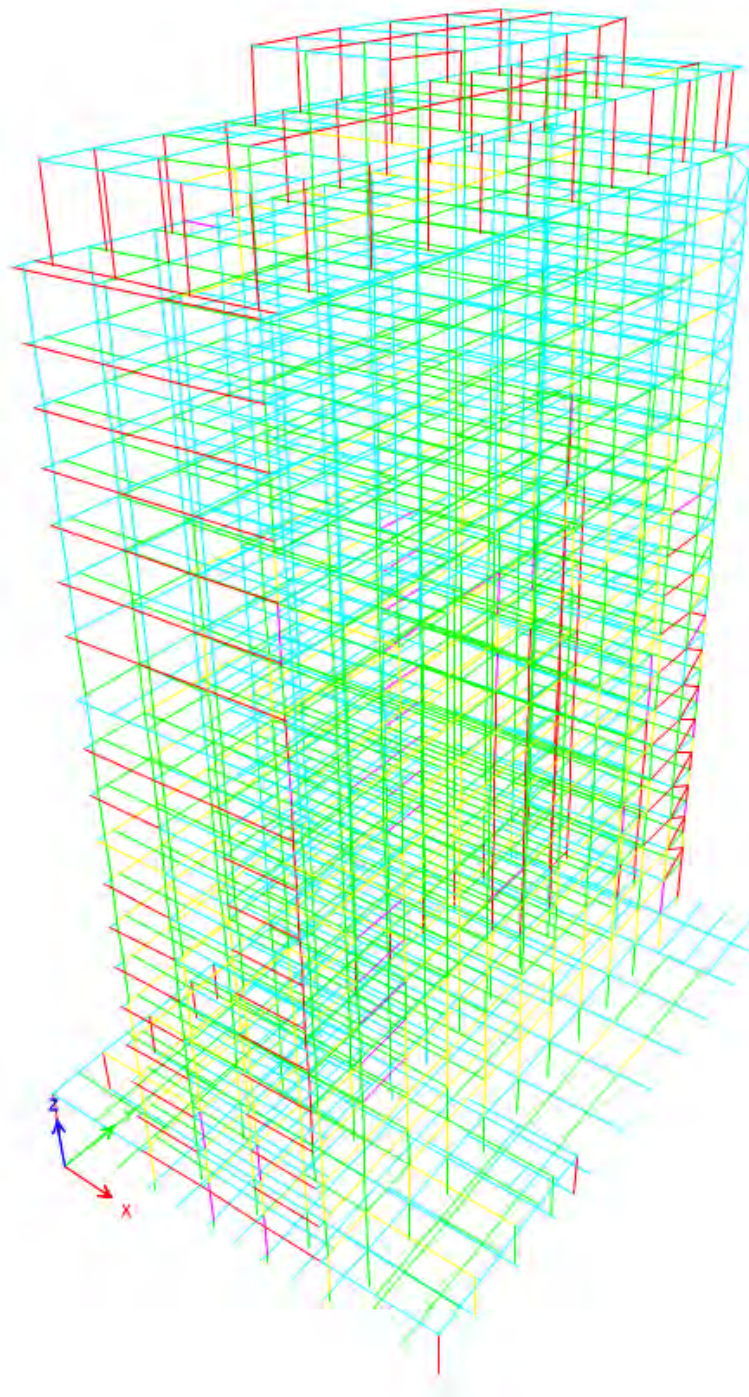
**Stress Contour Diagram for Seismic Load Combination**

Columns, beams and braces are designed in ETABS for the design load combinations by setting the design code as **CSA S16-14** and framing type as **Conventional Moment Frame**

3D view of the overall building is shown below and some the braces, beams and columns which are not satisfying for seismic load design combinations are **red** in color.

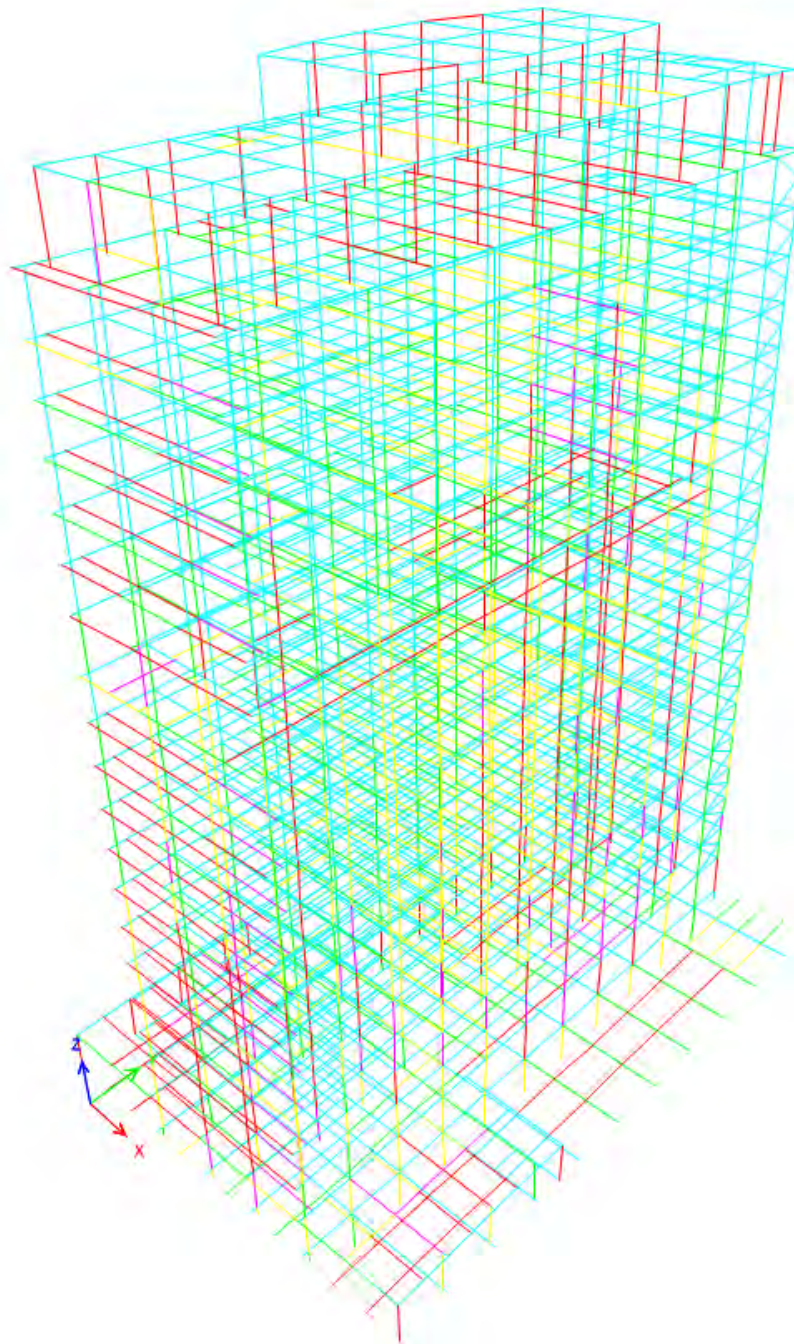
**Stress Contour Diagram for Gravity Load Combination**

Columns, beams and braces are designed in ETABS for the design load combinations by setting the design code as **CSA S16-14** and framing type as **Conventional Moment Frame**

3D view of the overall building is shown below and some the braces, beams and columns which are not satisfying for gravity load design combinations are **red** in color.

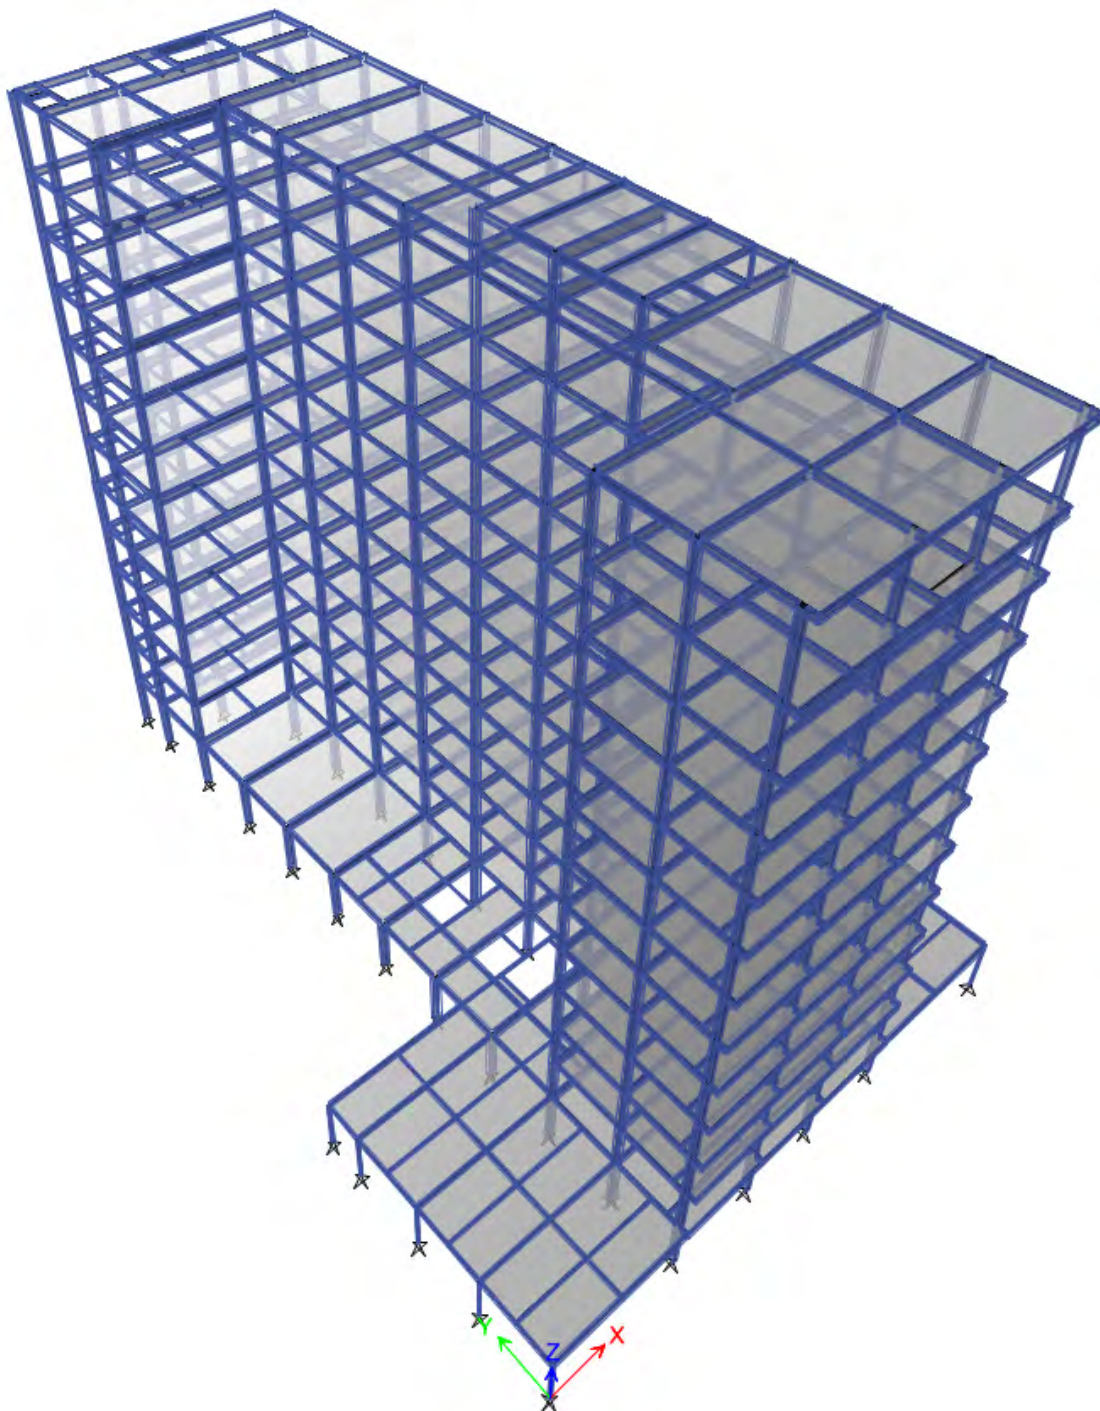
The ETABS model includes all elements such as columns, beams, braces and slabs (including the slabs' own weight). Below is a 3D view of the model. 1st floor in reality is considered as base level in ETABS model as the foundation walls are up-to 1st floor on all sides in reality

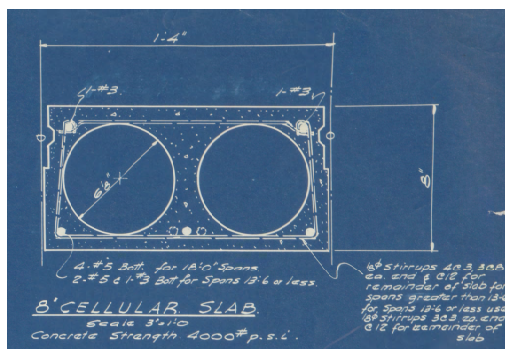
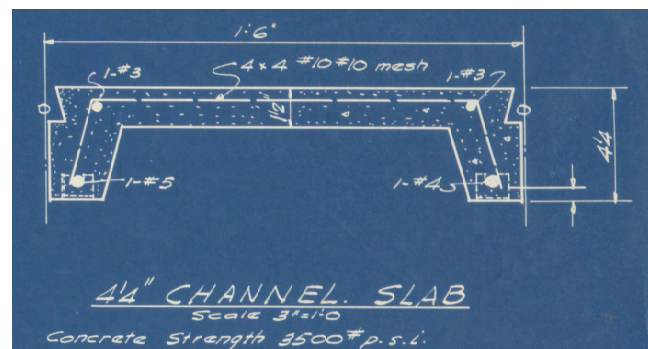
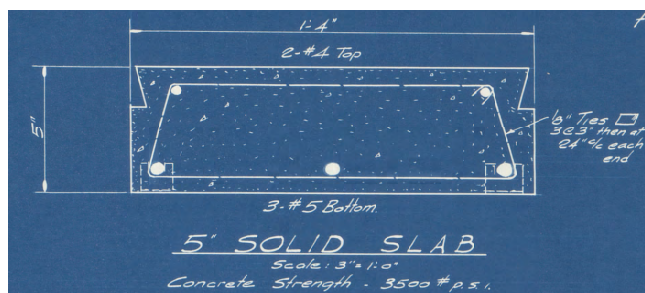
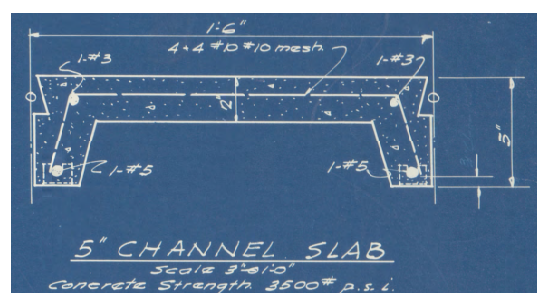
Concrete strength of the slabs are considered from the below images which are part of the structural drawings

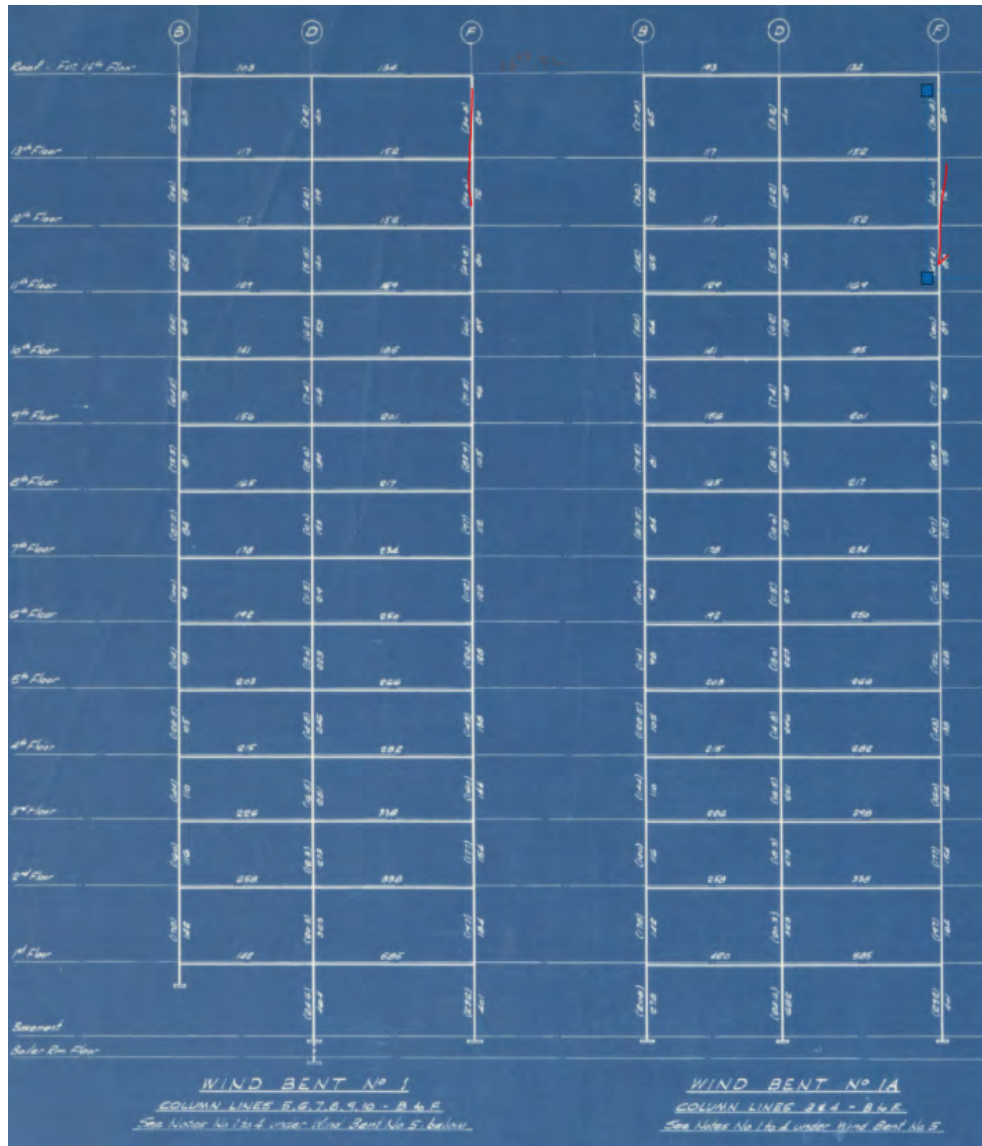
The supports at base level are considered as pin supports. Secondary beams are moment released in the model. Element properties and geometry are followed as per the drawings (sample drawing is shown below)

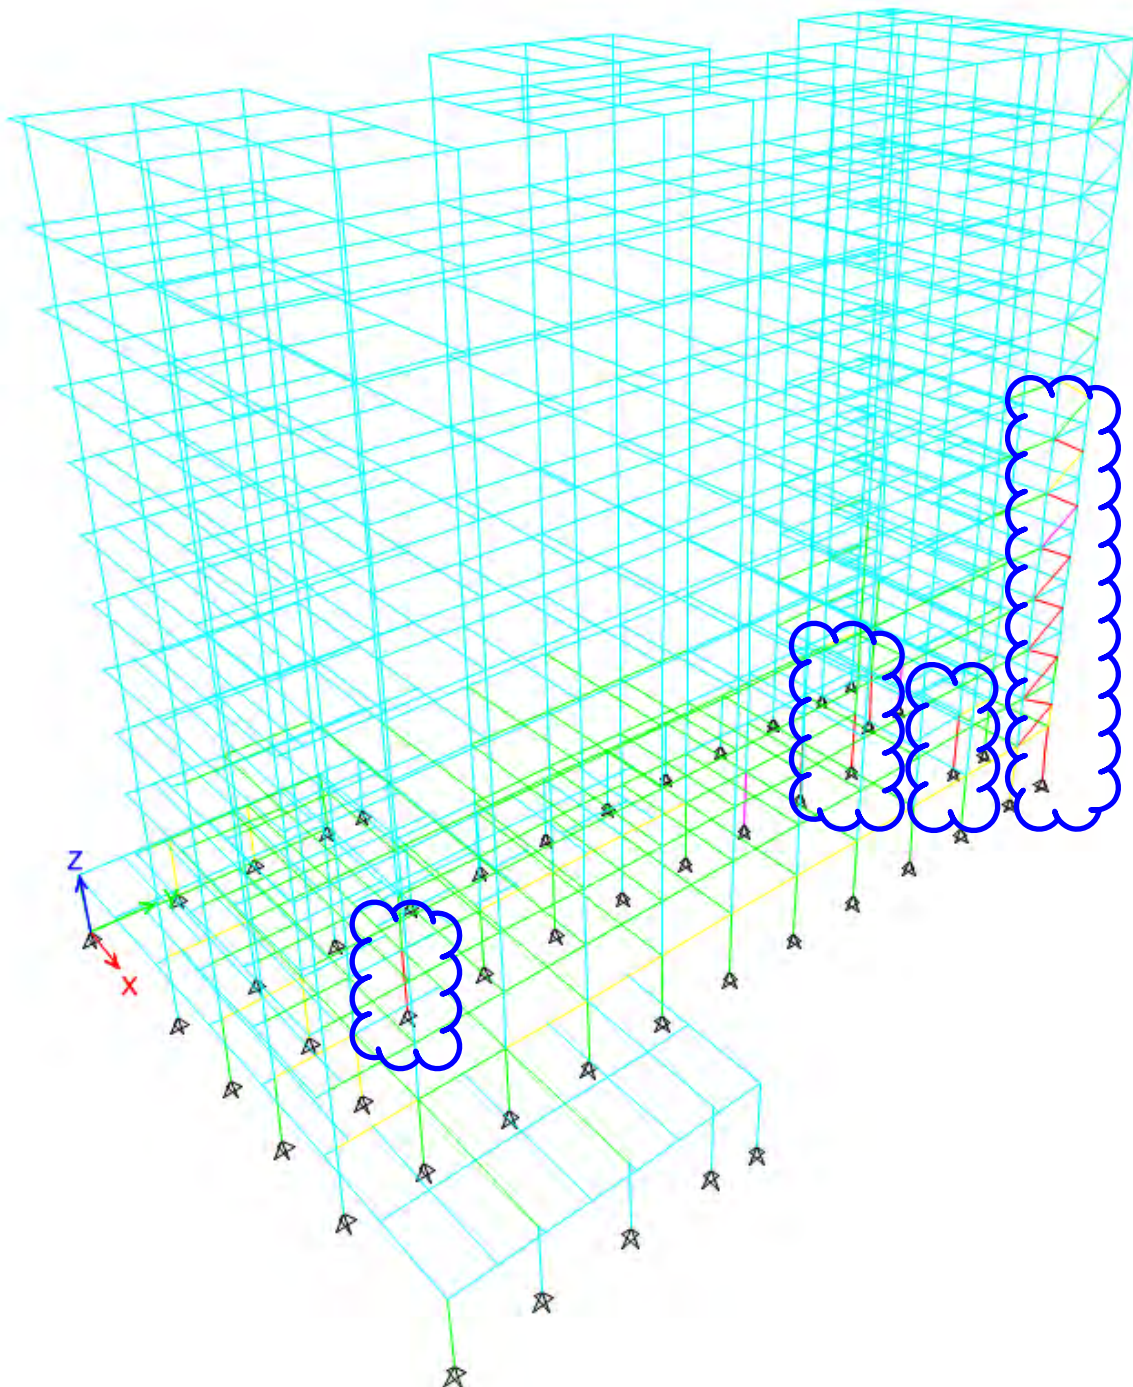
Columns, beams and braces are designed in ETABS for the wind load design combinations by setting the design code as **CSA S16-14** and framing type as **Conventional Moment Frame** and ignored the consideration for seismic code.

3D view of the overall building is shown below and some the braces and columns which are not satisfying the design are **red** in color and clouded.
