## **Traffic Control Signals - Clonmore Drive and Queensbury Avenue/Private Access**

**Date:** October 3, 2025

**To:** Scarborough Community Council

**From:** Director, Enforcement and Street Management, Transportation Services

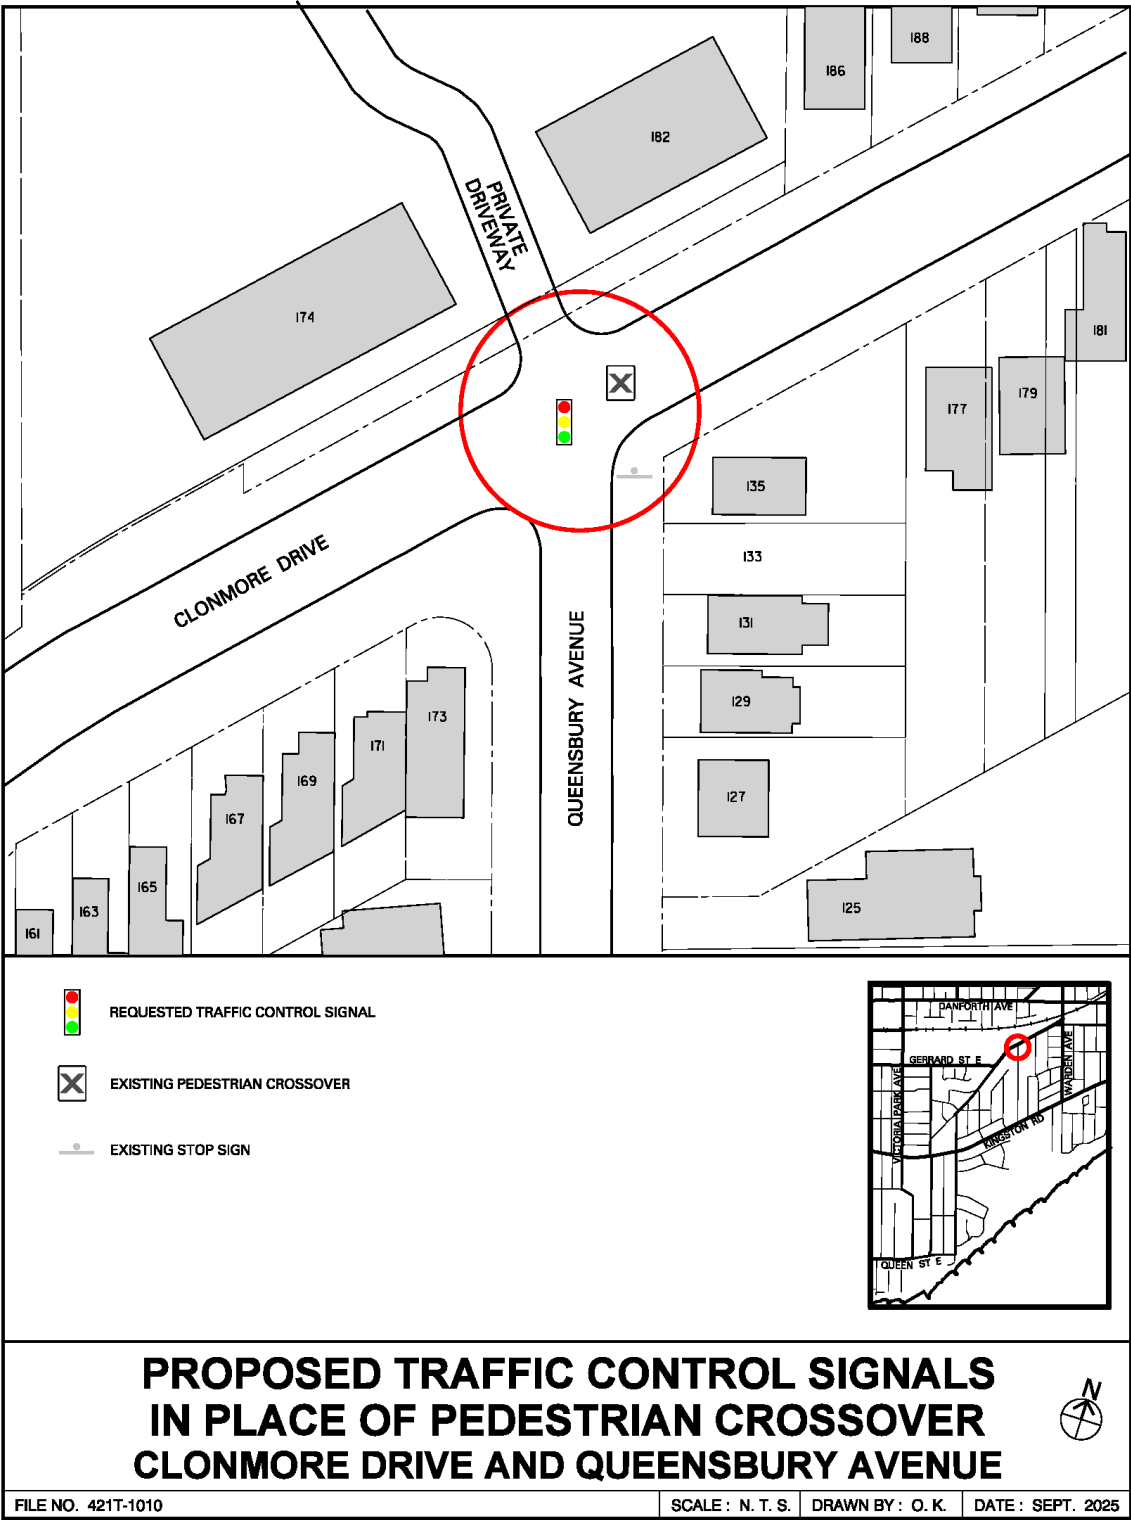
Attachment 1: Map - Proposed Traffic Signals in Place of Pedestrian Crossover - Clonmore Drive and Queensbury Avenue

Clonmore Drive and Queensbury Avenue form a "T" type intersection. Queensbury Avenue is stop controlled while Clonmore Drive is uncontrolled free flow. There is an existing pedestrian crossover located immediately northeast of Queensbury Avenue. As noted, a private driveway is located on the north side of the intersection, opposite Queensbury Avenue.

A map of the area is included in Attachment 1.

1. City Council not authorize the installation of traffic control signals at the intersection of Clonmore Drive and Queensbury Avenue/Private Access.
2. City Council not authorize the removal of the existing pedestrian crossover on Clonmore Drive, immediately northeast of Queensbury Avenue in conjunction with the installation of traffic control signals at Clonmore Drive and Queensbury Avenue.
