## **Operational and Safety Review - Pottery Road (north), Intersection of Bayview Avenue with Bayview Heights Drive and Evergreen Gardens**

**Date:** June 18, 2026

**To:** North York Community Council

**From:** Director, Enforcement and Street Management, Transportation Services

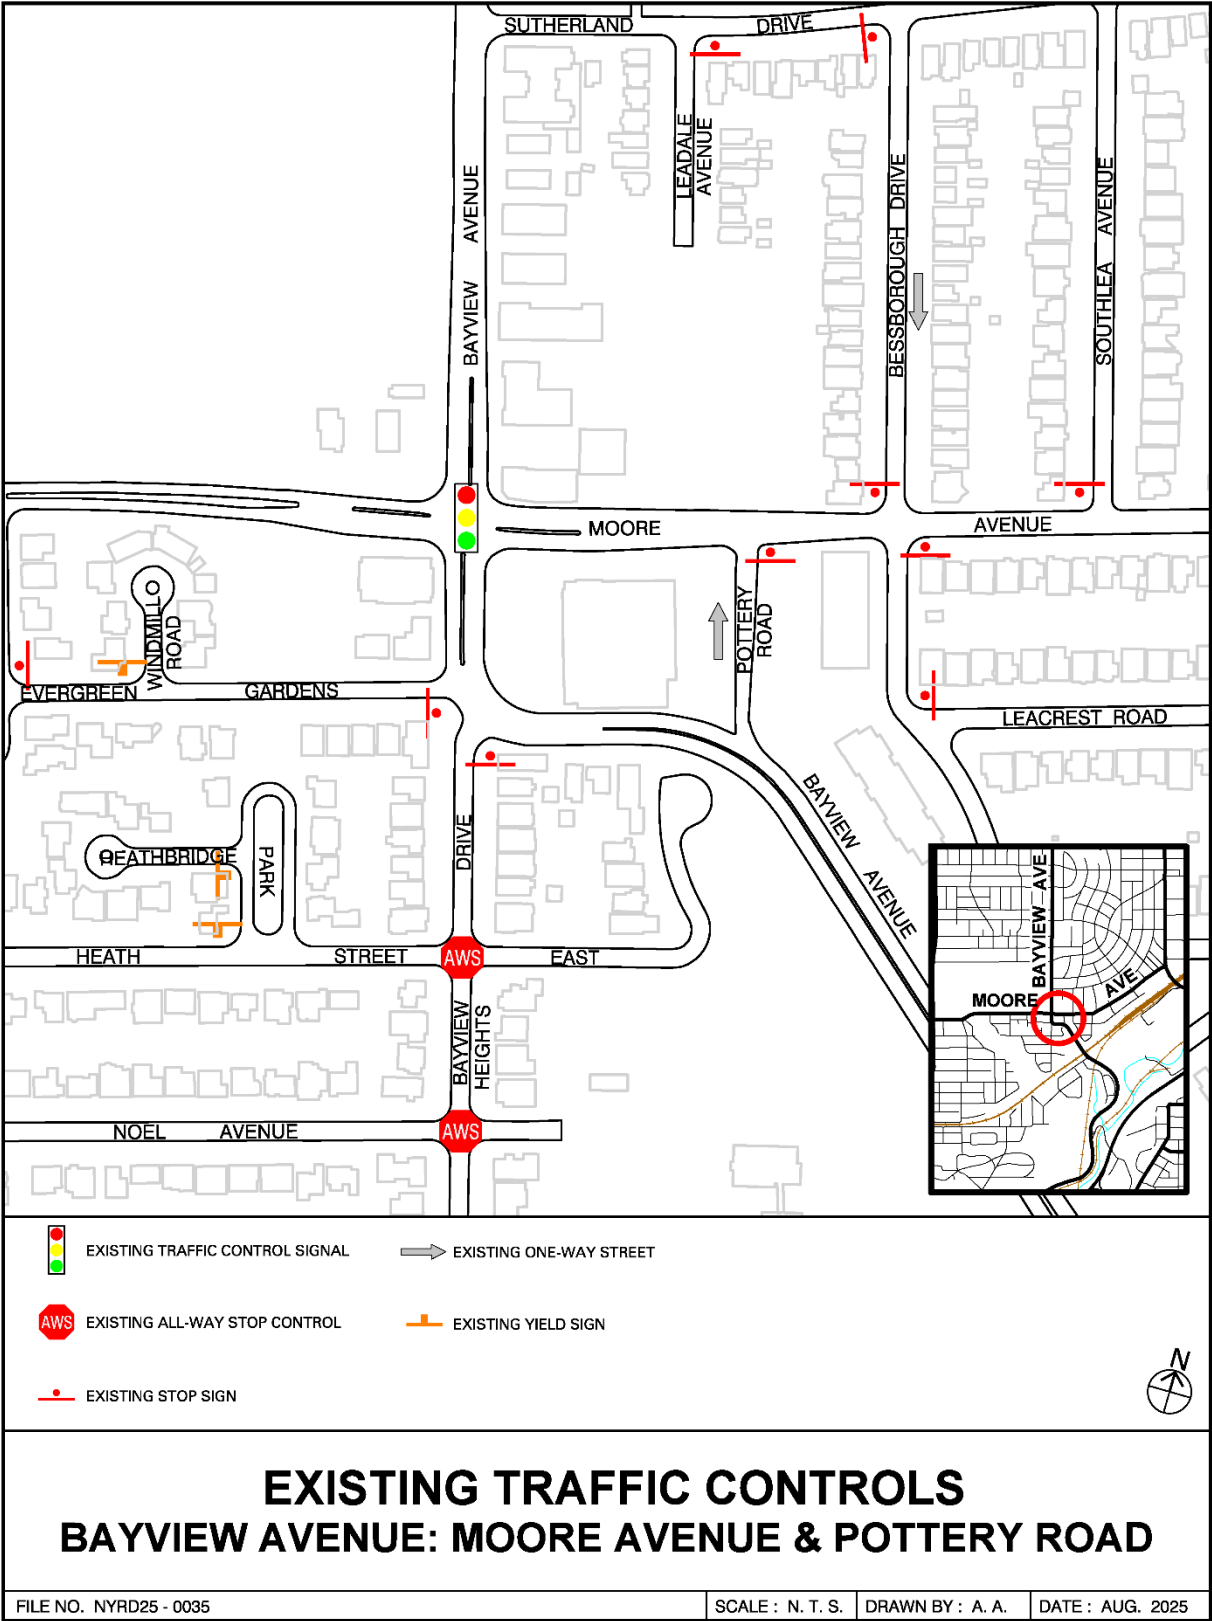
Attachment 1: Map - Existing Traffic Controls - Bayview Avenue, between Moore Avenue and Pottery Road

Bayview Avenue operates uncontrolled free-flow at the intersections with Bayview Heights Drive and Evergreen Gardens. Bayview Heights Drive and Evergreen Gardens are stop controlled at Bayview Avenue. Northbound left-turns from Bayview Avenue to Bayview Heights Drive and Evergreen Gardens are prohibited at all times.

The closest adjacent traffic controls are located approximately 60 metres to the north at Moore Avenue, and approximately 470 metres to the south at Nesbitt Drive in the form of traffic controls signals.

A map of the area is included in Attachment 1.
