Request for a Fence Exemption to the Toronto Municipal Code, Chapter 447 - 388 Beresford Avenue

Date: March 5, 2026

From: District Manager, Municipal Licensing and Standards, West District

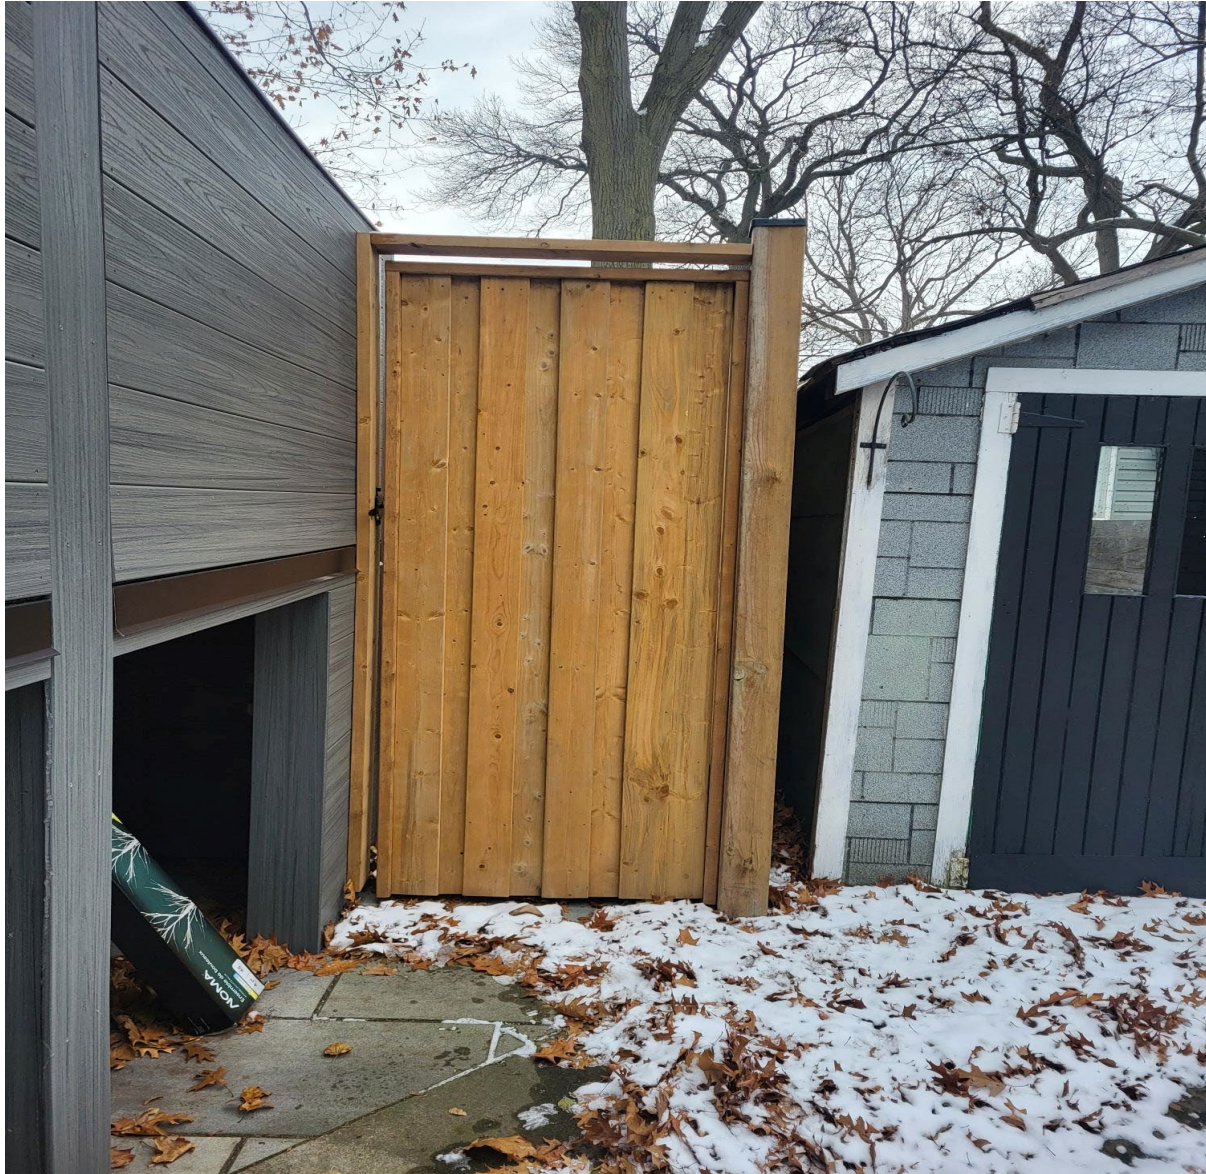
Attachment 2: North Side Wood Gate. Photograph taken by the attending Officer 388 Beresford Avenue.

1. Refuse to grant the application for exemption by the owner of 388 Beresford Avenue because the fence fails to comply with the provisions of Toronto Municipal Code, Chapter 447 Fences.

GENERAL LOCATION	SPECIFIC LOCATION	CONSTRUCTION and DEFICIENCY	BY-LAW SECTION and REQUIREMENT
Rear Yard	Rear Yard	Maintain existing wood fence and gate with vertical boards exceeding 2.0 meters in height	Chapter 447 Section 447-1.2 B (1) A fence must not be more than 2.0 meters in height

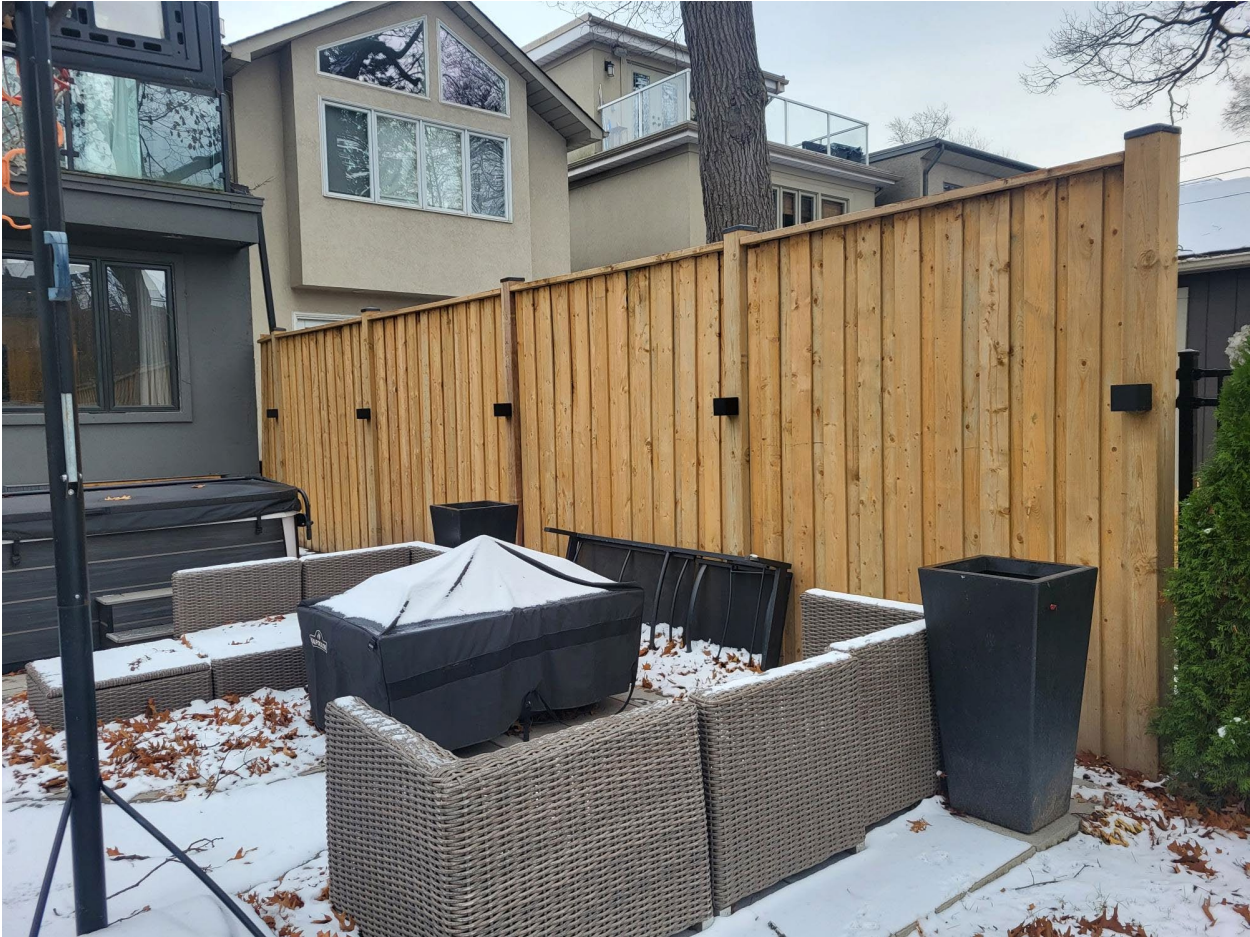
Attachment 3: South Side of Wood Fence. Photograph taken by the attending Officer 388 Beresford Avenue.

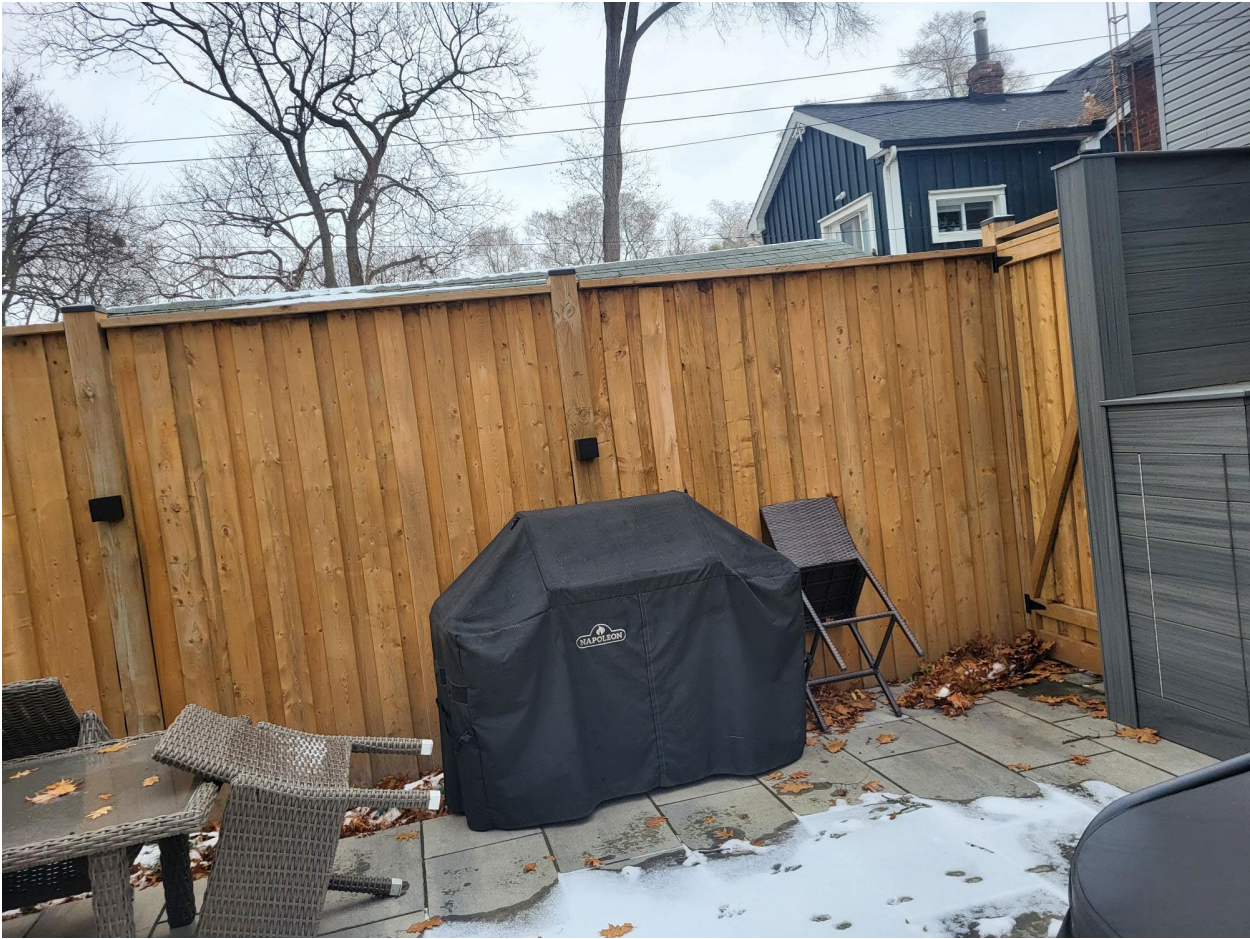
Attachment 4: North Side of Wood Fence and Gate. Photograph taken by the attending Officer 388 Beresford Avenue.

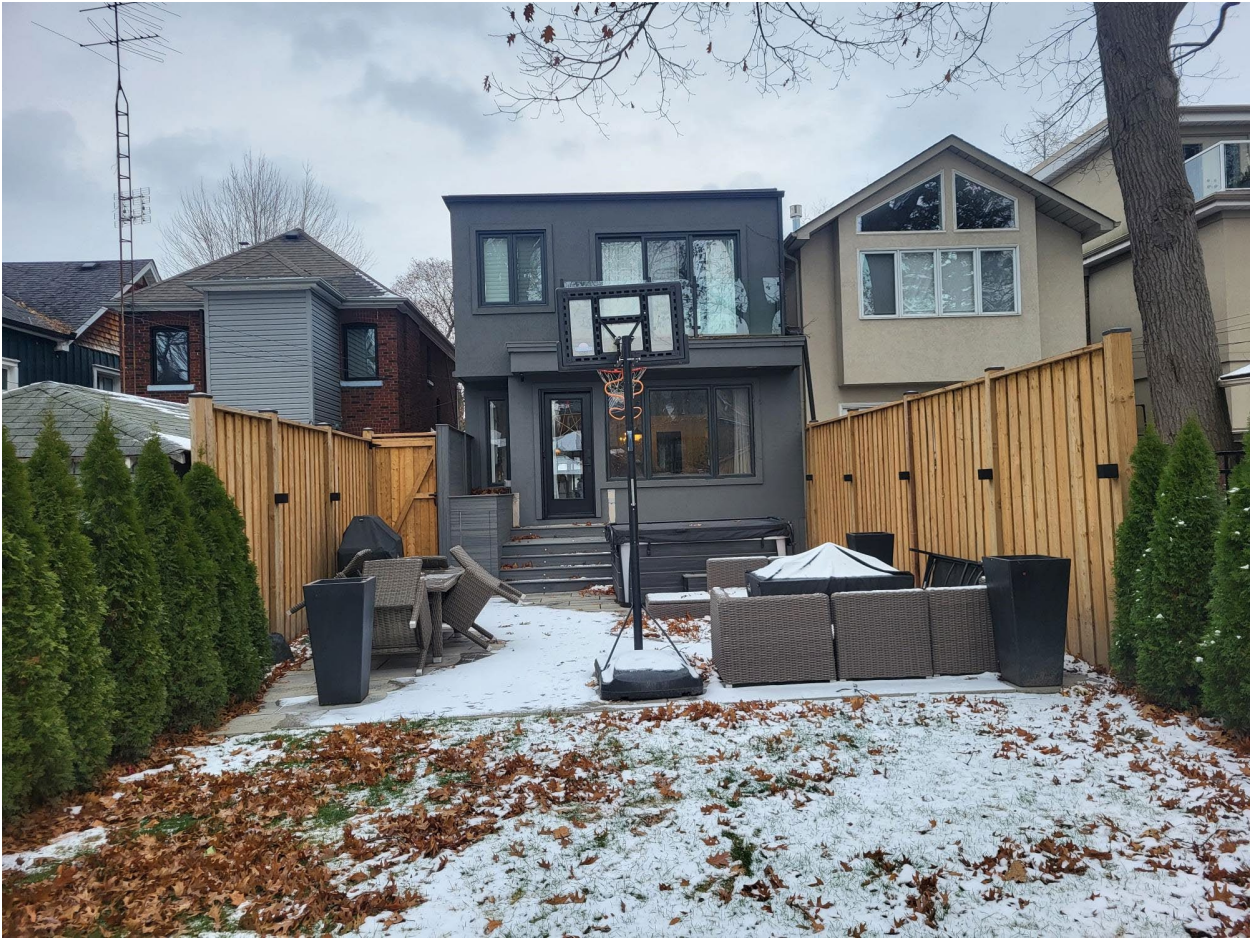
Attachment 5: West-facing photograph showing both the North and South side views of the wood fence. Photograph taken by the attending Officer 388 Beresford Avenue.
