**WESTON HERITAGE CONSERVATION DISTRICT PLAN**  
**Phase One**  
**Town of Weston**

## Drawing No. 1: Area Mapping Showing Phases

## Drawing No. 2: Phase 1 Mapping

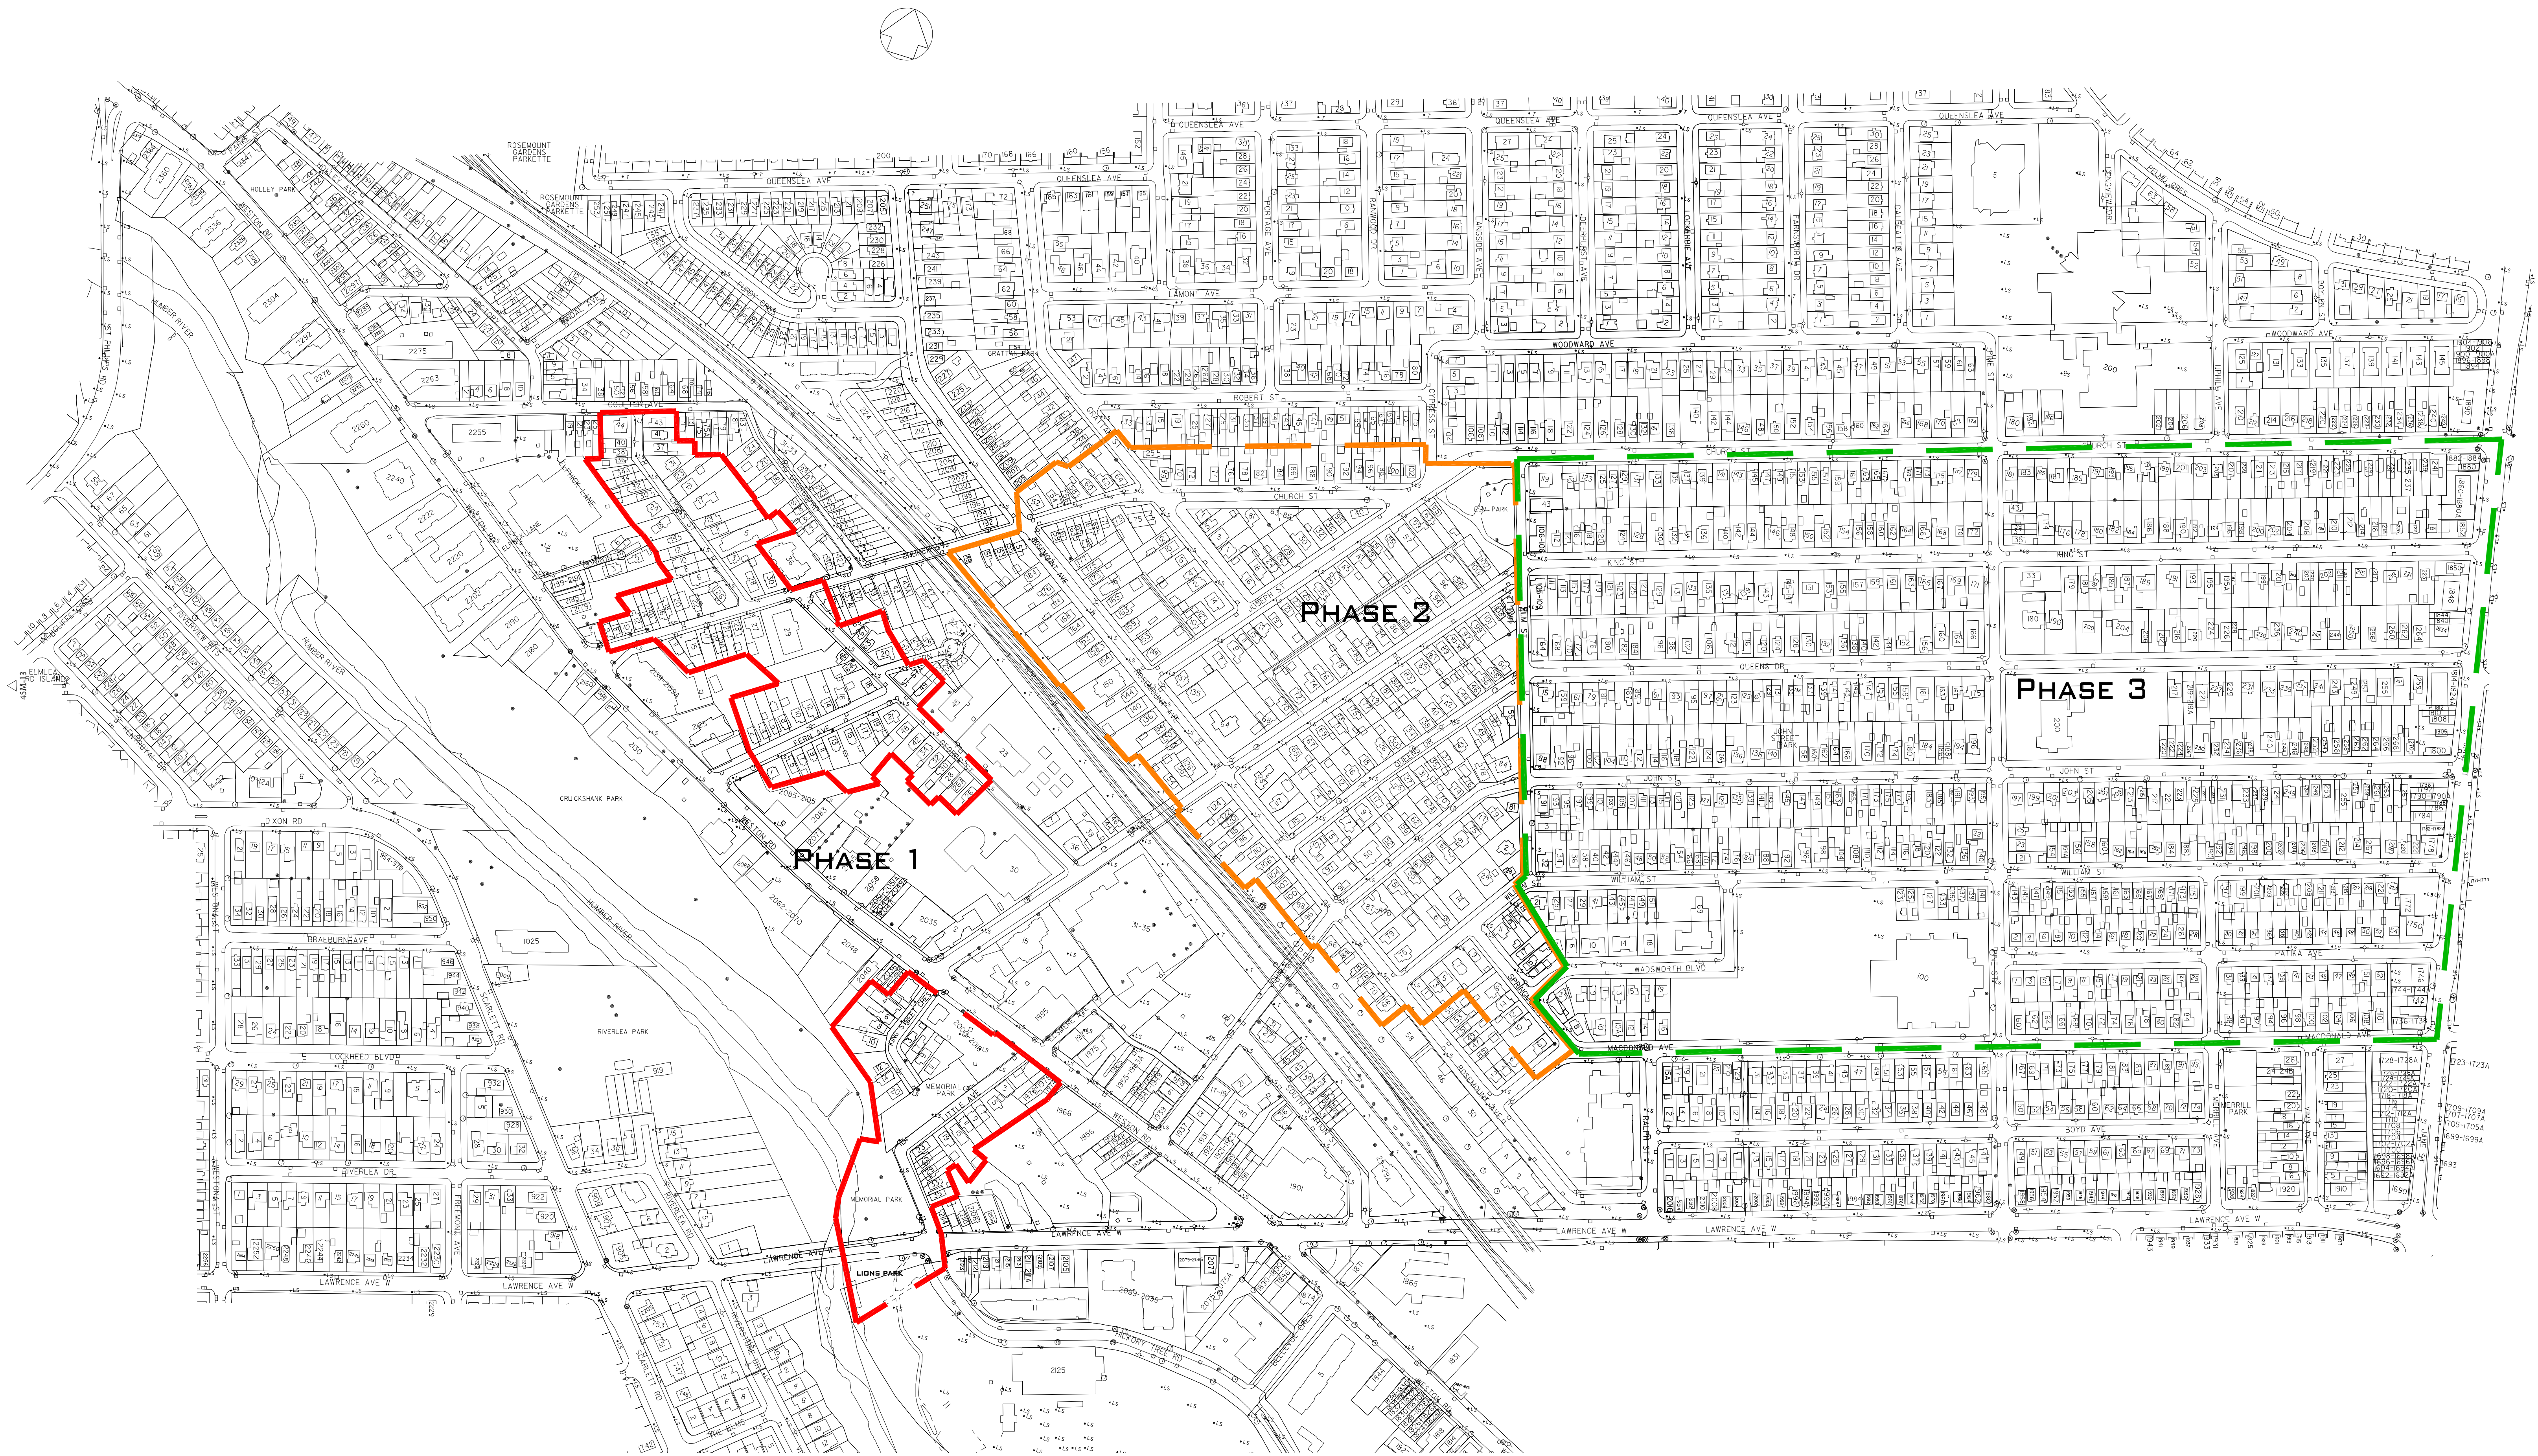
- PROPOSED PHASE 1 BOUNDARY
- PROPOSED PHASE 2 BOUNDARY
- PROPOSED PHASE 3 BOUNDARY

On the other hand, the area west of Weston Road recommended for inclusion in the district was expanded by adding the northern (passive) portion of Lions' Park on the south side of Lawrence Avenue and portions of Memorial Park on Weston Road. Six buildings (three commercial and one residential) on the west side of Weston Road were also included in the proposed district due to their age and heritage value. As well, the parking lot south of the old Fire hall, formerly the site of the Weston municipal offices, was added due to the strategic location of this lot in front of Memorial Park and the need to ensure sensitive and compatible architectural design if it is to be developed.

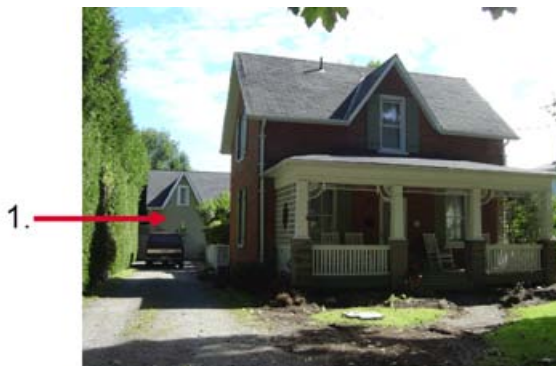
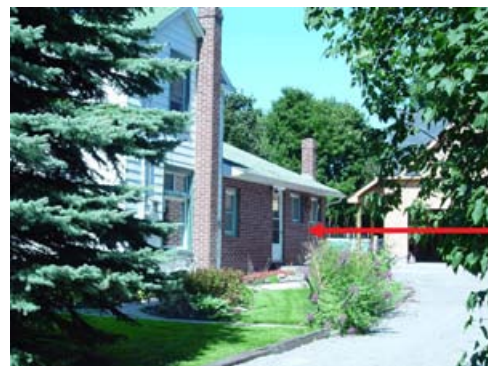
1. Greenhouses, garages, exterior additions and balcony design location to be situated at the rear of original building or on a non predominant side.

They should not compete with original building in scale and/or size, but should compliment the existing form and adjacent buildings.
2. Keep the roof line lower than the main roof ridge line.
3. The additions should step in at the sides, so that the existing building street facade remains dominant to all other facades.
4. Avoid asymmetrical additions to an existing building with a symmetrical facade.

5. There should be a discernable difference between original built form and new.

Refer to the following pages for Plans showing garage and exterior attached additions in the recommended locations.
