City Wide Study of Existing City of Toronto Dogs Off-Leash Areas (OLA)

CHERRY BEACH

Inventory and Analysis

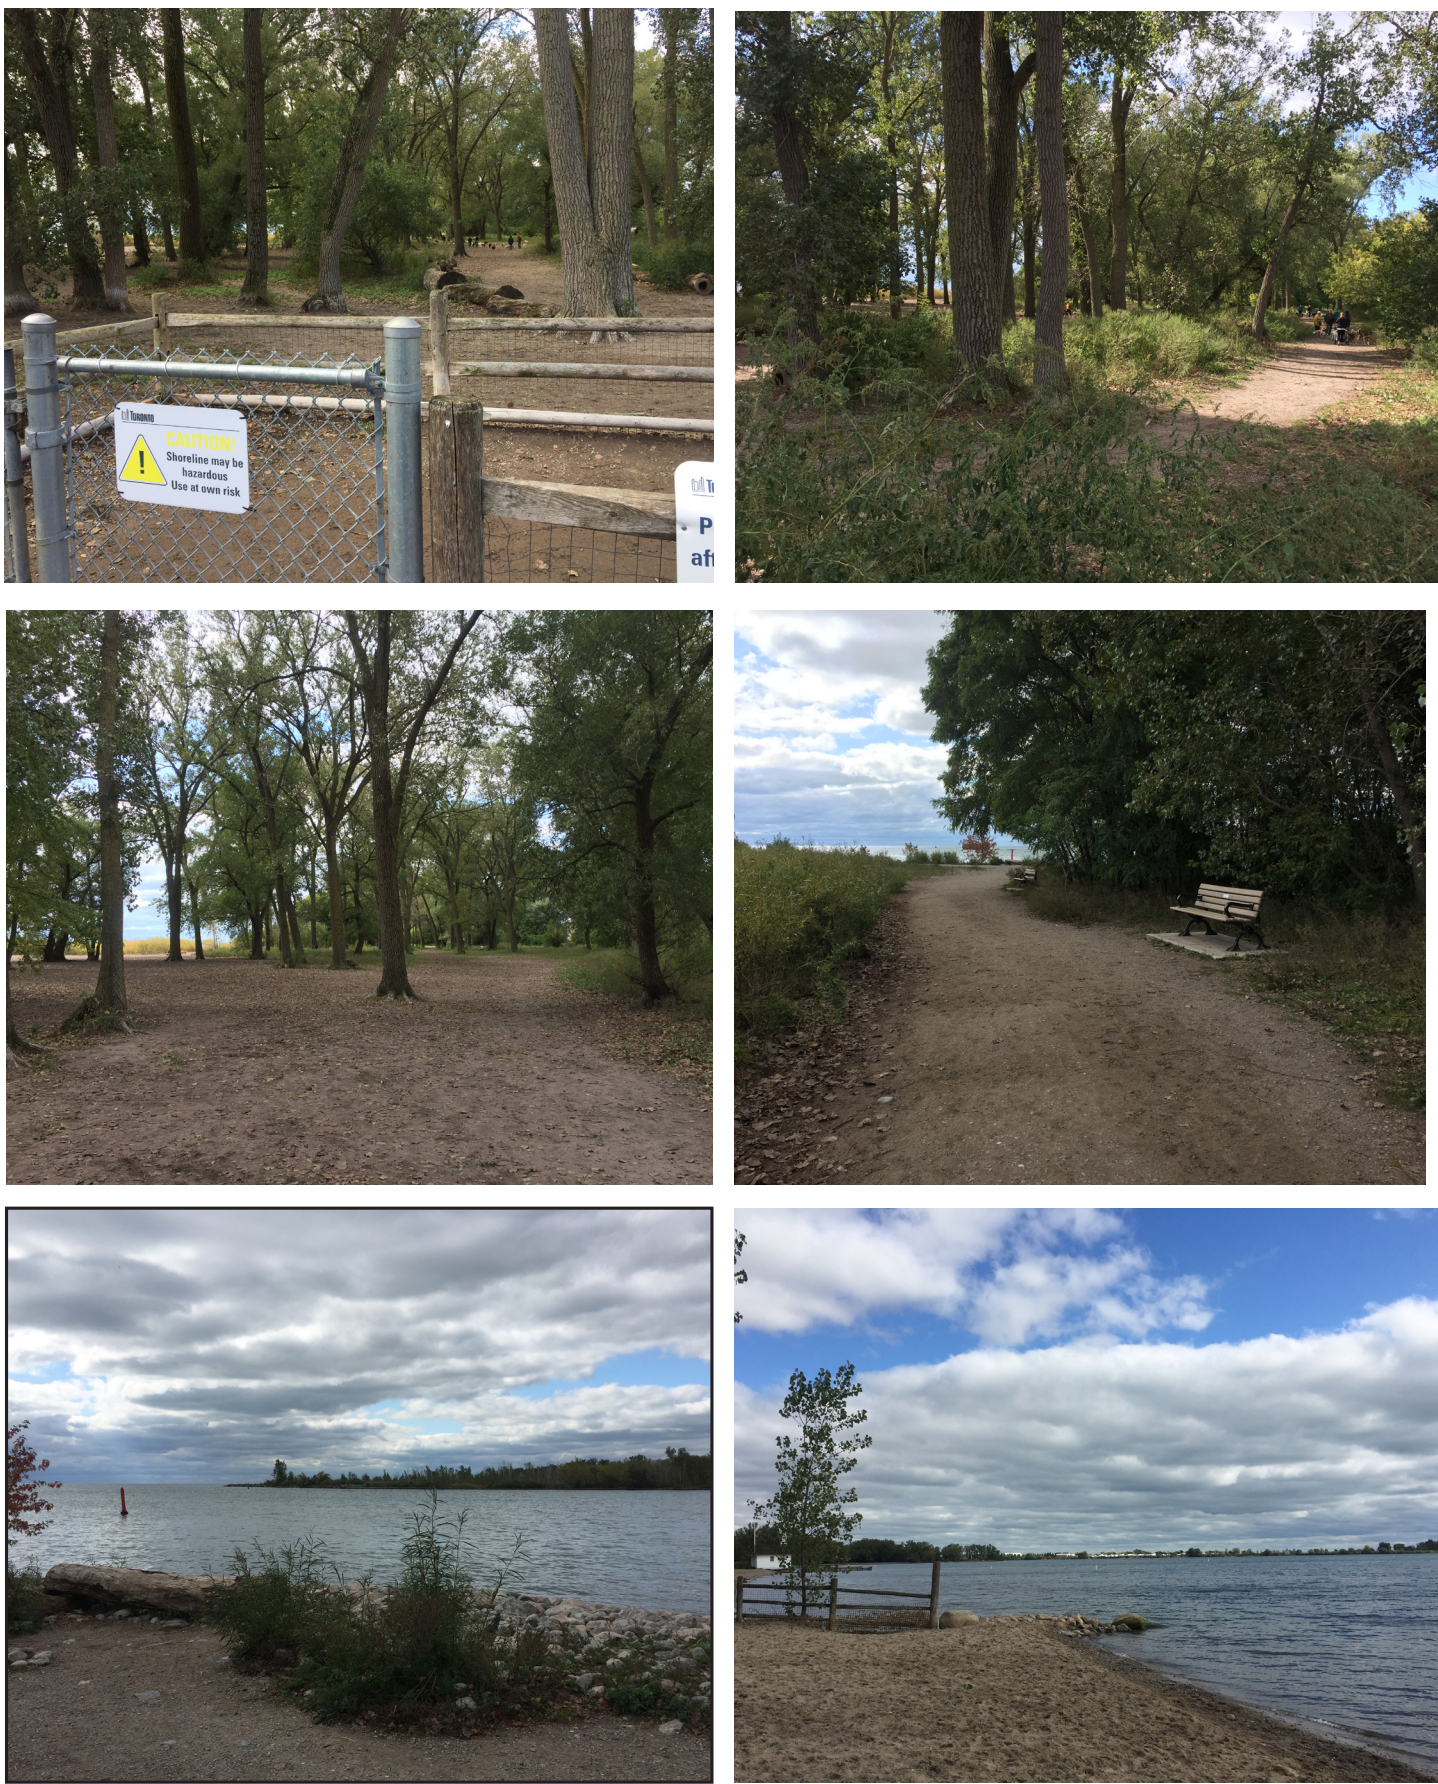
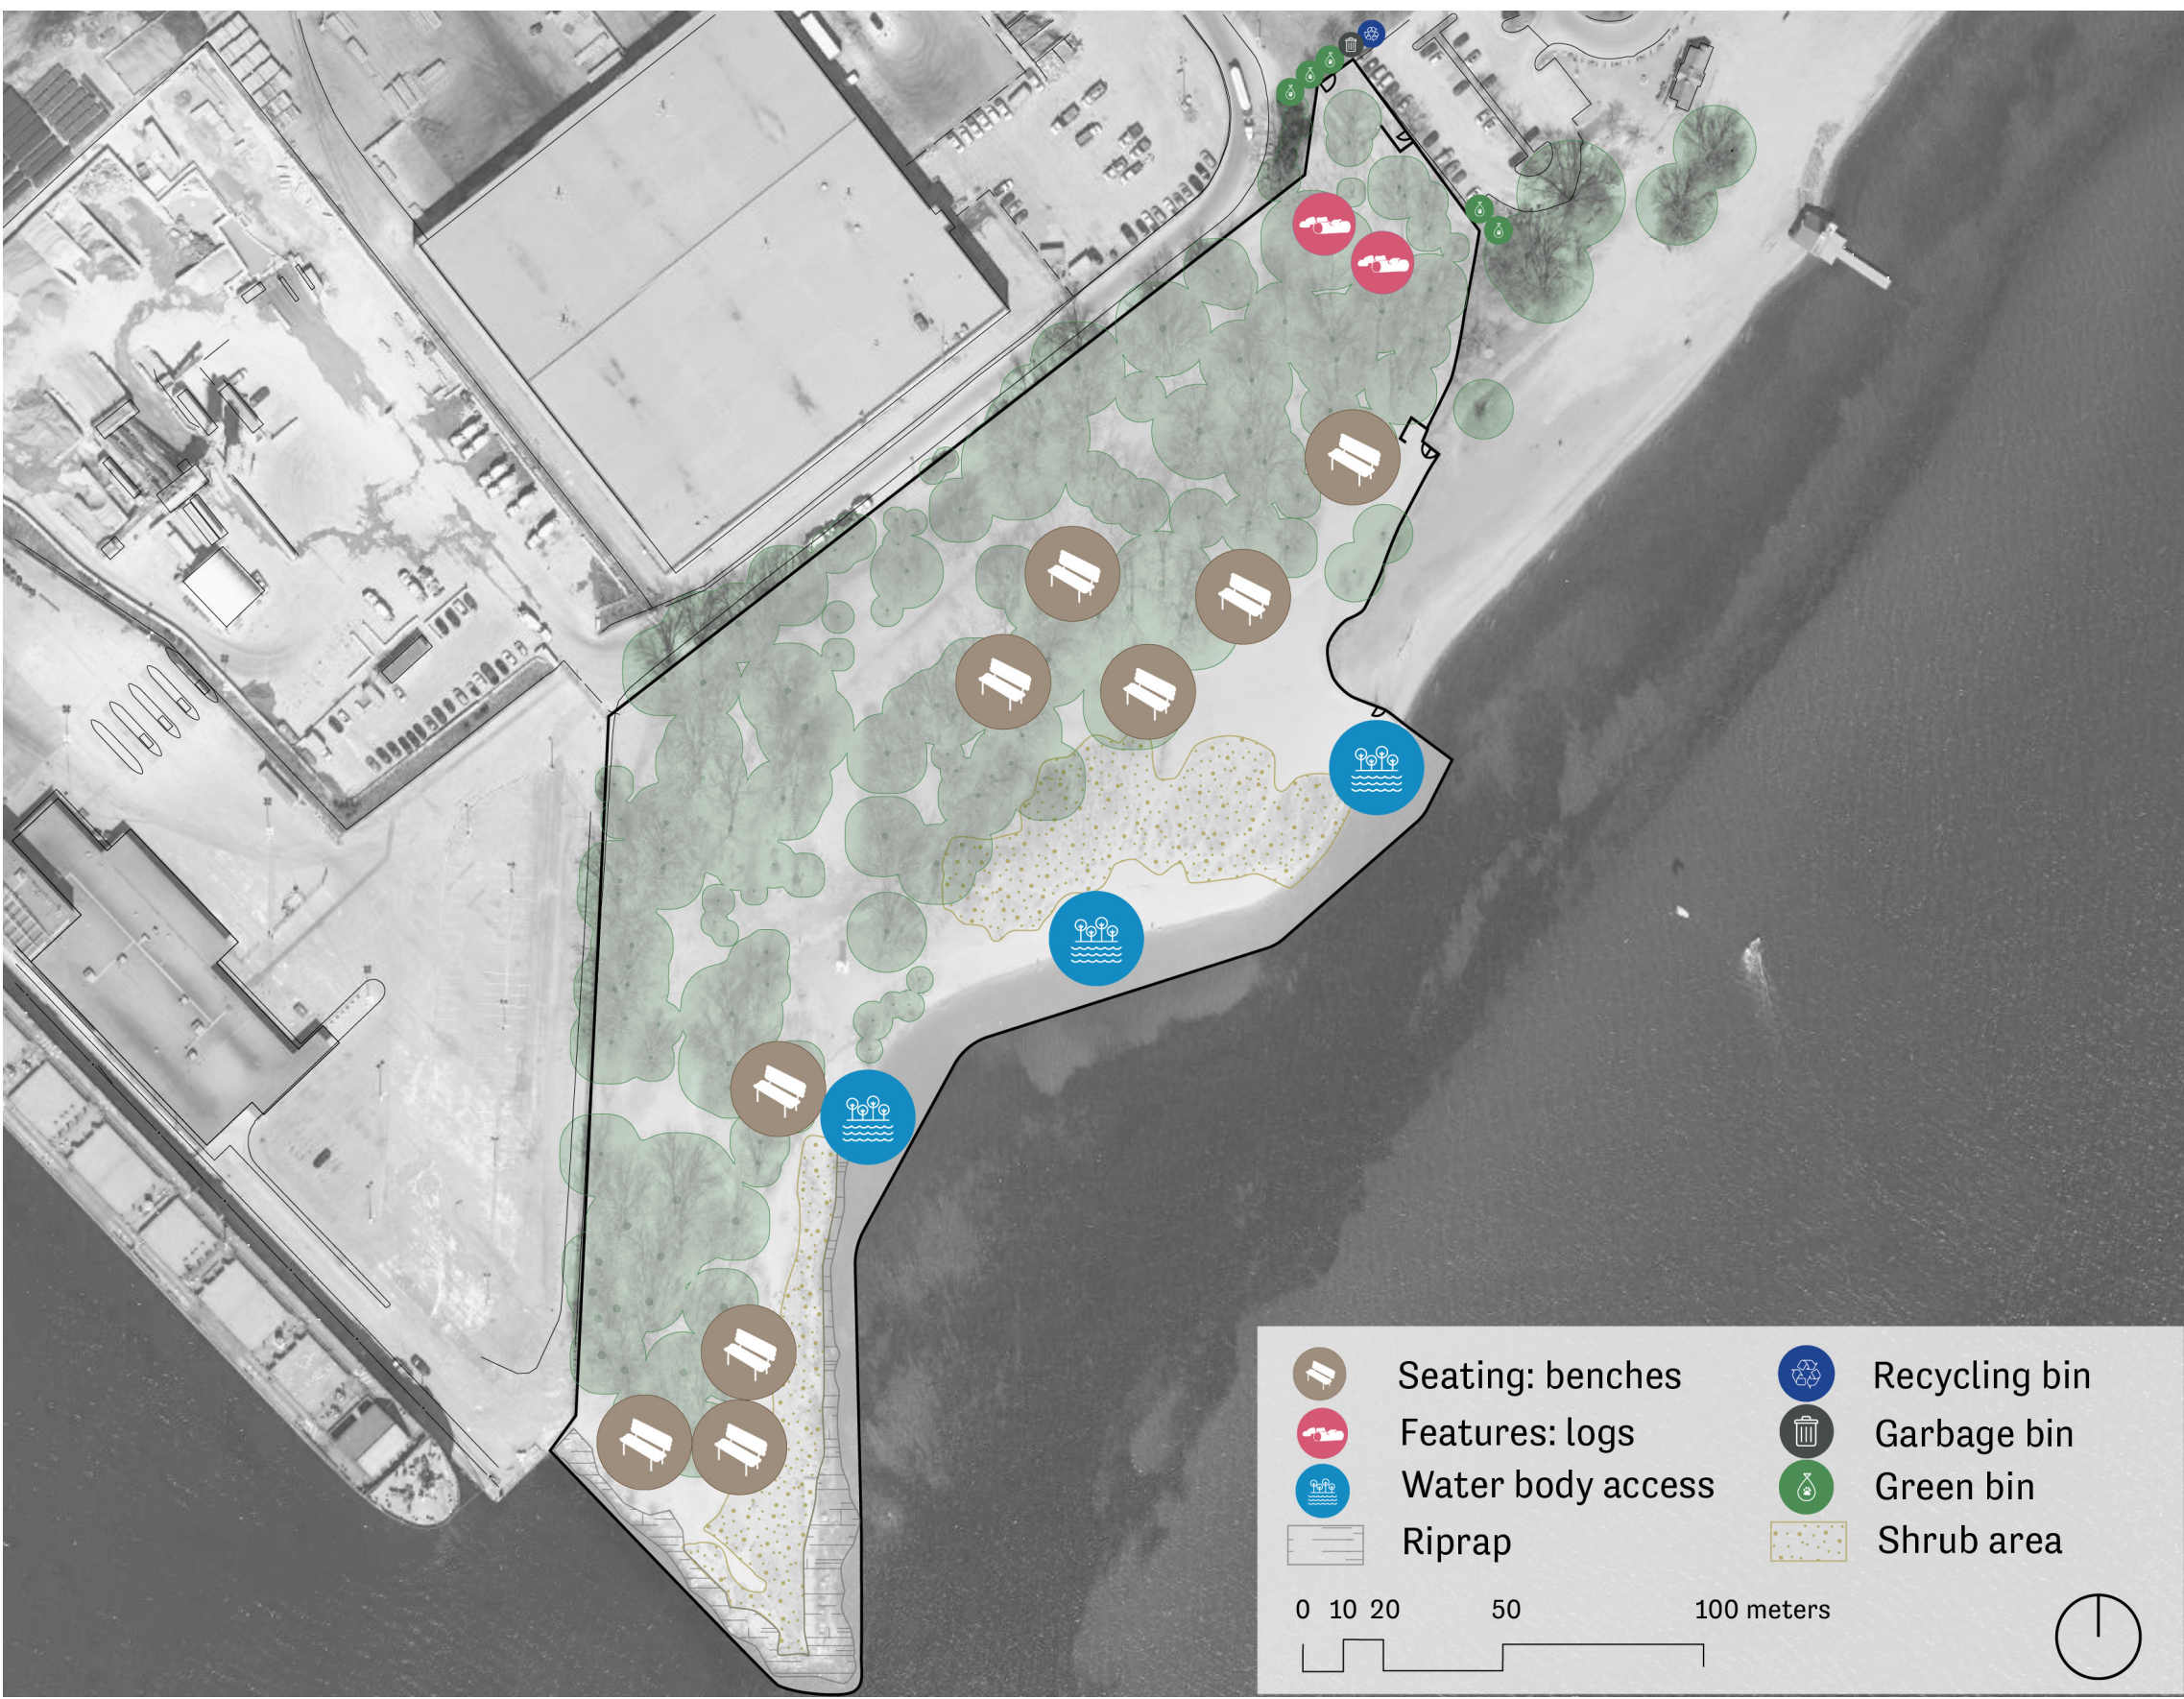
Topography	0-5% slope
Small Dog Area	no
Access Area	paved pathway
Surfacing	sand/grass/natural surface holes and digging damage pooling & mud/flooding
Fencing style	post and paddle with wire mesh chain link
Fencing height	1.2m
Fence condition	good condition, but post and paddle lower than required
Gates	3 single gates and 1 maintenance gate
Exits/Entrances	3 all from eastern portion of park.
Trees	5+ with roots exposed, soil compaction, urine rings (at entrance) Many areas with healthy trees.
Other vegetation	Environmentally Sensitive Area – shrub and groundcover varies

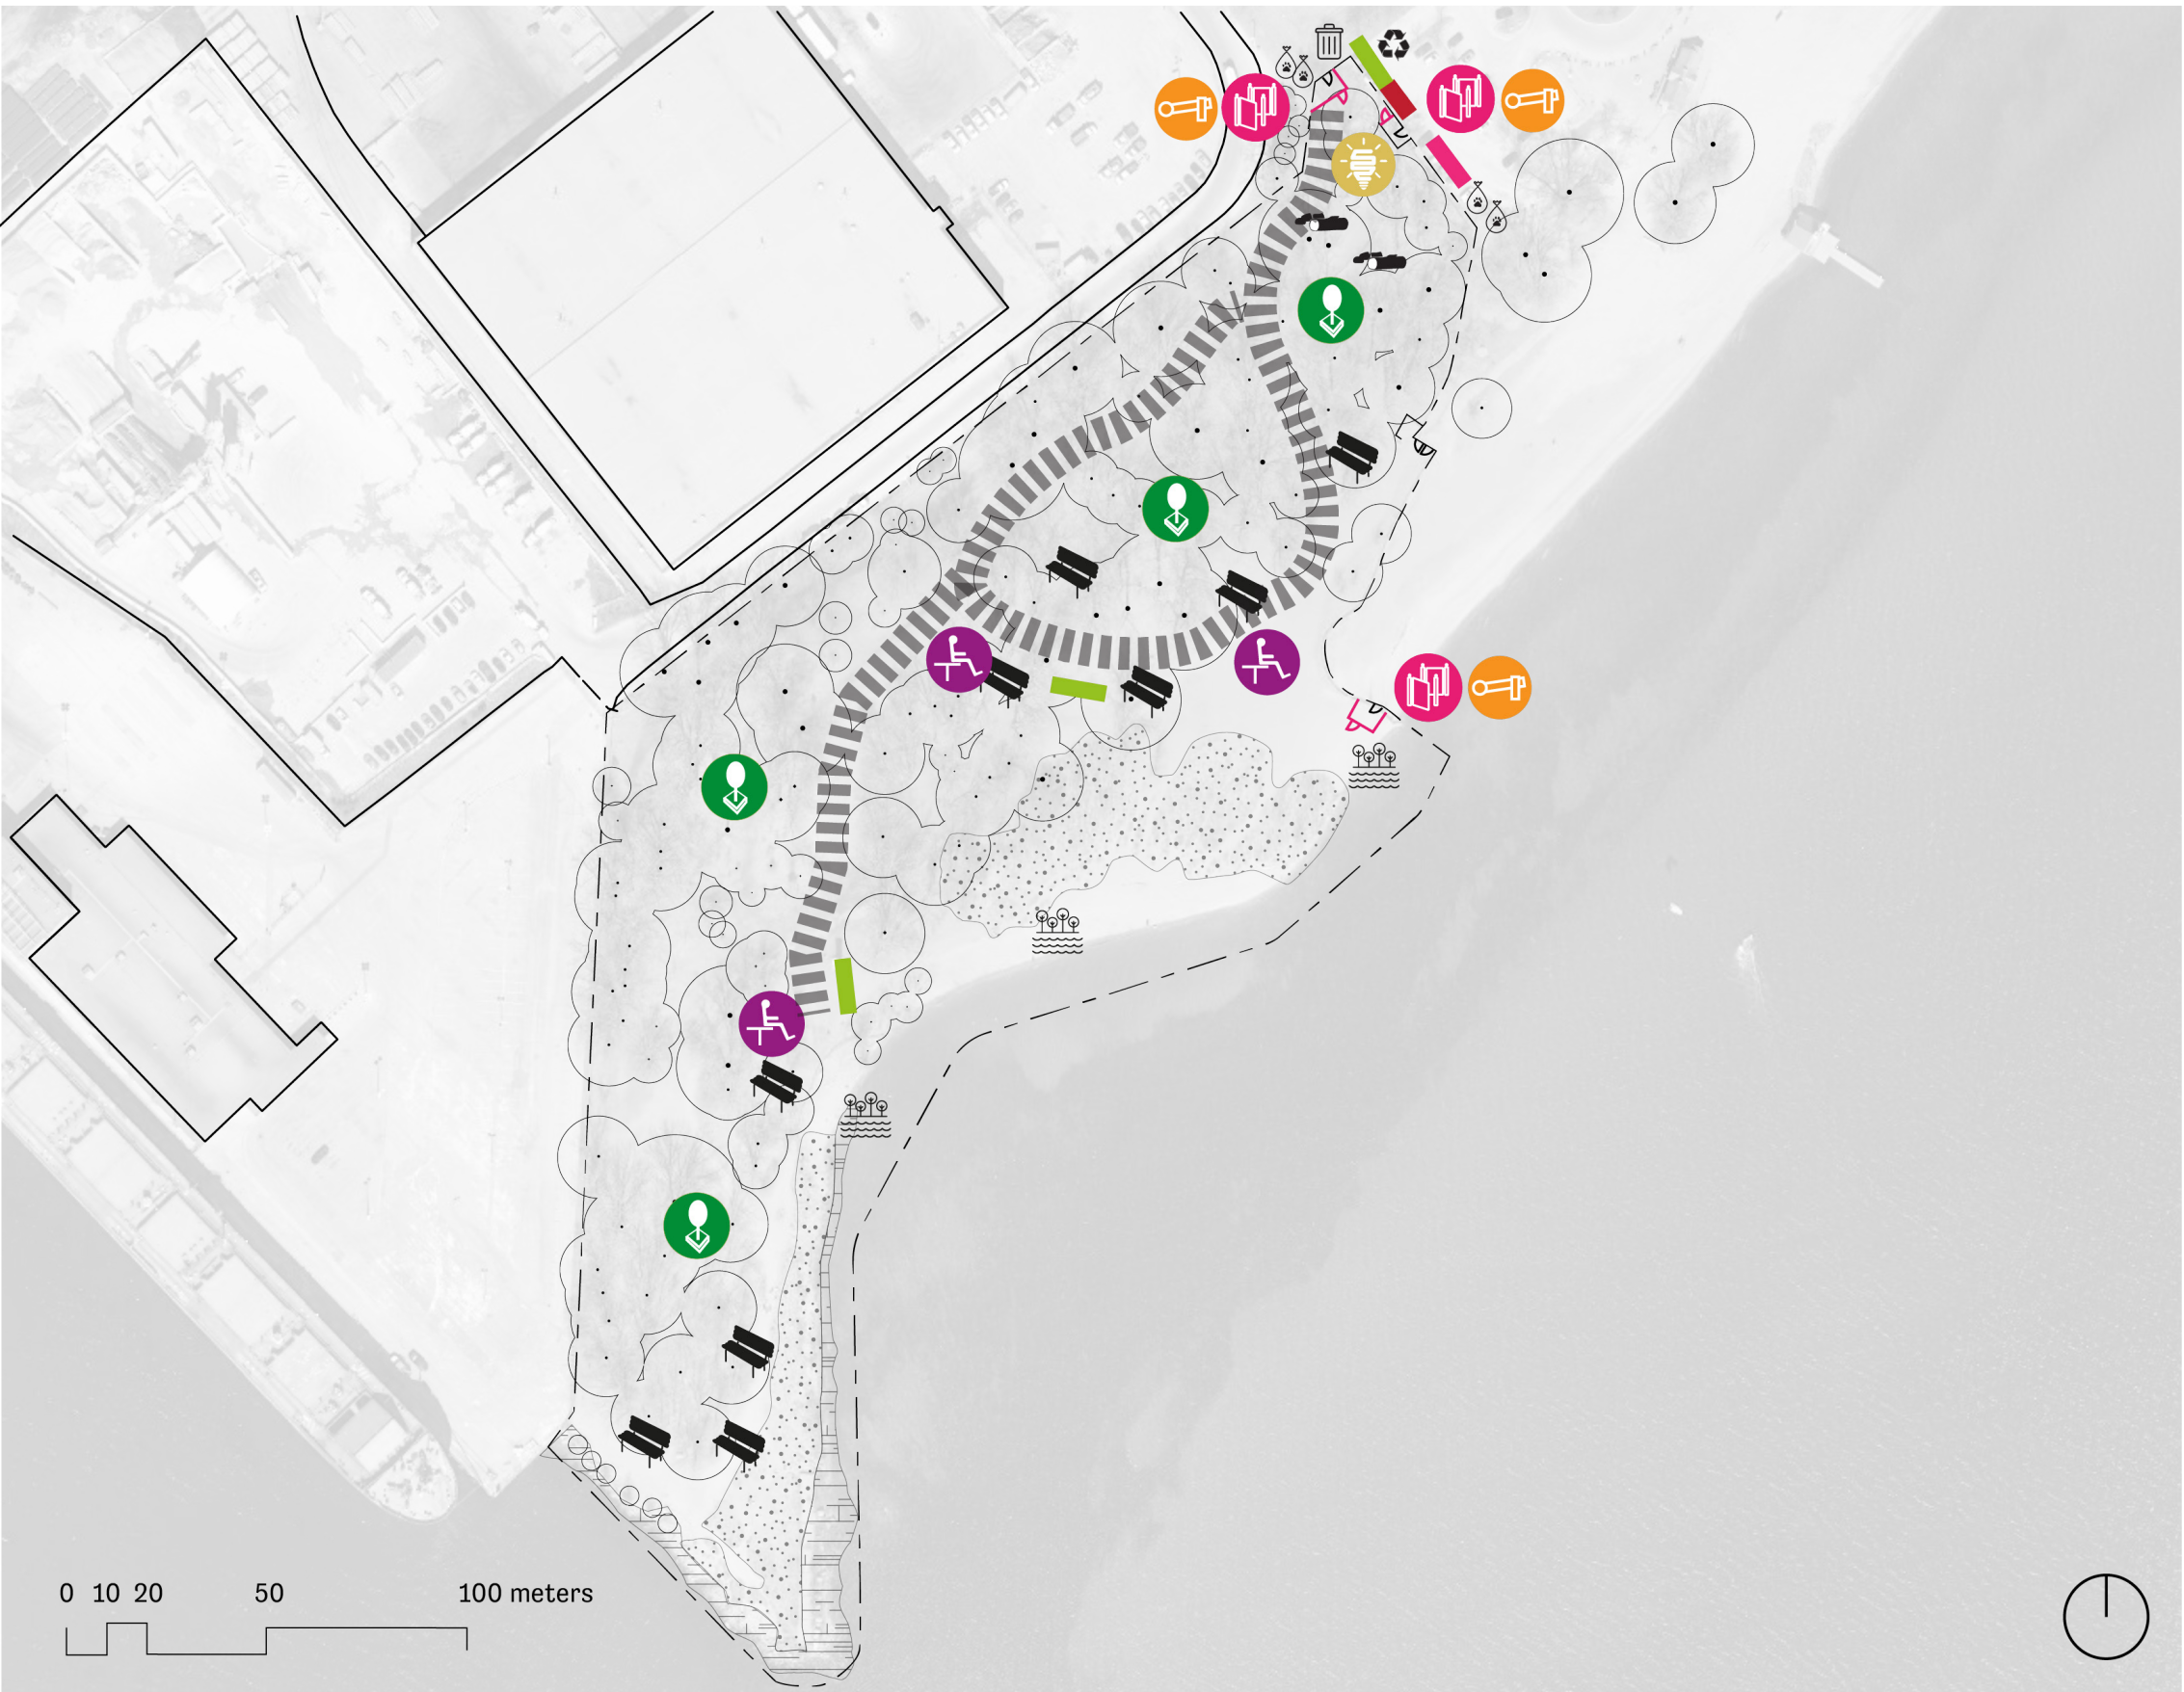
Preliminary Recommendations

Cherry Beach is located within an Environmentally Significant Area, and certain measures and precautions need to take place prior to any design recommendations.

The Cherry Beach OLA serves as an exemplar and contains attributes/criteria similar to the City's other existing OLAs. These recommendations are for demonstration purposes and are not intended to imply the OLA will be redesigned as illustrated in the immediate future.

D3.1 Replace existing latch with upgraded latch Replace the existing latching mechanisms on all gates with new mechanism that is designed to work efficiently, and without maintenance issues during all four seasons.	D3.2 Replace single gate with double gate system Both existing entry/exit gates are single gate systems. Proposed solution is to modified existing single gates to double gate with concrete pad.	D4.3 Provide accessible pathway within OLA Providing accessible, paved pathways (meeting AODA standards) encourages directive exercise within the OLA, and allows a larger proportion of dog owners to make use of the OLA. We recommend a looping pathway amongst the existing trees.
D4.5 Install accessible seating Providing accessible seating (meeting AODA standards) will allow for more comfort while spending time in the OLA. Seating to be located along accessible pathway.	D4.6 Install City signage within OLA and prior to entry Signage prior to entry will allow non OLA users to determine whether they are eligible to use OLA. Signage within OLA allows current users to become familiar with any changes to by-laws or code of conduct, and provide reference when needed.	D4.7 Relocate community boards at main access point Community boards provide a place where OLA users are able to post notices about community events, lost and found, and news. They are consider a best practice for public parks.

D4.8 Install educational/interpretive panels at main entry/exit High Park is located within an ESA and certain measures and precautions need to take place within these areas. Signage will assist in supporting the messaging and awareness of ESA sites.	D5.1 Install lighting at main entrance Lighting exists in the parking lot adjacent to the OLA. Recommendation to provide lighting at the main entry/exit for gates, garbage and community boards.	OM Update maintenance procedures Maintenance will perform weekly inspections, monitor and maintain shoreline for erosion and hazards, protect and monitor vegetation health and state of good repair and install surface bins in OLA to users to repair holes created by digging.

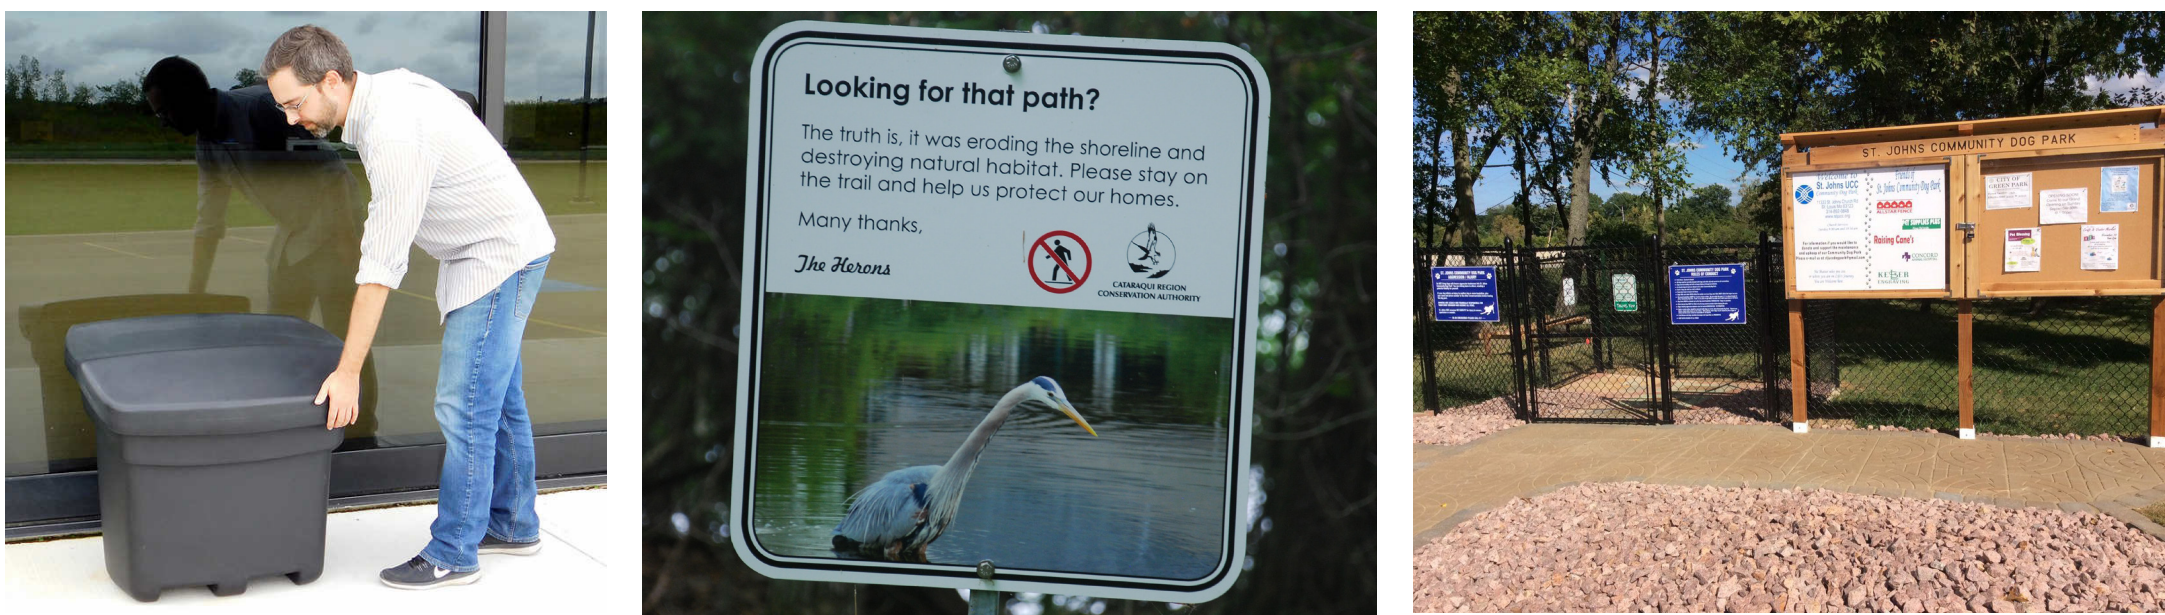
OM4 Protect and monitor vegetation health

There are many large existing trees within the OLA. Based on recommendations by a certified arborist, these trees need to be properly protected with protective fencing around tree trunks with river rock or mulch at the base to prevent compaction and digging.
