Cabbagetown Southwest  
Heritage Conservation  
District (HCD) Plan

CABBAGETOWN SOUTHWEST  
HERITAGE CONSERVATION DISTRICT

HCD PLAN

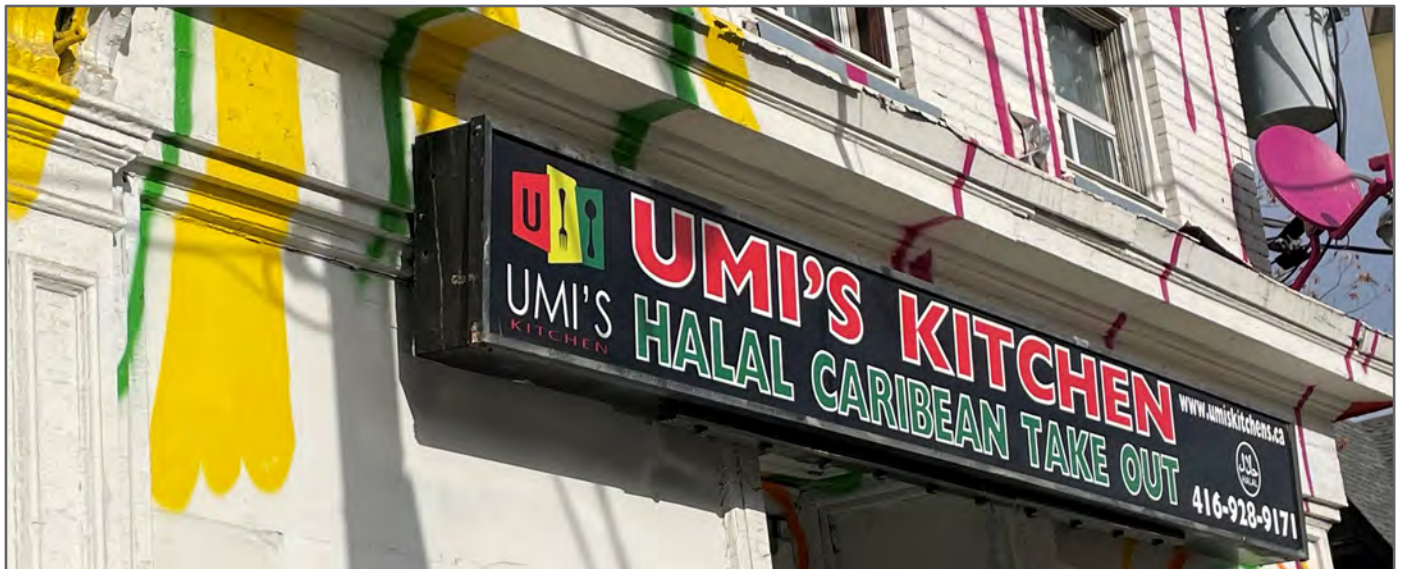
Figure 75: Existing signage on historic storefront at 346 Dundas St. E.; existing fascia boards (sign bands) should be utilized for contemporary signage.

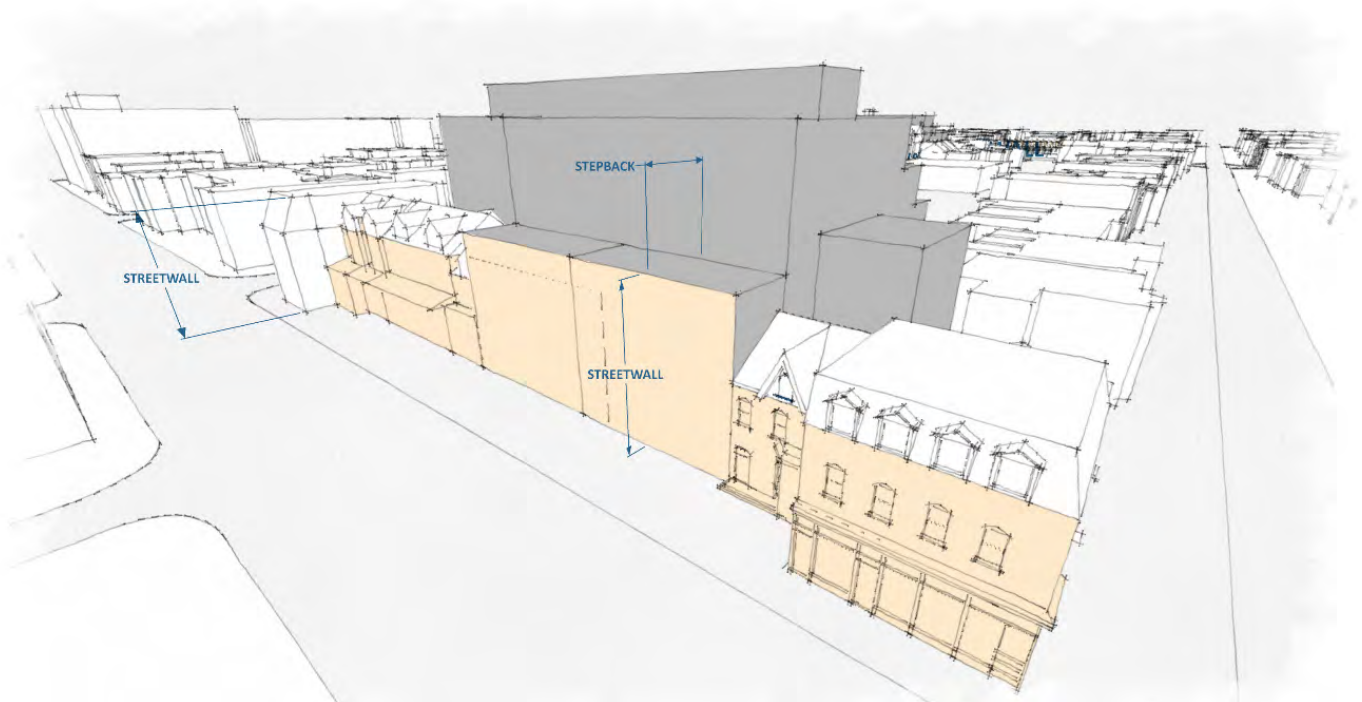
**Figure 84:** Diagram illustrating *new development* in the Dundas and Gerrard residential *character sub-area* that maintains the *streetwall* height. Its rear portions are higher than the *primary structures* of neighbouring *contributing properties* and it has a *stepback* aligning with the *primary structures* of neighbouring *contributing properties*.

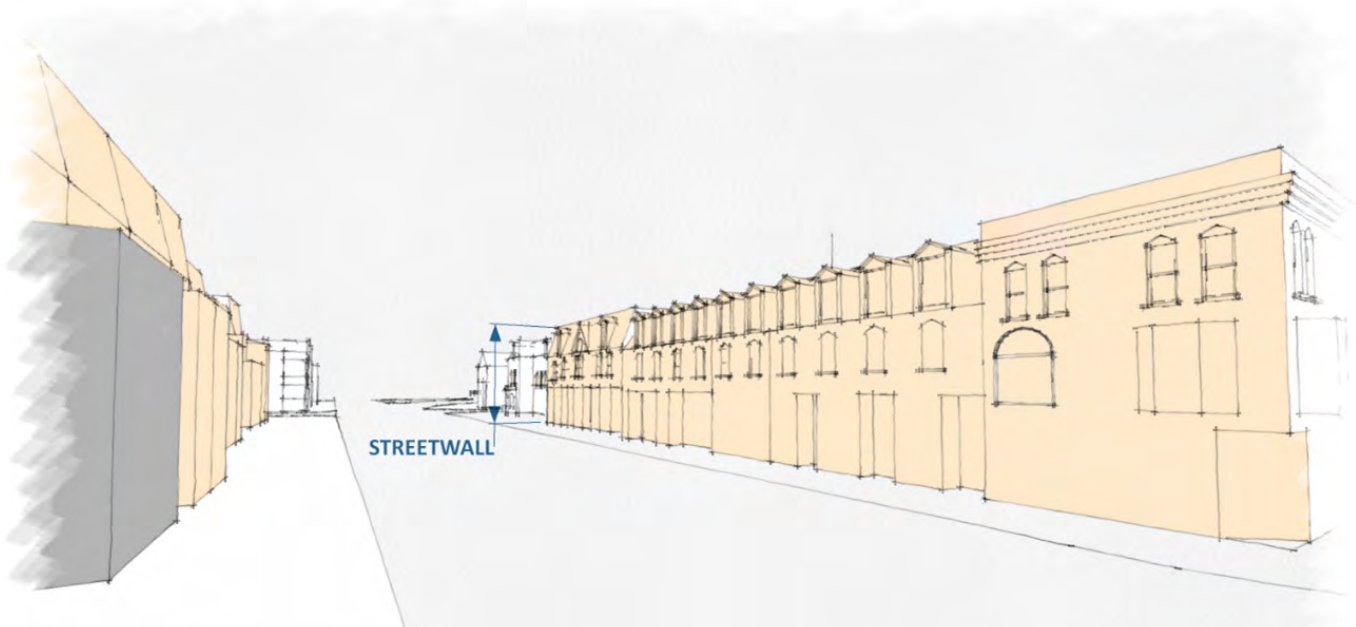
**Figure 85:** Diagram illustrating the *streetwall* height composed of a series of façades. The architectural features of the façades including bays, windows, dormers, and decorative features that express the articulation of the *streetwall*.

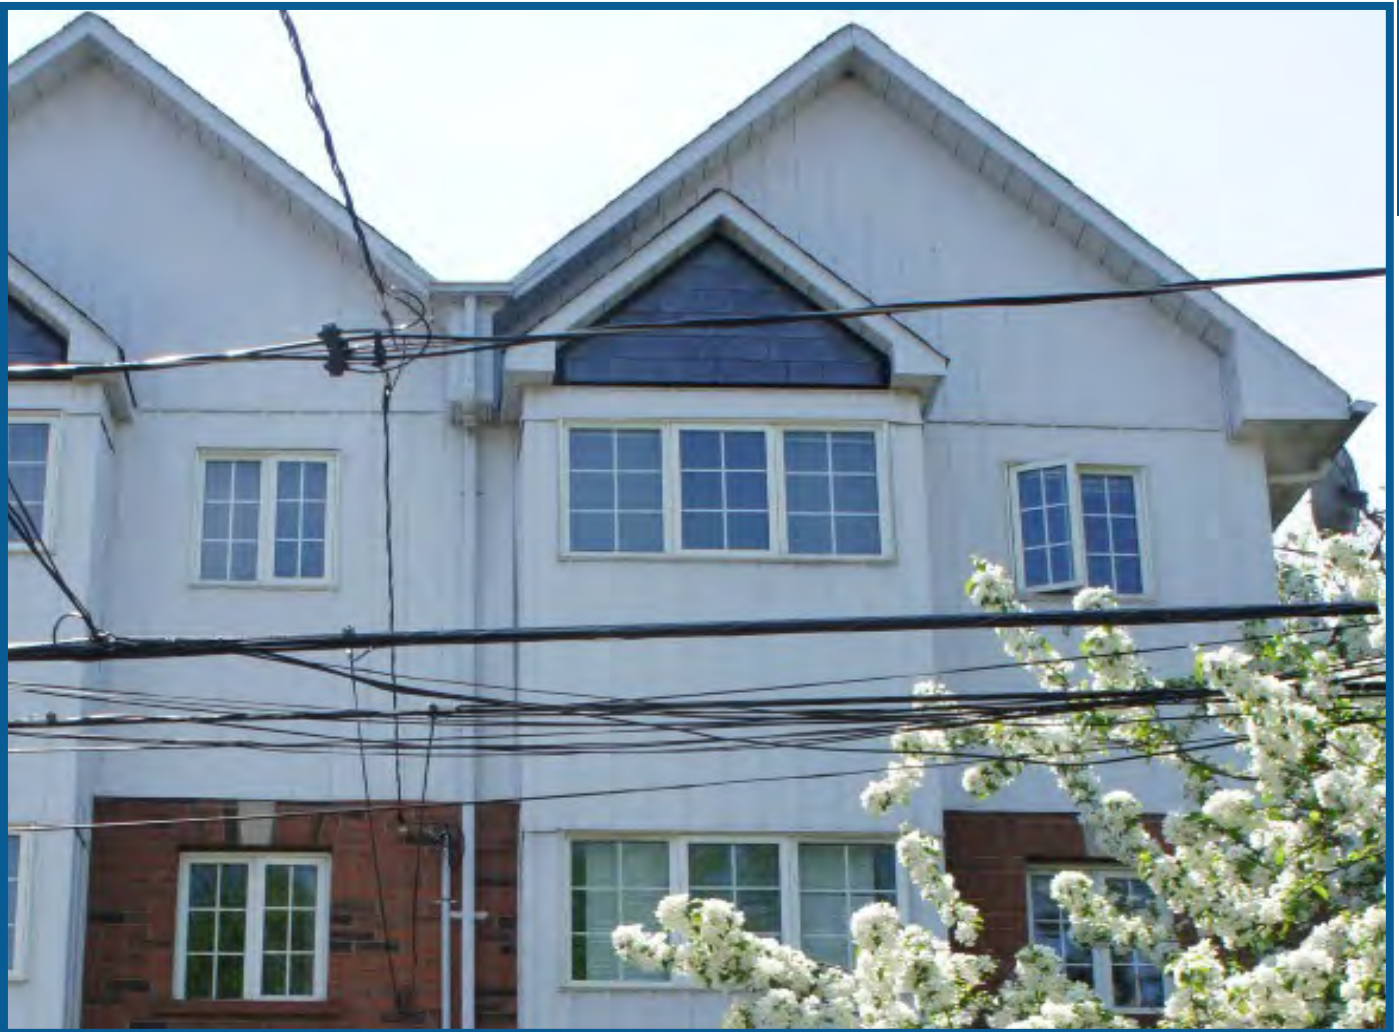
Figure 86: An example of a compatible roof profile for a non-contributing property.
