CABBAGETOWN SOUTHWEST
HERITAGE CONSERVATION DISTRICT

HCD PLAN

2024

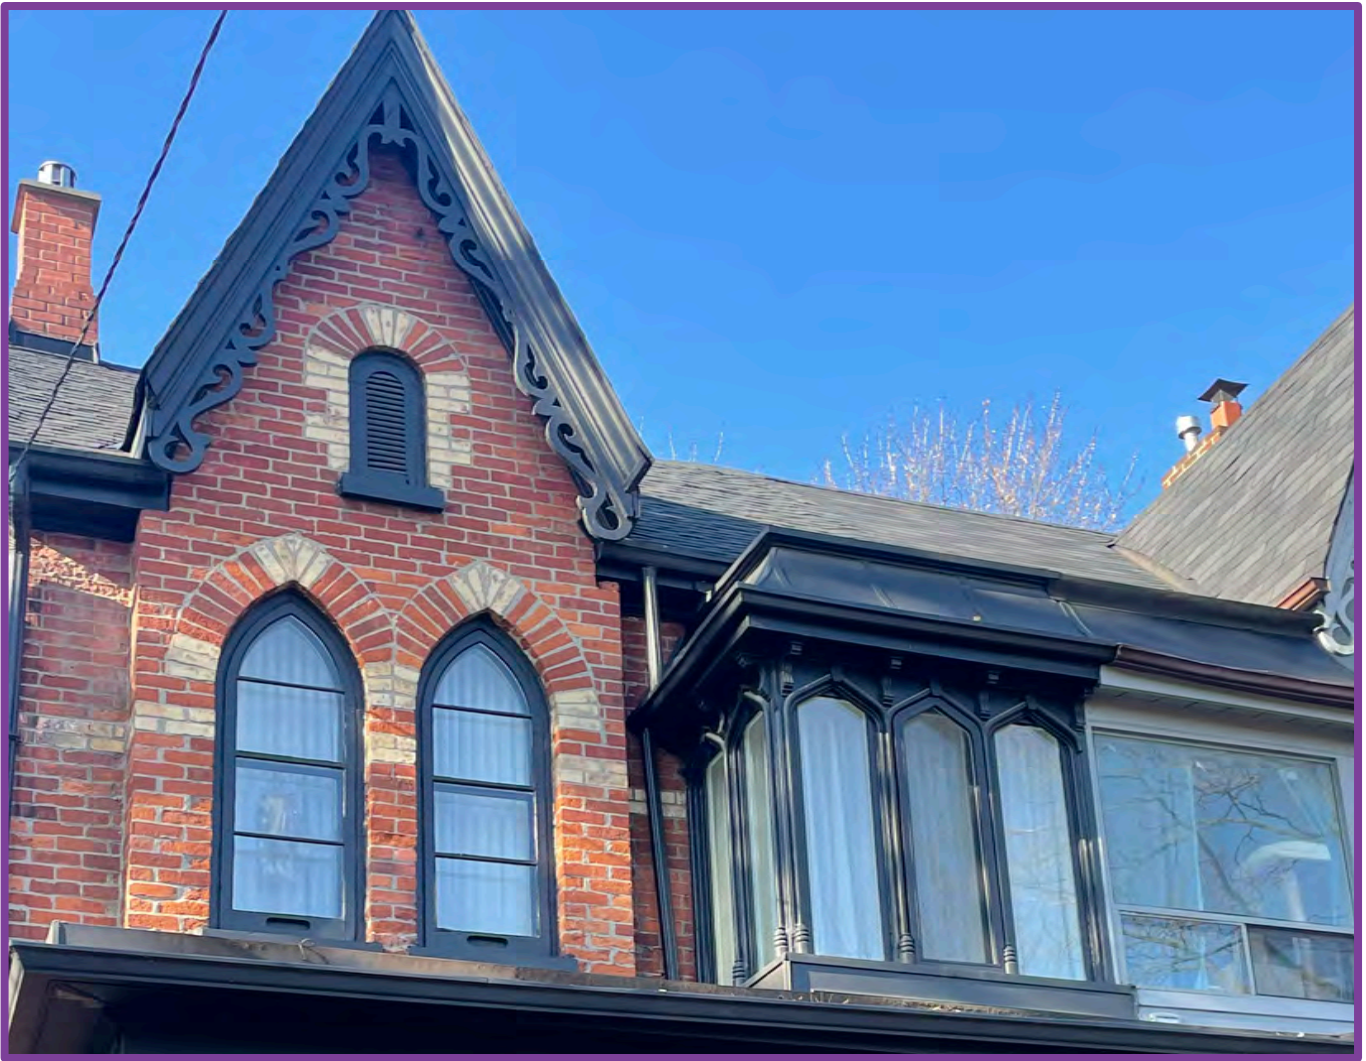
Figure 67: An example of conserved windows (left) on Berkeley St.

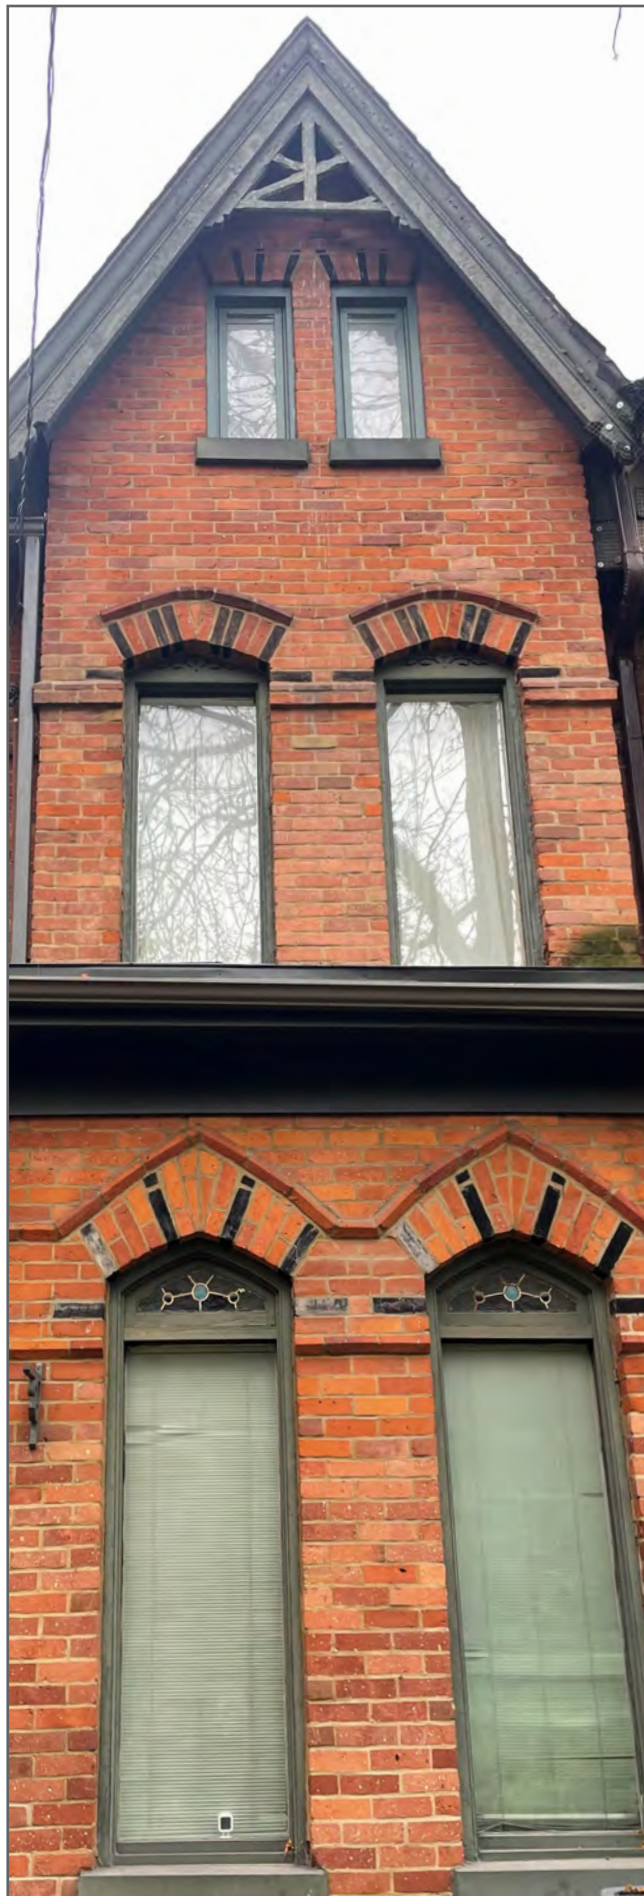
Figure 68: Retention of ground floor transom lights at 175 Seaton St.

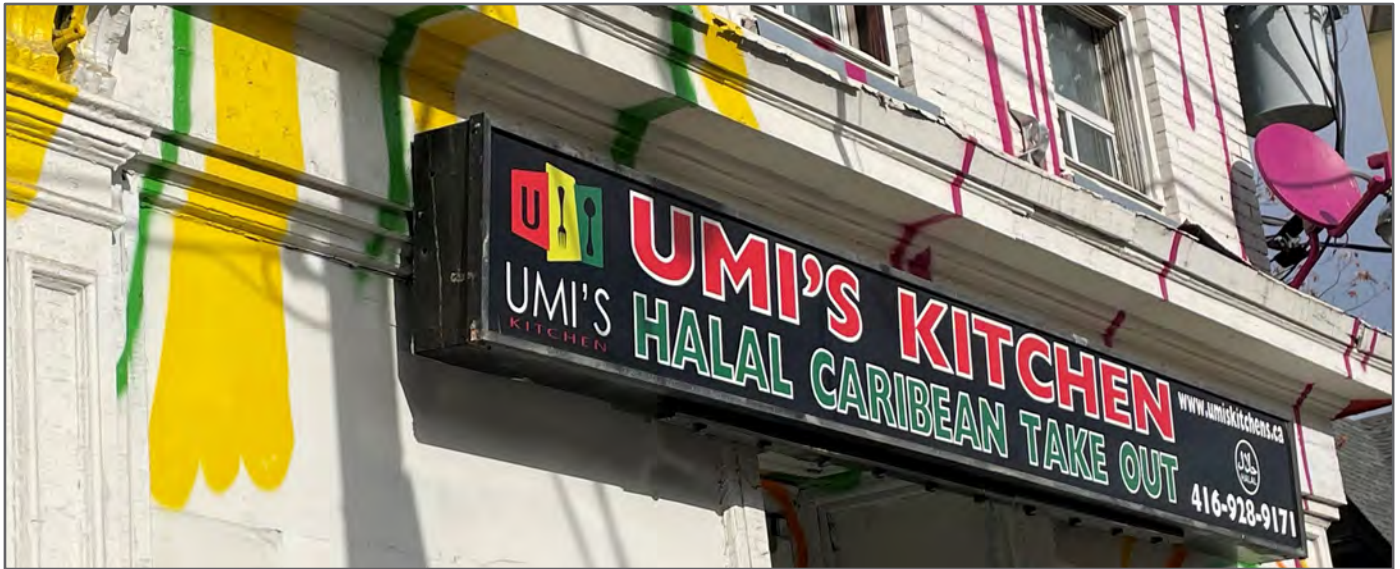
Figure 75: Existing signage on historic storefront at 346 Dundas St. E.; existing fascia boards (sign bands) should be utilized for contemporary signage.

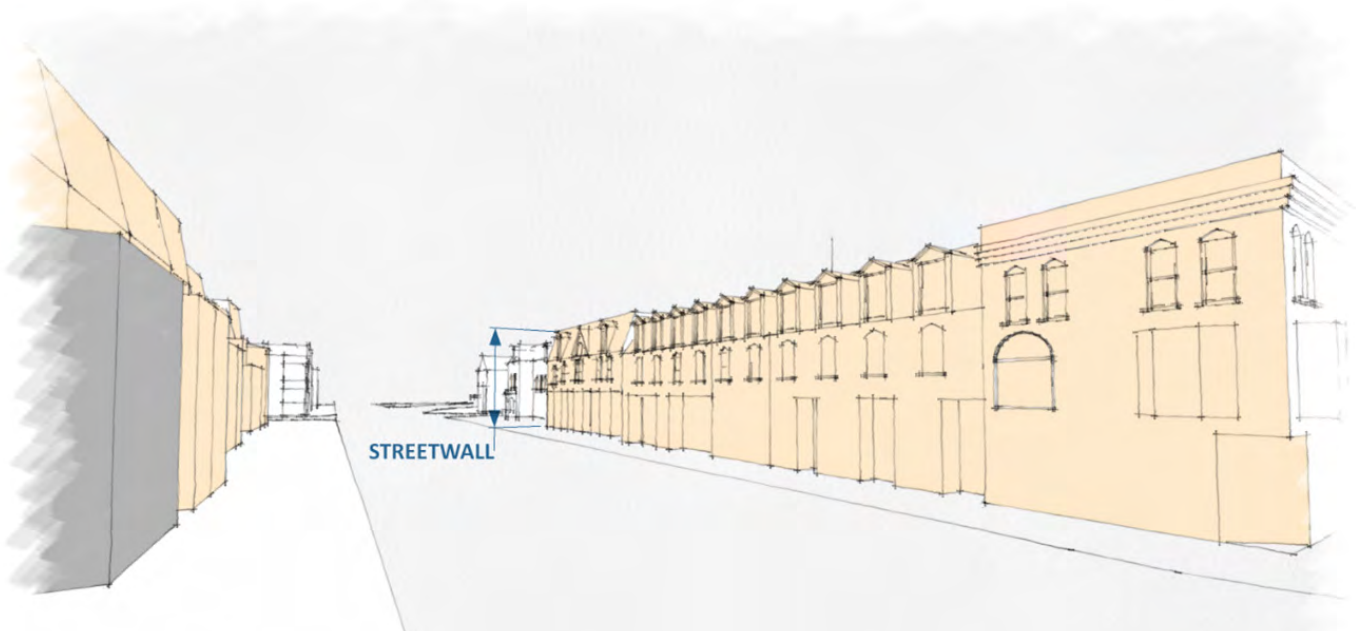
Figure 85: Diagram illustrating the *streetwall* height composed of a series of façades. The architectural features of the façades including bays, windows, dormers, and decorative features that express the articulation of the *streetwall*.
