Construction Update: December 24, 2024

Gardiner Expressway Strategic Rehabilitation: Dufferin Street to Strachan Avenue | Community Update

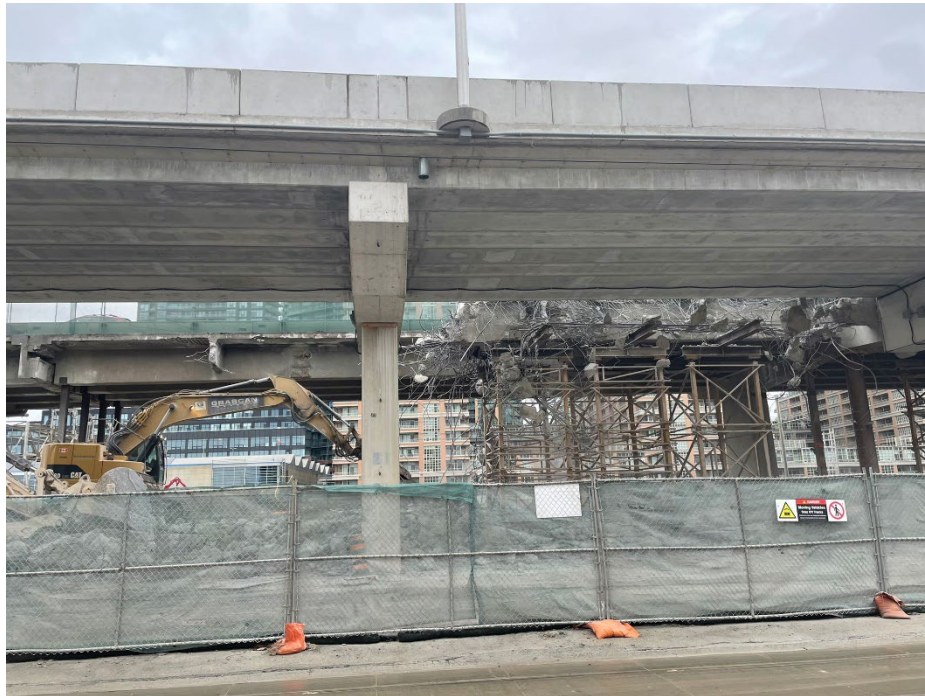
Demolition of bridge concrete deck and piers (bents) was completed for stage 2, including removal of steel girders.

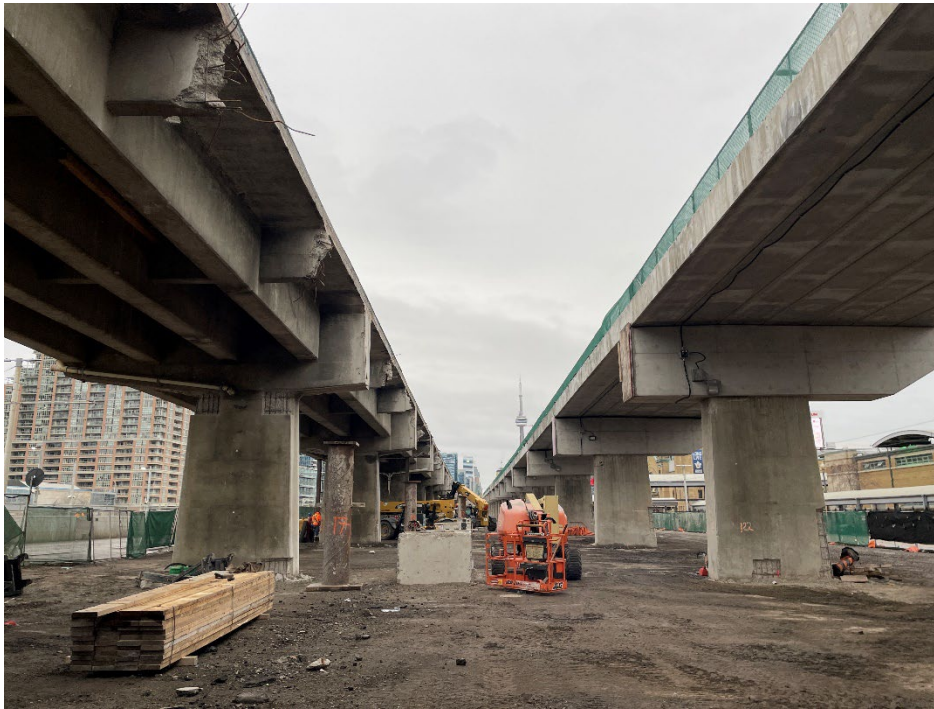
Fully removed steel girders at Stage 2 from Bent 31 to Bent 35.

- Removal of girders in Stage 1 has been fully completed.
- Installation of girders in Stage 1 has been fully completed.
- Completed prefabrication of 415 precast girders produced till date.
- Stage 2 steel girders removals from Bent 31 to Bent 35 (approx. 365m to approx. 450m East of GO Station) completed.

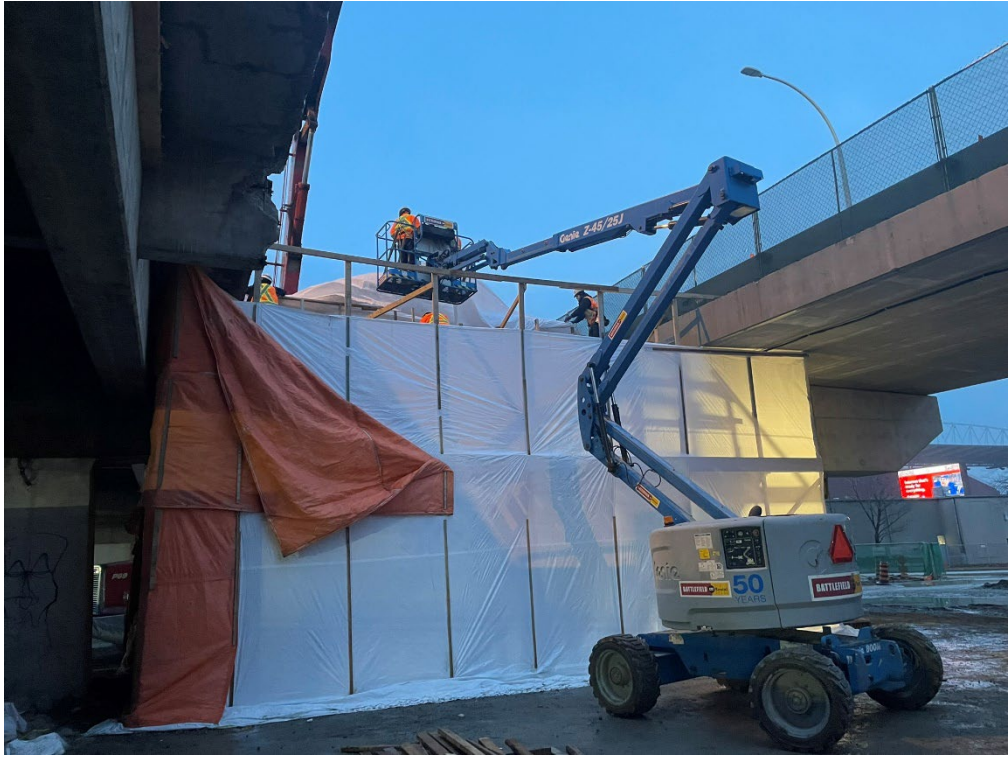
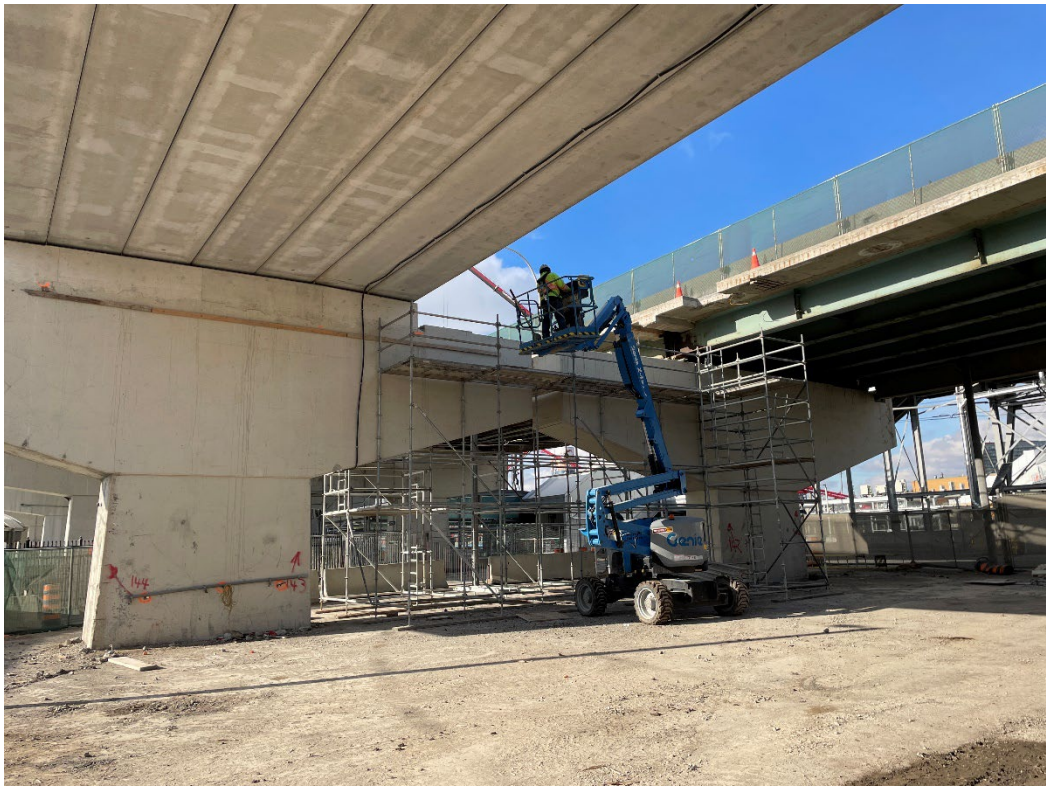
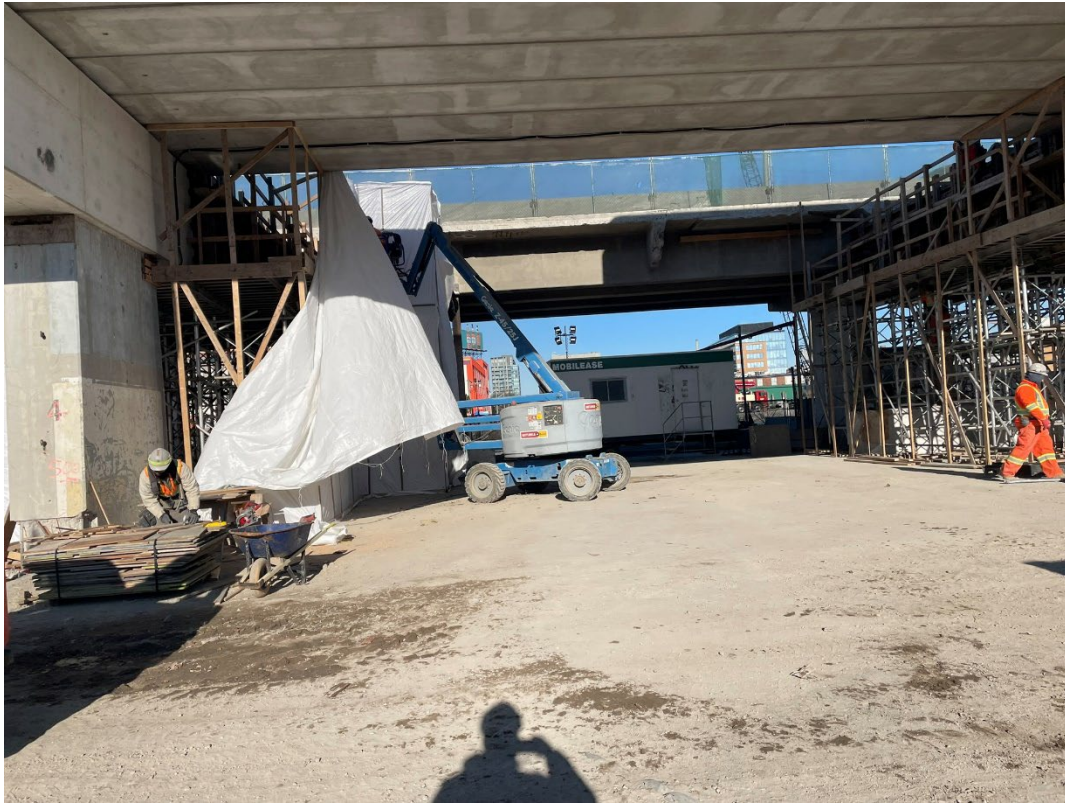
The three images above depict scaffolding (support system for formwork) for bent cap reconstruction is ongoing. The tent enclosure in image 1 is a measure to protect the concrete during cold weather conditions, while the concrete cures.

- Stage 2 scaffolding installation for bent cap construction ongoing from Bent 6 to Bent 10 (approx. 110m to approx. 35m west of GO Station) and at Bent 17 (approx. 100m east of GO station), progressing eastwards.

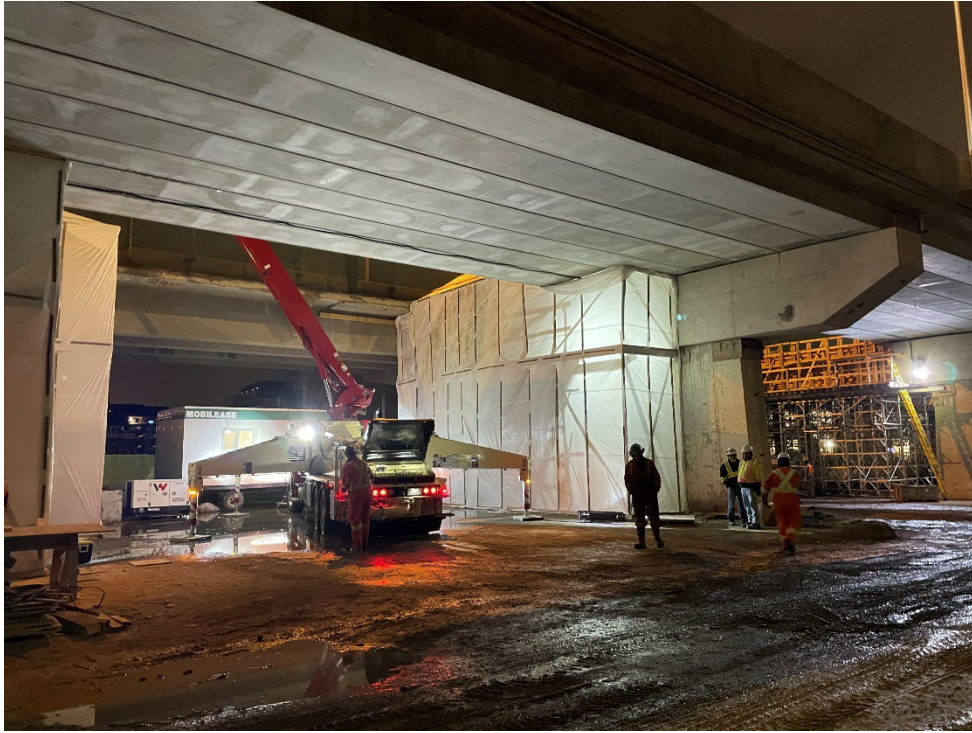
The image above depicts a concrete pump, used for one of the bent cap concrete pours.
