**Appendix C (Part 3)**

**Infrastructure Crossing Locations**

NEWTONBROOK CREEK GEOMORPHIC SYSTEMS MASTER PLAN

CROSSING NO. 15 - EXISTING CONDITIONS

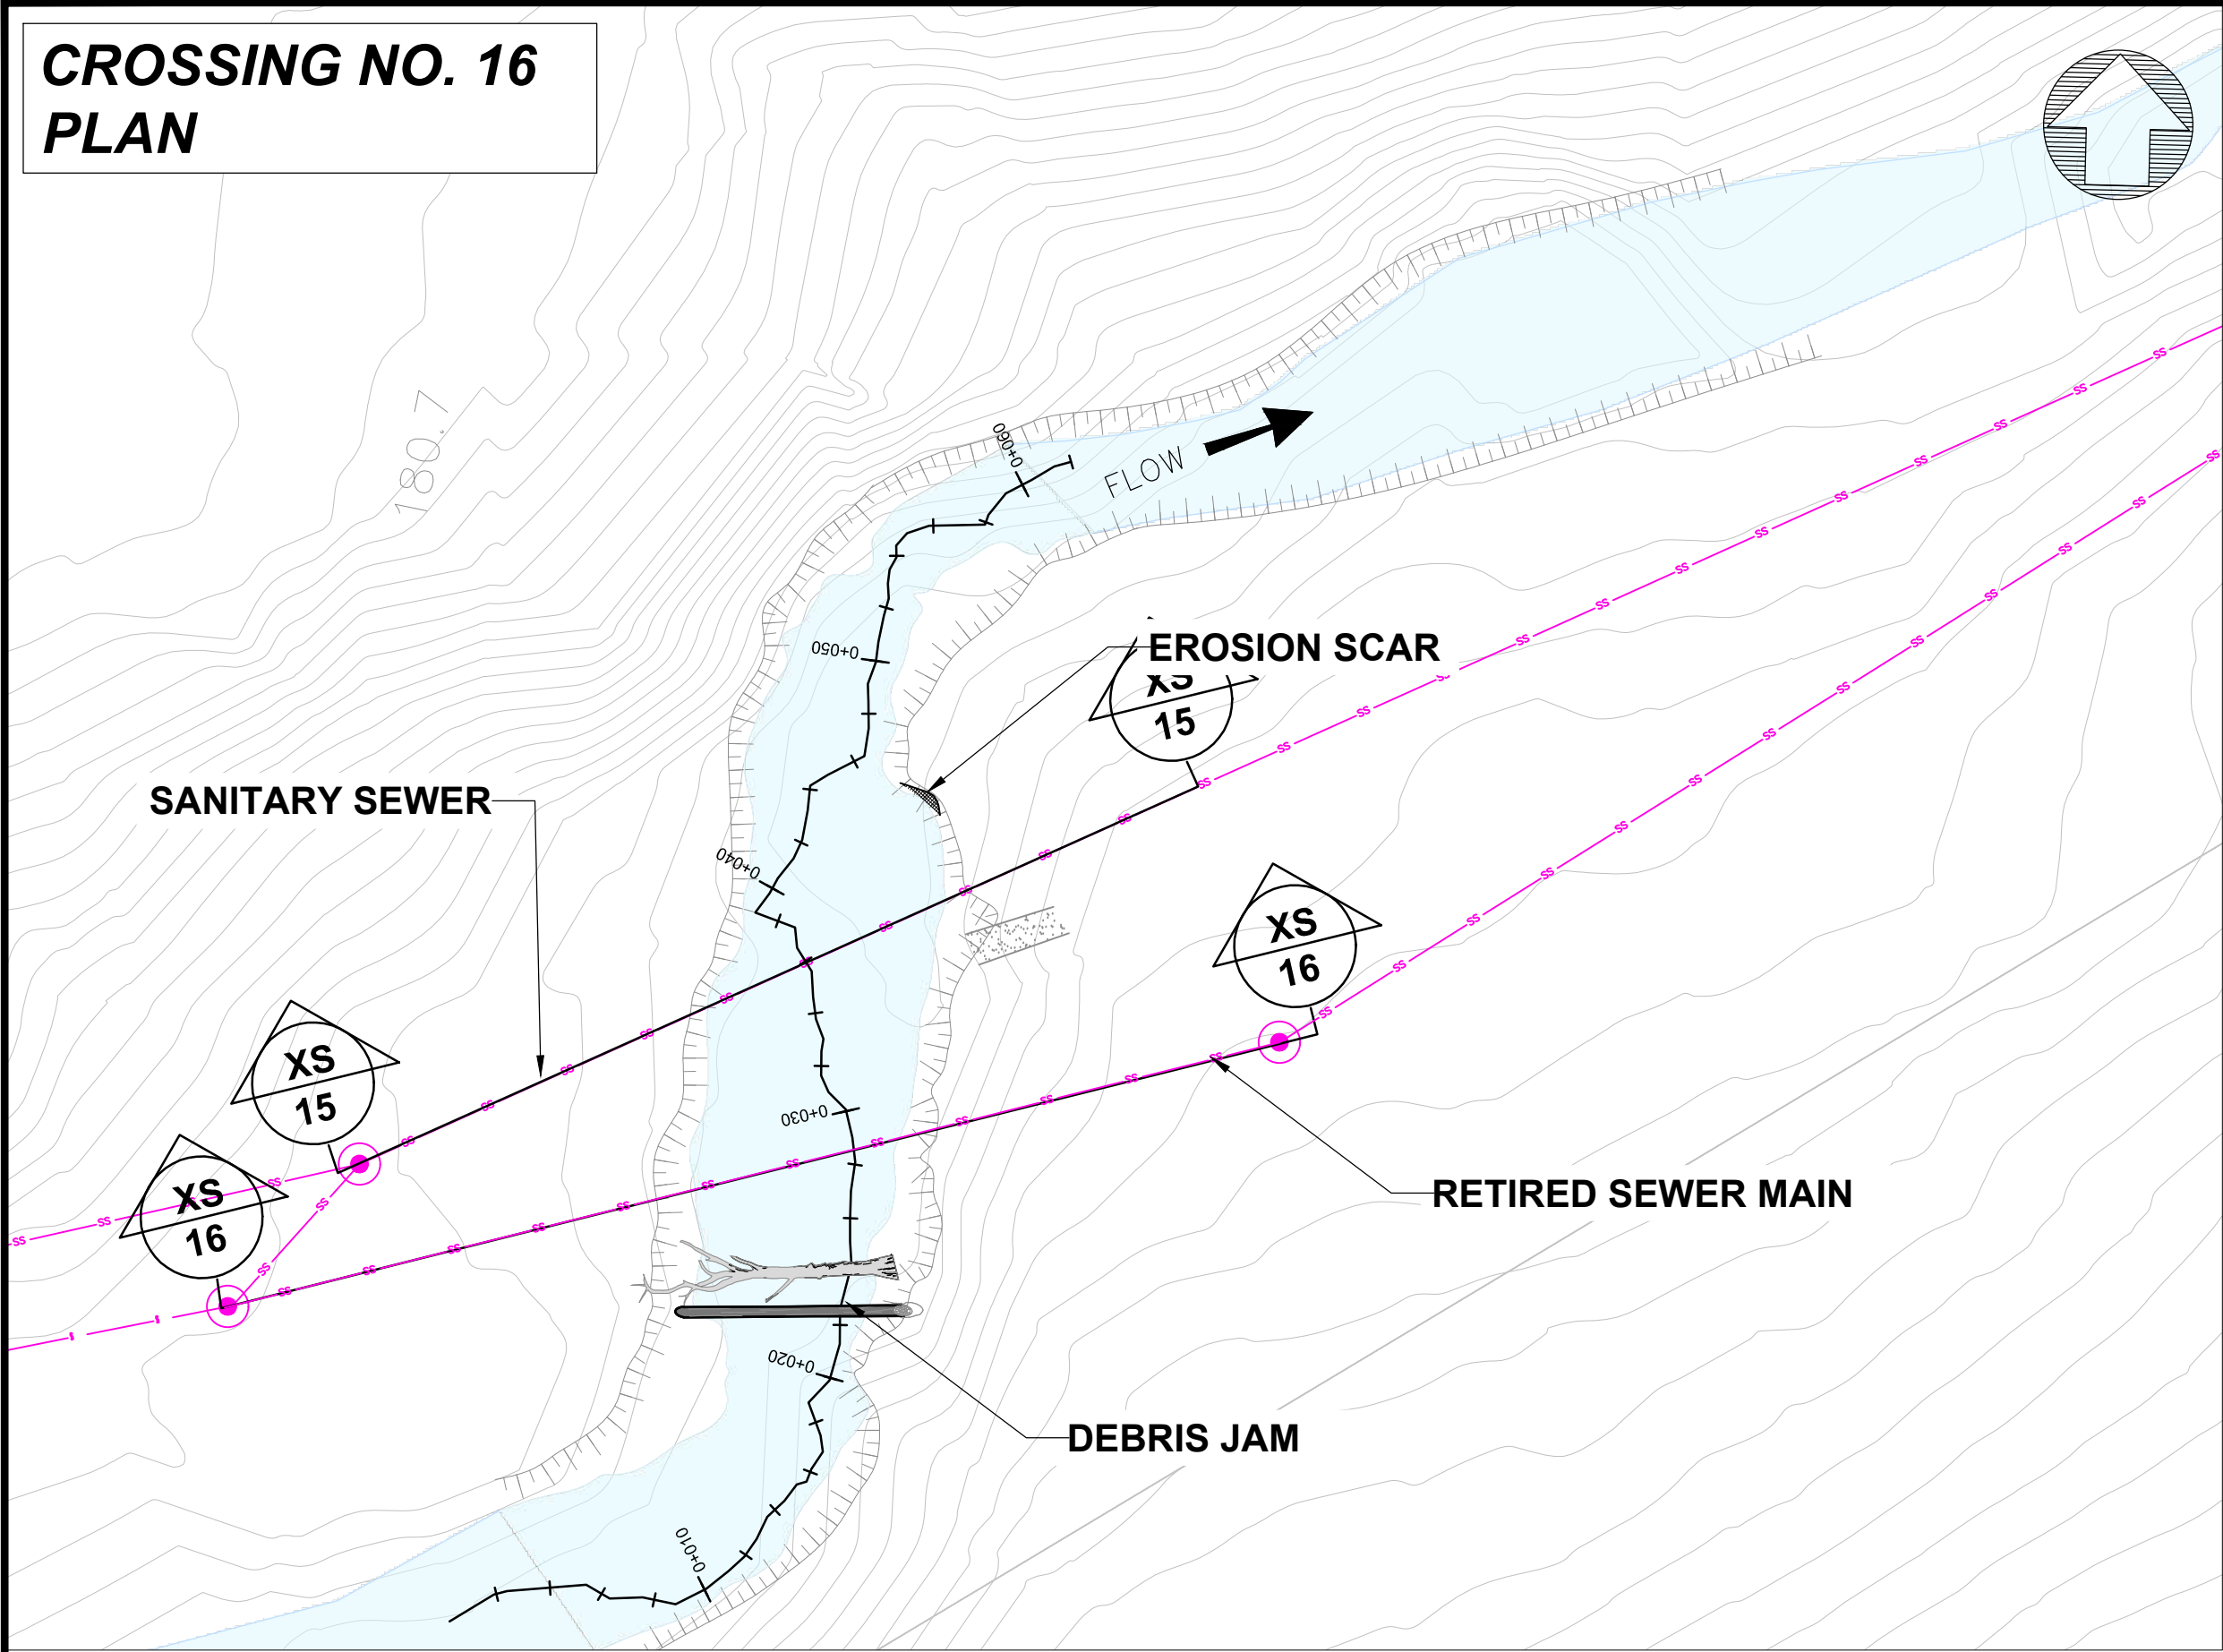
CROSSING NO. 16  
PLAN

CROSSING NO. 16 - EXISTING CONDITIONS
