St. Lawrence Centre for the Arts – Condition Assessment

City of Toronto
+VG Architects (Toronto) Ltd.

December, 2016

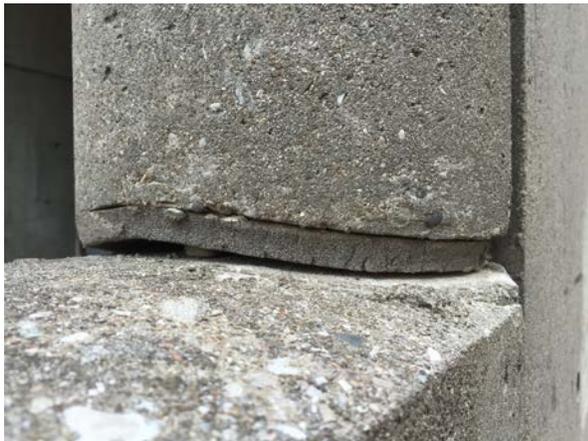
Dry sealant at joint between concrete shear wall and parapet

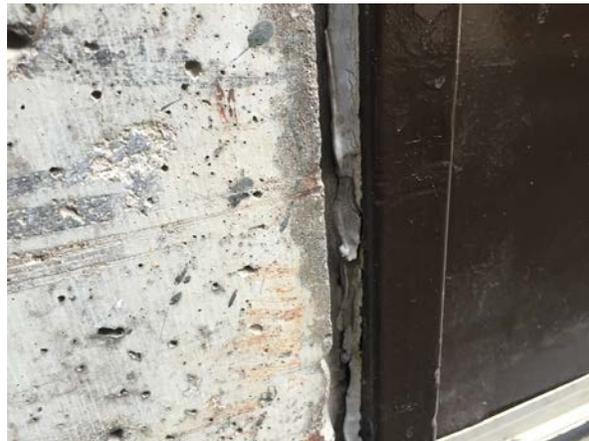
Dry sealant between window frame and concrete wall

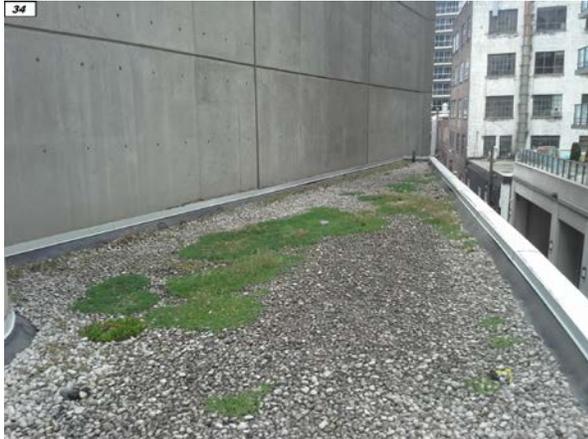
Moss and organic growth over flat roof surfaces

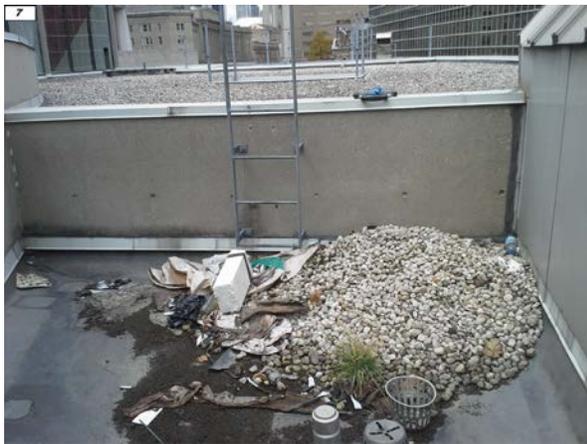
Debris accumulated over roofing membranes

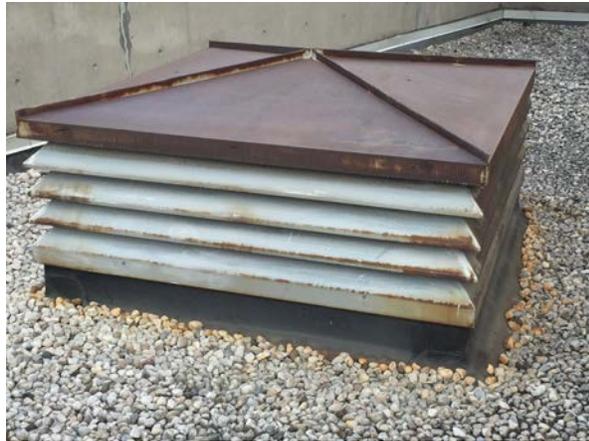
Old and deteriorated mechanical louvre

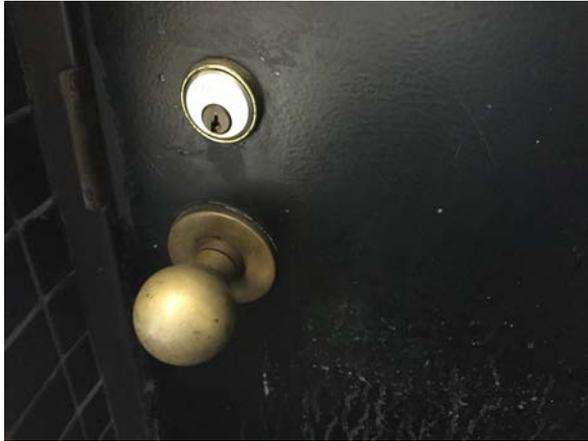
Old door hardware

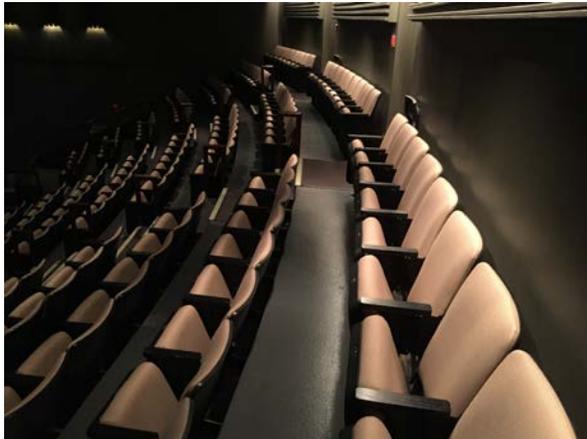
Seating in the Jane Mallett theatre

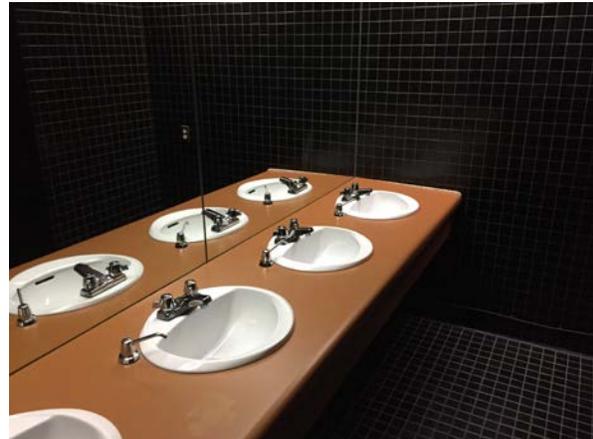
Older countertop and fixtures in public washrooms

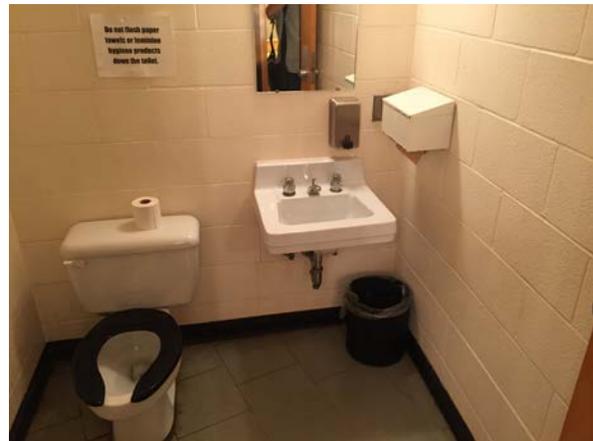
Back of house staff washroom

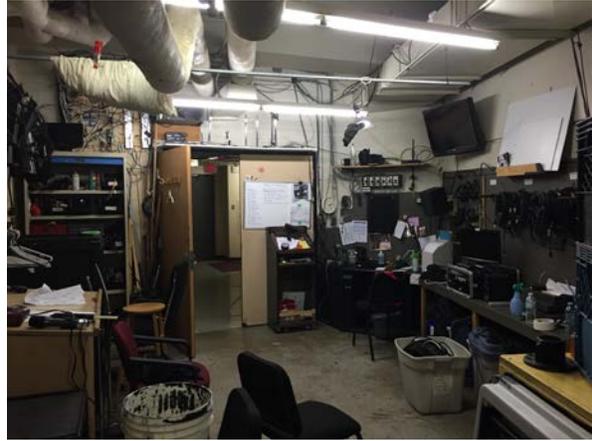
Clutter in work areas

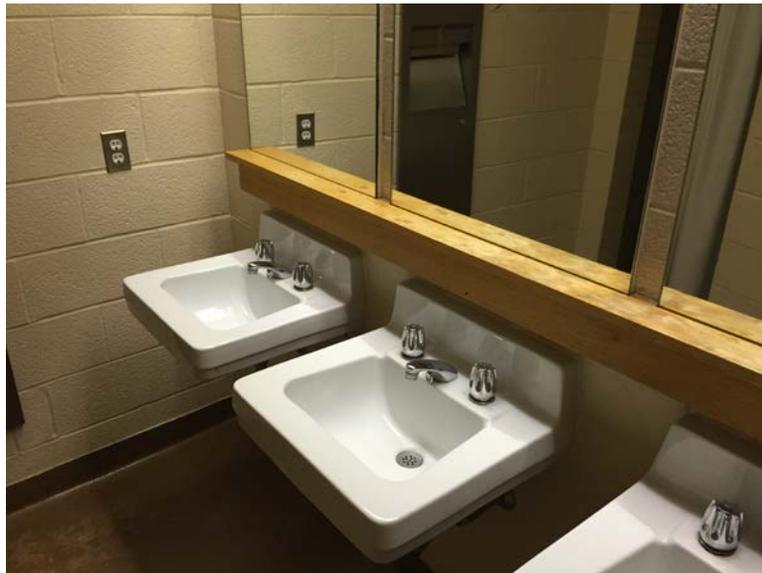
Older washroom fixtures in dressing room

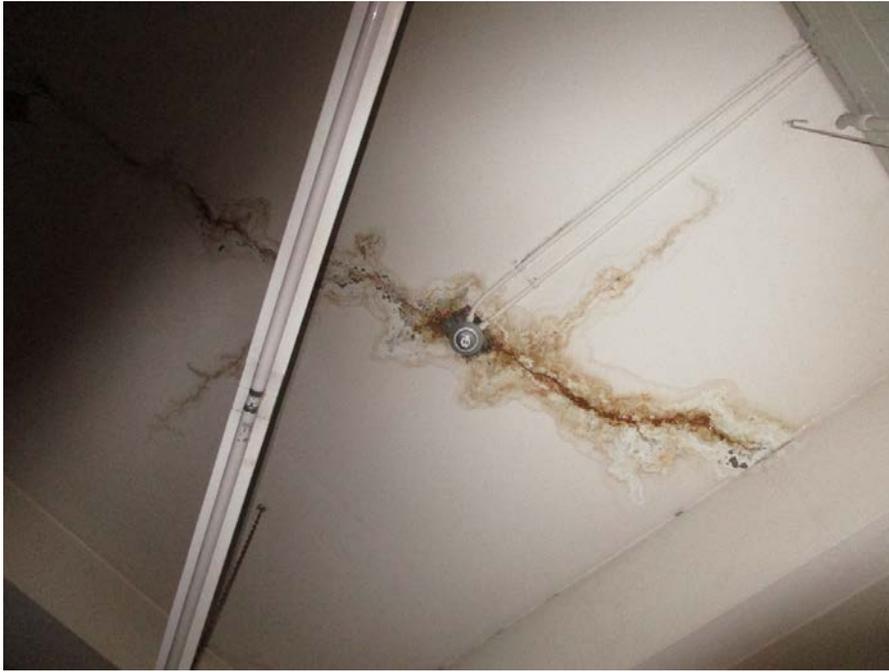
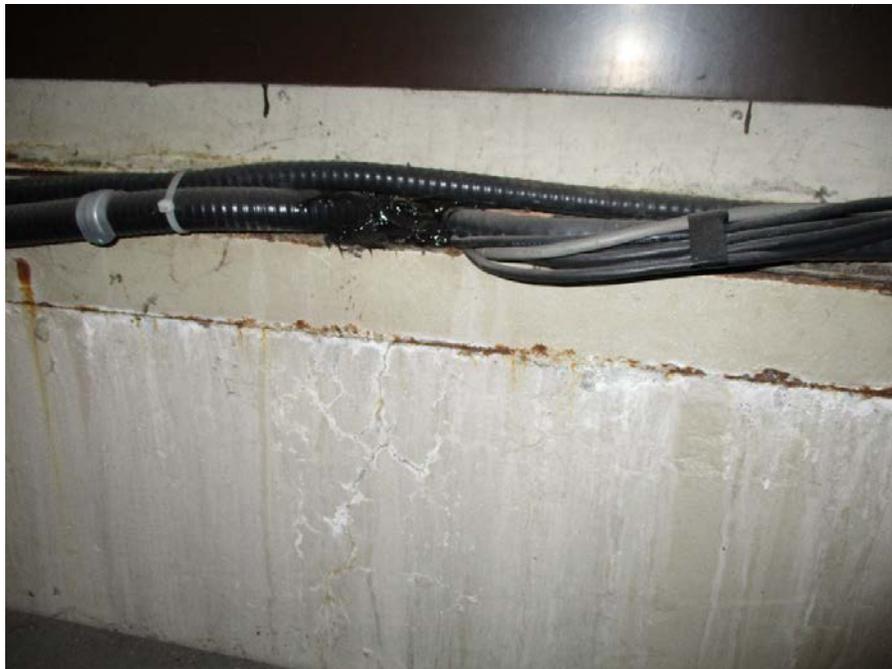
S.1: Water ingress at north mechanical room, accessed through men's room.

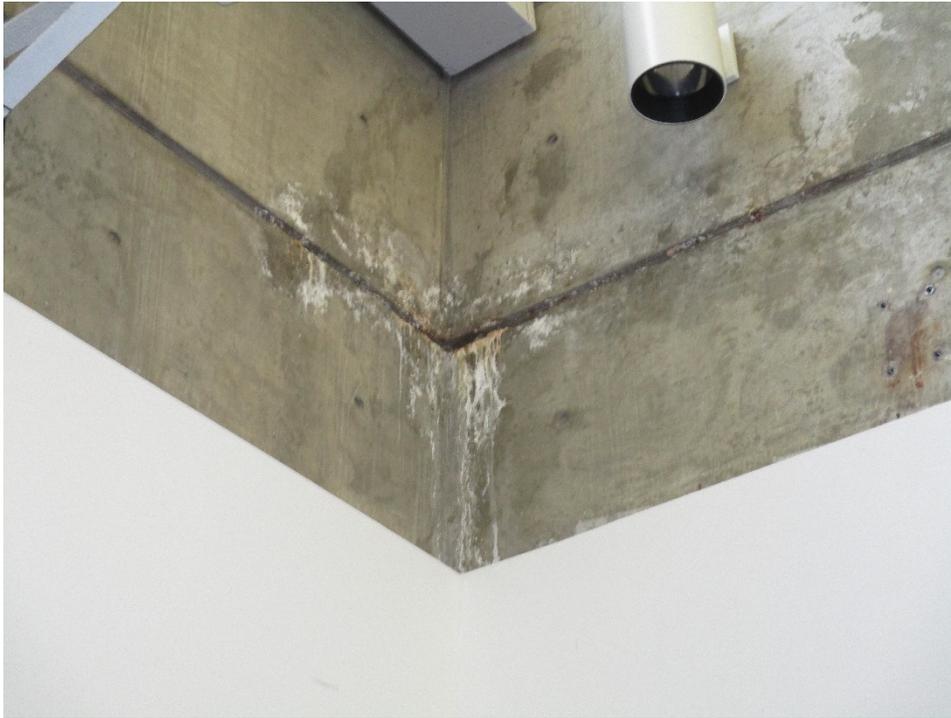
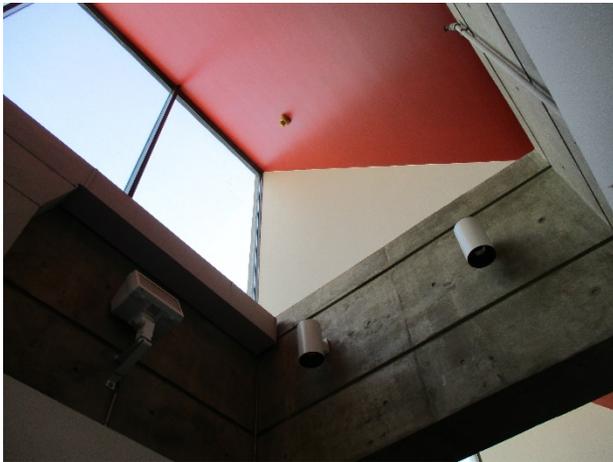
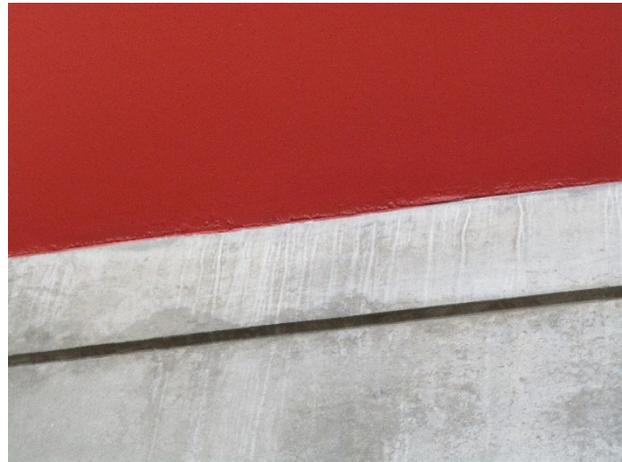
S.2: Water ingress around windows and lightwells in lobby (209 and 221).

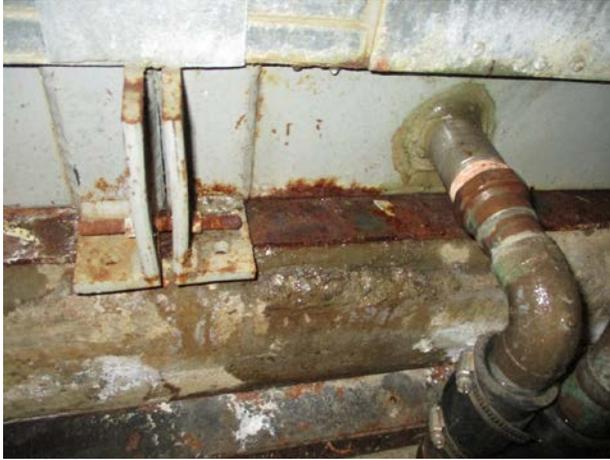
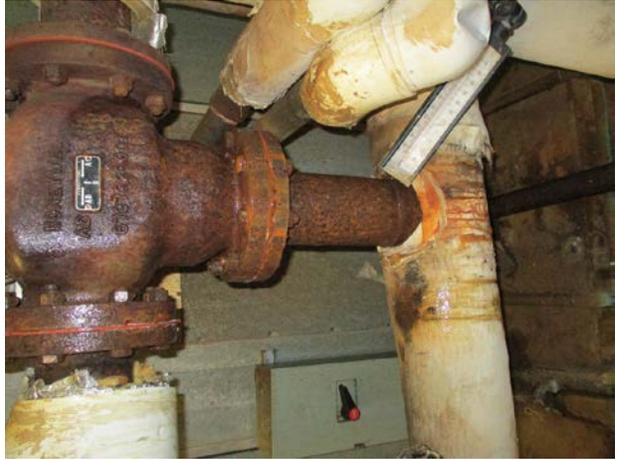
S.3: Condensation dripping from mechanical units and connections is pooling in mechanical rooms.

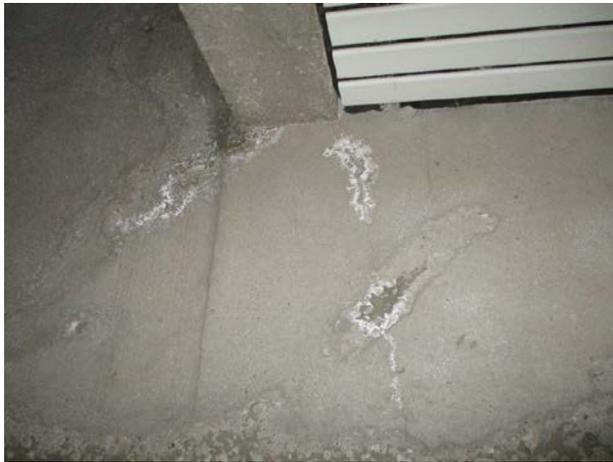
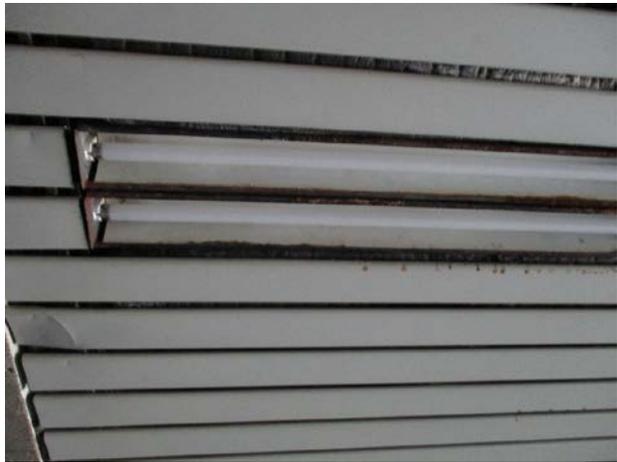
S.4: Corridor at east exit stair showing signs of water ingress (219).

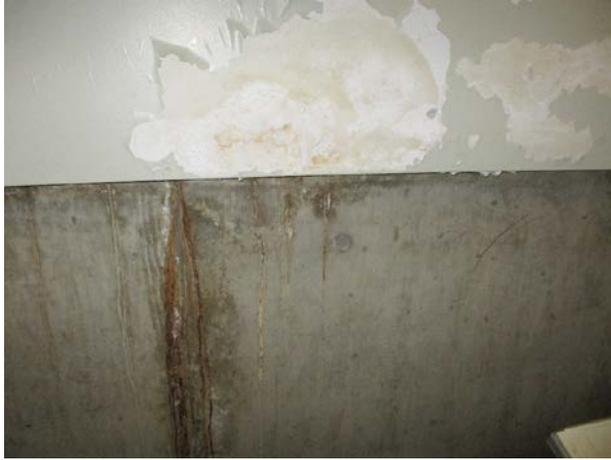
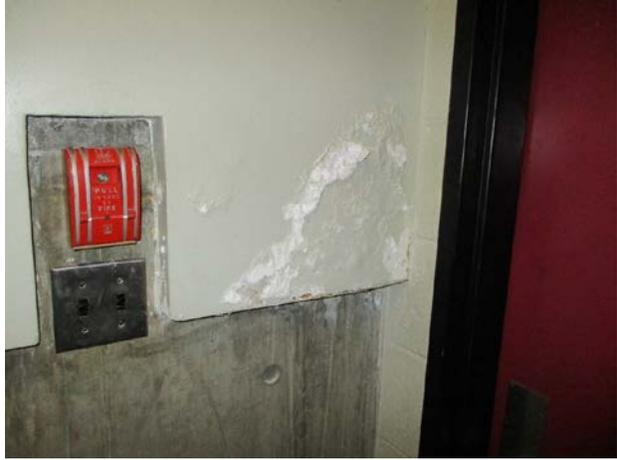
S.5: Water ingress through clerestory wall cross from stage manager's room (production rooms above VIP lounge).

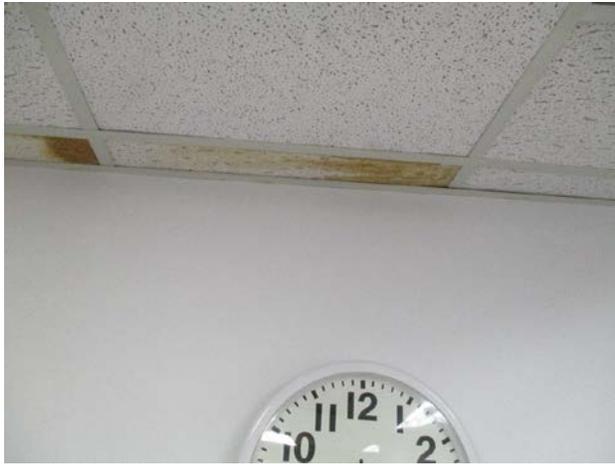
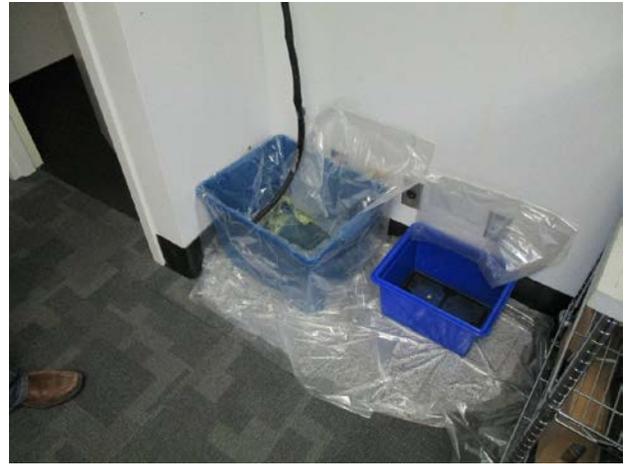
S.12: Significant water ingress into front house administrative offices.

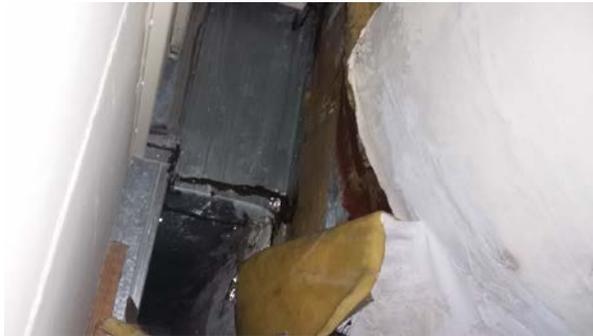
Damaged insulation on AHU S5.

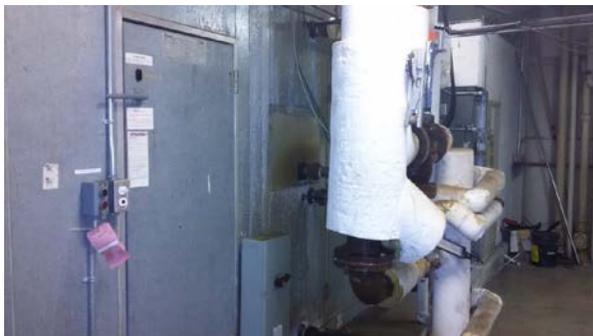
AHU S4 chilled water piping with missing insulation and visible condensation.

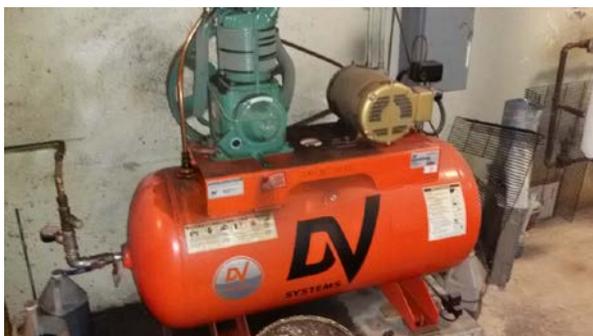
Air compressor with belt guard removed.

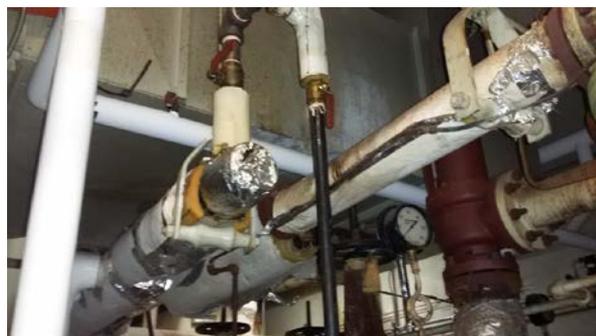
Poor insulation on piping associated with steam heat exchangers C-1 and C-2.

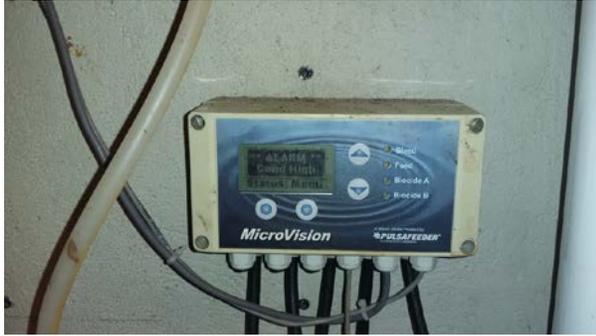
Condenser water chemical treatment control panel showing High Conductivity Alarm.

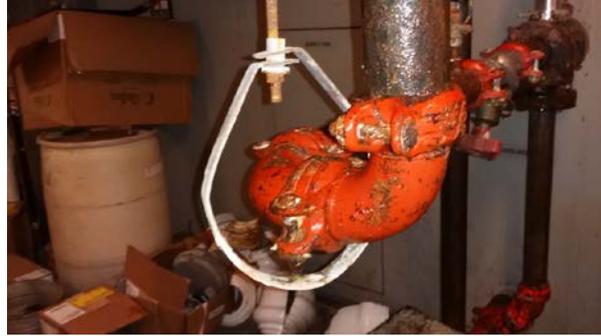
Chilled water piping with insulation removed and visible condensation on pipe.

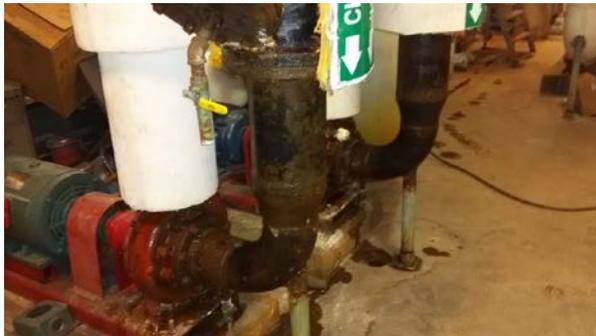
Chilled water return pumps and piping with missing and damaged insulation with visible condensation.

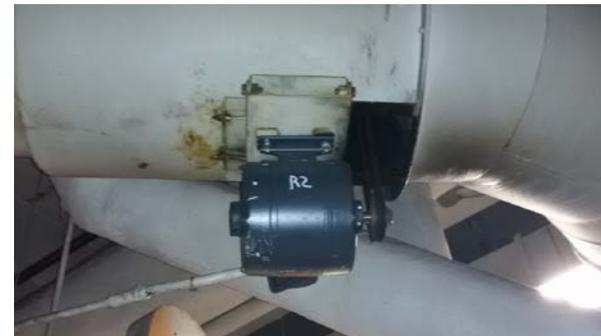
Unguarded fan belt on fan R-2.

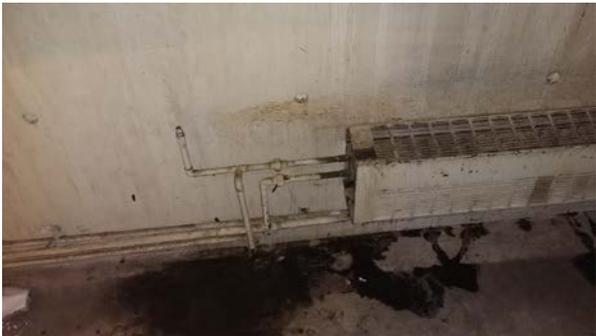
Storage room hydronic radiator in poor condition.

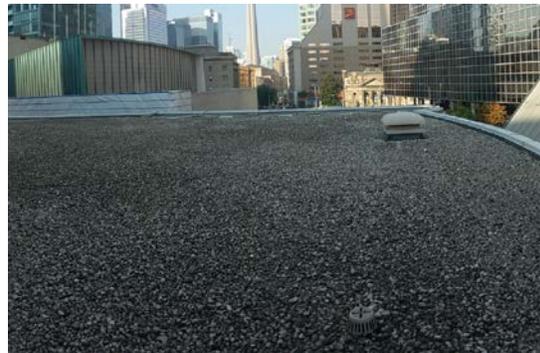
Roof drain and cover in good condition (lower right) with an exhaust fan cap in the background.

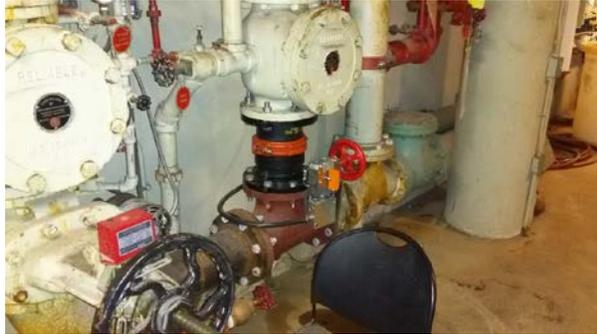
Sprinkler system valves. Valve in centre of image is in good condition. Valve in left of image is in fair condition.

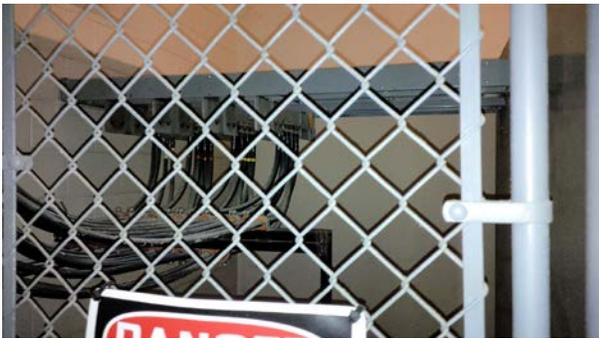
Photo 1: Toronto hydro incoming collector bus configuration

The incoming service from the utility utilizes a collector-bus arrangement (see PHOTO 1) whereby the incoming conductors are terminated at busswork outside of the main switchgear and is located on the basement level of the building in Room B-006.

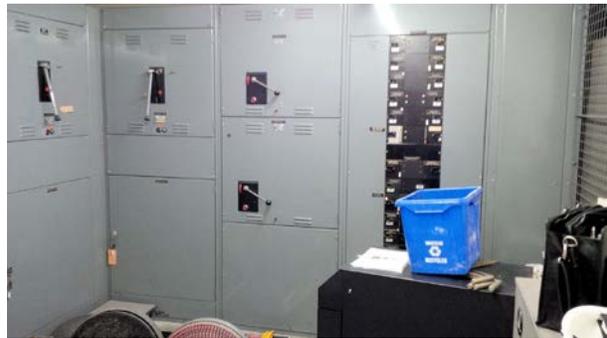
Photo 2: 2500amp;208/120v,3p,4w main switchboard

The split-service main switchboard is rated (for each side) at 2500amp, 208/120volt, 3phase, 4wire with a 70kAIC buss rating and has an integral utility metering compartment. There are "UNELEC" air circuit breakers (ACB) to service a Refrigeration Compressor (1600A-3P), Distribution Panel #DP.1 (1600A-3P), Distribution Panel #DP.2 (500A-3P), Distribution Panel #DP.3 (600A-3P), and a 600kva booster transformer (2000A-3P) for stage lighting (see PHOTO 2). This installation appears to date from a 1968 installation based on existing archived drawings reviewed as part of this Assessment.

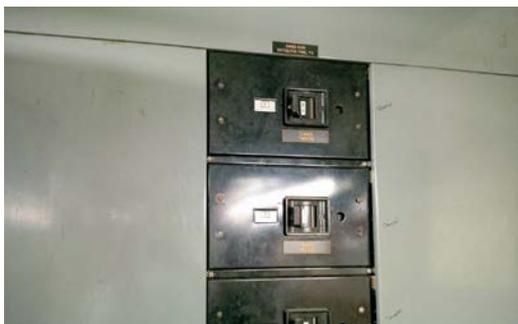
Photo 3: Distribution panel dp.4 (theatre dimming systems)

In addition there is another Distribution Panel labelled "Dimmer Room Distribution Panel #4" located in a satellite electrical room B-007 adjacent to main electrical room that appears to be the same vintage as the main distribution but does not appear on the electrical distribution diagram drawing (see PHOTO 3).

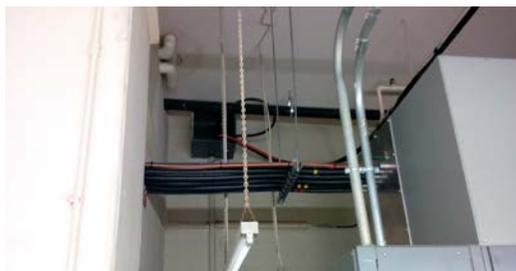
Photo 4: Branch "corflex" feeder conductors

It was not possible to examine the condition of the existing wiring extending from the Distribution Panels to the branch distribution systems connections to devices as most of these are installed in conduit except for what seems to be a relatively recent installation of Corflex conductors (see PHOTO 4) which appear to be in very good condition and properly terminated to the main switchboard in a non-ferric plate as required by Code. However, the expected 25-30year lifespan for the other existing conductors has been exceeded and wiring systems should be replaced during any renovation work being undertaken. This is particularly important as the integrity of conductor insulation is of concern for older wiring systems that have experienced high-load use such as theatrical lighting and refrigeration systems.

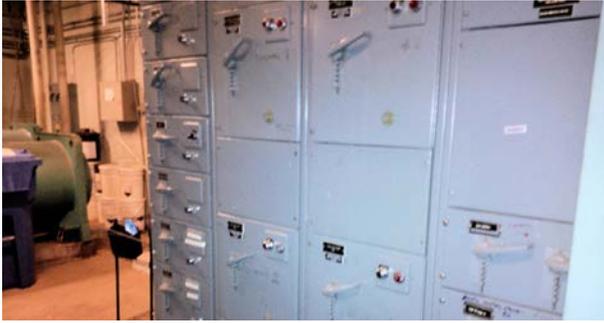
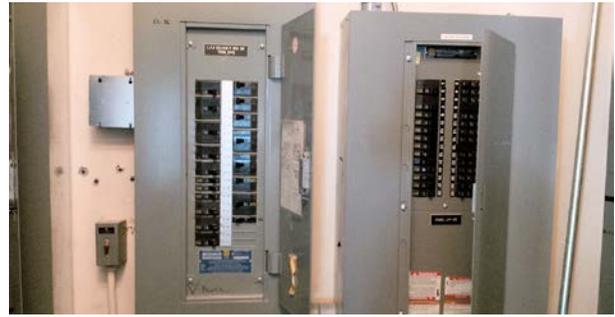
The Distribution Panels service branch panelboards located throughout the building along with Motor Control Centres (MCCs) for mechanical equipment and feed lighting and receptacle loads (see PHOTO 5 and PHOTO 6). There are multiple panels on each of the theatre area floor levels. The majority of the panels seem to be in fair condition but new circuit breakers for some of the older panels are becoming difficult to locate and replacement breakers may not be available in the near future. Most of these panels, and particularly their circuit breakers, have exceeded their expected life span and should be replaced.

Photo 5: Motor Control Centre (MCC)

Photo 6: Typical branch distribution panels

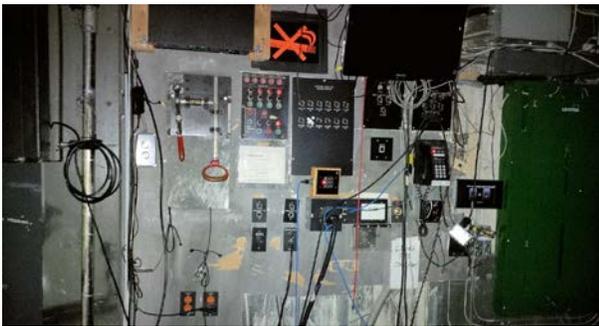
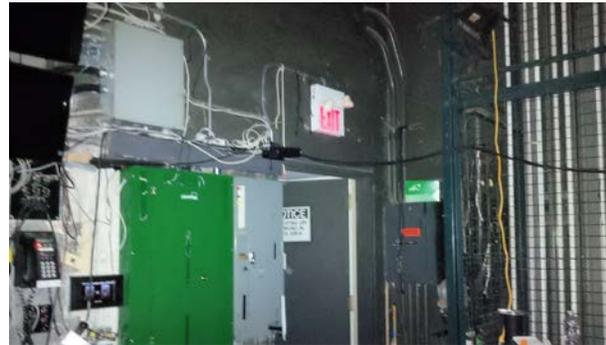
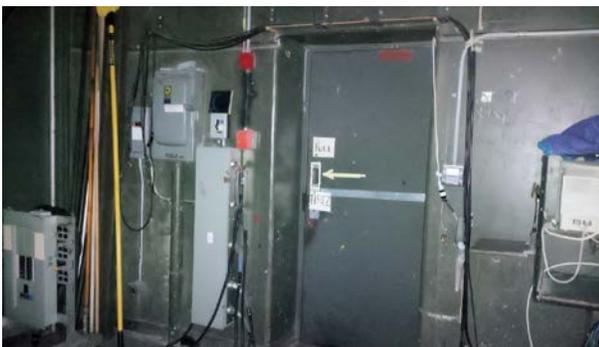
The theatre stage areas make use of several electrical distribution connection points including panelboards, disconnect switches, patch panels with cords, and extension cords (see PHOTO 7, PHOTO 8, and PHOTO 9) which are typical method of power distribution for theatrical venues. The majority of the panels and distribution equipment seems to be in fair condition but new circuit breakers for some of the older panels are becoming difficult to locate and replacement breakers may not be available in the near future. Most of these panels, and particularly their circuit breakers, have exceeded their expected life span and should be replaced.

Photo 7: Theatre stage distribution equipment

Photo 8: Theatre stage dimming panel and distribution panel

Photo 9: Theatre stage distribution equipment

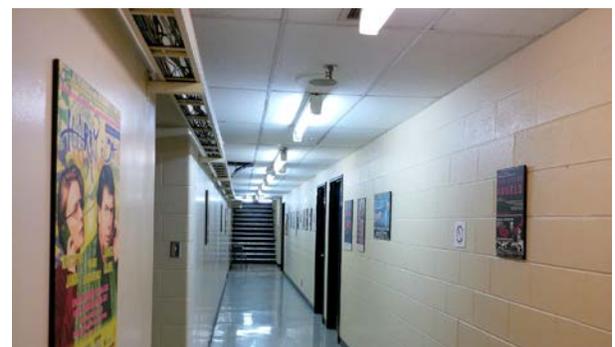
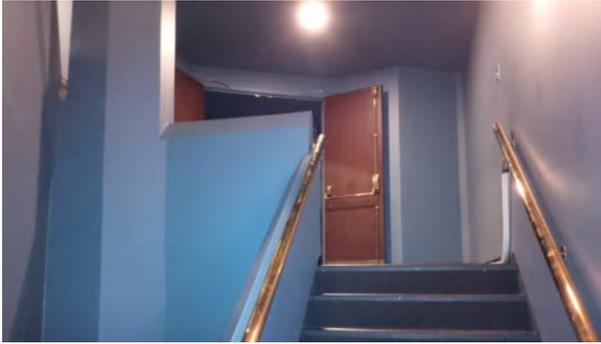
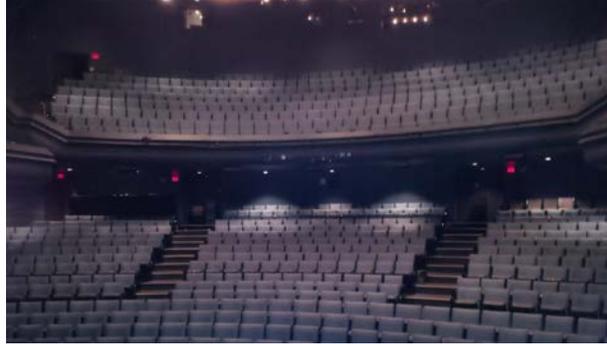
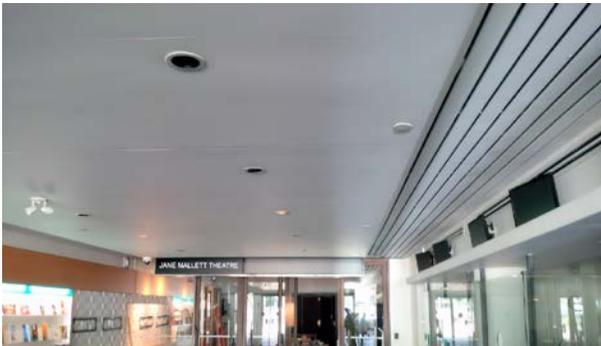
Generally, the illumination quality is poor and luminaires throughout the building are in poor condition and have exceeded life expectancy (see PHOTO 10, PHOTO 11, PHOTO 12, and PHOTO 13). Many luminaire diffusers and covers are either damaged or removed.

Photo 10: Typical service corridor wrap-around luminaires

Photo 11: Theatre stairwell incandescent luminaires

Photo 12: Theatre luminaires

Photo 13: Typical lobby luminaires

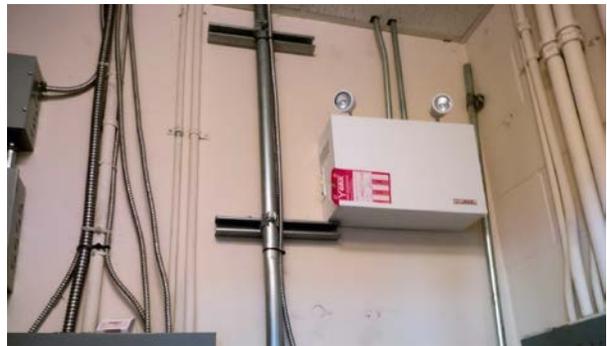
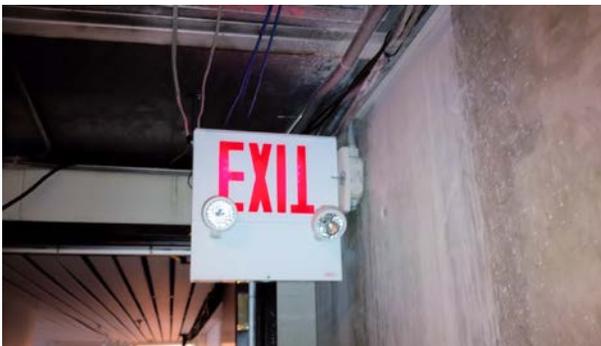
The building is not equipped with an emergency generator. Emergency lighting is comprised of battery units, remote light heads, and combination exit sign / emergency battery units (see PHOTO 14 and PHOTO 15). Some of the units did not seem operational while others appear to be relatively recent additions or replacements. Locations and spacing for the overall system did not appear to be sufficient to provide the minimum Code required levels of illumination along paths of egress including exits and stairwells. Quantity and locations for exit signage would not meet present-day wayfinding requirements. It was noted that one of the combination exit signs with integrated emergency battery lighting component had the text template upside down although interestingly still legible as an EXIT.

Photo 14: Typical emergency battery lighting unit

Photo 15: Typical combination exit sign (upside down text)

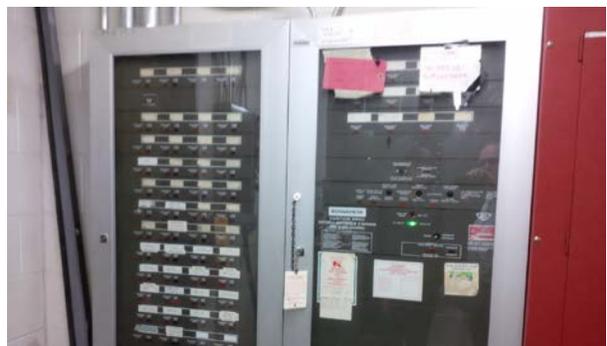
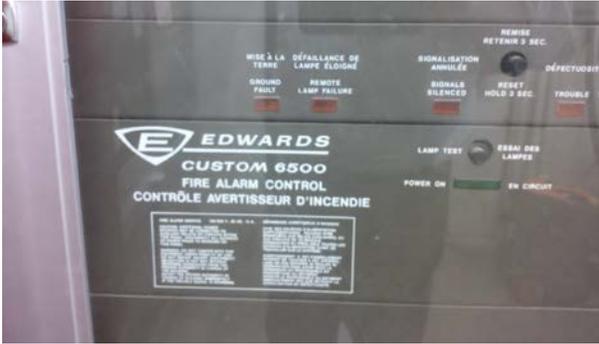
The building is sprinklered and is equipped with an "Edwards" Custom-6500 series fire alarm control panel located in the Basement Level main electrical room (see PHOTO 16 and PHOTO 17). The manufacturer no longer supports this fire alarm panel and new components do not exist. The use of refurbished parts is not allowed. During the visit it was noticed that components for a new fire alarm control panel by "Mircom" FX2000-series system were on site (see PHOTO 18) and we understand that the fire alarm panel replacement was scheduled to be executed. This is an intelligent addressable system and the system what we would have recommended.

Photo 16: Existing Fire Alarm Control Panel (FACP)

Photo 17: Existing "Edwards" custom 6500 FACP faceplate
