505 University Avenue, Toronto- Site investigation report

Prepared by:	Donovan Pauly, MSc, CAHP, APTi (Architectural Materials Conservator)
Prepared for:	Sam Trigilia
Location:	505 University Avenue, Toronto, Ontario
Date of site visit:	September 16-25

Objective

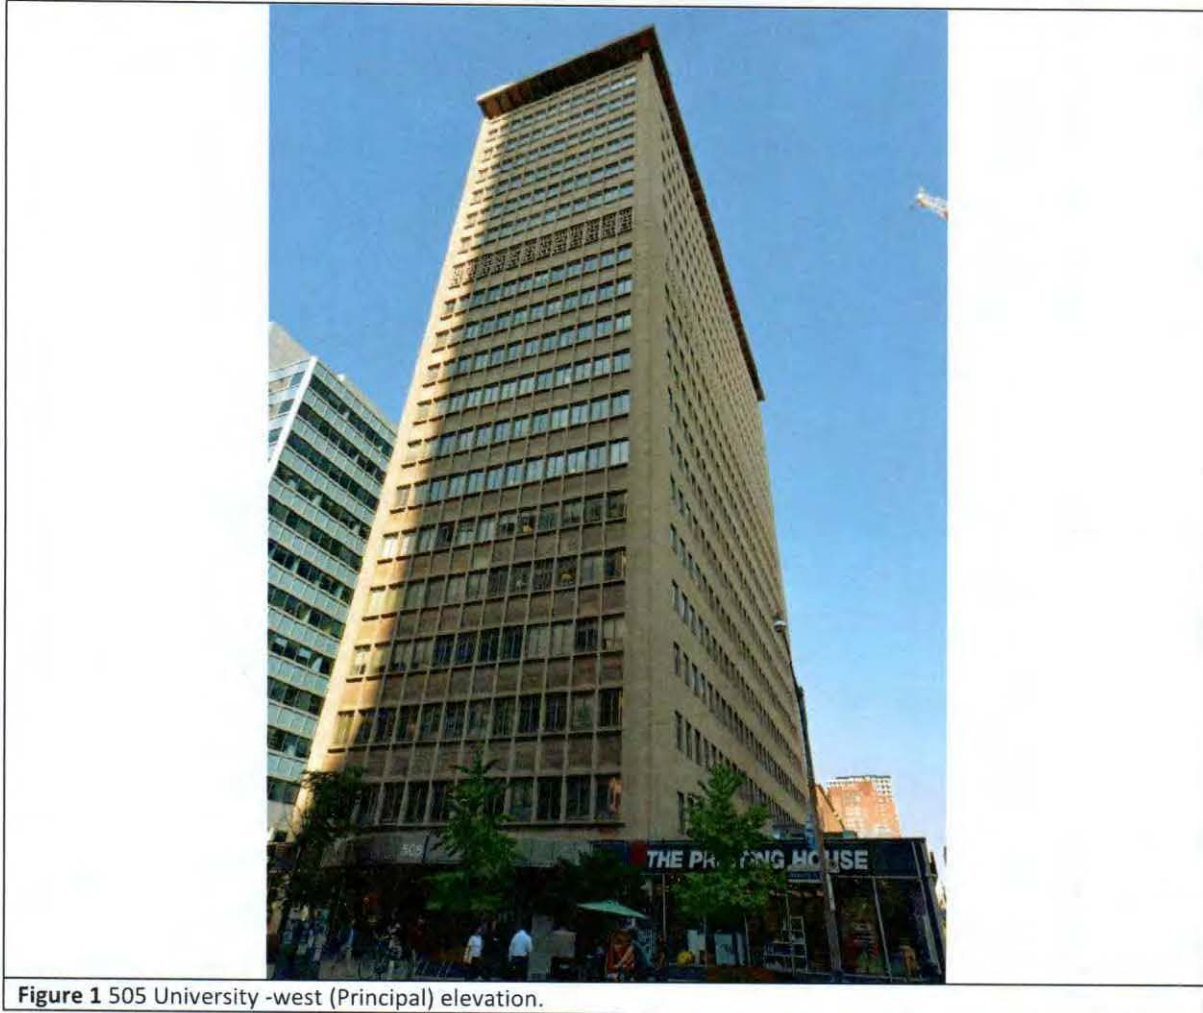
Figure 1 505 University -west (Principal) elevation.

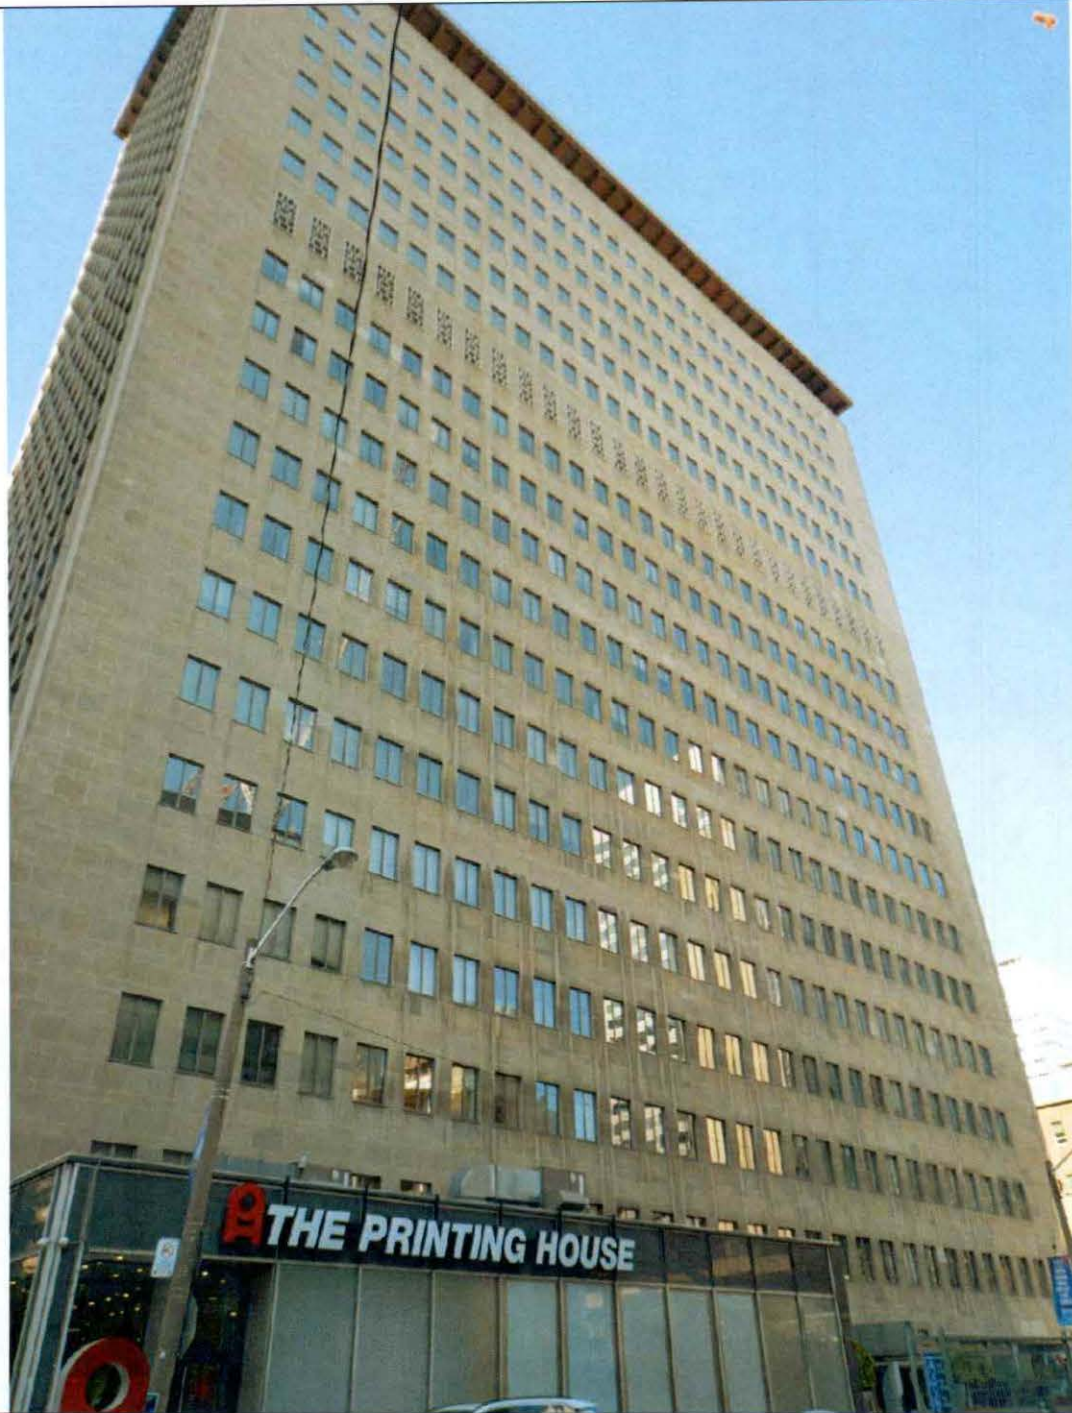
Figure 6 Overview of the south elevation.

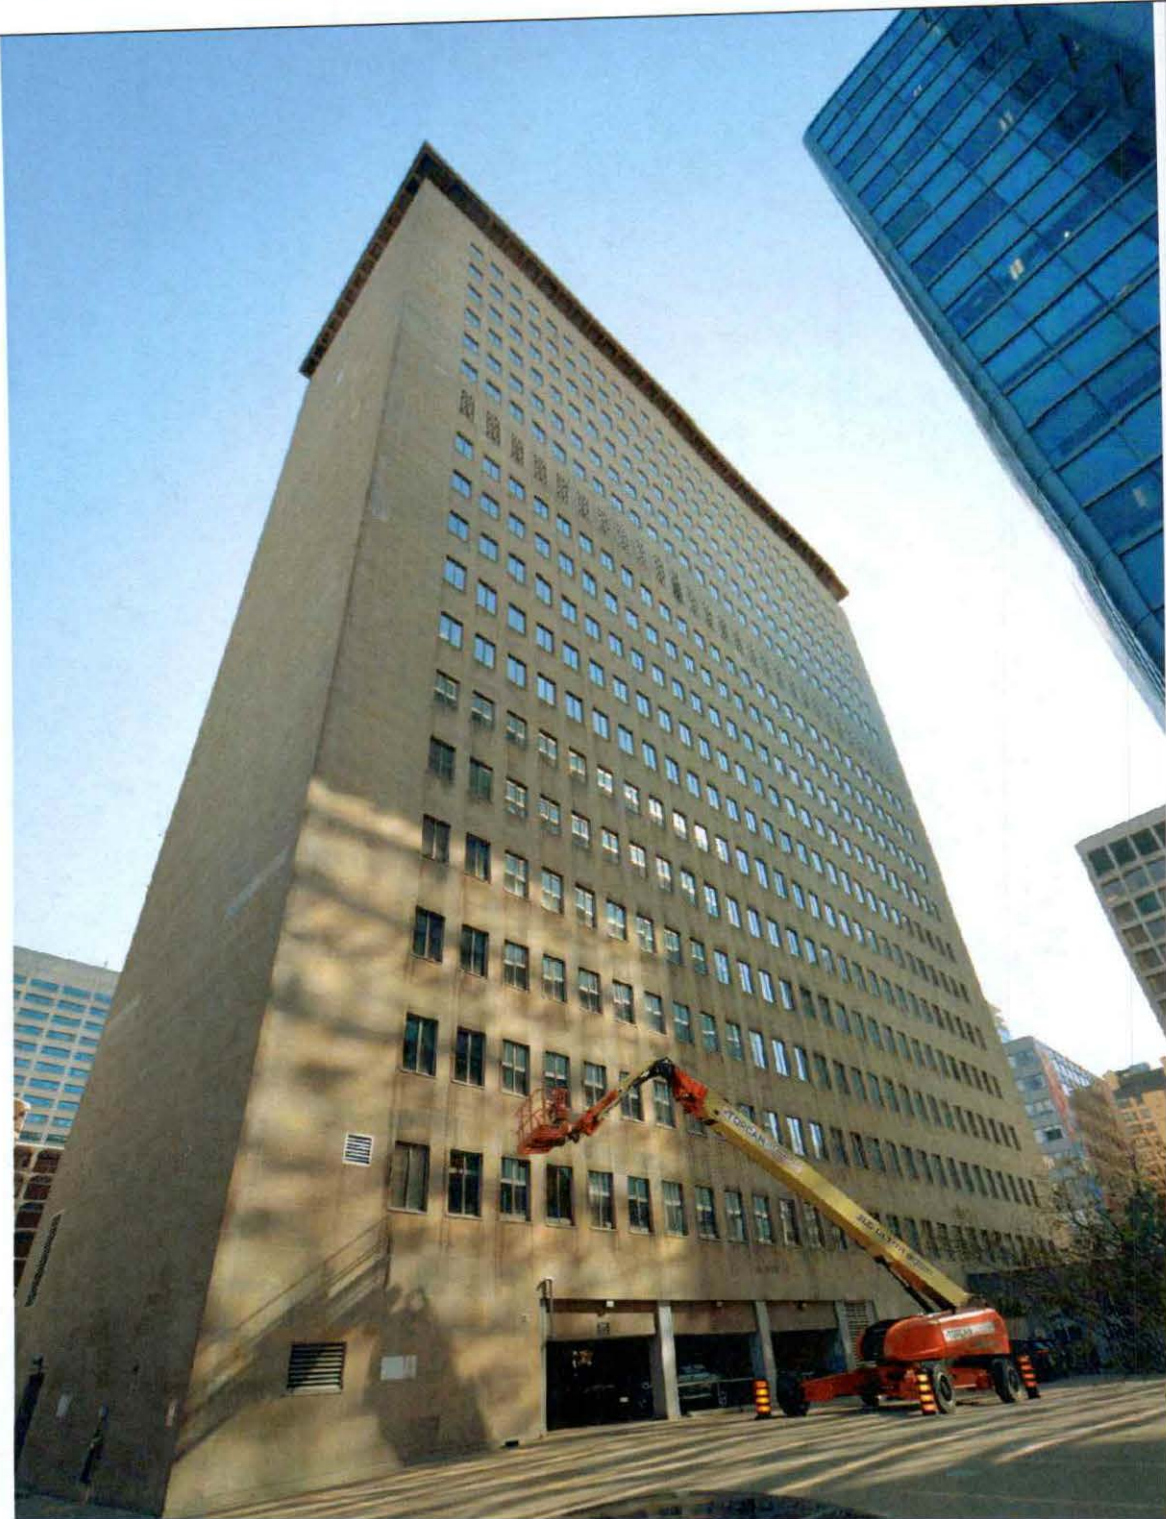
Figure 8 Overview of the north elevation.

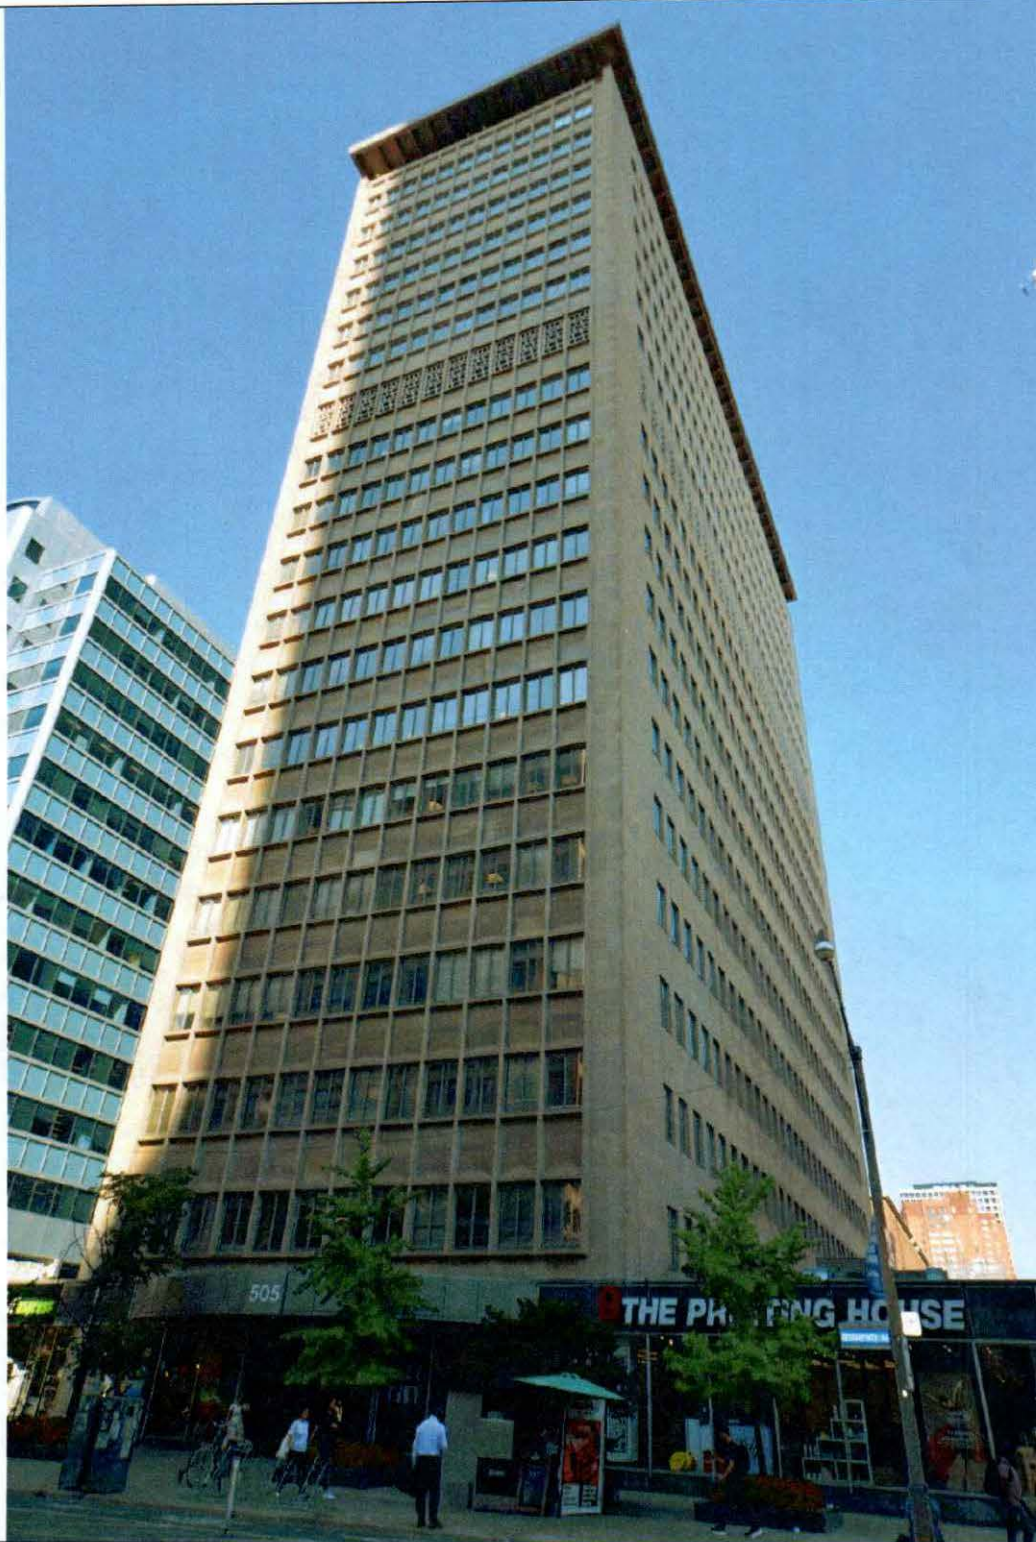
Figure 9 Overview of the west elevation.

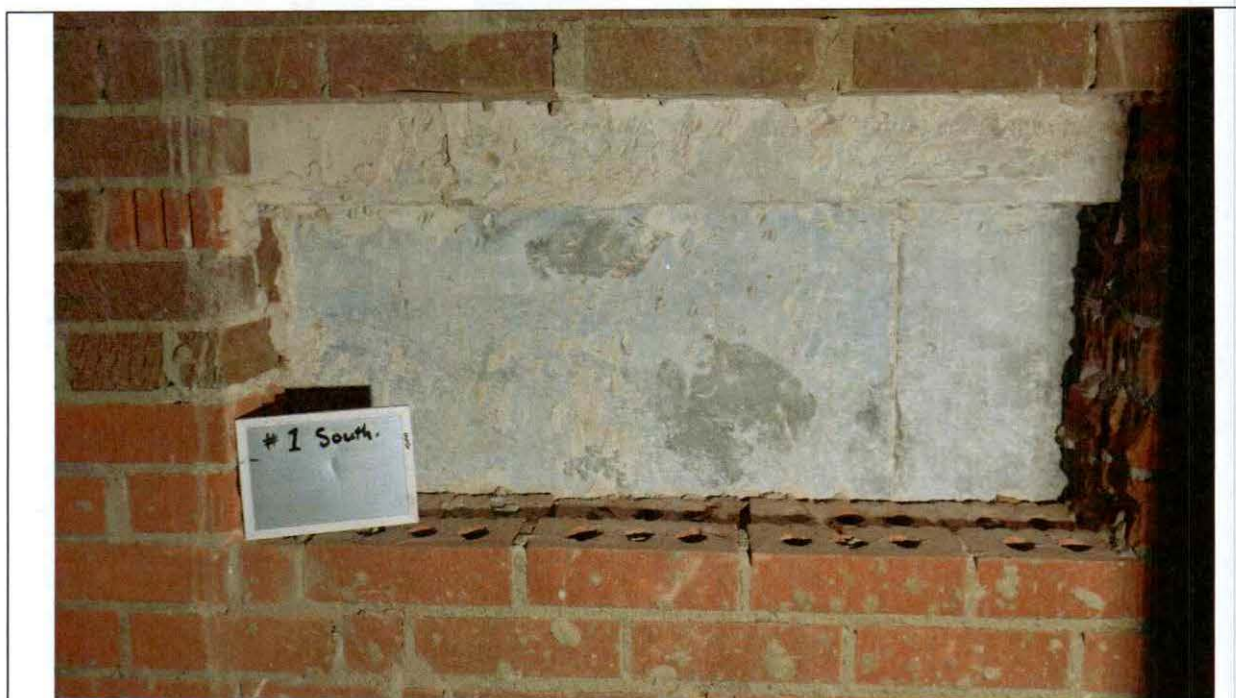
Figure 10 Investigation opening #1 in vent shaft. 2 wythes brick masonry to back of stone.

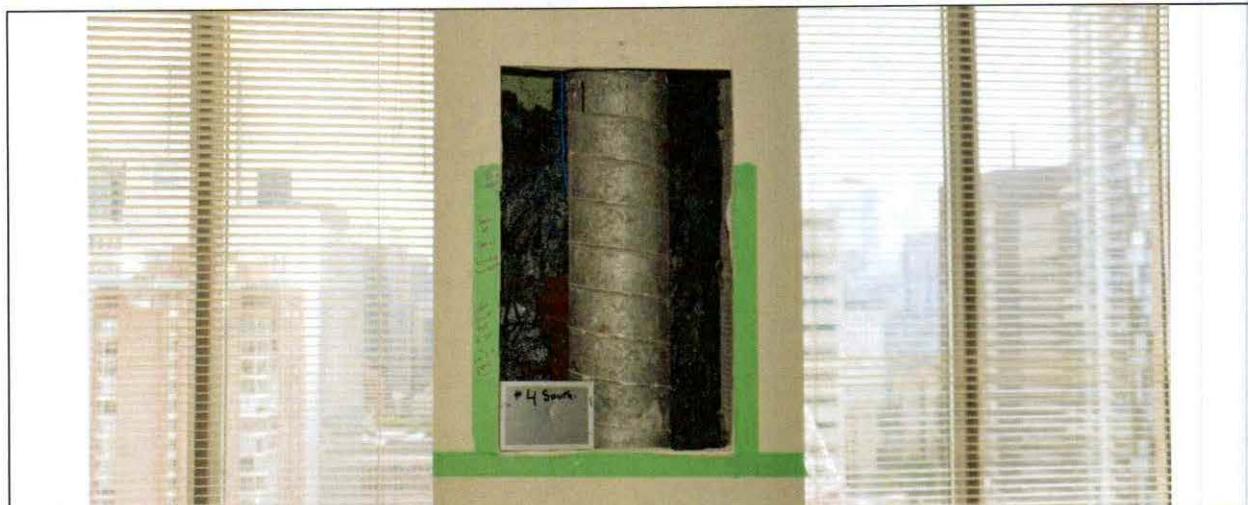
Figure 16 Investigation opening #4 spiral vent duct in front of mullion masonry

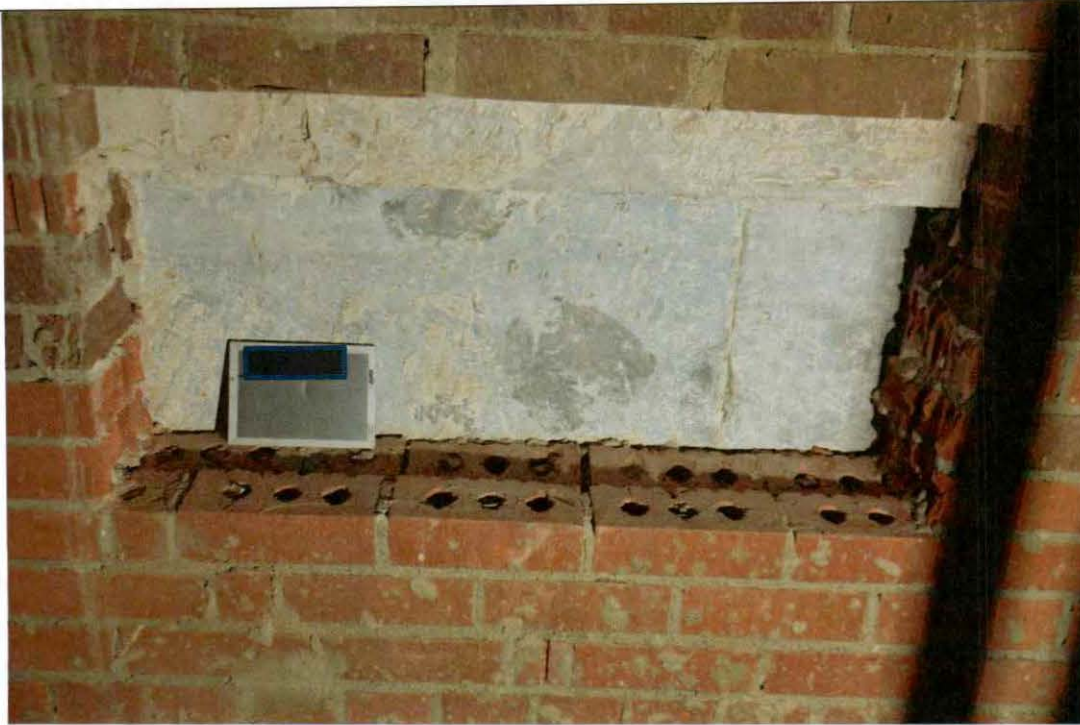
Figure 18 Investigation opening #5 in vent shaft.

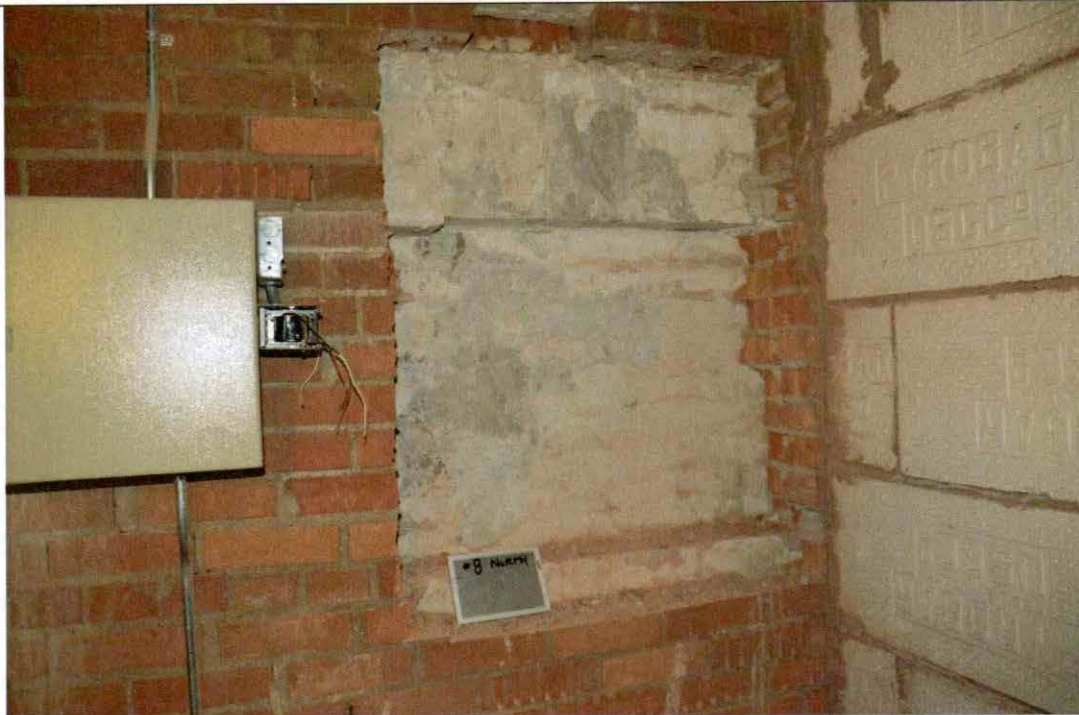
Figure 24 Investigation opening #8 in vent shaft.

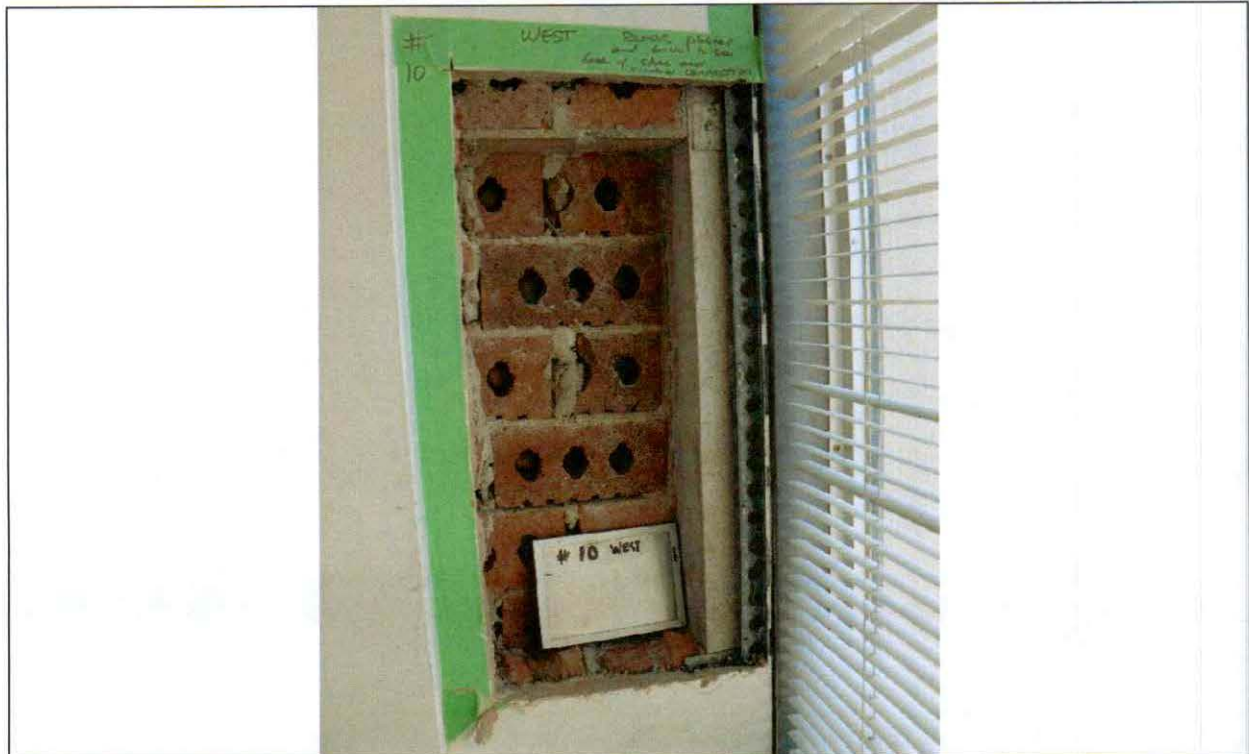
Figure 28 Investigation opening #10 window mullion.

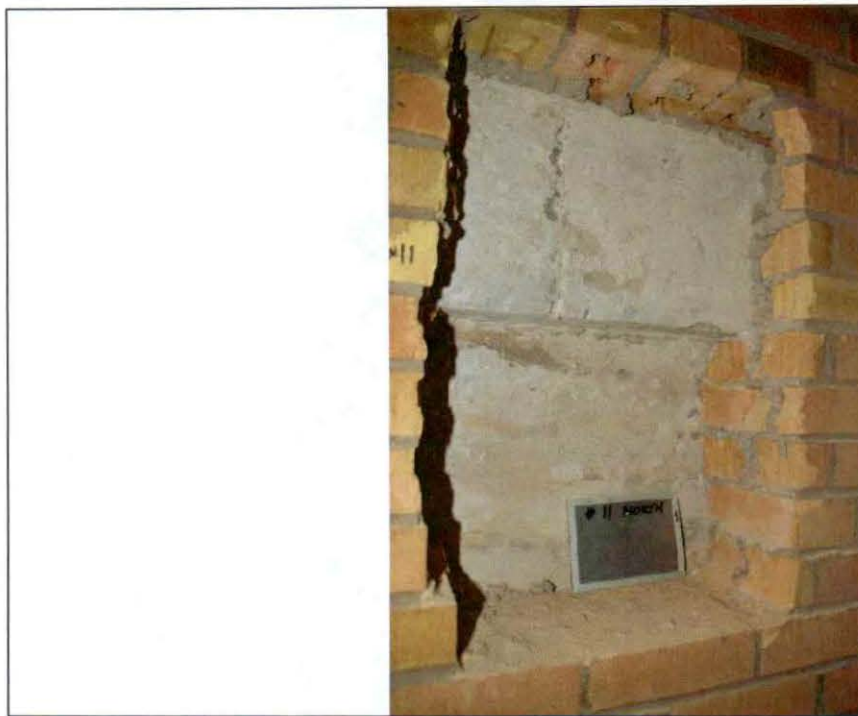
Figure 30 Investigation opening #11 in vent shaft.

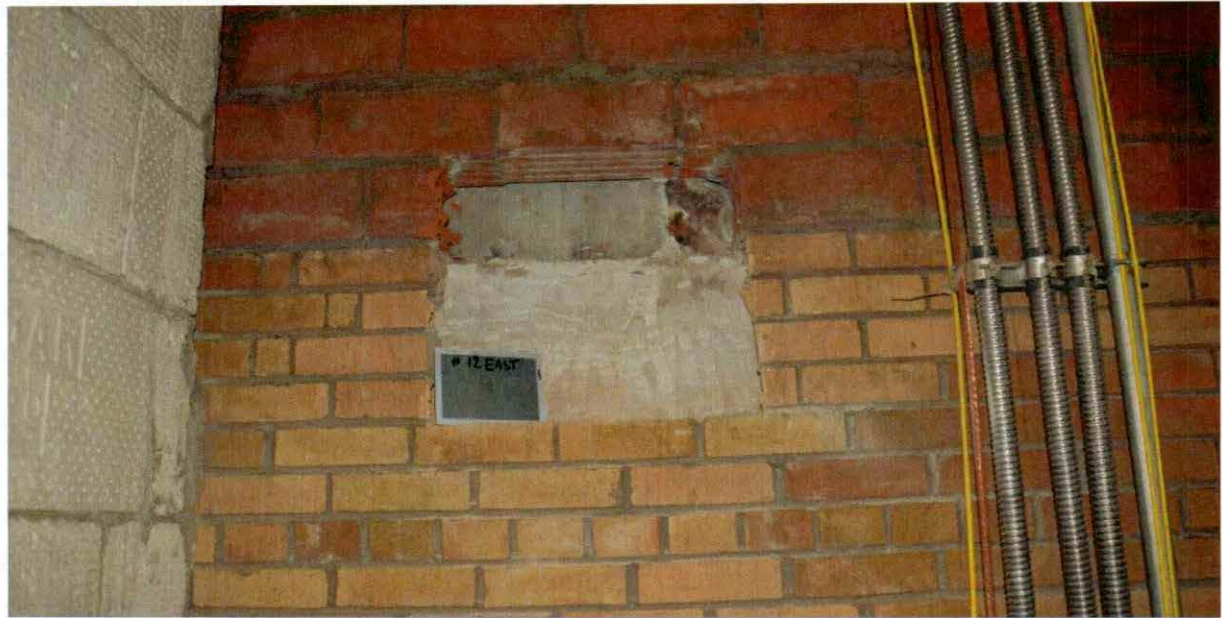
Figure 32 Investigation opening #12 in vent shaft.

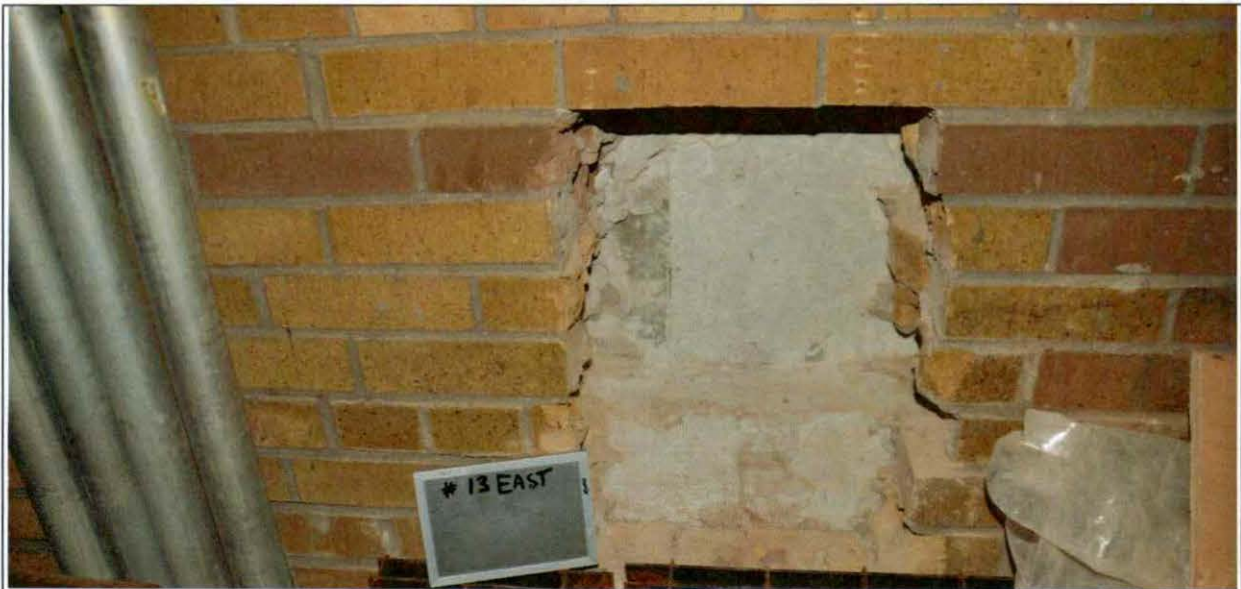
Figure 34 Investigation opening #13 in vent shaft.

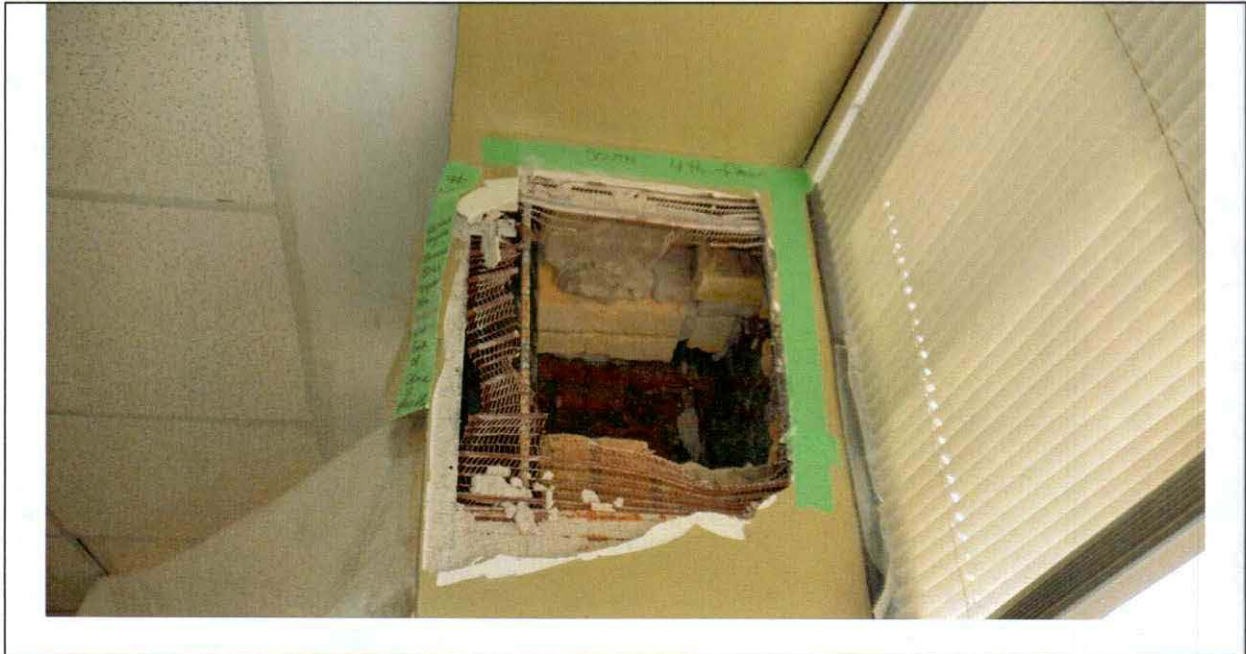
Figure 40 Investigation opening #16 at column.

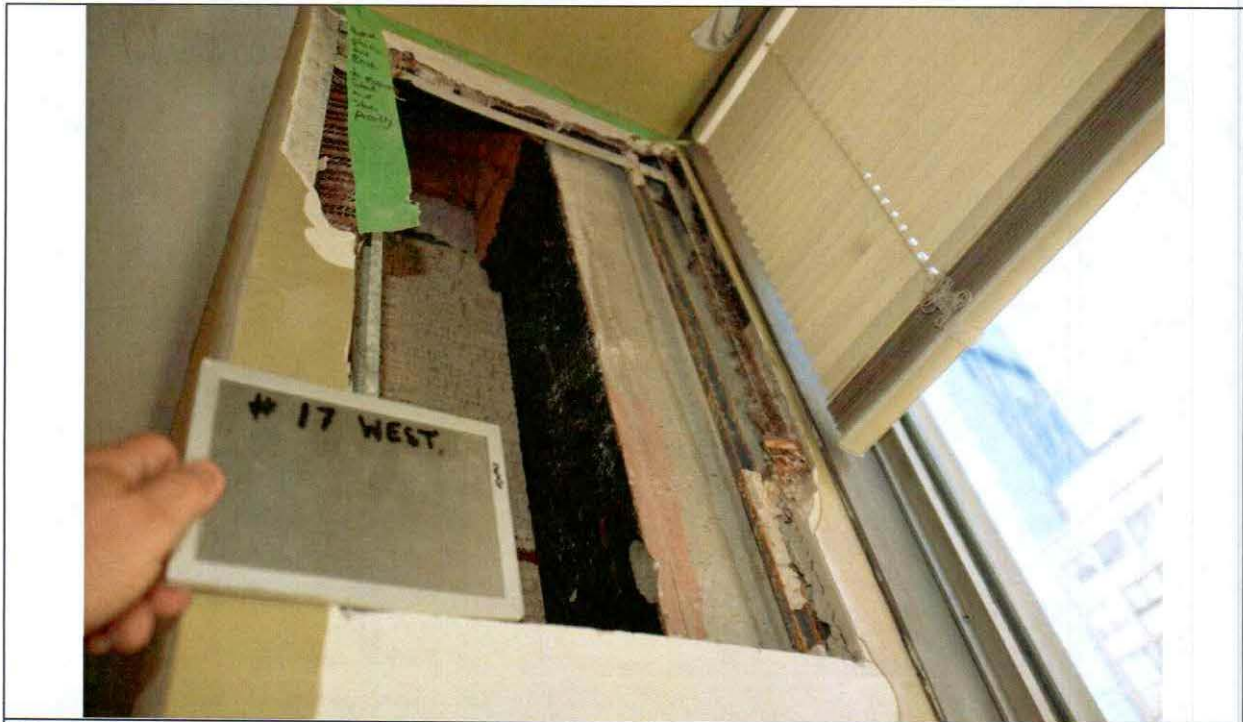
Figure 42 Investigation opening #17.

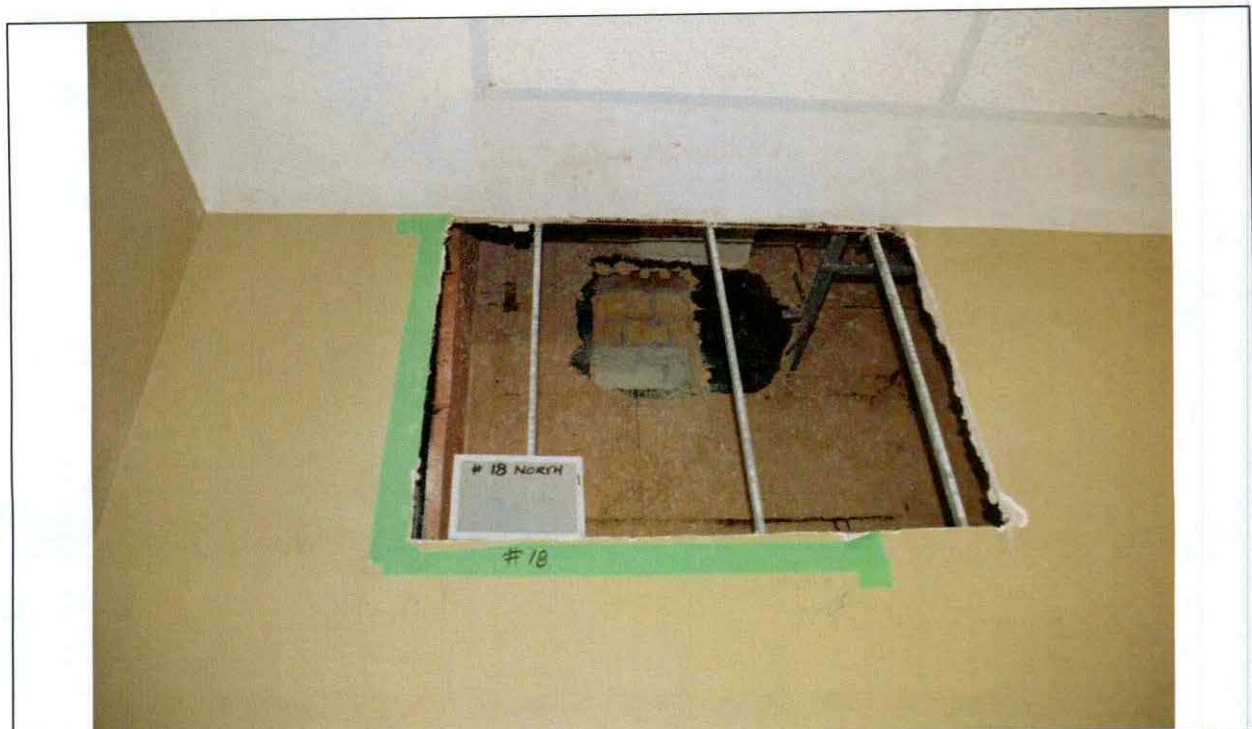
Figure 44 Investigation opening #18.

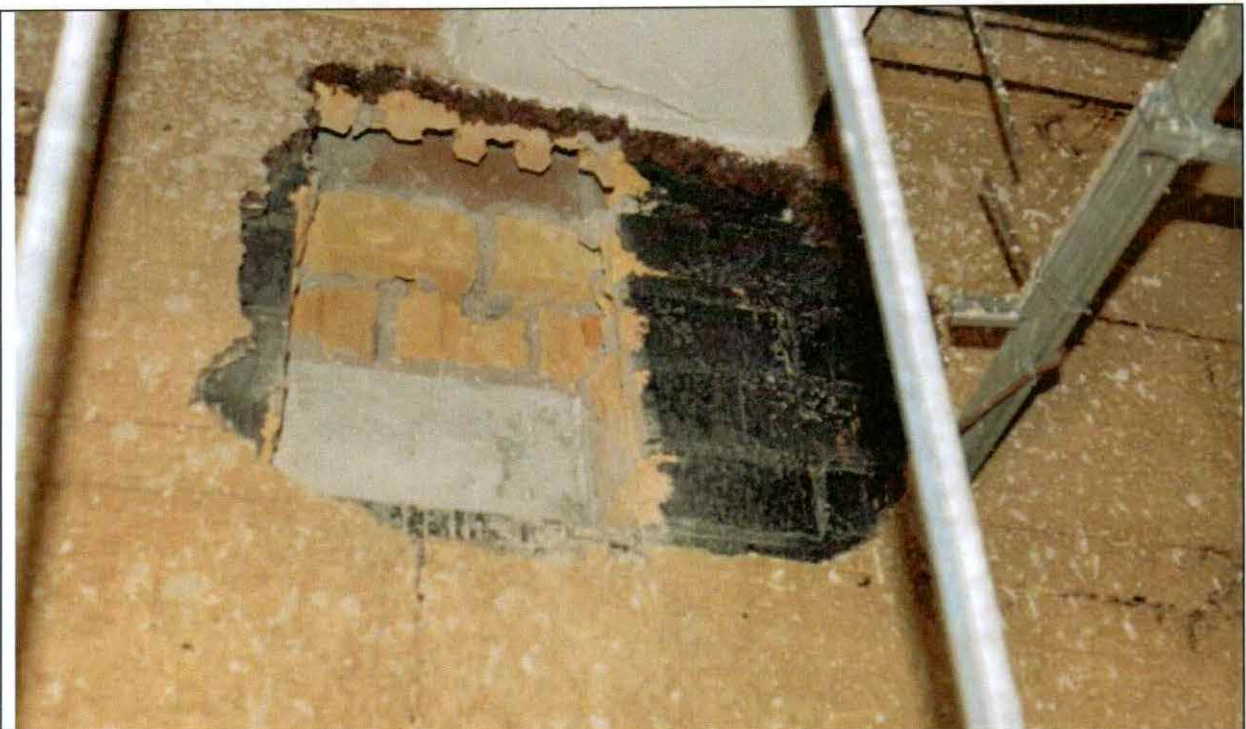
Figure 45 Investigation opening #18 Detail. Corkboard and brick masonry were removed. Stone is block bonded into backup.

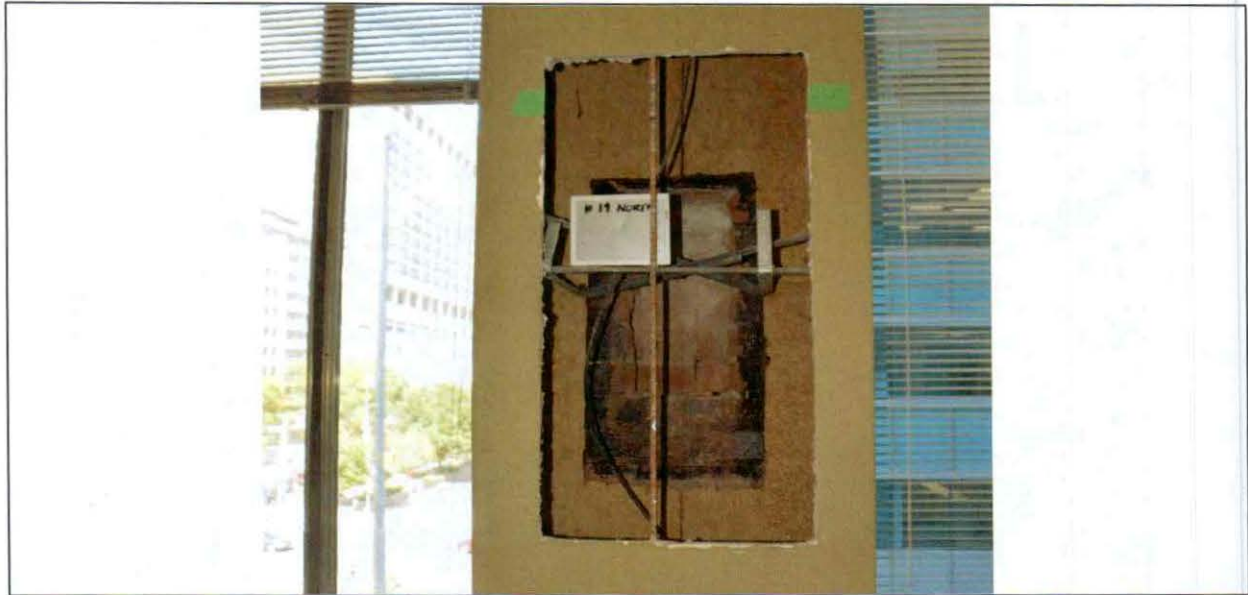
Figure 46 Investigation opening #19.

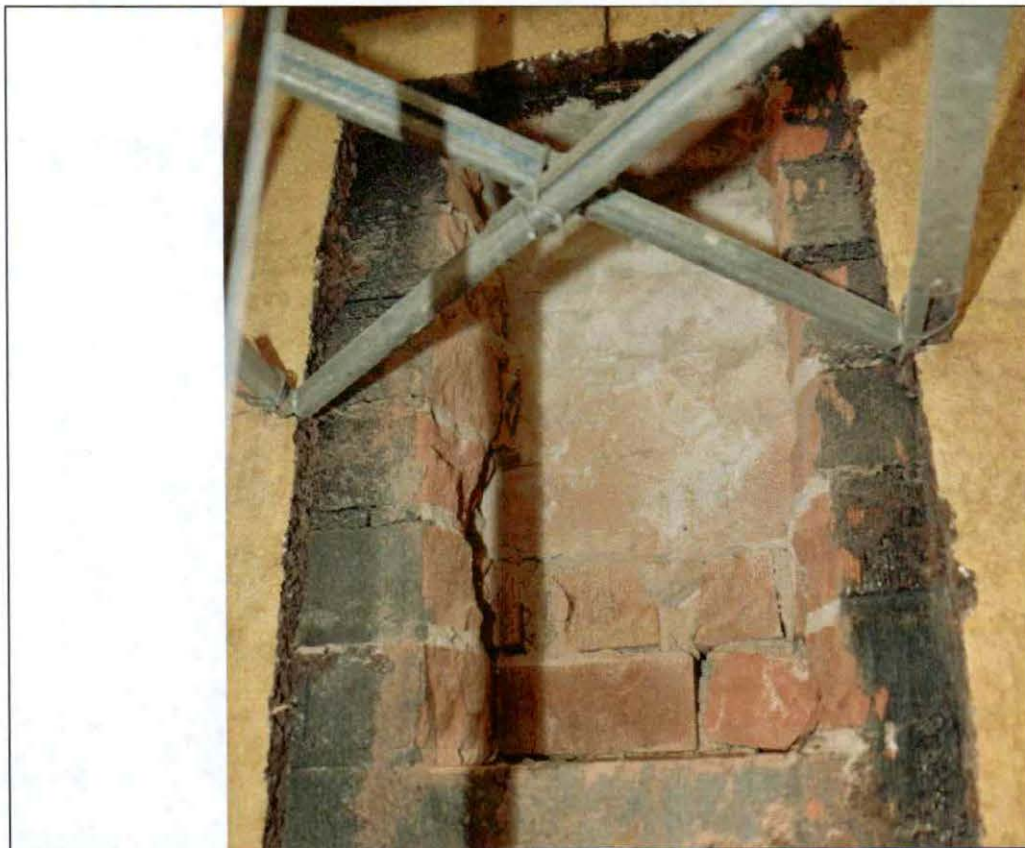
Figure 47 Investigation opening #19 Detail. Corkboard and brick masonry were removed. Stone is block bonded into backup.

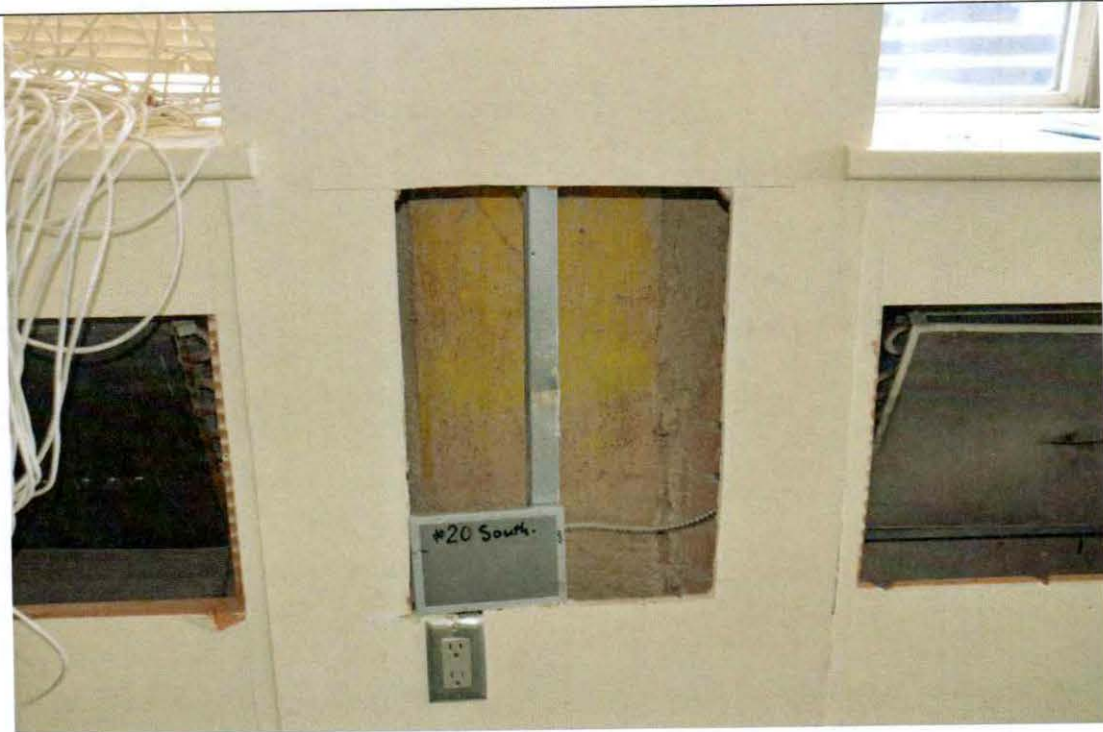
Figure 48 Investigation opening #20 at column.

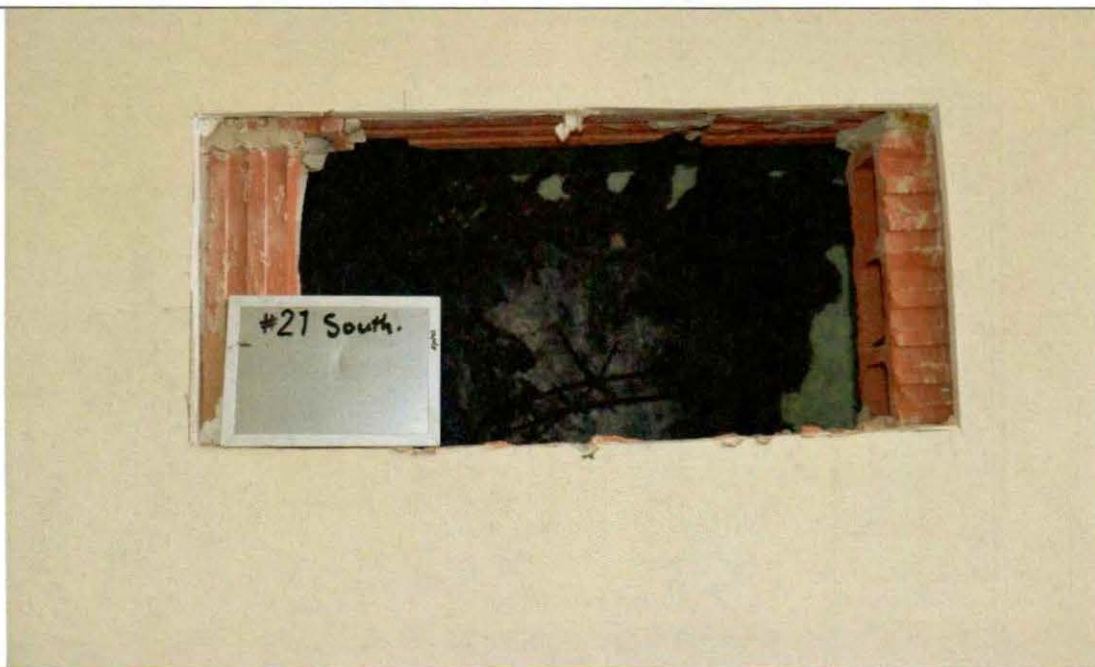
Figure 50 Investigation opening #21.

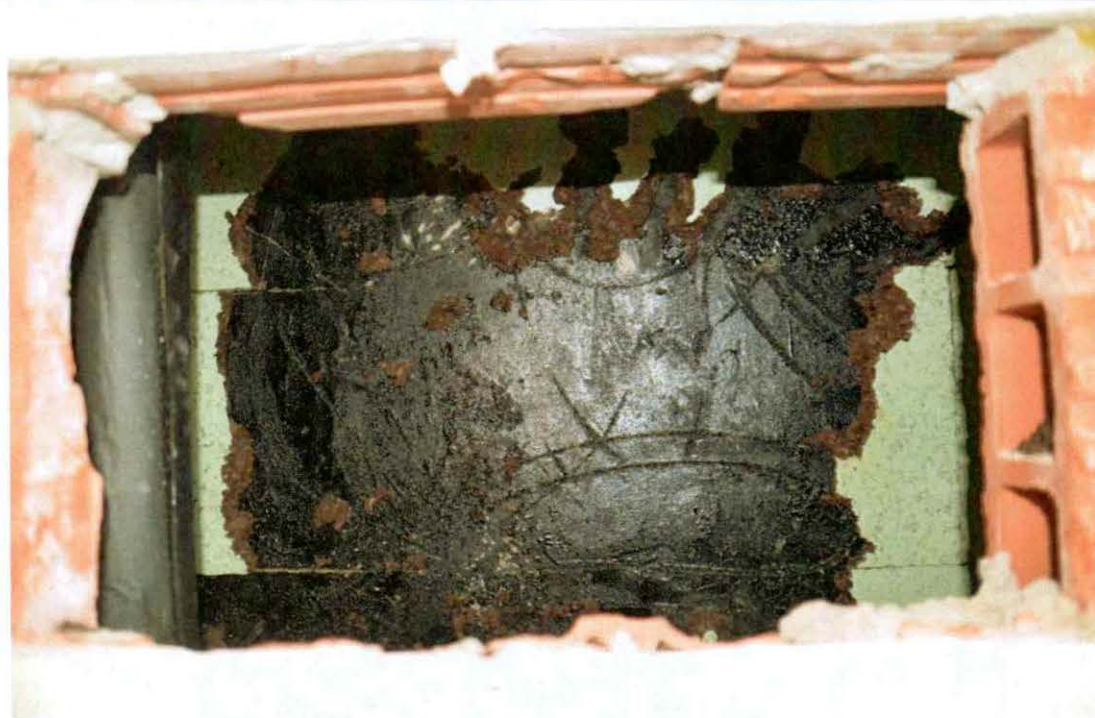
Figure 51 Investigation opening #21 Detail. The corkboard was removed back of the stone was parged and bitumen paint coated.

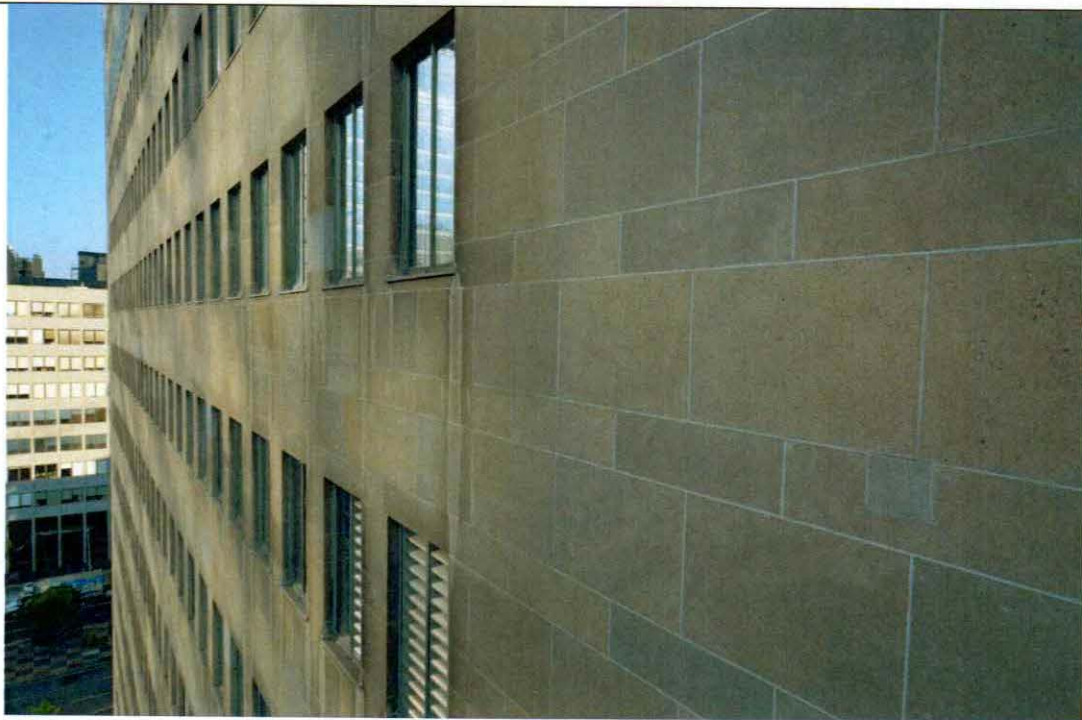
Figure 55 South elevation at the 5th floor. The masonry is in good condition. Note replaced window mullion panel- Indiana limestone and surface mortar patch (RHS).

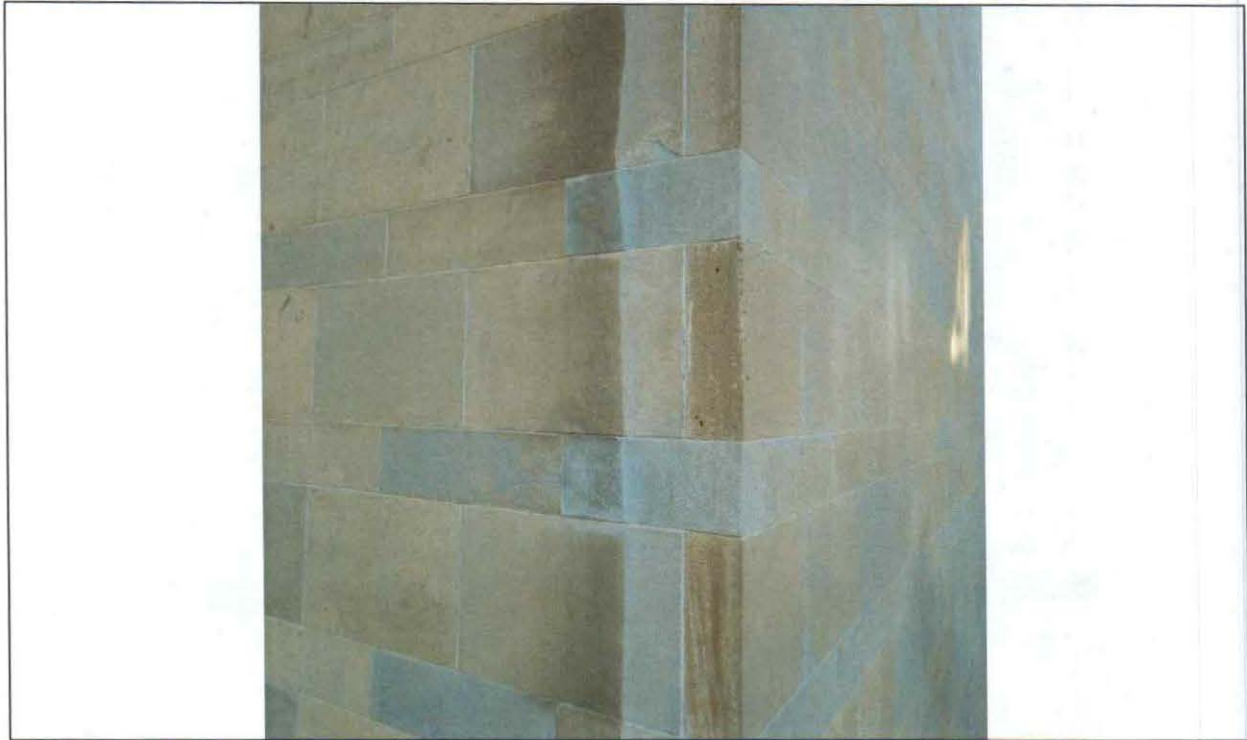
There is also a slightly less concerning crack at the southeast corner on the south elevation mirroring the cracking on the north. This crack also seems to start near grade, passing through mortar joints and eventually through some stones at the 3rd and 4th floors, and terminating at the 5th floor. This cracking/movement does not display any significant displacement in the veneer. This is a very similar pattern to the movement crack on the north and it is equally difficult to pinpoint the cause. This cracking also should be addressed soon and some additional investigation to determine and remediate the cause(s) would be prudent. The other corners of the building (southwest and northwest) were also visually examined to determine if cracking is occurring there, and one cracked (bonder) stone and some debonded mortar joints were noted at the southwest corner of the south elevation at the 4th floor similar to the east end but less severe.

Figure 58 Southeast corner elevation at the 2nd floor. Note that debonded joints continue to grade.

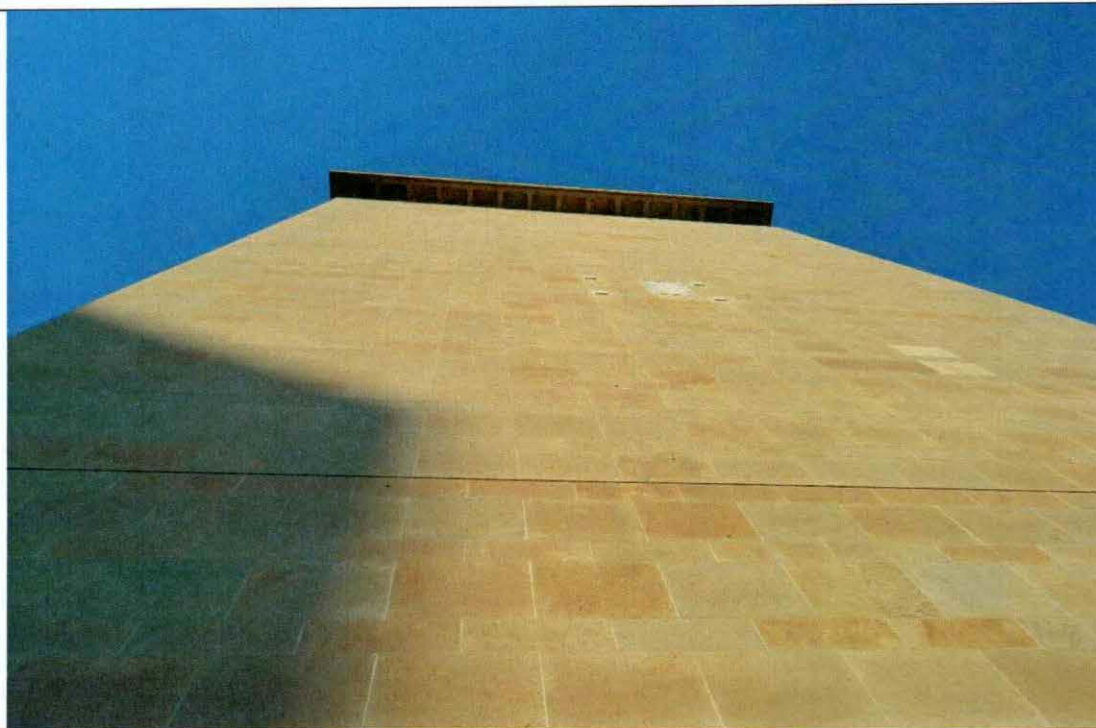
Figure 61 East elevation floors 12-20. The masonry is in good condition.
